NASA CR-72780

EXPERIMENTAL LIQUID METAL SLIP RING PROJECT

HUGHES AIRCRAFT COMPANY

FINAL REPORT

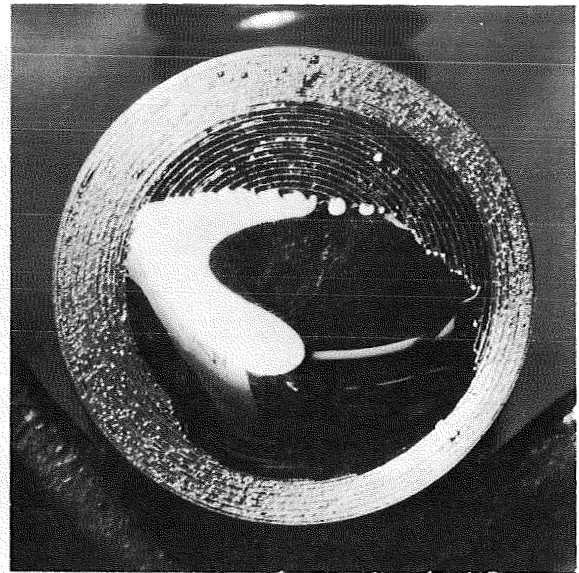
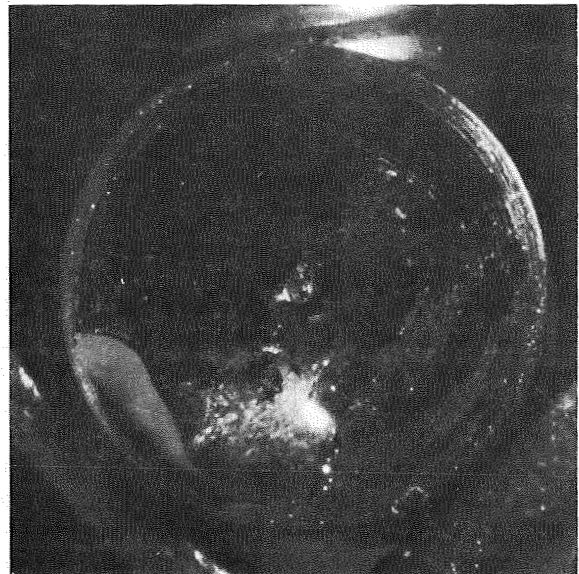
FIGURE 22. Tungsten Electrode Before and After Screening Test

Pendant drops of gallium were noted on a few MEFs, but none fell during the screening test exposure. The calculated resistance of the gallium in the gap was adjusted for such drops by excluding their approximate volume. These drops formed mostly during the handling necessary to attach the voltage and current taps and arrange the MEFs on the racks in the thermal chambers. It was noted that after such a drop had been formed for a few days, the MEF could be inverted and the liquid metal drained out of the drop, leaving a wrinkled empty sack. The excess liquid metal would be

(a) Wiped for weighing, pre-test

(b) Drop of liquid metal applied

(c) Drop of liquid metal spread.  
Note surface film.

(d) Rewetted, post-test

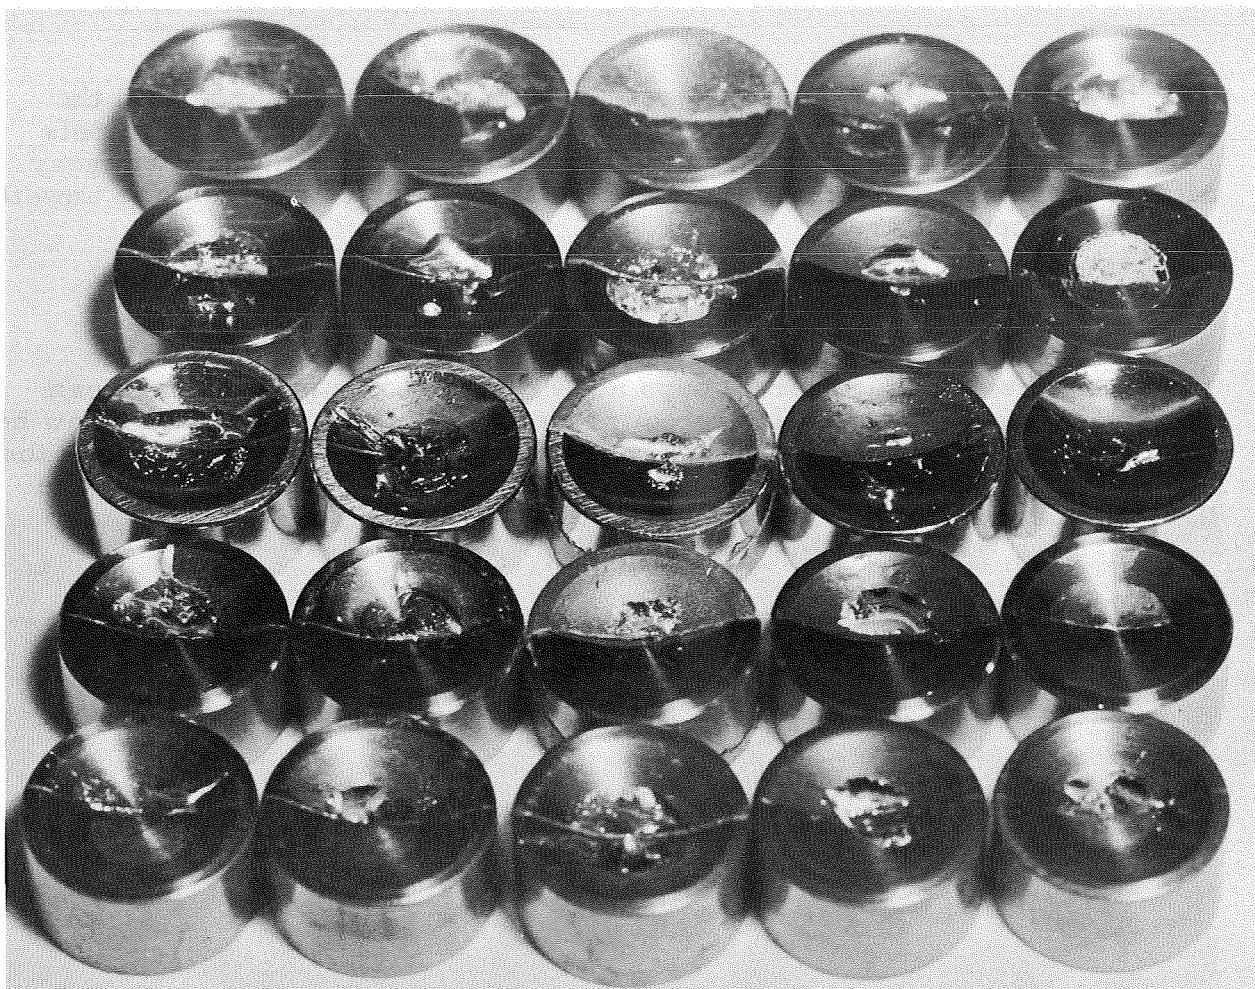
FIGURE 25. Barrier Film Samples After Screening Test

The barrier film samples are shown in Figure 25 after they were tapped to remove all gallium that was not tightly adhered. The uncoated electrode material is in the foreground of each sample. Figure 26 can be used to locate the samples in Figure 25.

All 25 of the barrier film-electrode material combinations showed wetting or gallium residue on the barrier film. For the nickel-plated copper substrate material the least wetting of the barrier film occurred with the Braycote perfluorinated polymer, followed by the bonded teflon coating, although the bare nickel surface under the gallium was wetted to about the same extent. The bare stainless steel was almost free of gallium, but each barrier film was wetted except the perfluorinated polymer, to which the gallium adhered and left a thin residue. It is clear that the natural oxide film on the electrode materials is a better barrier film than any of the applied films insofar as resistance to wetting by gallium is concerned.

None of the barrier films was damaged by the gallium. The Parylene C coating failed to adhere to the bowl of the stainless steel sample. The Parylene C became markedly "frosted" on the beryllium sample. The gallium wetted and corroded the beryllium-copper/Parylene C sample on the bare metal. The beryllium-copper samples which had been heated to cure the coating resisted wetting by the gallium.

FIGURE 26. Location of Barrier Film-  
Electrode Material Samples in Figure 25

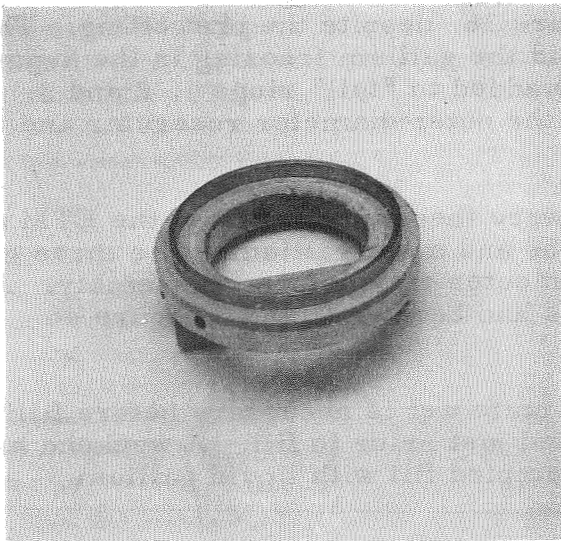
b) Ring 4 with Masking Tape Applied

The gallium only wets the nickel when sufficient pressure is applied, so that the chance of inadvertently wetting a surface is small. However, in order to attain a well-defined edge to the wetted area, masking tape was used as shown in Figure 44. The masking tape was readily removed with no visual residue. Unwet bands of from 0.010 inch (0.25 mm) to 0.030 inch (0.75 mm) remained in the corners of the inner and outer rings of the cup gap configuration. The coverage of the center lands of the radial gap rings was generally complete. Several dents in the damaged area of inner ring 9 were not wet at the bottom. No attempt was made to protect the bottoms of the small grooves, but only a few slight spots of gallium adhered there.

FIGURE 44. Initial Wetting of Cup Gap Inner Ring

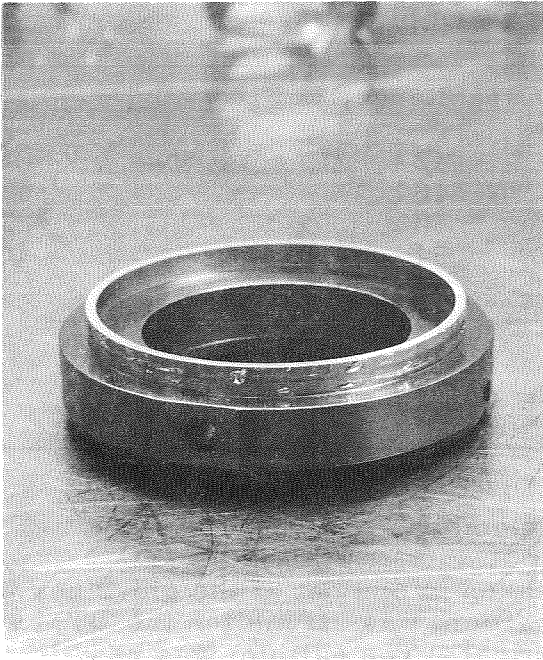
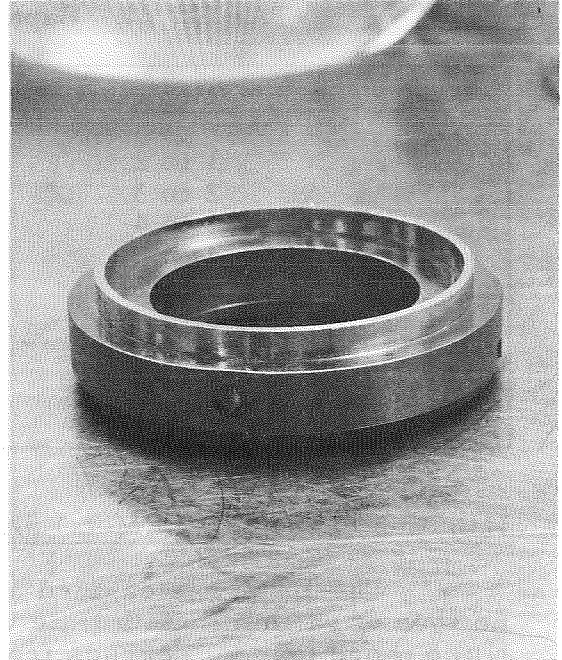
a) Inner ring after attempted fill. Circumferential track is from dial indicator used to check runout.

b) Inner ring made shiny wet before reassembly.

c) Outer ring after attempted fill. Note that some areas are wet and some are not.

d) Outer ring rewetted and filled.
