APOLLO SERVICE PROPULSION SYSTEM ROCKET ENGINE  
BIPROPELLANT VALVE IMPROVEMENT PROGRAM

Phase I Report

Report 8317-PI

July 1970

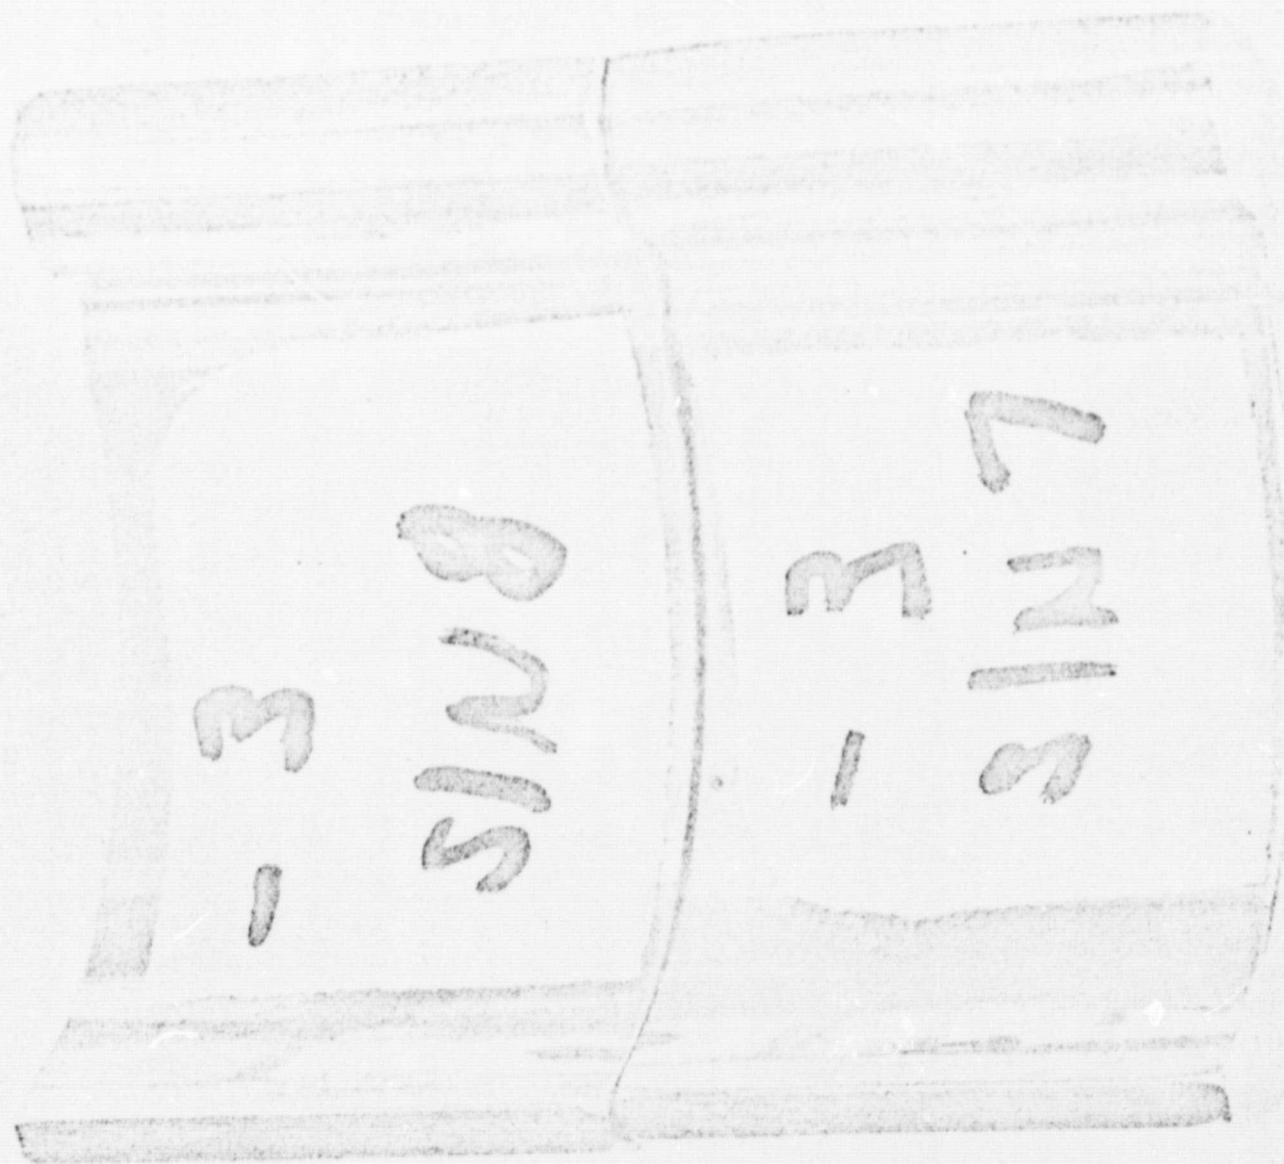
Oxidizer Followers after Wet Cycle Testing

Oxidizer Cams and Followers - Minor wear similar to that shown in Figure 37 was noted on all parts. Some lubricant (very little) remained on loading surfaces. The minor wear was in the centers of the cams and followers.
