**ADVANCED REFRACTORY ALLOY CORROSION LOOP PROGRAM**

**QUARTERLY PROGRESS REPORT NO. 22**

**For Quarter Ending October 15, 1970**

NUCLEAR SYSTEMS PROGRAMS  
SPACE DIVISION

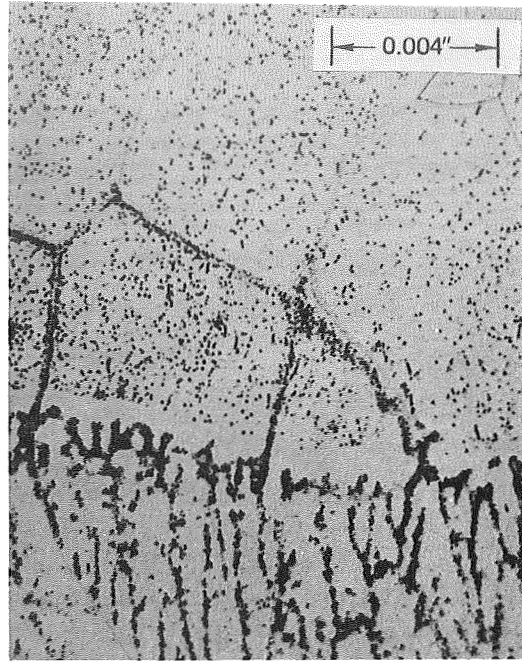
a. Near bottom - potassium inlet showing tack weld joining wire and centerbody

b. Near top of insert

Figure 10. T-111 Swirler Wire from Plug Section of Boiler.

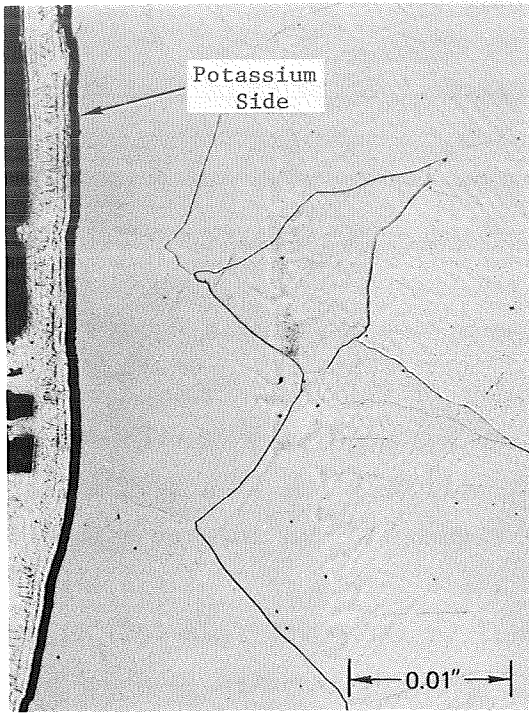
a. 3/8-inch OD potassium containment tube

b. 1-inch OD lithium containment tube

Figure 13. Repair Welds in Top Coil of the 3/8- and 1-inch T-111 Tubing from the Boiler.

boiler which were representative of the hottest (2240°F) part of the boiler. The repair welds on both the 3/8 and 1-inch tubing appeared to be in excellent condition as shown in Figure 13. The areas shown represent the weld metal-base metal interface, which past experience has shown to be the most critical from the standpoint of alkali metal compatibility, and, as clearly seen, no evidence of corrosion is evident.

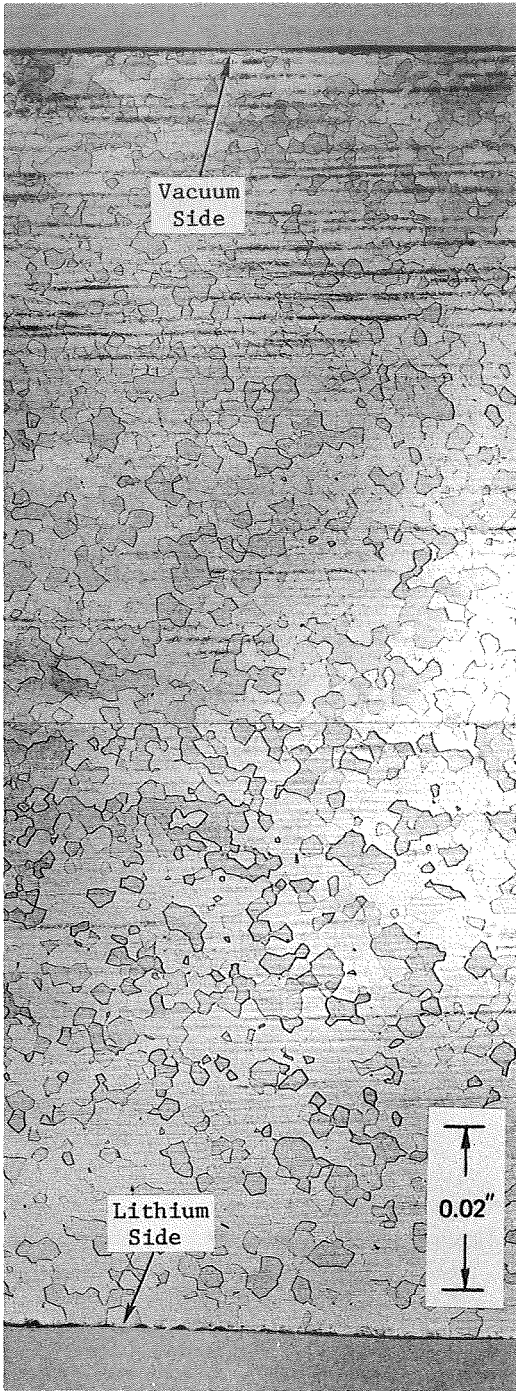
Figure 17. Repair Socket Weld in 3/8-inch Lithium Exit Line from Boiler.

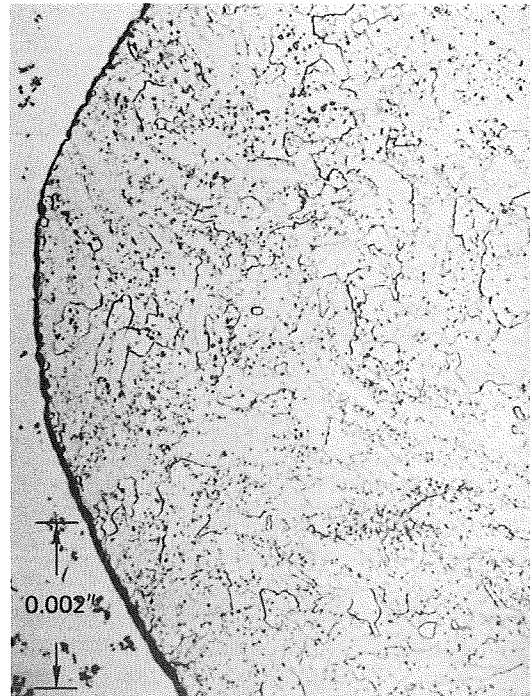
a. Mo-TZC Alloy

Figure 28. Pretest Microstructure of Materials Used for Turbine Simulator of the T-111 Rankine System Corrosion Test Loop.

Sections from the Mo-TZC first, second and tenth stages and the Cb-132M sixth stage nozzle and blades were examined in the vapor impingement area. No change in general microstructure was observed in any of the specimens examined as shown in Figures 24-27. The only anomalous feature is a thin coating on the leading edge of the first and second stage blades and on the second stage nozzle as shown in Figures 24 and 25. Microprobe evaluation will be performed to determine the composition of the film. Typical pretest photomicrographs of each material are shown in Figure 28.
