**MSC APOLLO 13 INVESTIGATION TEAM**

**SPACECRAFT  
INCIDENT INVESTIGATION**

**VOLUME III**

**SPECIAL ANALYSES AND TESTS  
IN SUPPORT OF INVESTIGATION**

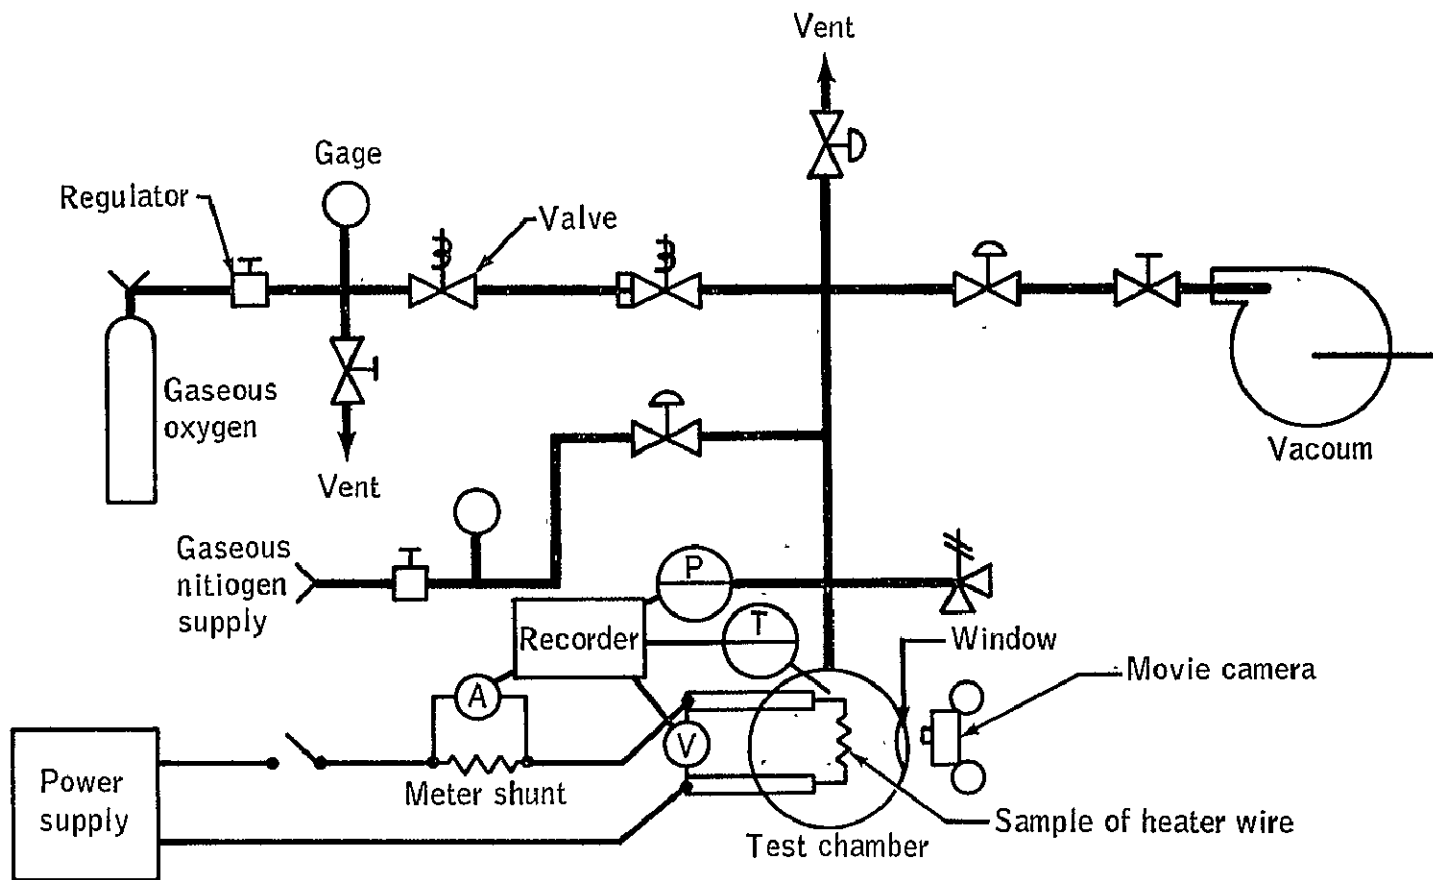
Figure B.16-1.- Low pressure gaseous oxygen ignition schematic.

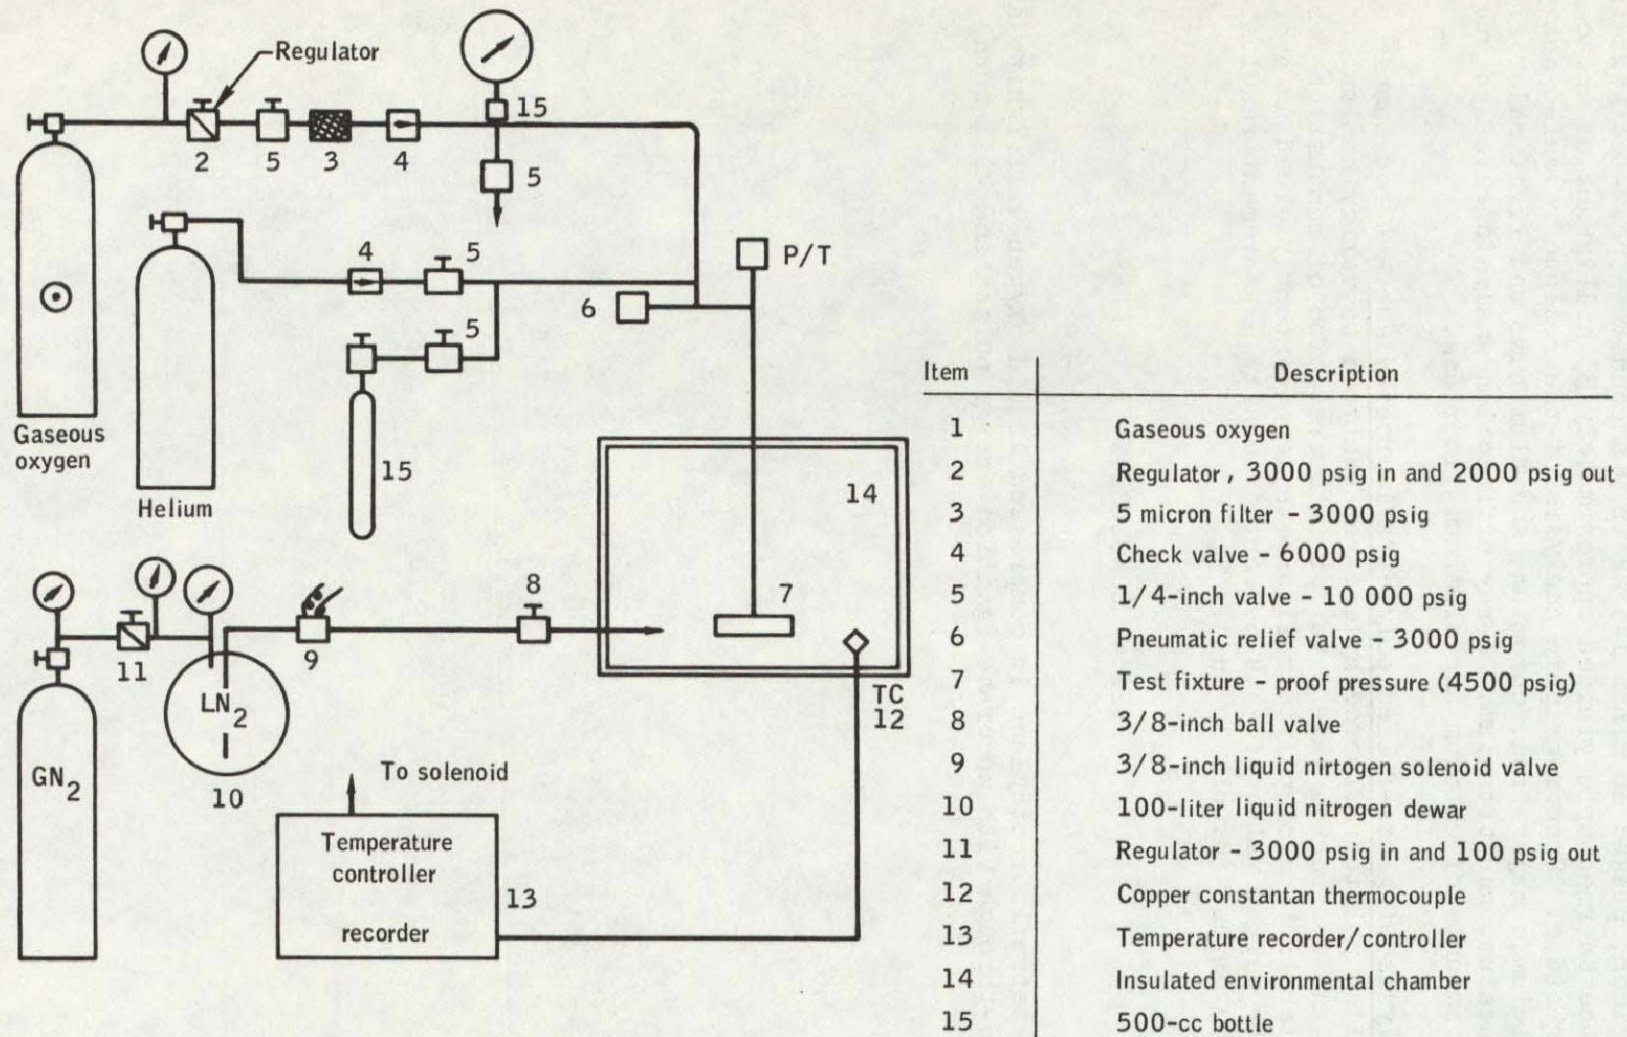
Figure B.22-1.- Test fixture for hot-wire ignition.

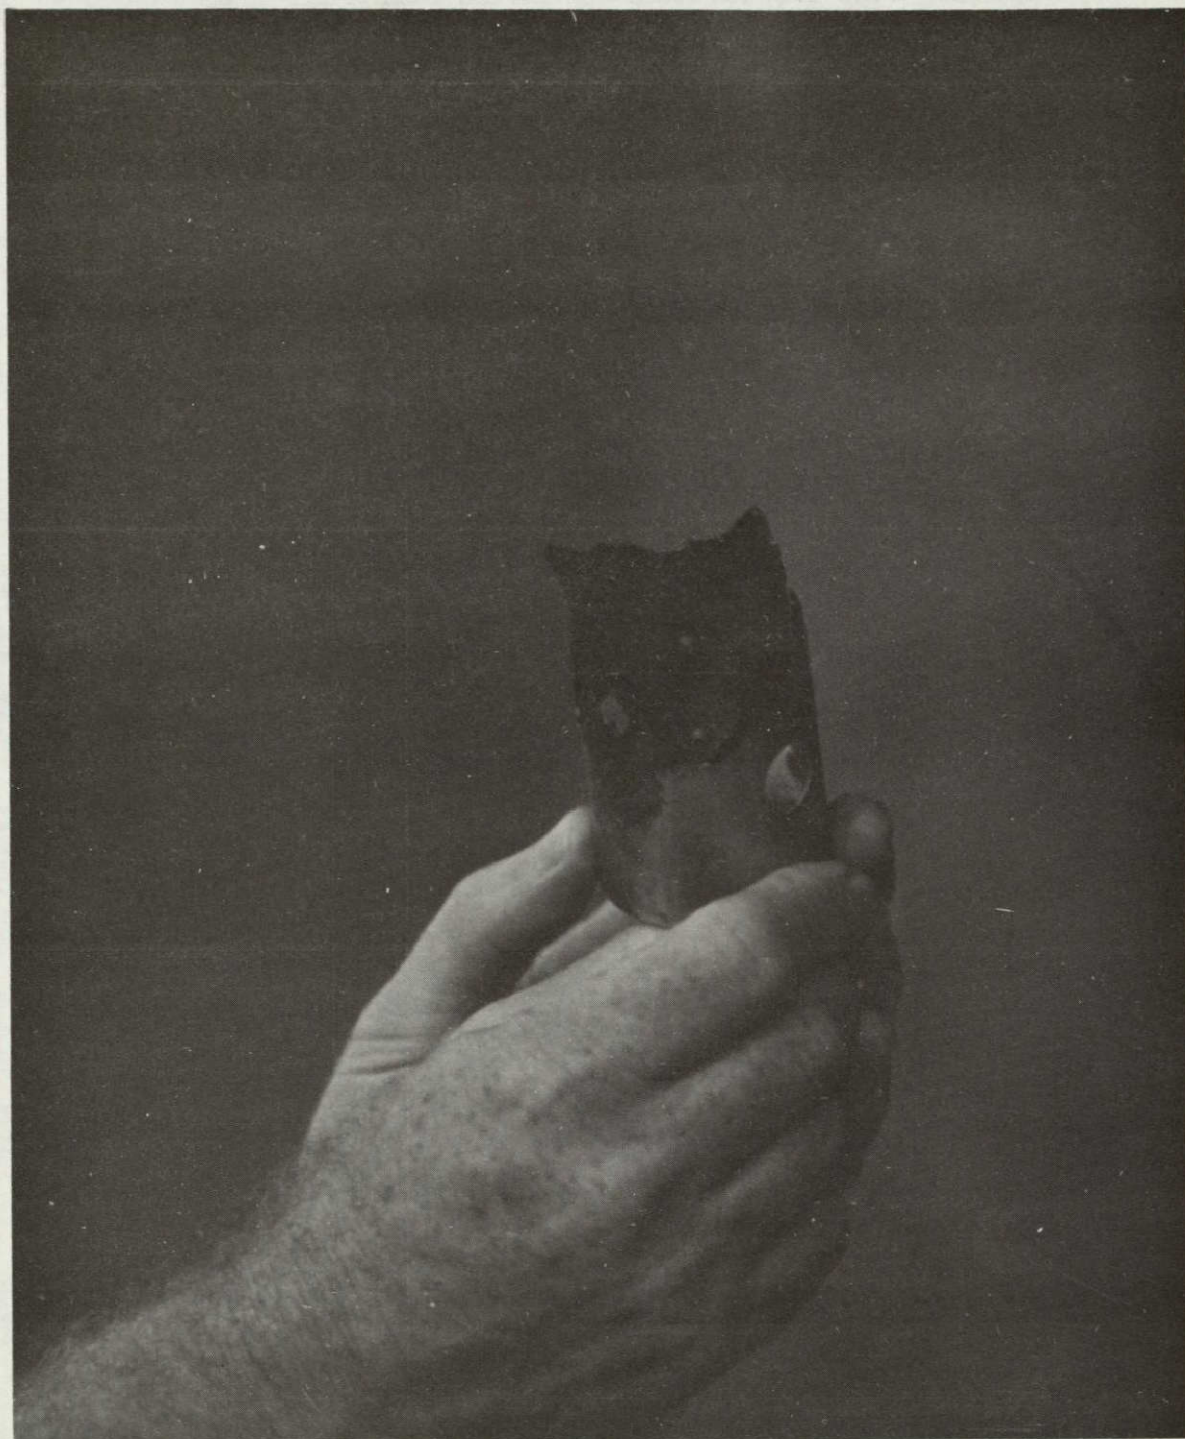
Figure B.34-7.- Portion of probe which remained in the test chamber.

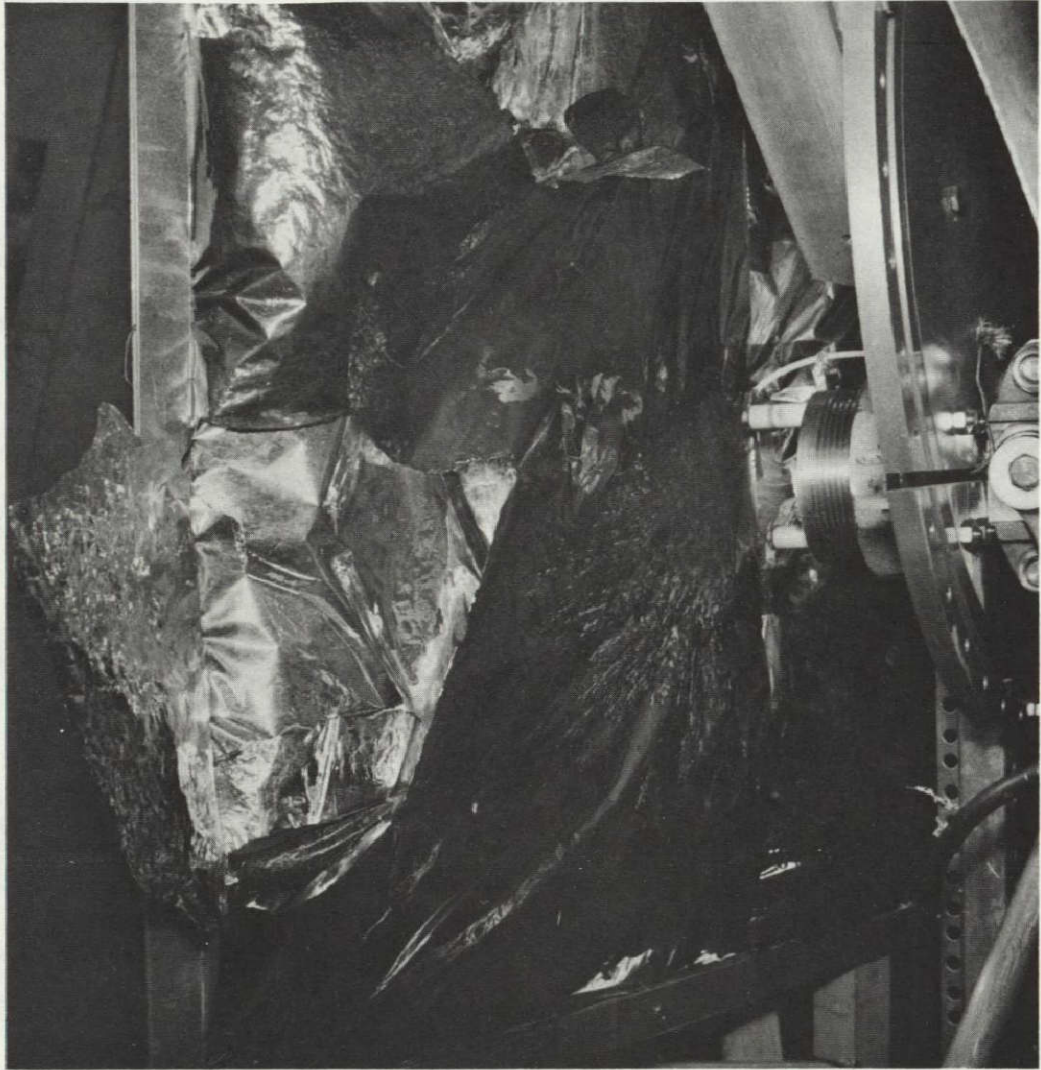
Figure B. 52-2.- Tearing of insulation by 1000 °F stream of oxygen. No burning observed.

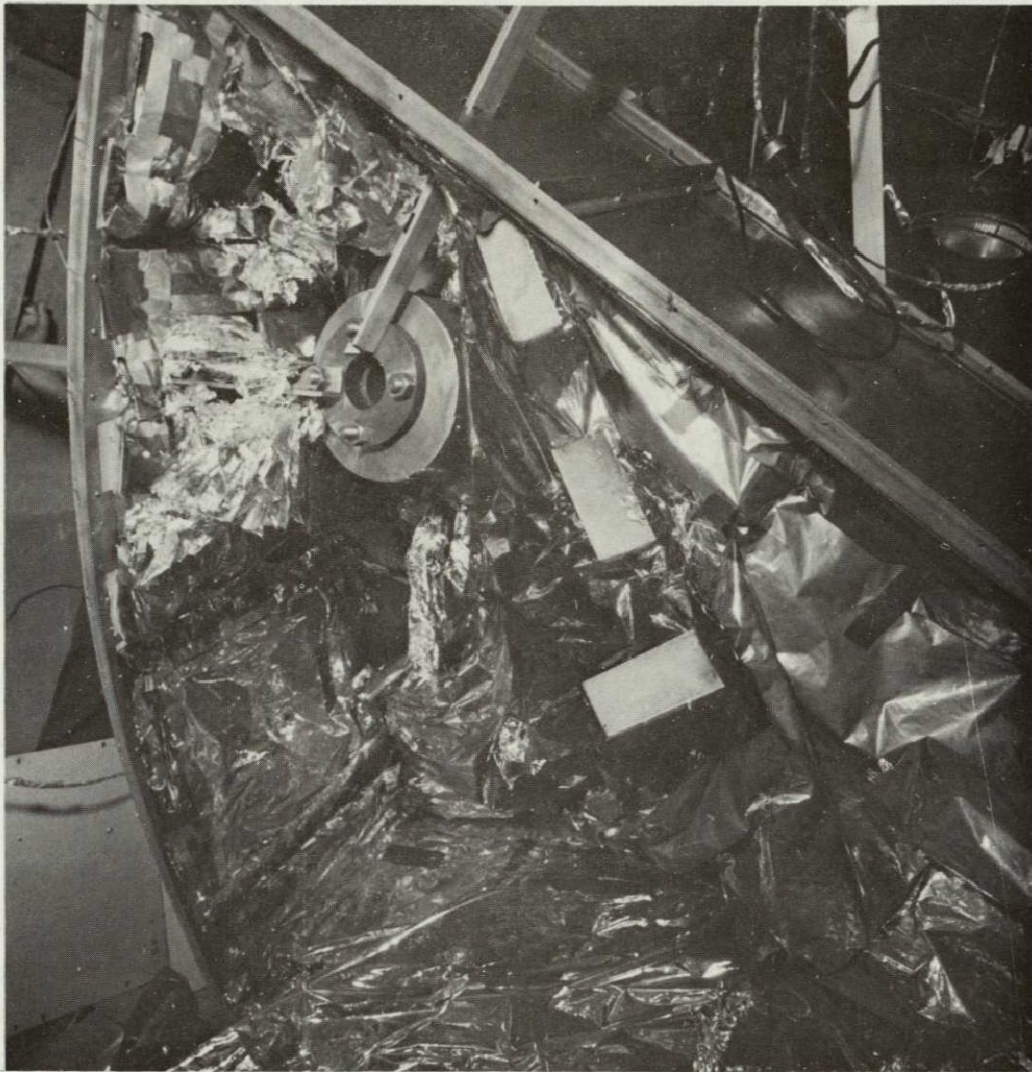
Figure B. 52-3.- Damage to multilayer insulation by impingement of oxygen stream.

The results of these tests indicate that the Mylar insulation blankets are difficult to ignite by impingement of high-temperature oxygen alone or in conjunction with burning Kapton. Although the duration of flame impingement on the Phase II tests was very short (less than 30 milliseconds), the severity of the tests is indicated by photographic data.
