NASA CR-72841

MECHANICAL PROPERTIES AND LOX COMPATIBILITY OF STAINLESS STEEL-CLAD TITANIUM PREPARED BY EXPLOSIVE WELDING AND VACUUM DEPOSITION

BATTELLE MEMORIAL INSTITUTE

December 31, 1969

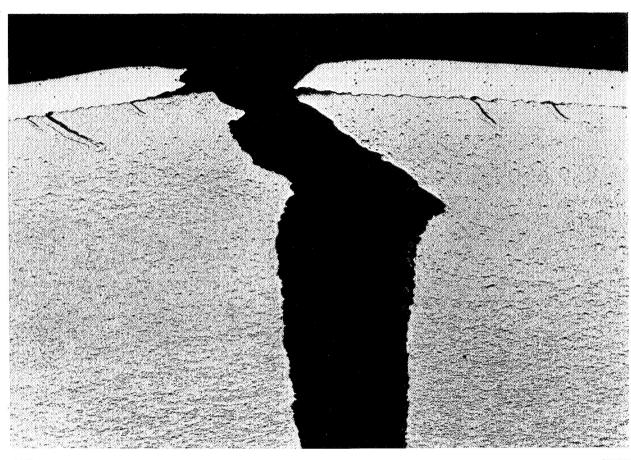
20X 8D381

FIGURE 10. EXPLOSIVELY WELDED THICK-COMPOSITE BEND-TEST SAMPLE

The 1200 F heat treatment clearly enhanced the ductility of the composite relative to the as-welded samples, when samples were tested with the titanium stressed in tension. A similar but smaller ductility increase was noted for samples bent with the stainless steel cladding stressed in tension. Although both the as-welded and welded-and-heat-treated samples failed while being bent with the largest available anvil (2.0-inch radius), the heat-treated sample bent to a greater angle (75 degrees versus 20 degrees) before failure occurred. Figure 10 shows the welded-and-heat-treated sample after bending with the cladding stressed in tension. This sample was similar in appearance to the somewhat less ductile as-welded sample. Failure in both samples was caused by the growth of cracks originating in melt pockets at the weld interface and propagating in the titanium alloy. These cracks in various stages of growth are clearly shown in Figure 10.

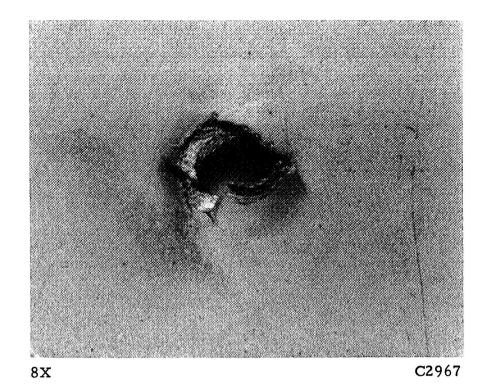
FIGURE 22. APPEARANCE OF SPECIMEN P-6 AFTER PUNCTURE-IMPACT EXPERIMENT

The 0.008-inch stainless steel cladding surface is shown. Some discoloration and melting of thin section of titanium could be seen after impact. A flash was observed during rupture.

A series of experiments was conducted in which the cup holding the LOX was pierced from the bottom side using the apparatus diagrammed previously in Figure 15. A flash of light was observed in 3 cases out of 20 when the specimen, which formed the bottom of the cup, was pierced from the titanium side (LOX touching the stainless steel). Eight of the 17 specimens which did not flash showed oxidized (discolored) areas in the vicinity of the titanium rupture when viewed under a microscope. In two instances areas which had become molten were observed. Hence, 11 out of the 20 specimens reacted in this type of evaluation. The appearance of a typical reacted specimen from the stainless steel side is illustrated in Figure 22. The ragged surface at the pierced hole is clearly evident.
