**TOPICAL REPORT NO. 4  
SNAP-8 REFRACTORY BOILER DEVELOPMENT PROGRAM**

**MERCURY THERMAL SHOCK TESTING OF 2½-INCH-DIAMETER  
BIMETALLIC JOINTS FOR SNAP-8 APPLICATIONS**

**By  
S. R. Thompson**

**NASA Lewis Research Center  
Contract NAS 3-10610  
Edward R. Furman, Project Manager**

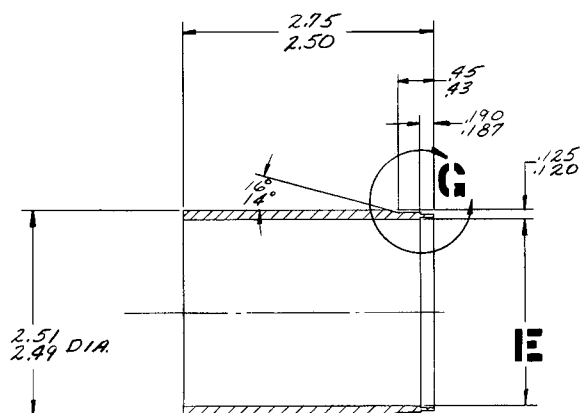
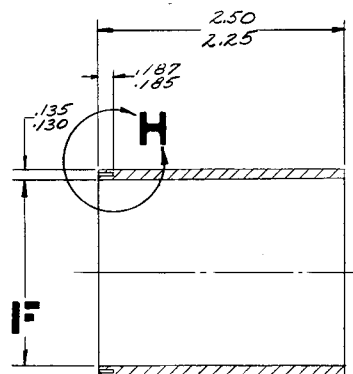
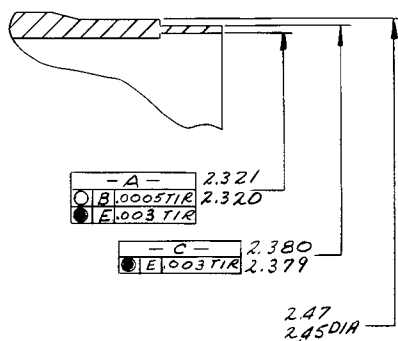
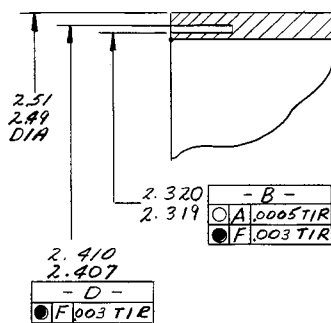
Figure 1. Brazed Joint Design Configuration, Dwg. No. 47C143236.

The basic design configuration for the 2.5-inch-OD brazed samples was a tongue-in-groove, as shown in Figure 1. The two brazed assemblies (Serial No's 14-14 and 16-16) discussed within this report, were vacuum brazed at 2160°F - 2180°F for five minutes, using the cobalt-base filler alloy designated J-8400 (B50T56-S1)\*. After brazing, both brazed assemblies were nondestructively inspected using visual, dye penetrant, ultrasonic, and mass spectrometer techniques, and no rejectionable defects were observed. The Nuclear Metals, Inc. coextruded joint was purchased by the NASA - Lewis Research Laboratory and assigned to GE - NSP for thermal shock testing without performance of additional pretest inspection by GE - NSP. In addition to the different methods utilized in fabrication of the test specimens, the wall thickness of the coextruded joint was 0.020 inch less than that of either brazed assembly; i.e., 0.110 inch vs. 0.130 inch.

(PIA) MAT'L - 316 SST  
SEAMLESS TUBING PER  
ASTM A 269-65

(PIB) MAT'L - TANTALUM  
UNALLOYED PER  
ASTM B-365-62T EXCEPT  
H<sub>2</sub> LESS THAN 10 PPM

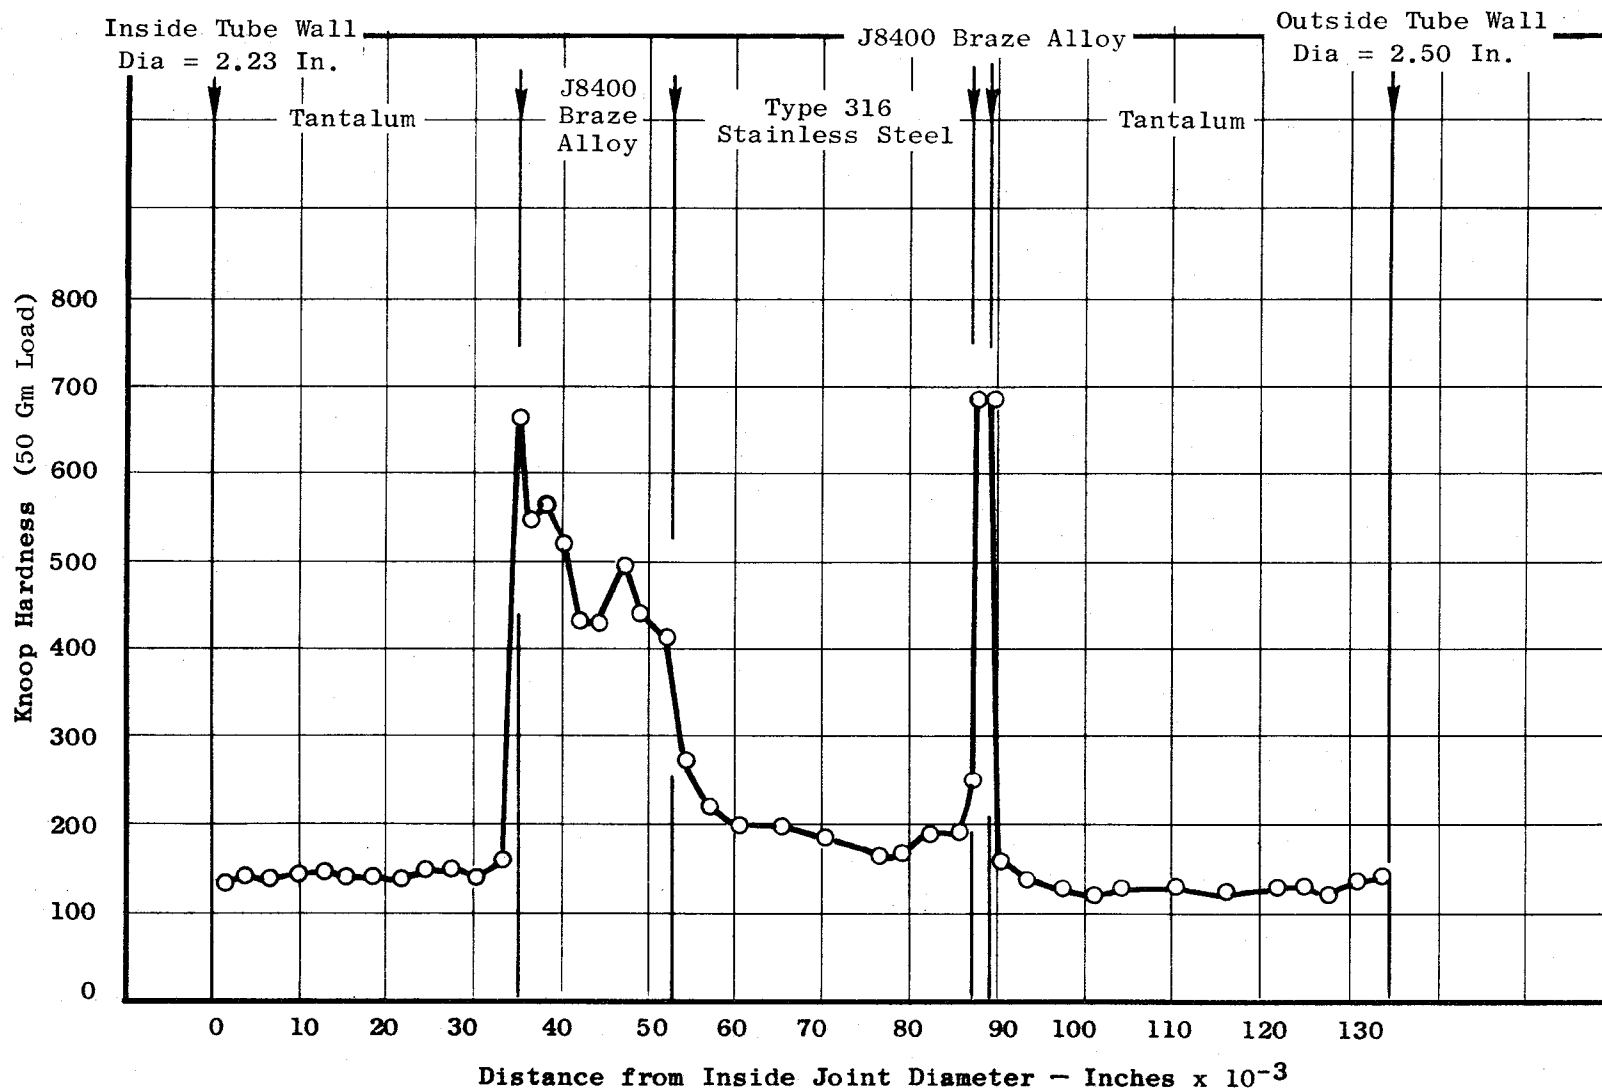
Figure 10. Hardness Traverse Across Wall of 2 1/2-Inch Diameter Tantalum/Type 316 Stainless Steel Transition Joint (S/N 14-14 at 0°) After Mercury Thermal Shock Test (155 Cycles).

entrance braze flow side (outermost tantalum section). The reaction zone in the stainless steel was largest on the inside surfaces of the tongue (Kn 270 at 0.002 inch from the interface and Kn 200, 0.006 inch away); the lower hardness readings were encountered less than 0.002 inch away from the outside surfaces of the stainless steel tongue. The width of the diffusion zone in the outermost tantalum areas was approximately 0.007 inch to 0.011 inch; the hardness decreased in that area from Kn 180, 0.0005 inch from the braze interface to the base hardness of Kn 125.

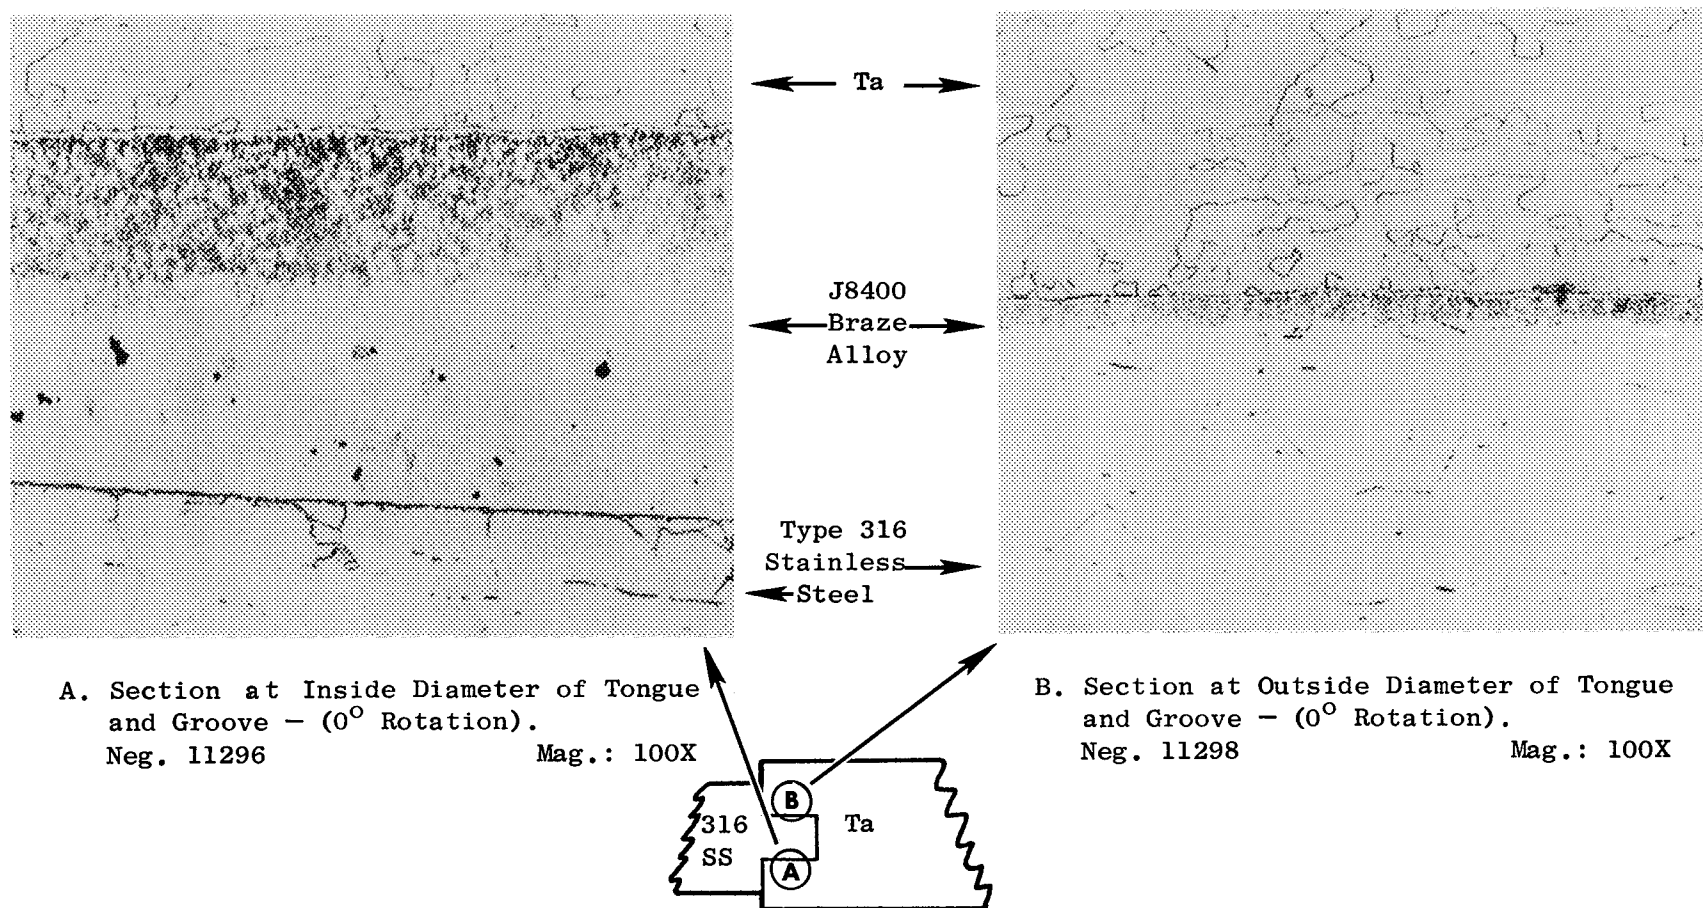
Figure 11. Representative Microstructures of Brazed Transition Joint, S/N No. 14-14, After Mercury Thermal Shock Test (155 Cycles).

The metallographic sections prepared from joint S/N No. 14-14, at 0°, 160°, and 316° rotation from the ultrasonic index, yielded essentially identical microstructures. Again, complete agreement between the actual

structures and the ultrasonic indications was not achieved, although generally better correlation was evident than with sample S/N No. 16-16. The microshrinkage present in sample S/N No. 14-14 (Figure 11A) was uniformly widespread, and individual voids were very small (0.0001 inch). It was possible that these voids were the cause for the ultrasonic indications at the above specified locations if the inspection equipment sensitivity was set too high. Also, the spacing between each void (approximately 0.010 inch) may have been small enough that the sensing transducer could not resolve their separation, since the transducer does sweep a finite distance. One additional factor that should be pointed out, since it could have influenced the ultrasonic data, was that the braze alloy on the inside of the tongue and groove (both brazed assemblies) was two-phase in nature, as shown in Figures 11A and 12A. This zoning effect essentially represented another possible interface, and the chemistry changes present therein could have altered the speed of the sound waves passing through, which in turn could cause suspect areas to appear on the ultrasonic "A" scans. Because none of the described phenomena for joint S/N No. 14-14, as well as joint S/N No. 16-16, were unacceptable from a structural standpoint, it was obvious that the ultrasonic inspection technique required refinement to more clearly define objectionable defects. The bulk of the difficulties associated with ultrasonic inspection of tongue-in-groove brazed specimens were contingent on the lack of a satisfactory "standard" brazed specimen. To alleviate the problem, "standard" specimens containing good and bad brazed areas at prespecified locations, are presently being prepared for future applications.

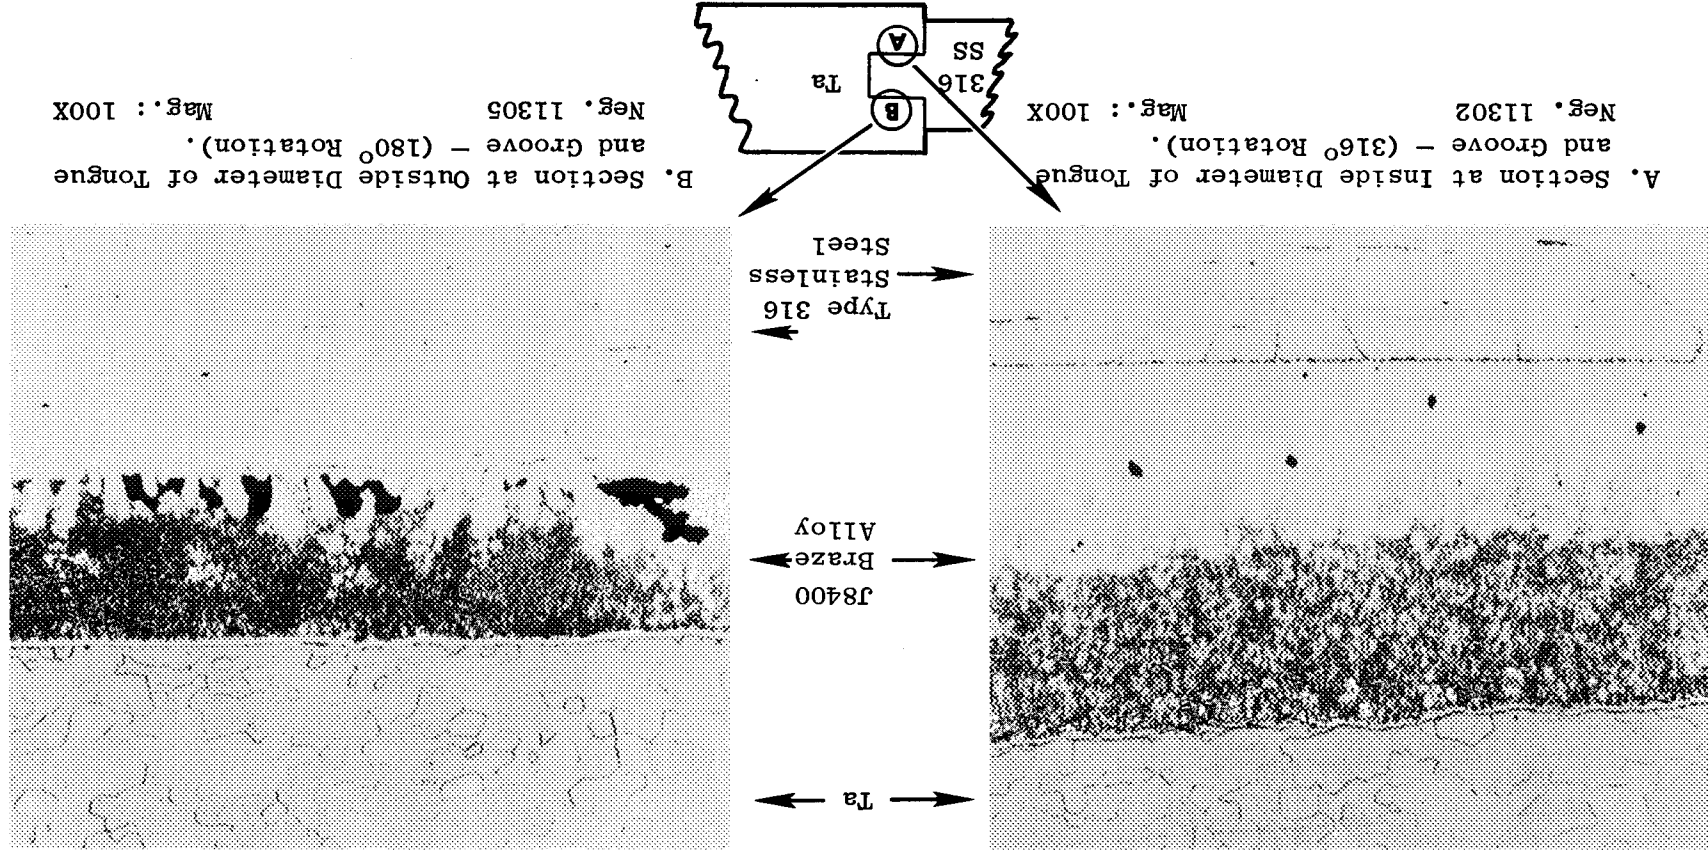
Figure 12. Representative Microstructures of Brazed Transition Joint, S/N No. 16-16, After Mercury Thermal Shock Test (100 Cycles).

brazed flow paths of both assemblies. These voids were formed on cooling from the original brazing thermal cycle - they occur in the last portions of the braze alloy which solidify, and their occurrence is a normal brazing by-product if freezing of the alloy at a location between the entrance feed fillet and the discussed area blocks the supply of liquid braze. As shown in Figures 12B and 14B, the largest zones of microshrinkage were found in joint S/N No. 16-16, near the base of the tongue and groove in the sections taken at 180° and 226° rotation from the ultrasonic inspection reference index. As indicated previously, these sections represented (ultrasonic) intermediate and best-bonded areas of that assembly, and their presence to the extent shown in the microphotographs was not anticipated. Further, the extent of their size and agglomeration, while greater than desired, was not prohibitive from a brazing or structural standpoint. Microstructural examination of the most suspect area (at 0° rotation) of Specimen S/N No. 16-16 revealed a completely sound brazed section, in direct contradiction to the ultrasonic data. The lack of agreement, between the ultrasonic indications and the actual microstructures present, may possibly be explained by realizing that in cutting the assemblies, and subsequent metallographic preparation, material removal may be somewhat different than expected. Thus, the sections examined may not have coincided exactly with the desired locales, and the joint characteristics could be completely different at the positions examined.

- c. The two-zone nature of the braze in S/N No. 16-16 extended around the base of the tongue from the wide gap side and into the 0.005 inch capillary side for approximately 0.030 inch. Thus, some microshrinkage was also noted on the capillary side of that joint (see Figure 12B).

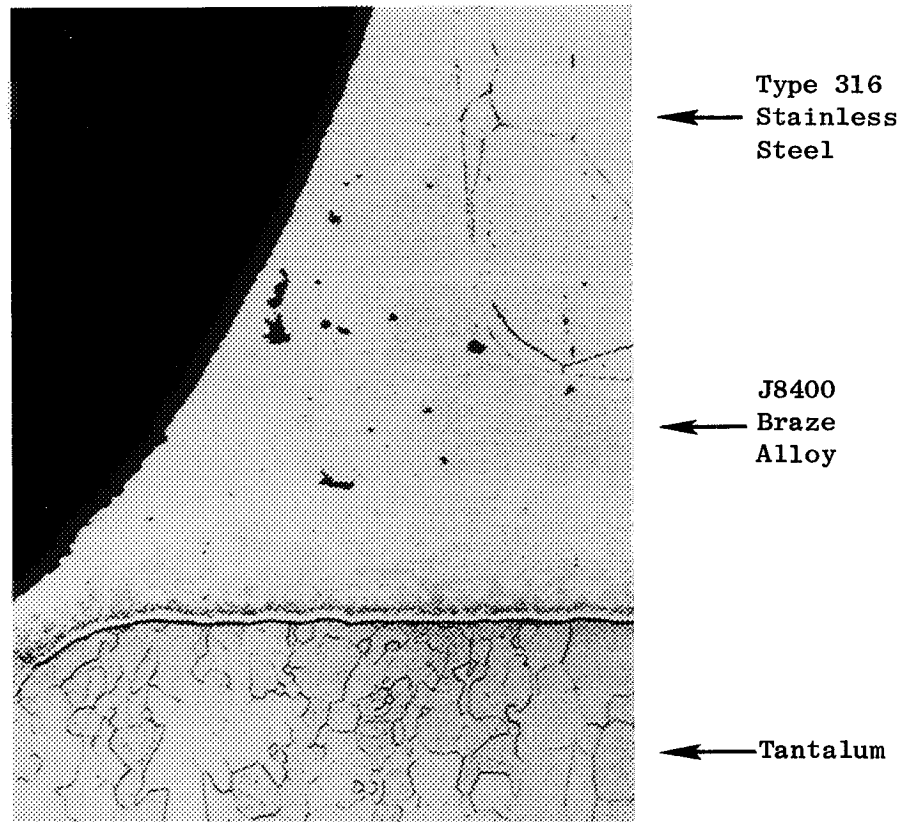
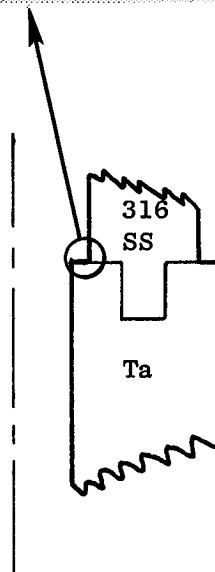
Figure 13. Typical Microstructure at Inside Braze Fillet of Brazed Joint, S/N No. 16-16, After Mercury Thermal Shock Test (100 Cycles).

Microstructural examination at high magnification (to 1000X) of the internal piping surfaces and the internal braze fillets produced no significant evidence of mass transfer, mercury corrosion, or joint deterioration caused by the repeated thermal/mercury shock cycles. Figure 13 shows a typical appearance of the inner braze fillet area for joint S/N No. 16-16; similar structures were also present at the inner fillet areas of joint S/N No. 14-14.

Neg. 11304

Mag.: 100X

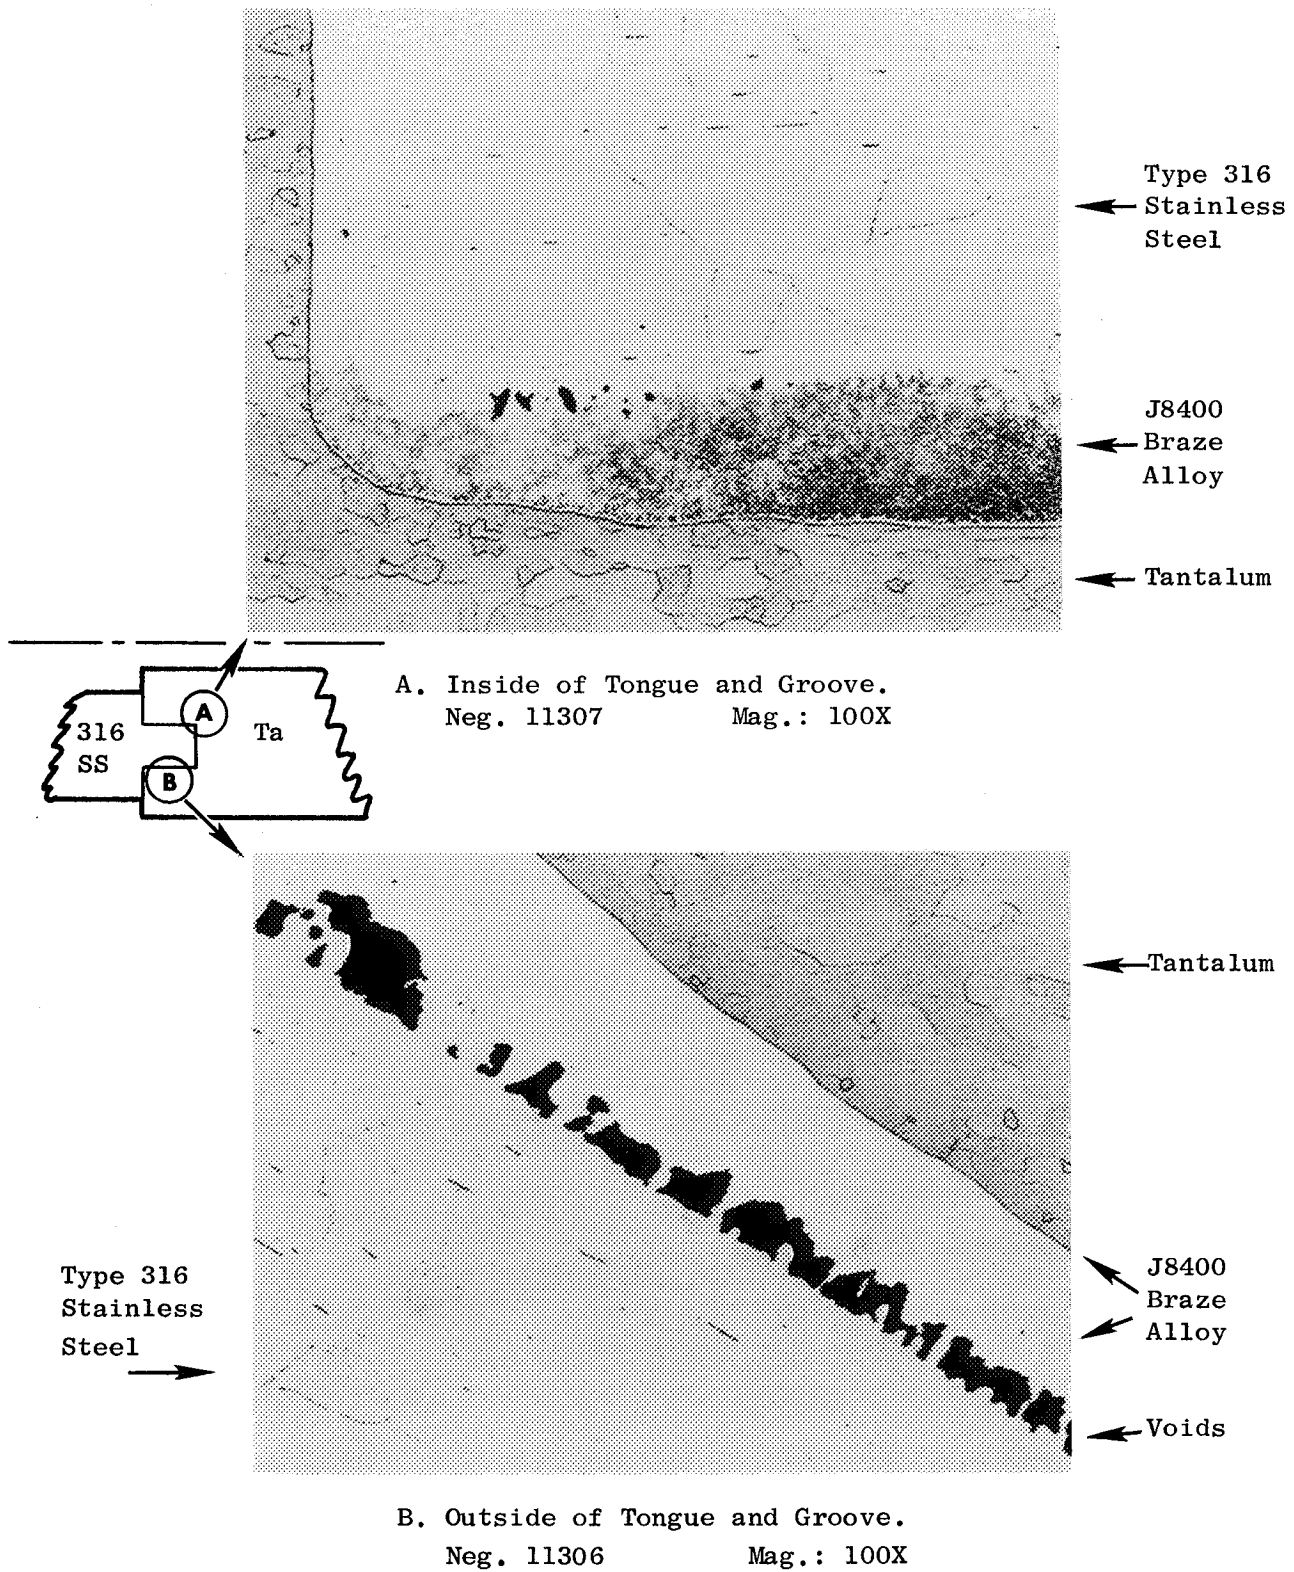
Figure 14. Microstructures Near Base of Tongue and Groove of Brazed Joint, S/N No. 16-16 at 226° After Rotation Mercury Thermal Shock Test (100 Cycles).

- f. As shown in Figure 14B, the corners at the base of the tongue and groove of joint S/N No. 16-16 were rounded (approximately 0.001-inch radius). This effect could have been produced by (1) interalloying of the base metals with the braze alloy during the brazing cycle or (2) the initial machining operation. In either event, the effect was beneficial, since the stress concentration factors are reduced; thus, the assembly can more readily withstand the stresses associated with thermal cycling. A similar corner rounding was observed for joint S/N No. 14-14.

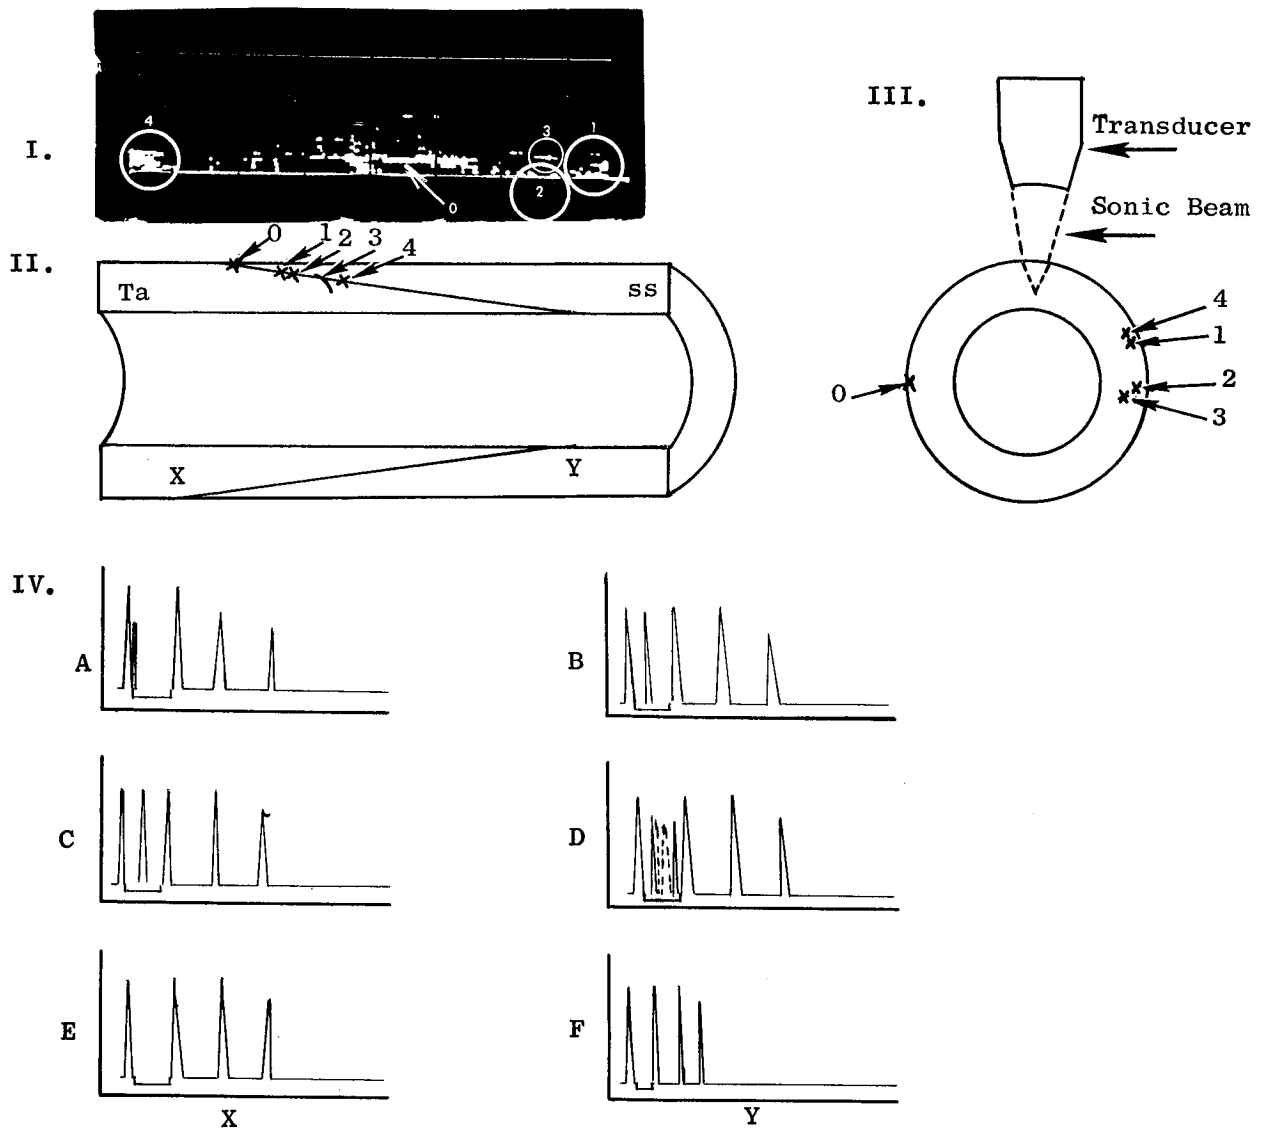
Figure 15. Presentations from Ultrasonic Inspection of Coextruded Tantalum/Type 316 Stainless Steel Joint After Mercury Thermal Shock Test (55 Cycles).

The ultrasonic inspection was performed using a focused transducer and a longitudinal wave mode through the total joint wall thickness; scans were made circumferentially along the outside diameter of the joint area. A "C"scan ultrasonic trace was prepared, from repeated "A" scans, by means of appropriate gating techniques, to differentiate and record any electronic signals different from those obtained for the outside and inside tube wall reflections and those found for a completely bonded cross section. The nature of the ultrasonic indications is shown in Figure 15.

- I. C-scan recording depicting areas of interface discontinuity. White indicates response areas.
- II. Longitudinal cross section indicating depth of indications relative and wall thickness. Note depth of #3
- III. Transverse cross section of joint indicating depth of indication and method of ultrasonic inspection.
- IV. A-scan presentation of A. defect #0 near OD B. defect #2 depth C. defect #1 & 4 depth D. defect #3 change of depth E. & F. change of time base due to velocity change created by change of ratio of Cb-1Zr to S.S.

The susceptibility of the coextruded joint to failure under severe thermal shock conditions was clearly indicated. Further, good agreement was realized between ultrasonically detected flaw locations and actual separation points of the joint.

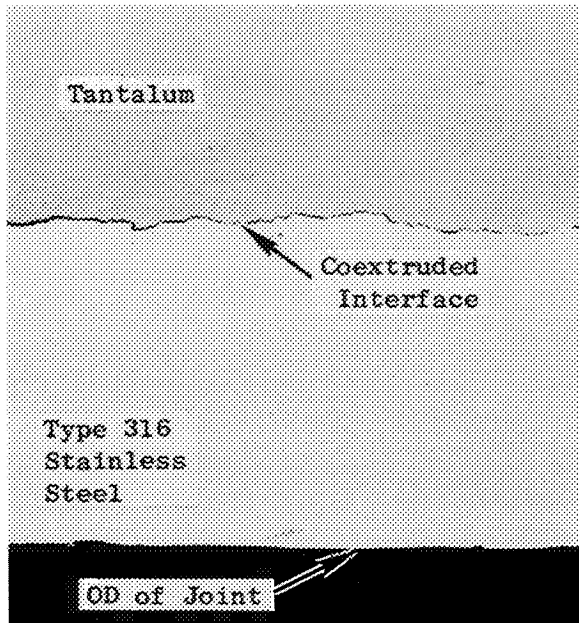
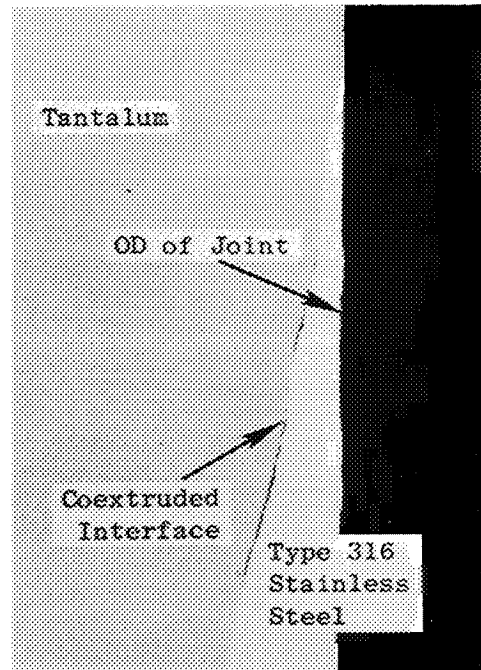
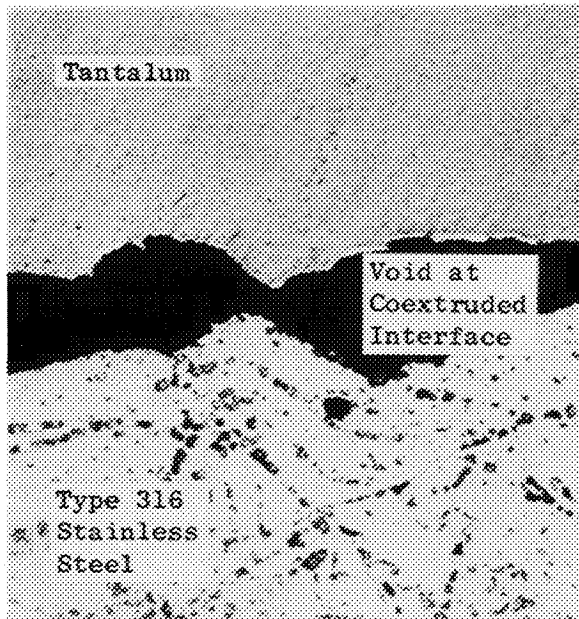
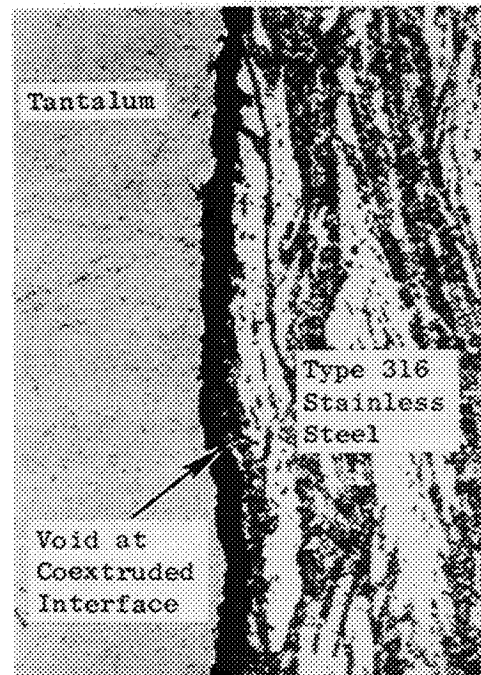
Figure 16. Typical Microstructures in Joint Area Coextruded Tantalum/Type 316 Stainless Steel Joint After Mercury Thermal Shock Test (55 Cycles).

After "Zyglo" inspection, the joint was sectioned for microstructural study at the principal ultrasonic and "Zyglo" suspect areas. Several microstructures obtained at these locations are presented in Figure 16. The correlation between the inspection indications and the actual microstructures was excellent; i.e., at every suspect location examined, separation of the interface was observed metallographically. No evidence of any significant intermetallic phase formation at the interface was observed during examinations to 1000X. Further, no microstructural

Unetched  
F900311

Etchant: 10 Oxalic  
100 H<sub>2</sub>O  
Electrolytic  
F900313

indications of mercury corrosion or erosion were found along the inside of the assembly. Microhardness traverse data were determined across the wall of the coextruded specimen. As shown in Table I, essentially constant hardness values were obtained throughout the individual components, tantalum and stainless steel, in the joint area. The data also verified the visual observations that no intermetallic phases were present at the joint interfaces.
