NASA CR-72852

# ADVANCED SUPERALLOY PROTECTION SYSTEMS EVALUATION

GENERAL ELECTRIC COMPANY

Contract NAS 3-12414

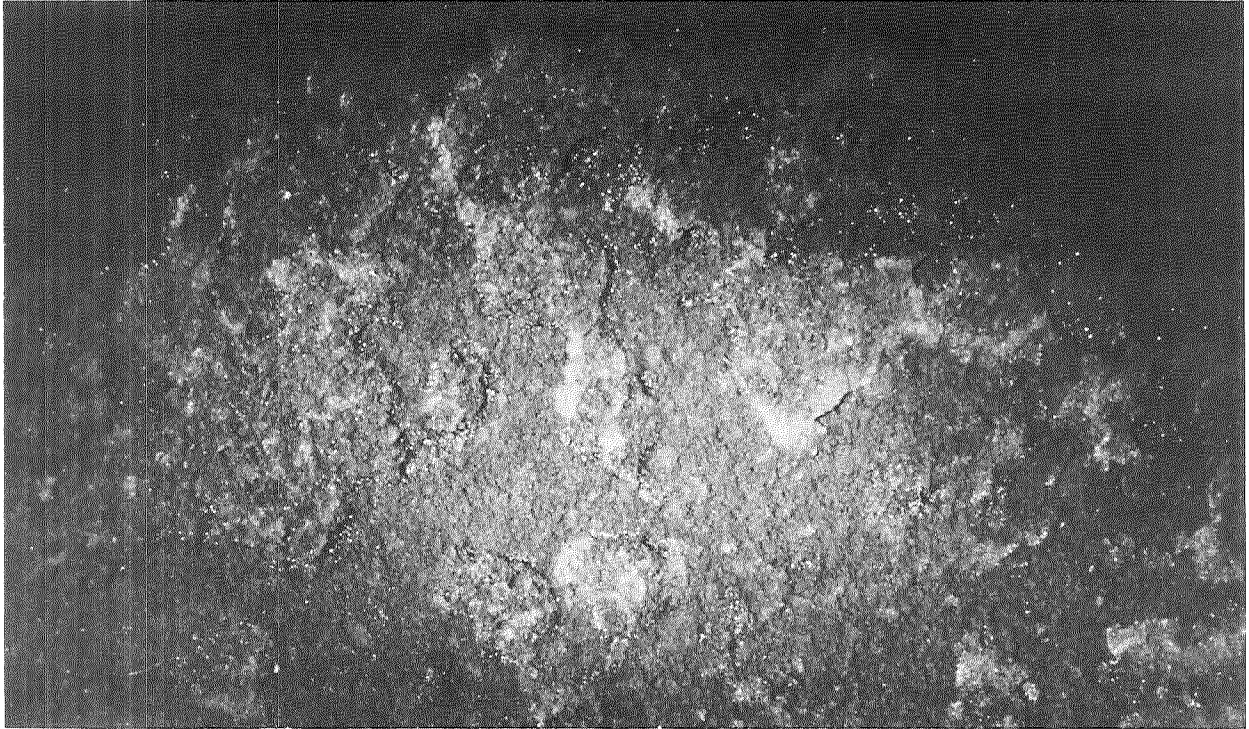
Figure 12. Appearance of Manganide/Chromide System After 158 Hours Static Oxidation at 2000°F (1367°K) (C70052709, 10X).

Figure 12 illustrates the surface appearance of the specimen with spalling clearly visible. Figure 13 shows a metallographic section of the impact areas of the 1900°F (1310°K) specimen. Loss of coating is evident not only as a spalled patch on the impact side, but also loss of coating is complete on the opposite surface. Furthermore, intergranular oxidation is evident.

Figure 14 is a photomicrograph showing an area of the specimen with the primary diffusion layer separated from the substrate. The appearance reflects the gross weight loss indicative of spalling which was shown in Figure 12. The coating spalled along the original boundary of the metallized diffusion zone. This boundary appeared as a dark band in the as-coated structure shown in Figure 4.

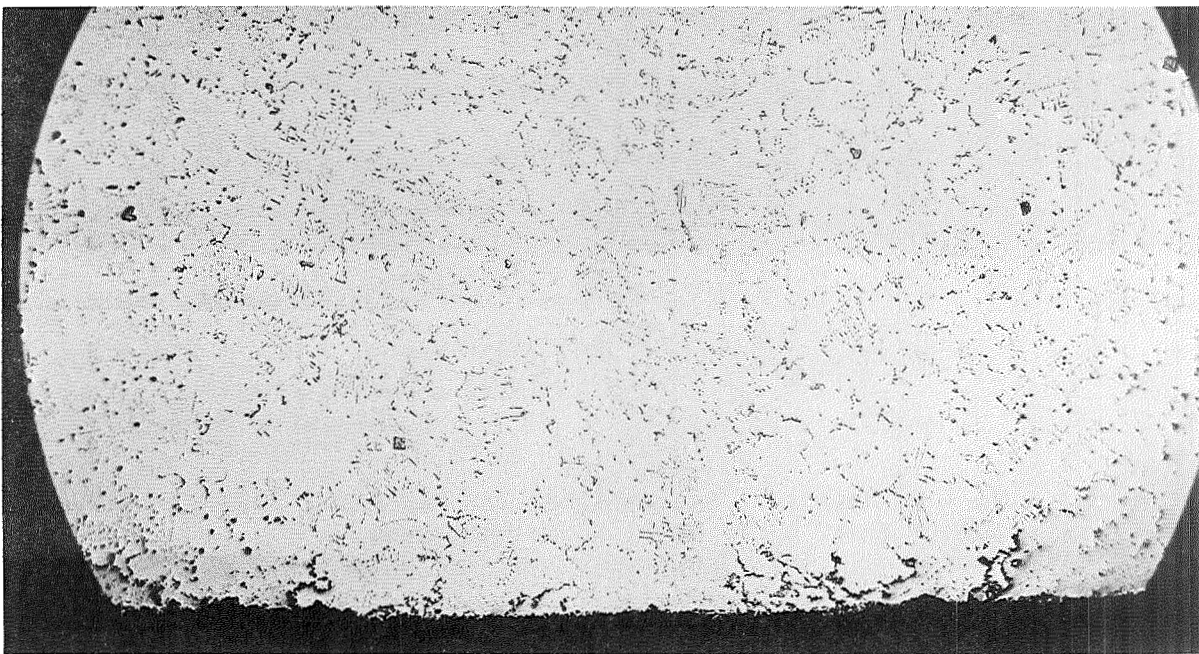
A. Impacted Surface

B. Surface Opposite Impact

Figure 13. 1900°F (1310°K) Ballistic Impact Site on Mn + Cr Metallide System After 200 Hours Static Oxidation at 2000°F (1367°K). Intergranular Oxidation May be Seen on the Surface Opposite Impact (F 6007, F 6008, 50X).

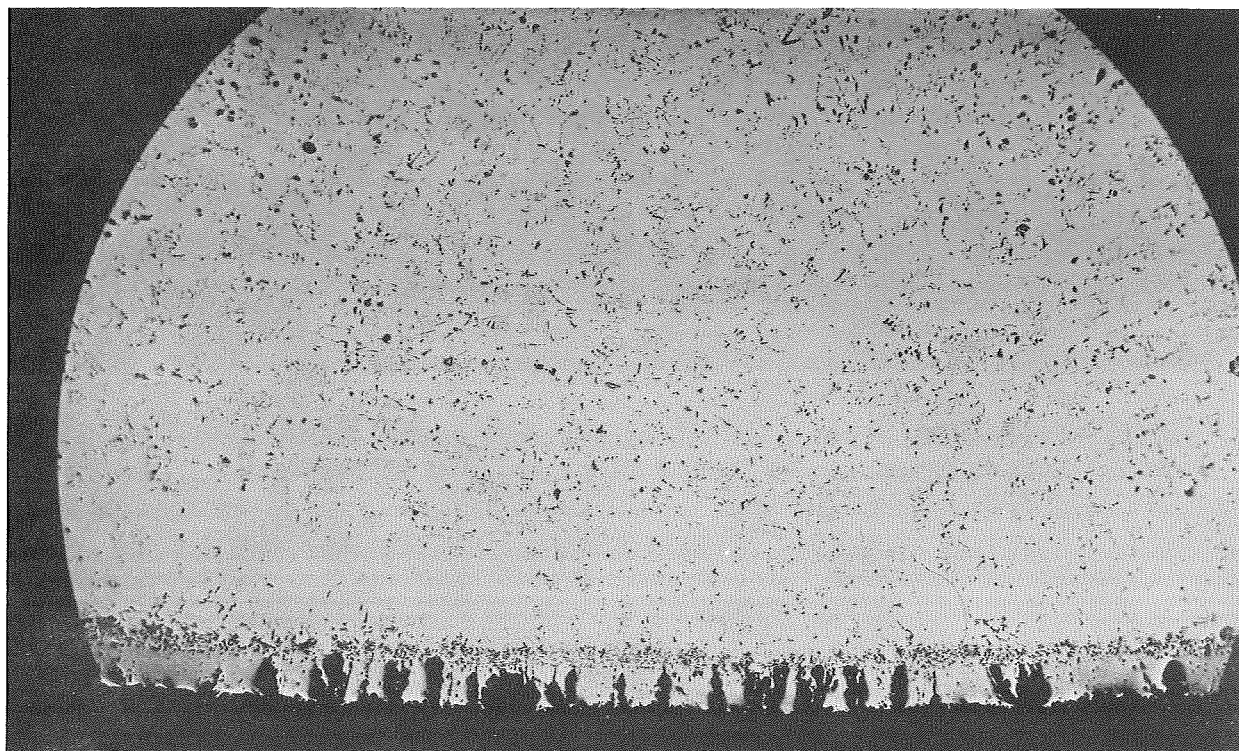
Figure 18. Ballistic Impact Sites 1900°F (1310°K) Impact on Al + Y Metallide System After 200 Hours Static Oxidation at 2000°F (1367°K) (F 6009, F 6010, 50X).

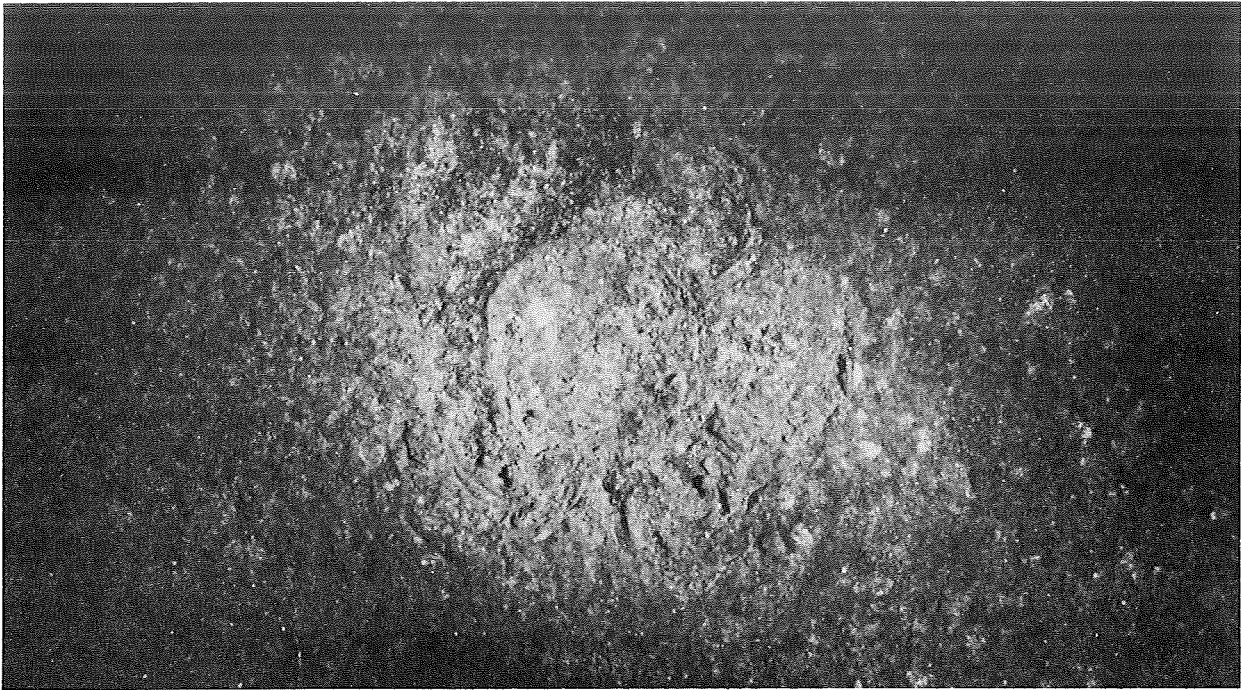
Figure 23. Macroscopic Appearance of Ballistic Impact Sites on Ta + Al Metallized System After 200 Hours at 2000°F (1367°K) (C70052719, C70052720, 10X).

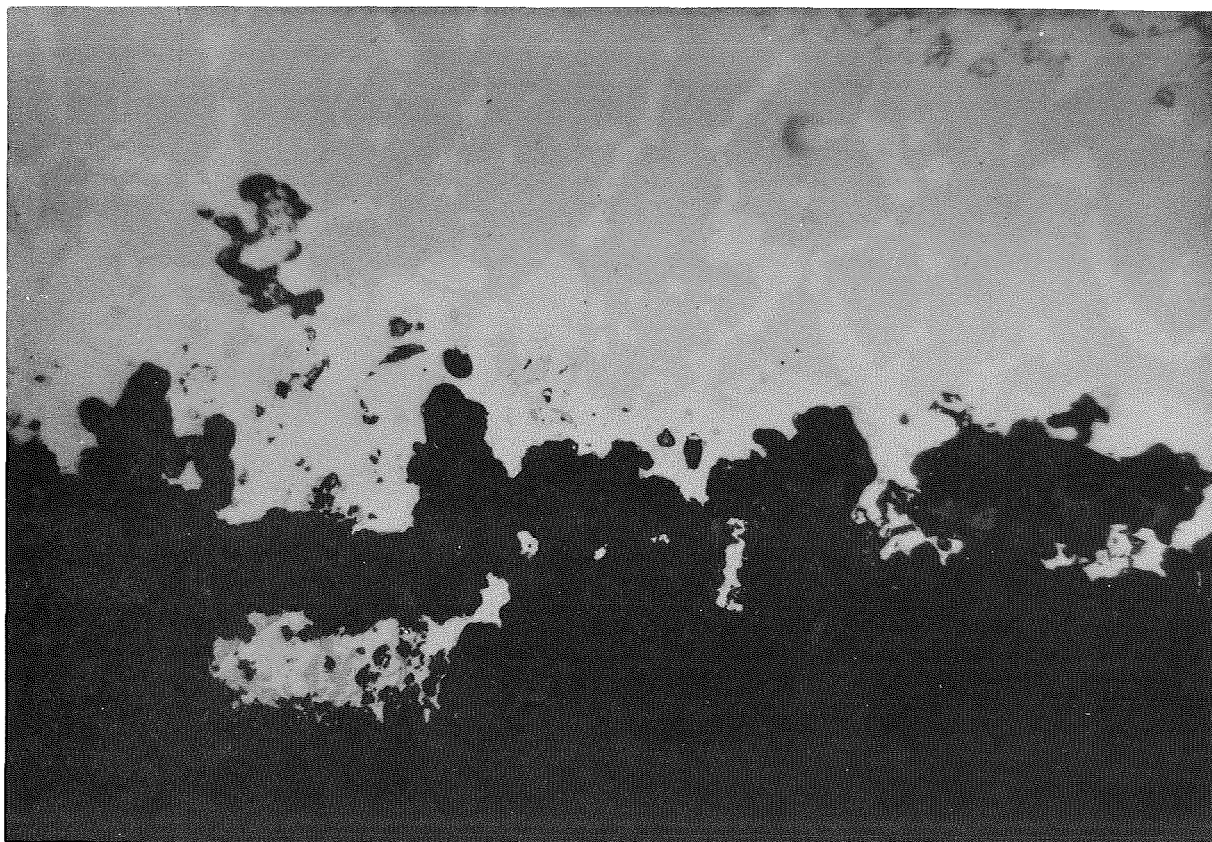
Figure 24. Microstructure of Ta + Al Metallide System on NASA/TRW VI-A After 200 Hours Static Oxidation at 2000°F (1367°K) (F 6004, 500X, Unetched).

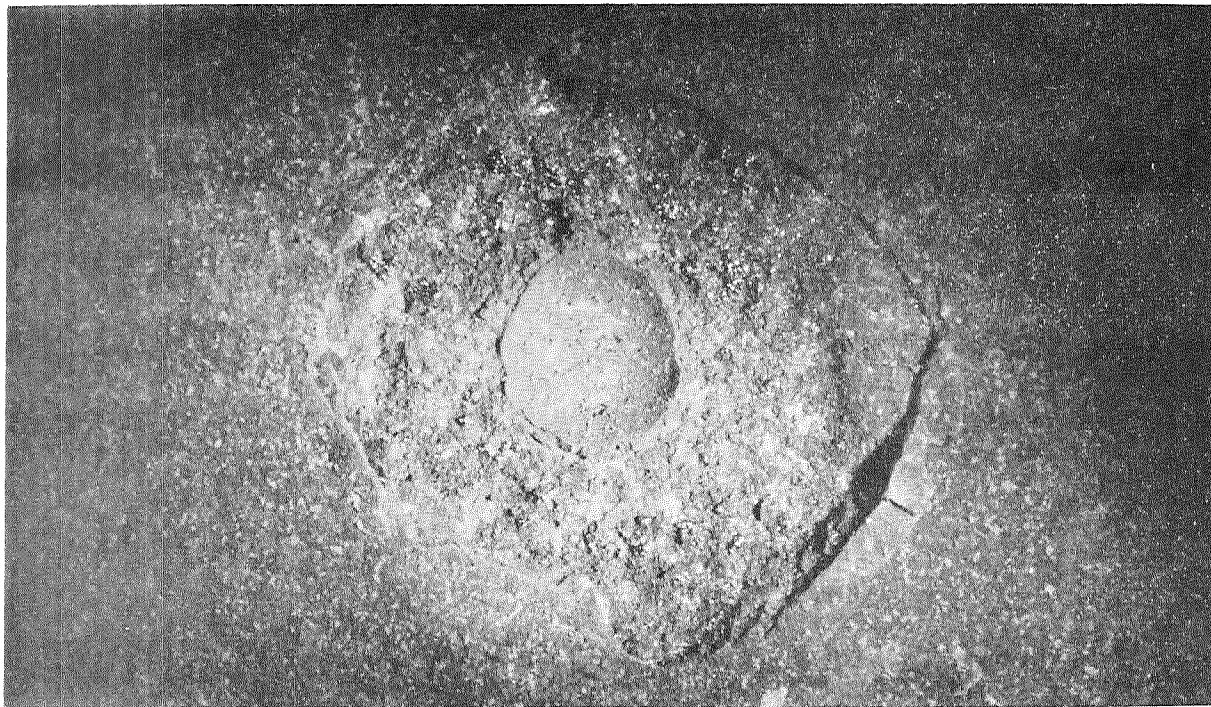
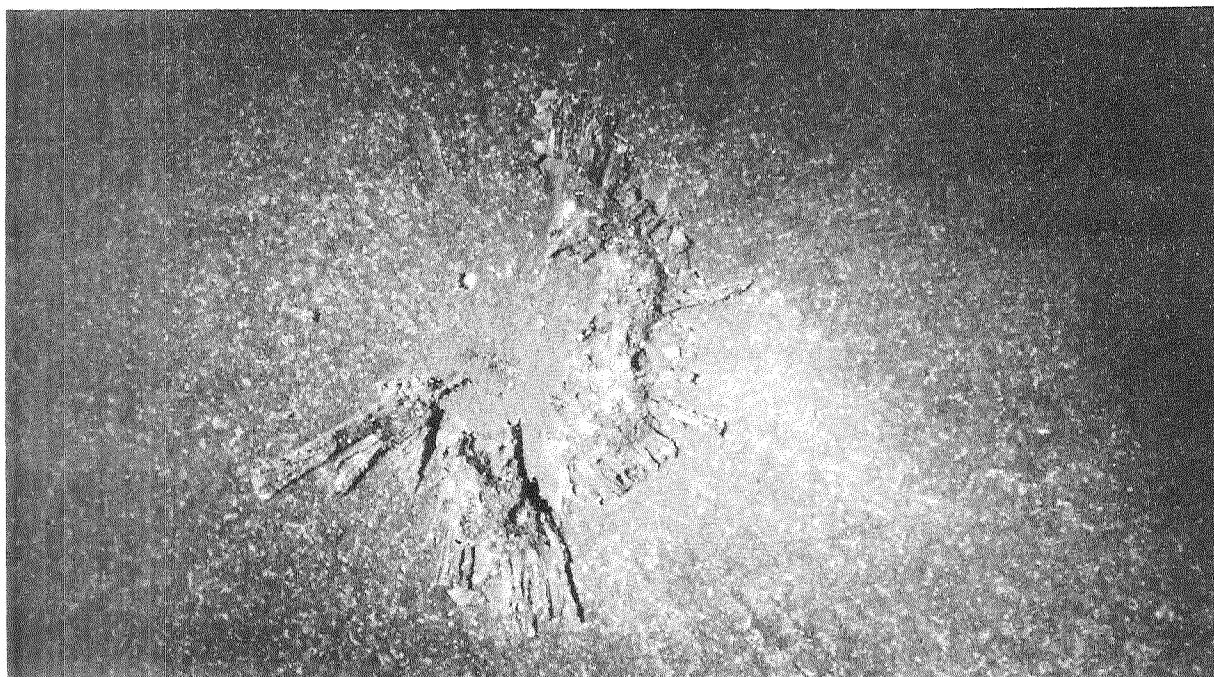
A. Impacted Surface

B. Surface Opposite Impact

Figure 29. Room Temperature Ballistically-Impacted Aluminum Metallized System After 200 Hours Static Oxidation at 2000°F (1367°K) (C70052715 Lower, C70052716 Upper, 10X).

Figure 29 illustrates a ballistically-impacted specimen after oxidation. This specimen had been impacted at room temperature and as previously reported, was badly spalled and then oxidized at the impact site. The elevated-temperature impacted specimen was not badly spalled but suffered damage and subsequent oxidation on the impact surface.
