ADVANCED TURBINE ENGINE MAINSHAFT LUBRICATION SYSTEM INVESTIGATION

PHASE II

Part I - Background, Test Elements and Results, and Conclusions for
System Performance

NASA CR-72854
AL69T016

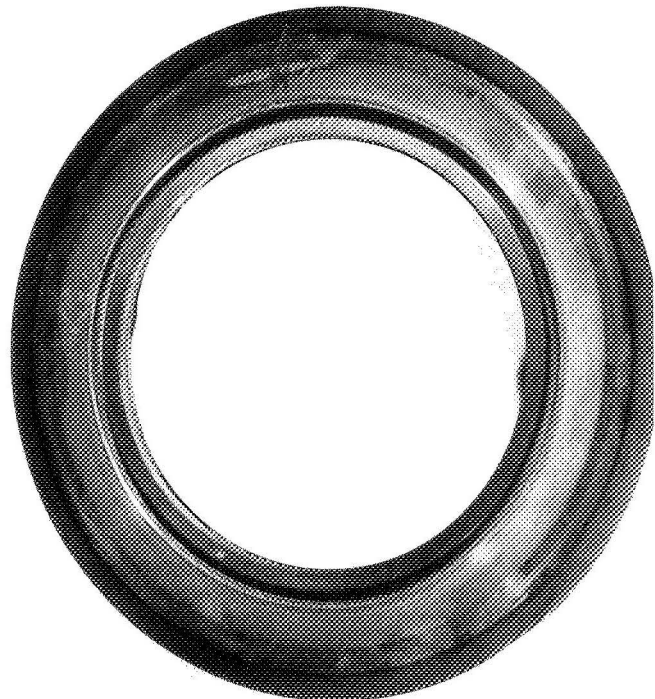
d) Oil Seal Runner

ENCLOSURE 21

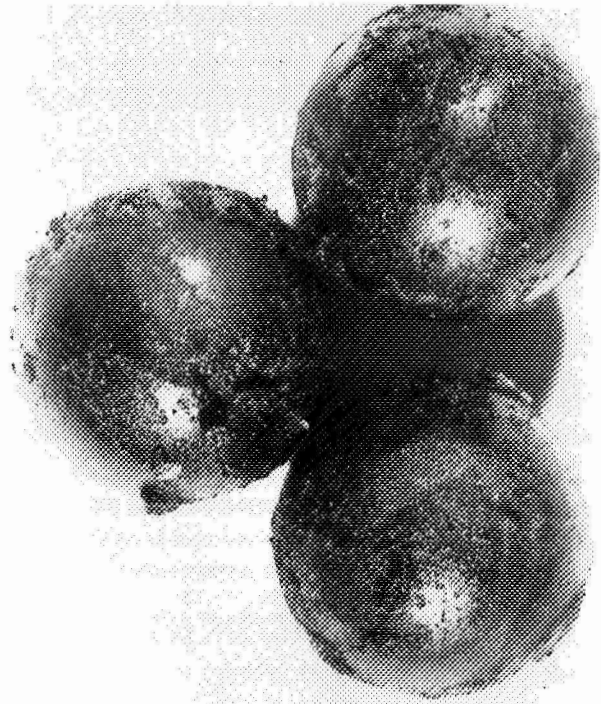
d) Balls

ENCLOSURE 22

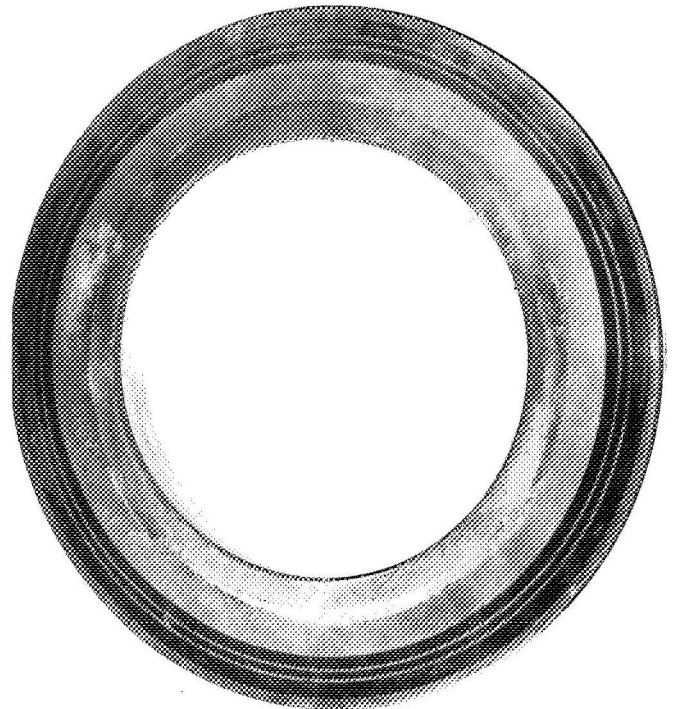
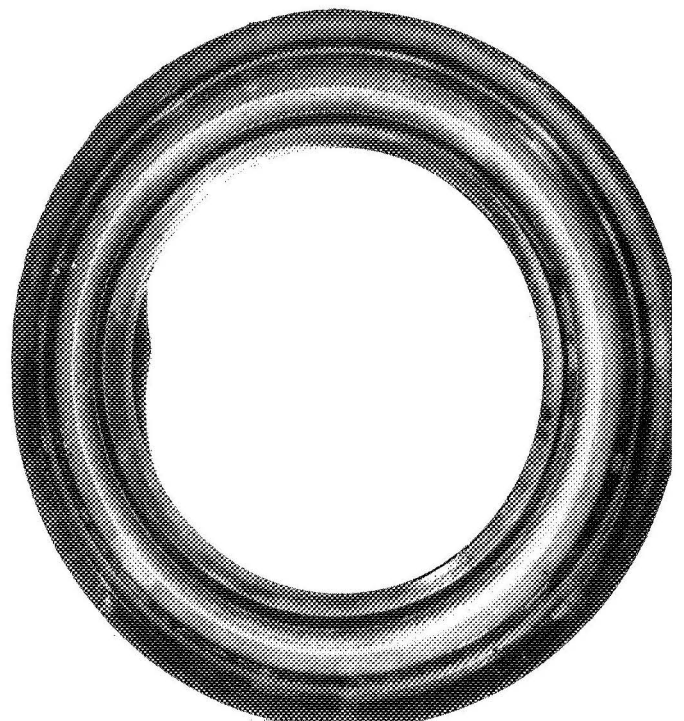
ENCLOSURE 25

Test Seal Parts After 650°F
Mobil XRM 154D Oil Screening Run For 3.0 Hours

Upon disassembly, the test bearing was found in good condition. The air seal and shoulder were in good condition with negligible wear. The oil seal carbon had worn a negligible amount but its mating shoulder was heavily worn, with up to 0.005" deep grooves at the location of the carbon contact. It was noted that during this test the oil seal shoulder ran 50° to 100°F hotter than it did during a previous test run at similar test bearing and oil-in temperatures using Mobil XRM-109F plus 10% Kendall Heavy Resin. This may indicate that the silicone fluid is a poorer heat transfer medium or that its heat generation or deposit forming characteristics are different in the rubbing seal interface.

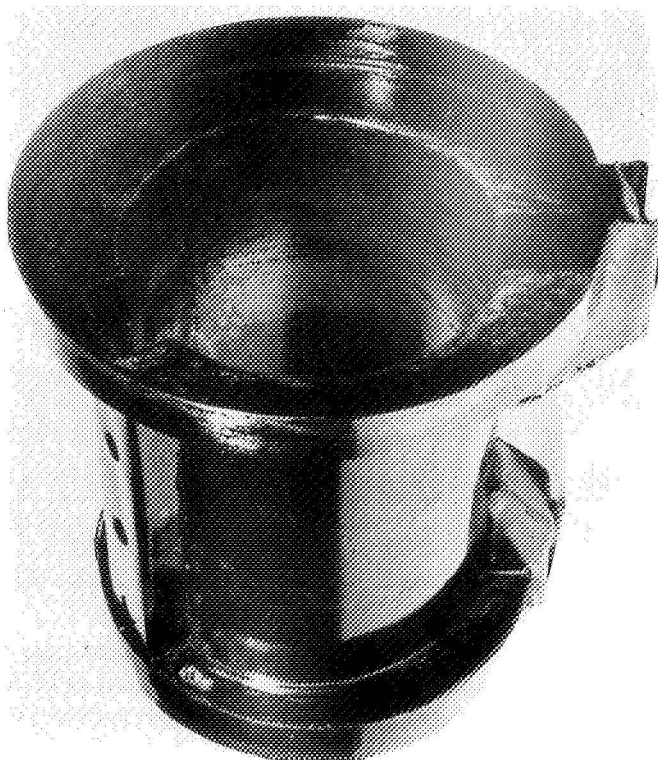
ENCLOSURE 46

TEST RIG PARTS AFTER 650°F MOBIL XRM 109F AND 10% BY WEIGHT
KENDALL HEAVY RESIN 0839 ENDURANCE RUN FOR 250 HOURS

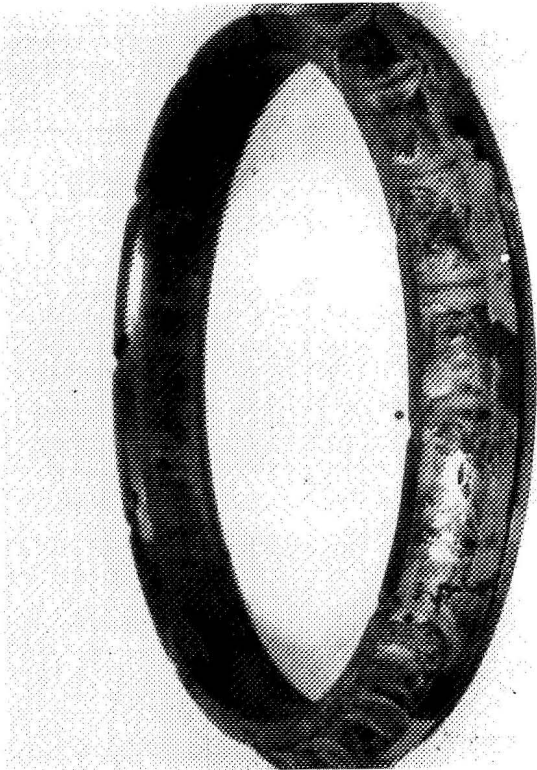
a) Inner Race

TEST BEARING PARTS AFTER MOBIL JET II OPEN ATMOSPHERE TESTS AT
490° TO 660°F AND SPEEDS FROM 14,000 TO 20,000 RPM

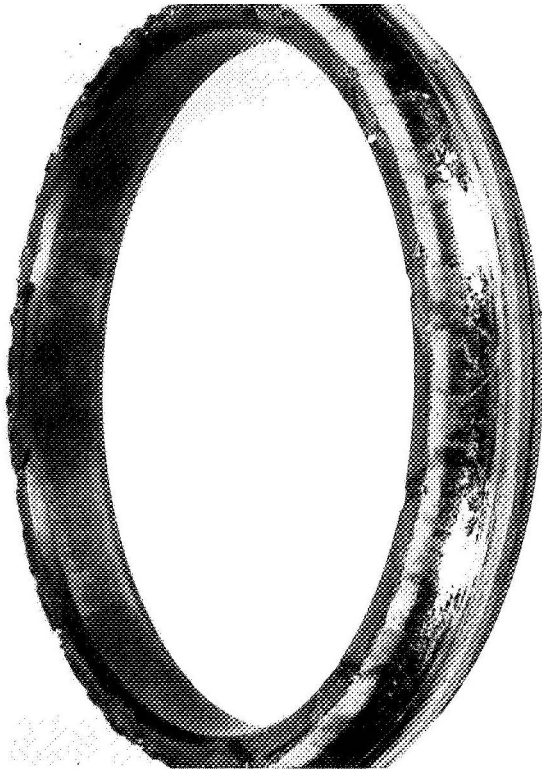
a) Inner Race

TEST BEARING PARTS AFTER MOBIL JET II OPEN ATMOSPHERE
TEST AT 390° TO 575°F AND SPEEDS FROM 14,000 TO 20,000 RPM
