**NASA CONTRACTOR  
REPORT**

**NASA CR-1810**

**REFRACTORY METAL VALVES  
FOR 1900° F SERVICE IN  
ALKALI METAL SYSTEMS**

*Prepared by*  
**GENERAL ELECTRIC COMPANY**  
Cincinnati, Ohio 45215  
*for Lewis Research Center*

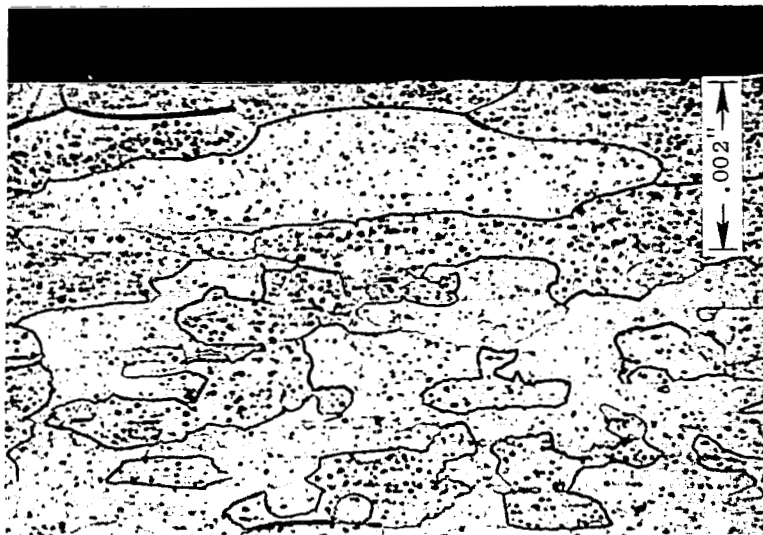
MB-1299J

Figure 47. Microstructures of ASTAR 811C Alloy Before and After Exposure to Flowing Lithium for 5000 Hours at 2100°F. No Corrosion was Observed. The Alloy Recrystallized During the Test Exposure.

Etchant:  $30\text{gNH}_4\text{F}-20\text{mlHNO}_3-20\text{mlH}_2\text{O}$

Metallographic examination of the tensile specimens after exposure to the lithium revealed no evidence of corrosion. Representative photomicrographs of each specimen are shown in Figures 47 through 52.

The ASTAR 811C and T-222 alloy specimens which had not been recrystallized prior to testing were found to be recrystallized after the 5000 hour exposure to lithium at 2100°F. Figures 53 and 54 show the pretest and posttest conditions of the ASTAR 811C and T-222 alloy specimen respectively.

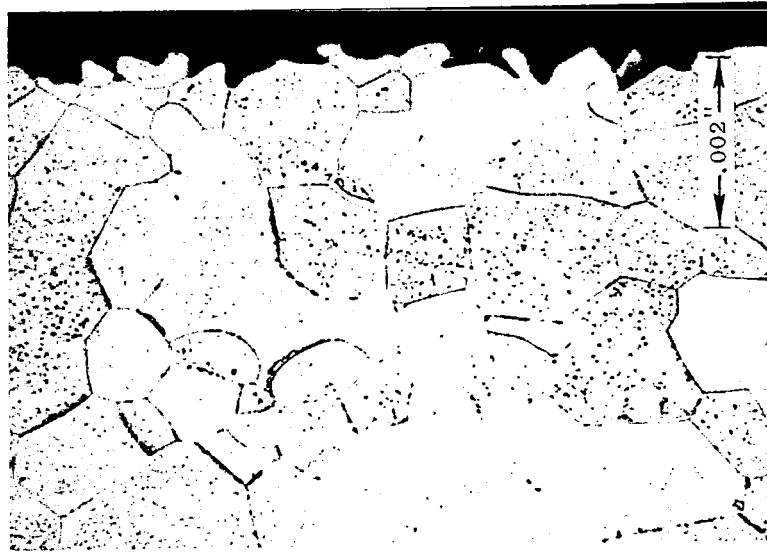
MB-1300J

Figure 48. Microstructures of ASTAR 811CN Alloy Before and After Exposure to Flowing Lithium for 5000 Hours at 2100°F. No Corrosion was Observed. The Surface Roughening is Believed to be a Result of Acid Pickling Prior to Loop Assembly.

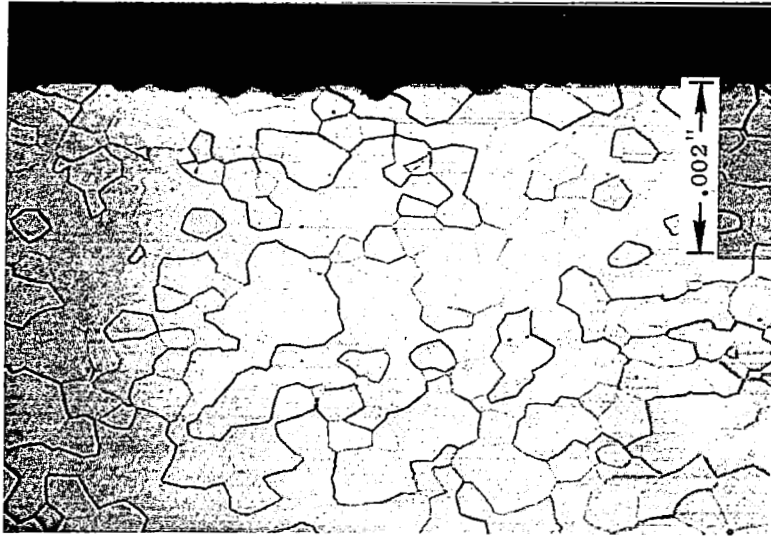
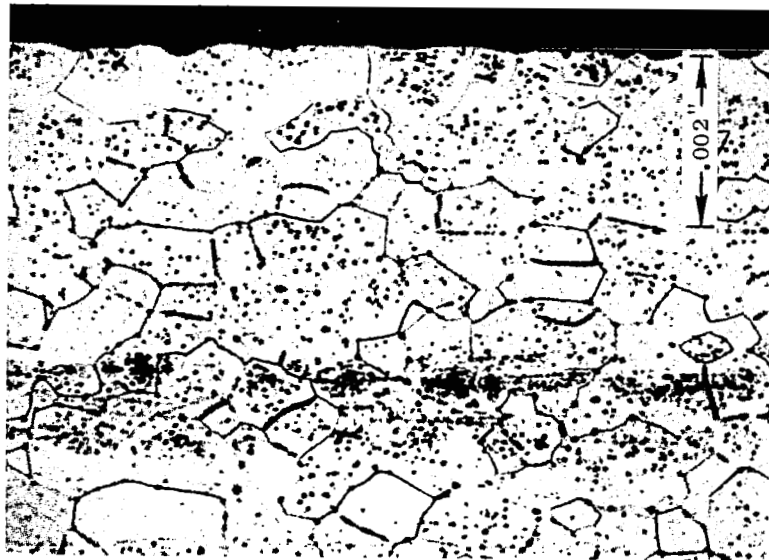
Figure 50. Microstructures of T-111 Alloy Before and After Exposure to Flowing Lithium for 5000 Hours at 2100°F. No Corrosion was Observed. The Precipitate in the Posttest Microstructure Results from the Thermal Exposure.

Etchant:  $30\text{gNH}_4\text{F}-20\text{mlHNO}_3-20\text{mlH}_2\text{O}$
