FINAL REPORT  
SOLAR CELL CONTACT DEVELOPMENT

Contract No. NAS 5-11595

Space and Defense Products Department  
3M Company  
St. Paul, Minnesota 55101

FINAL REPORT  
SOLAR CELL CONTACT DEVELOPMENT  
28 June 1968 - 28 June 1969  
and  
1 January 1970 - 1 March 1970

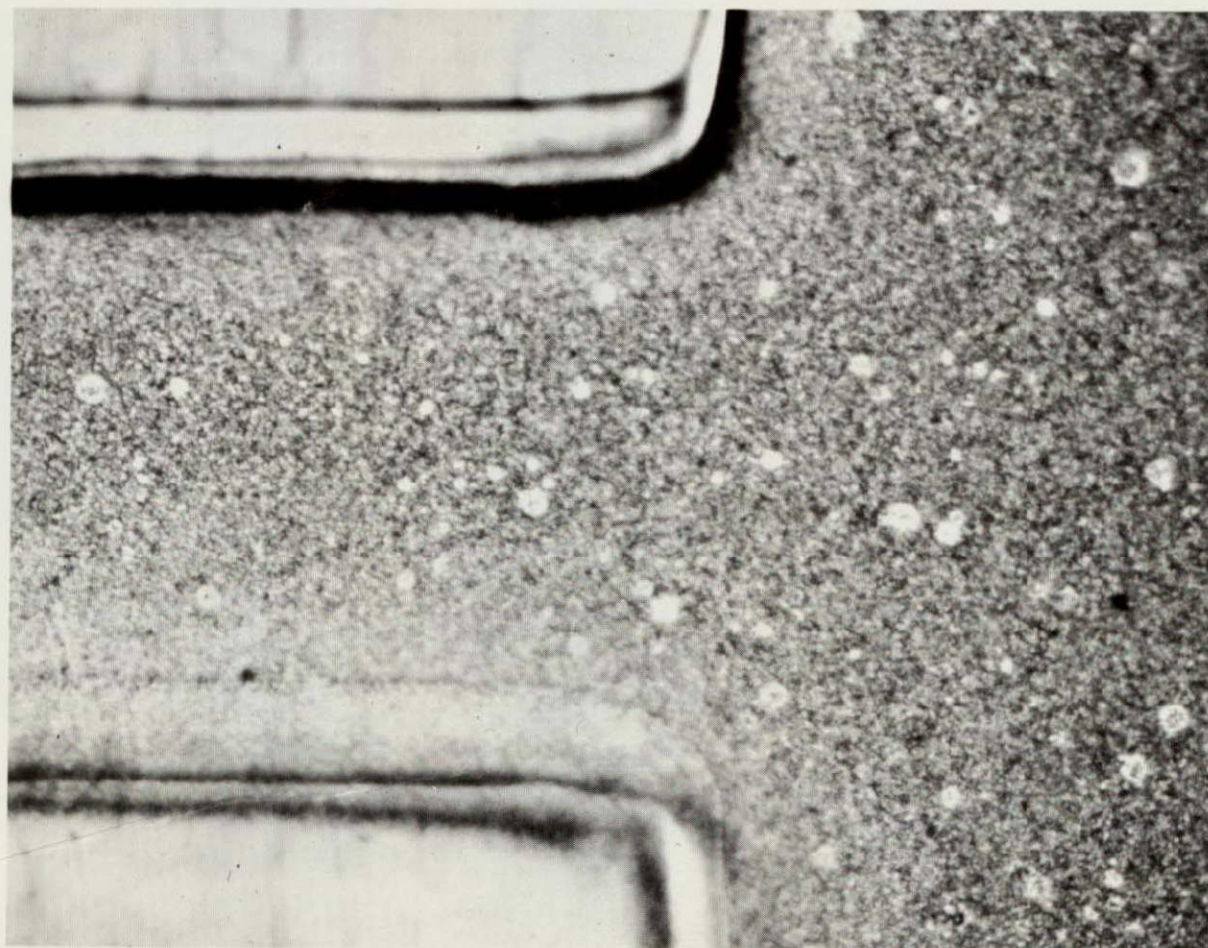
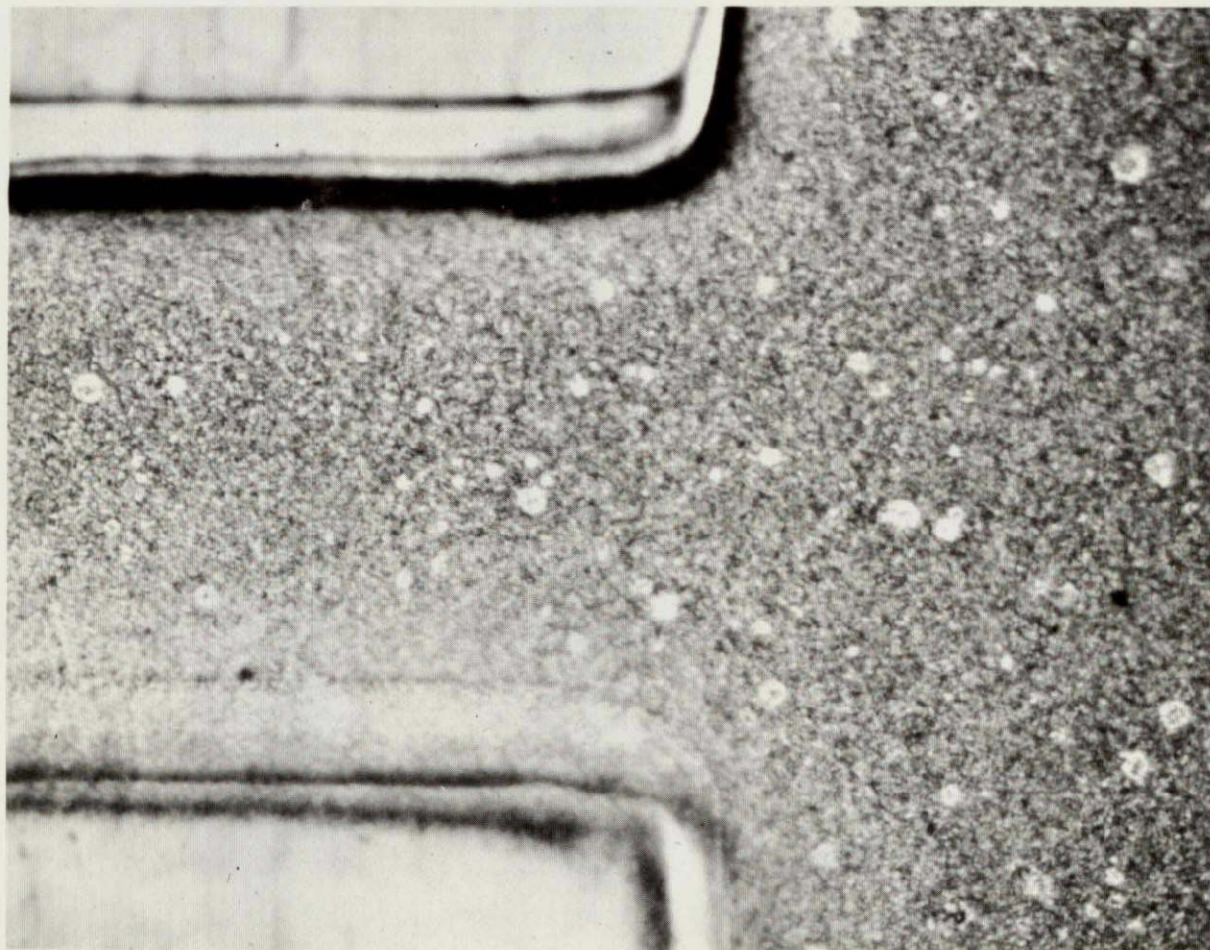
CONTRACT # NAS 5-11595 FINAL REPORT FIG #12

Figure 12 Photomicrograph of a Ti/Ag contact (320X)

A photomicrograph of a sputtered contact is shown in Figure 12. Single crystalline grains or grain boundaries are not evident, although the surface is very rough in appearance. Surface roughness is not caused by the sputtering process but is due to the original roughness of the Si blank.

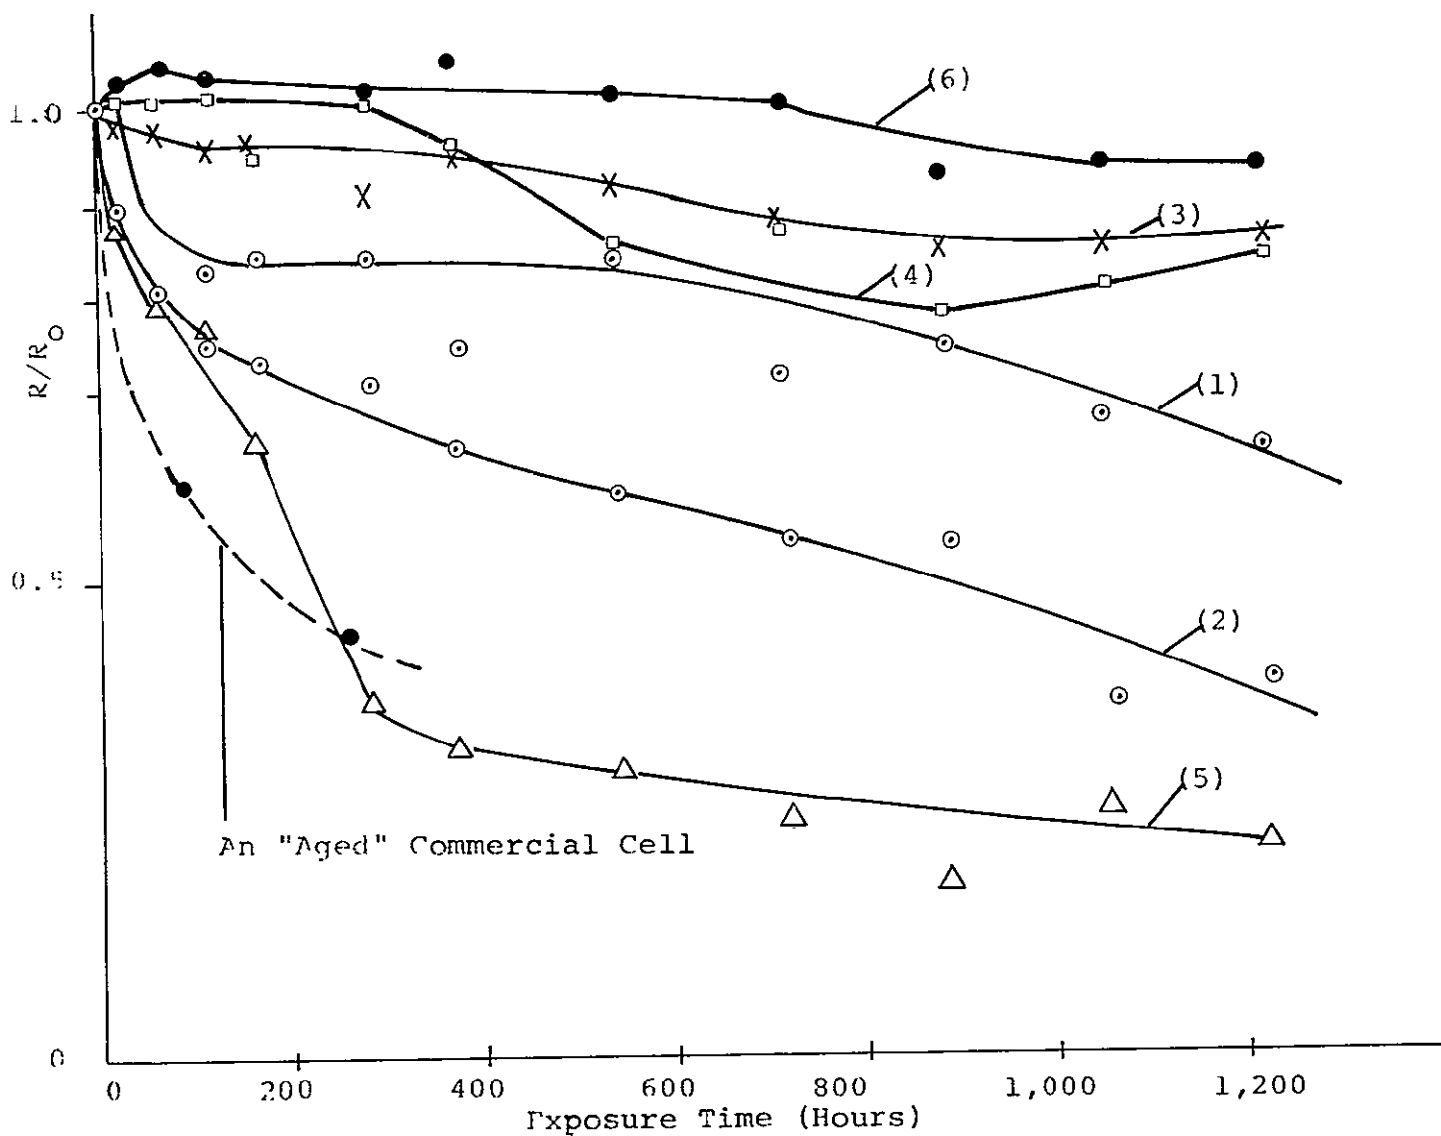
CONTRACT # WAS 5-11585 FINAL REPORT FIG # 15

Figure 15 Degradation in series resistance as a function of humidity exposure time

In Figure 15 the resistance ratio  $R_0/R$  is plotted as a function of exposure time where  $R_0$  is the initial series resistance and  $R$  the resistance at a given exposure. Resistance values were determined from the maximum slope of I-V characteristics at around 0.7 V forward bias.

It is evident from Figure 15 that cells 1 and 2, which were not given a special predeposition treatment after etching in HF, degraded rapidly over the first one to two-hundred hours of humidity exposure whereas cells 4 and 6 did not. Cell 5, which was sintered at a higher than normal temperature, degraded most seriously. Cell 6, with Ti-Pt/Ag contacts, was particularly stable and degraded at most by 10% over the long exposure time. Many small blisters were observed to develop on cells 2 and 5 during humidity tests; i.e., on the two most seriously degraded cells. A few small blisters developed on cells 1 and 3. No blisters developed on cells 4 and 6.

The above findings, although limited in extent, clearly demonstrate the importance of predeposition treatment of cell blanks on the quality of sputtered Ti/Ag and Ti-Pt/Ag contacts. In addition, this fabrication step has a significant effect on the degradation of contacts in humid environments. The exact reason for this is not known although we believe it is due to an effect of impurities remaining on or in the cell blank after HF etching, even though cell blanks were thoroughly washed in deionized water after etching. Some insoluble phosphide or fluoride compounds may possibly remain on the surface after etching. Or, HF or F may penetrate into a thin surface layer of Si and later diffuse to the surface and attack the Ti layer. In any event, heat treating cell blanks in forming gas in the 600° to 800°C temperature range just prior to contact deposition gave much improved contacts. Additionally, an Ar glow discharge pretreatment also appears reasonably effective as seen in Figure 15.
