**NASA CR-111948**

**TENSILE MICROSTRAIN PROPERTIES  
OF TELESCOPE MIRROR MATERIALS**

*Final Report*

**STANFORD RESEARCH INSTITUTE**  
Menlo Park, California 94025

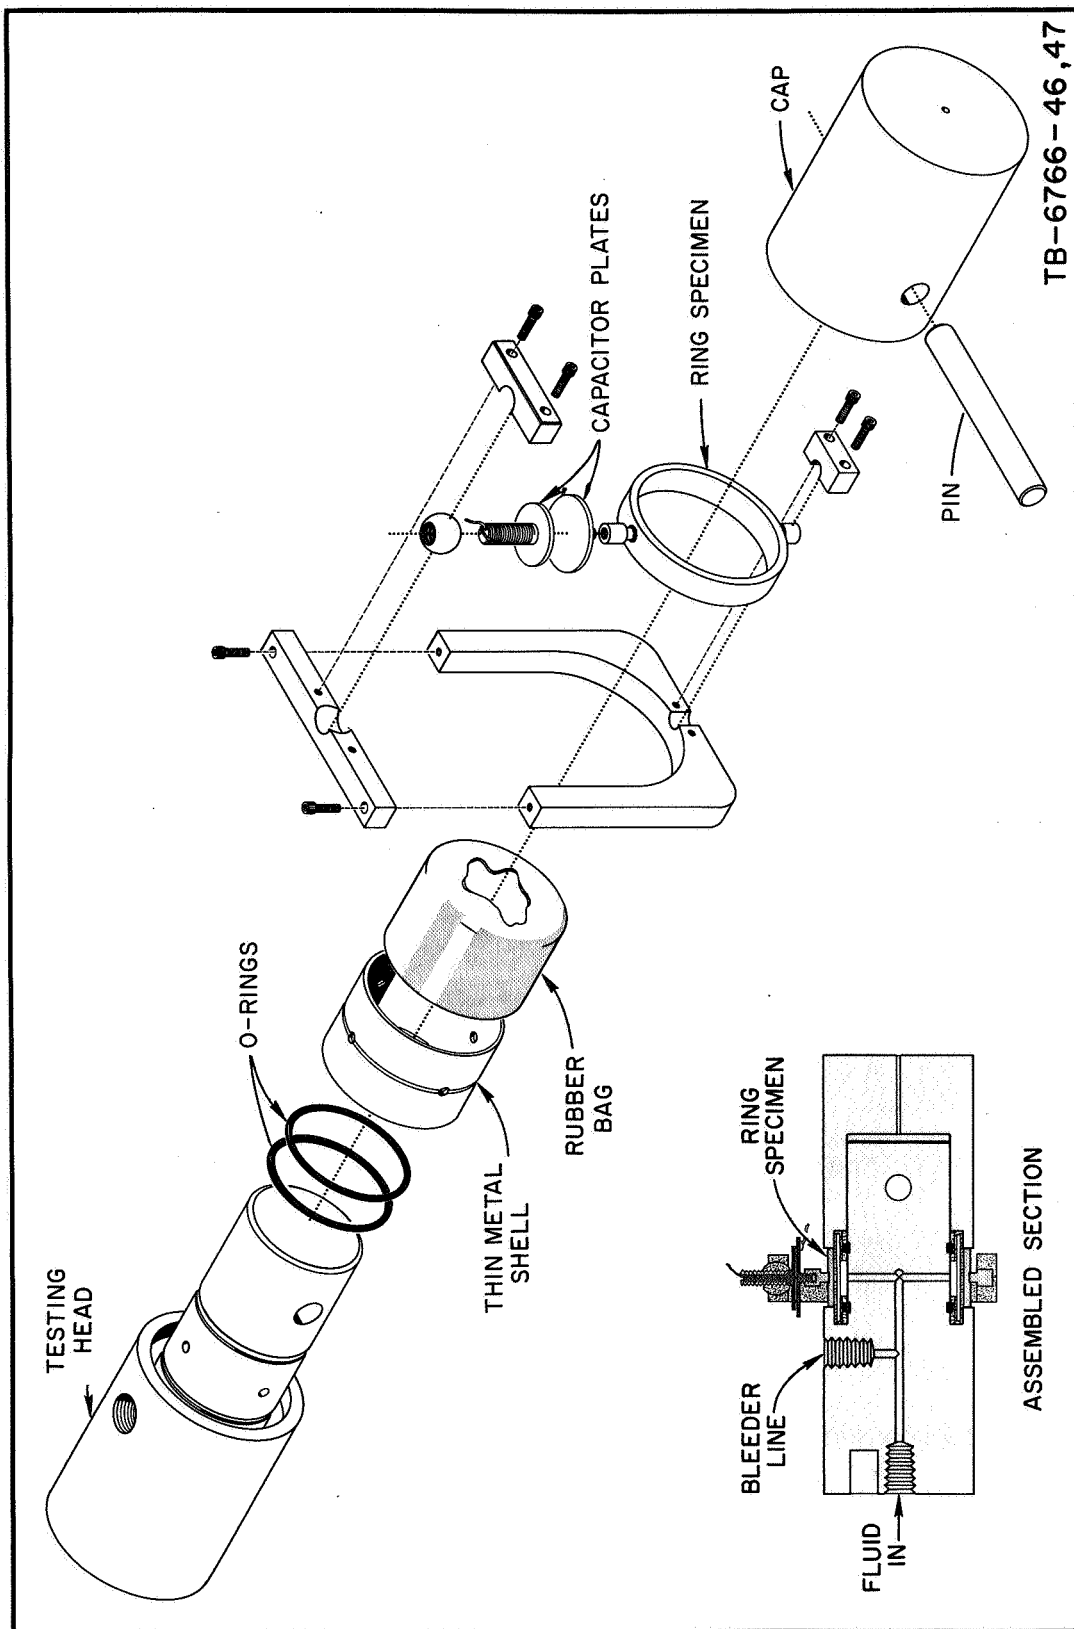
FIGURE 1 SCHEMATIC SKETCH OF MICROSTRAIN TEST APPARATUS

The testing procedure used here for measuring microstrain is basically a hoop-stress technique with hydrostatic loading applied to the inside surface of a ring-shaped specimen through a thin elastomeric membrane (Ref. 3,4). The applied pressure is therefore always perpendicular to the specimen surface and is perfectly uniform over the entire ring periphery. The specimen to be tested is unconstrained (free-floating) during the test. There are, therefore, no clamps or holders to cause misalignment or localized stress concentrations. A diagram of the testing head is shown in Figure 1.

The basic testing head is a two-section stainless steel assembly. A porous thin metal shell is inserted over the base of the test head and a rubber bag is then stretched over the shell. At the ends the rubber is tucked beneath the shell, and a leak-proof seal is accomplished by two O-rings that are placed between the metal shell and the testing head. A cap is then positioned over the end of the test head and rigidly held by a pin, as shown in the drawing. Hydraulic fluid (in this case, water) enters the assembly at the end of the test head and passes through the thin-wall metal shell to inflate the rubber bag.

The test specimens are right circular rings 55.88 mm (2.200 in.) o.d., 50.80 mm (2.00 in.) i.d., and 3.35 mm (0.250 in.) high. To eliminate any friction between the specimen and the testing head, a small gap is left at the ends of the specimen. This gap is kept small to prevent the rubber from protruding and thereby applying a load to the ends of the specimen.

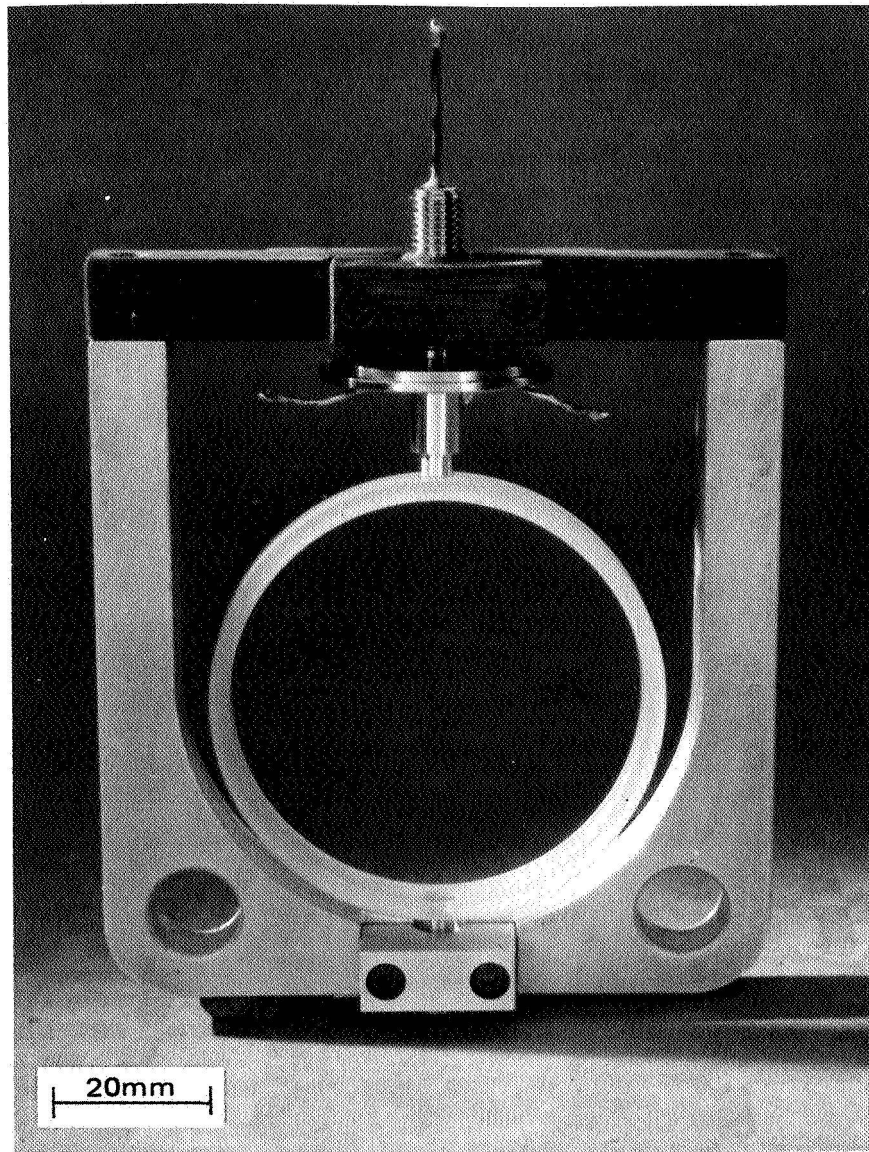
TA-8631-1

FIGURE 2 TEST SPECIMEN WITH CAPACITANCE GAUGES

A capacitance system is used to measure changes in ring diameters. The specimen and assembled capacitor plates are shown in Figure 2. Small tabs are fastened diametrically on the ring with epoxy adhesive. Into one tab is screwed a flat 28.6 mm (1.125 in.) diameter stainless steel capacitor plate. A yoke assembly holding a second stainless steel plate, diameter 25.4 mm (1 in.), is then attached to the other

tab. The plates can be aligned parallel by the ball adjustment at the top of the yoke. The plates are spaced about 0.10 mm (0.004 in.) so as to produce an interplate capacitance of about 30 picofarads.

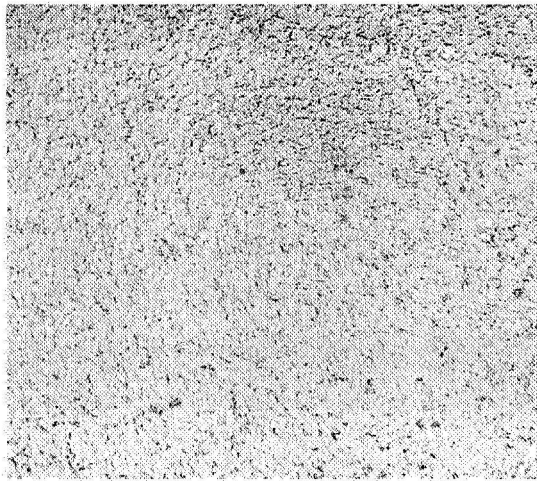
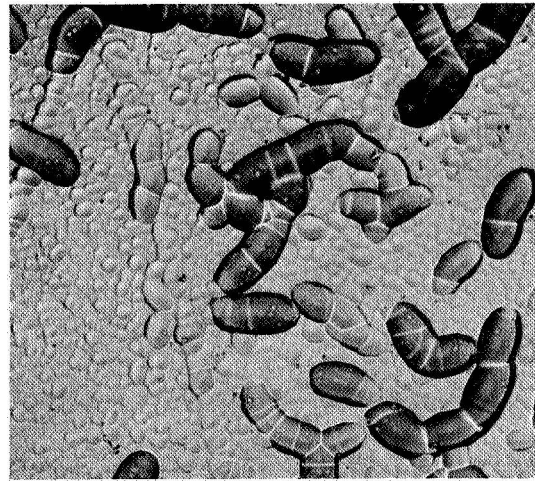
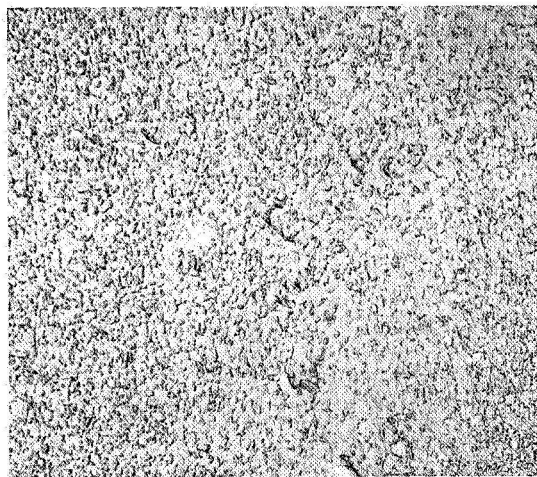
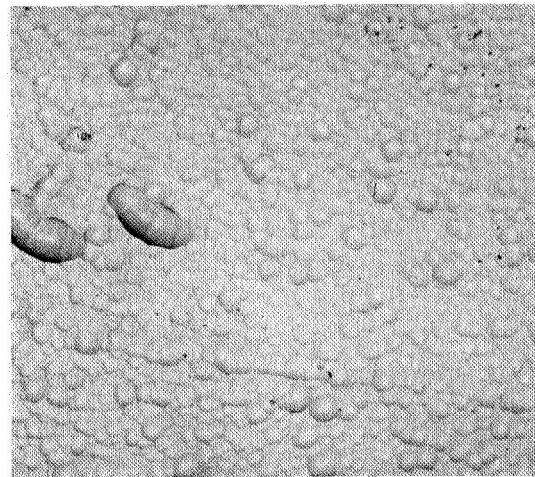
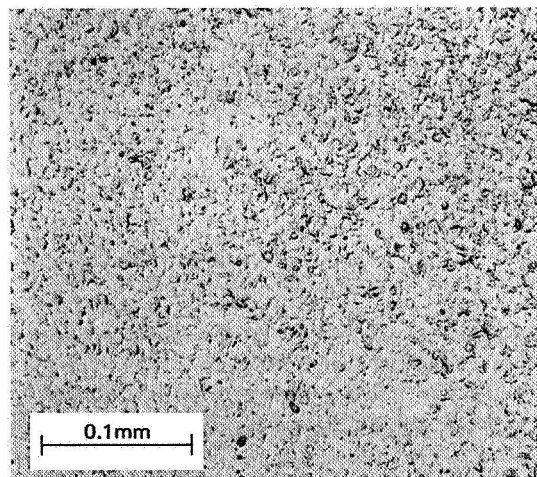
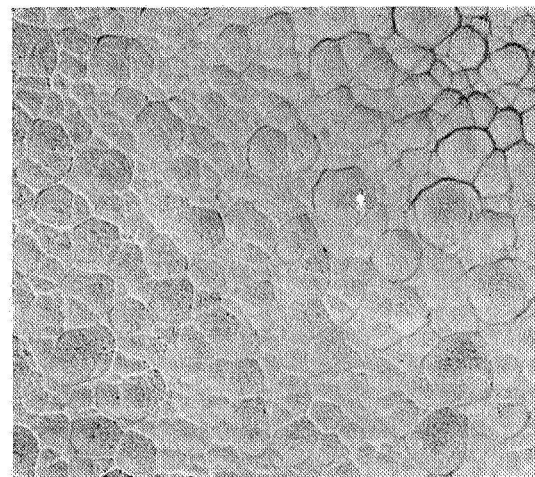
TA-8631-2

**FIGURE 3 PHOTOMICROGRAPHS OF THE THREE MIRROR MATERIALS BEFORE AND AFTER ETCHING**

Two samples each of the fused silica, ULE fused silica, and Cer-Vit were etched to remove 0.10 to 0.12 mm (0.004 to 0.005 in.) from all surfaces. For fused silica and ULE fused silica the etchant was a 48% aqueous solution of hydrofluoric acid. For the Cer-Vit samples the hydrofluoric acid was diluted to 24%. Figure 3 shows photomicrographs of the three mirror materials before and after etching.

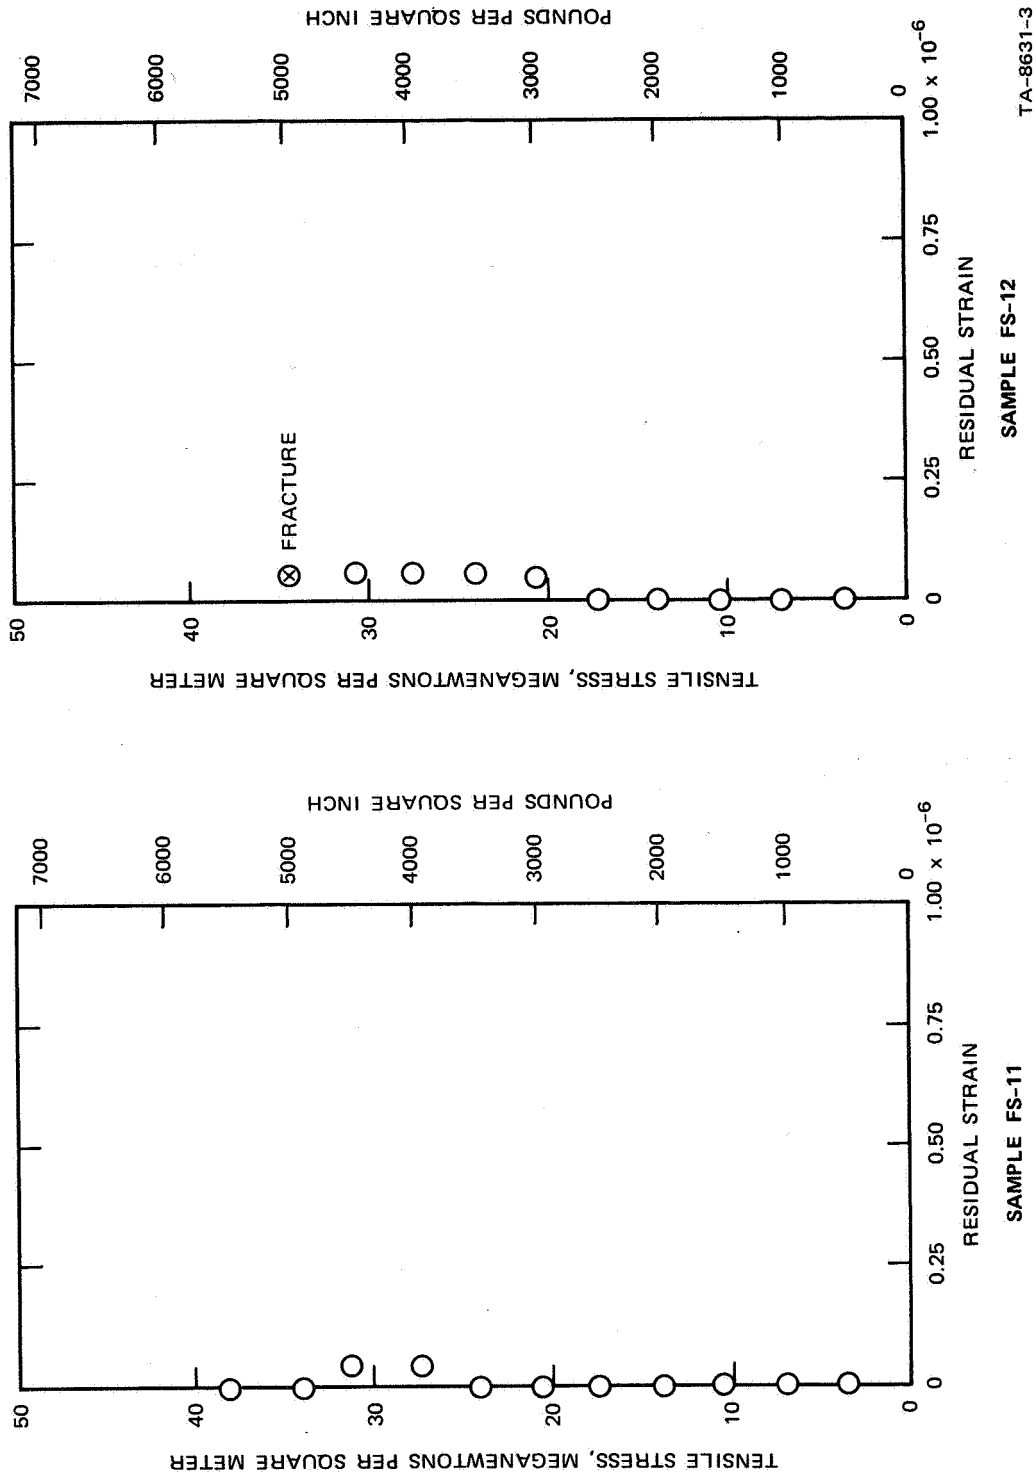
FIGURE 4 MICROSTRAIN MEASUREMENTS FOR TWO UNETCHED FUSED SILICA SPECIMENS

The microstrain behavior for fused silica in the unetched (as-ground) and etched conditions is shown in Figures 4 and 5. No microyielding was observed in either of the two unetched samples. Sample FS-11 behaved elastically when stressed to  $38 \text{ MN/m}^2$  (5500 psi). Sample FS-12 did show a strain of  $5 \times 10^{-8}$  (the detection limit) at  $21 \text{ MN/m}^2$  (3000 psi) but did not yield further when loaded higher, until  $34 \text{ MN/m}^2$  (5000 psi), at which point the sample fractured. Considering the total stress-residual strain curve it was concluded that this sample also was elastic to within the strain detection limit of the measuring system.

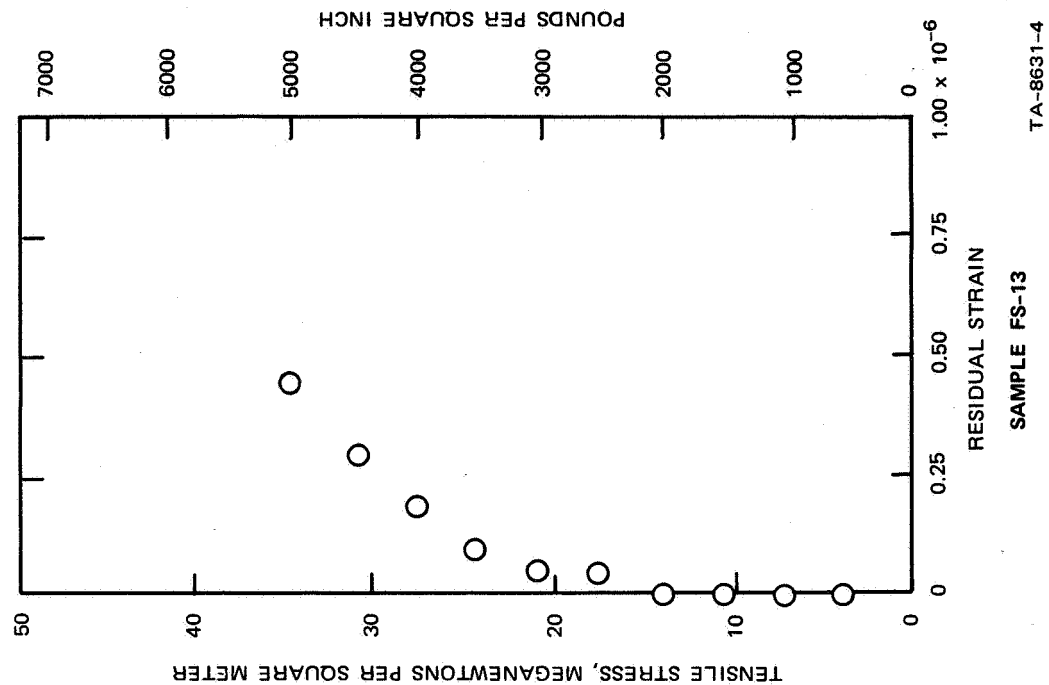
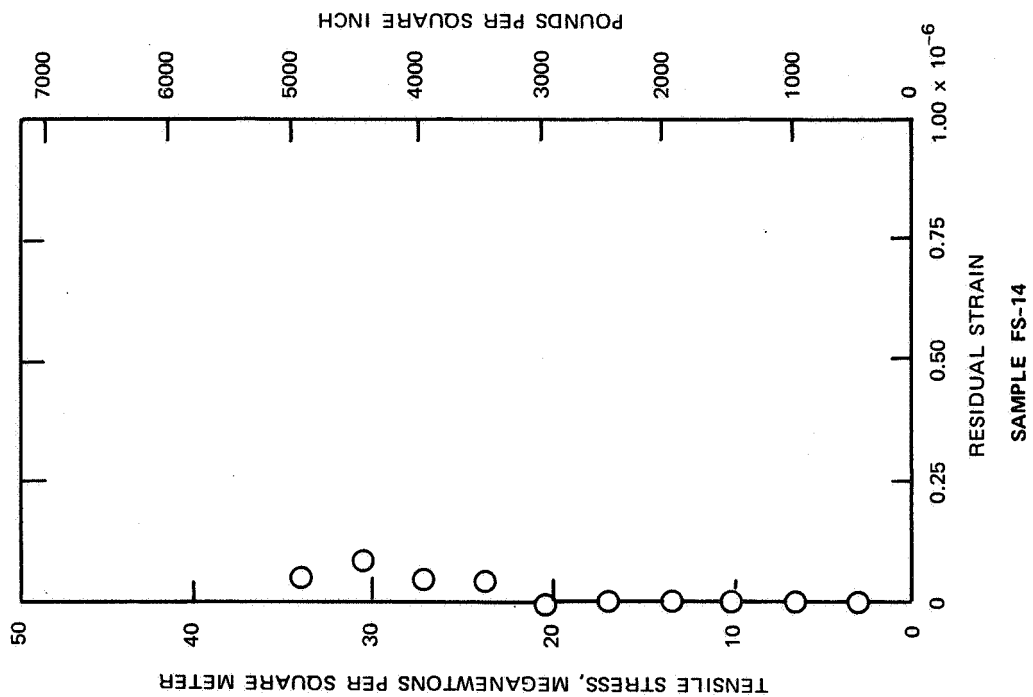
FIGURE 5 MICROSTRAIN MEASUREMENTS FOR TWO ETCHED FUSED SILICA SPECIMENS

The results of etched fused silica are nearly identical to those of the unetched. No microyielding was observed when sample FS-14 was tested to  $34 \text{ MN/m}^2$  (5000 psi). The second etched sample (FS-13) showed what appeared to be microyielding--a total strain of about  $5 \times 10^{-7}$  when loaded to the same stress level. This is the total strain measured and is the accumulated value from each of the previous stress levels. The onset of microyielding was at  $17 \text{ MN/m}^2$  (2500 psi). In this test there was significantly more time-dependent (anelastic) strain recovery than in any of the previous tests. For sample FS-14 there was a total anelastic strain of about  $10^{-6}$ , which appears to be fully recovered in about six to eight minutes. All but  $10^{-7}$  was recovered in about four minutes. Sample FS-13, on the other hand, showed an anelastic recovery of over twice this amount, approximately  $2.5 \times 10^{-6}$  after being stressed to about  $28 \text{ MN/m}^2$  (4000 psi), with a corresponding increase in time--over twelve minutes. This greatly increases the difficulty of comparing the initial base line of strain to that after loading, and effectively reduces the strain detection limit to about  $2 \times 10^{-7}$ . This raises an uncertainty as to whether the permanent strain measured for FS-13 was real. Considering the results of the other etched and unetched fused silica samples, it is concluded that no microyielding occurred.

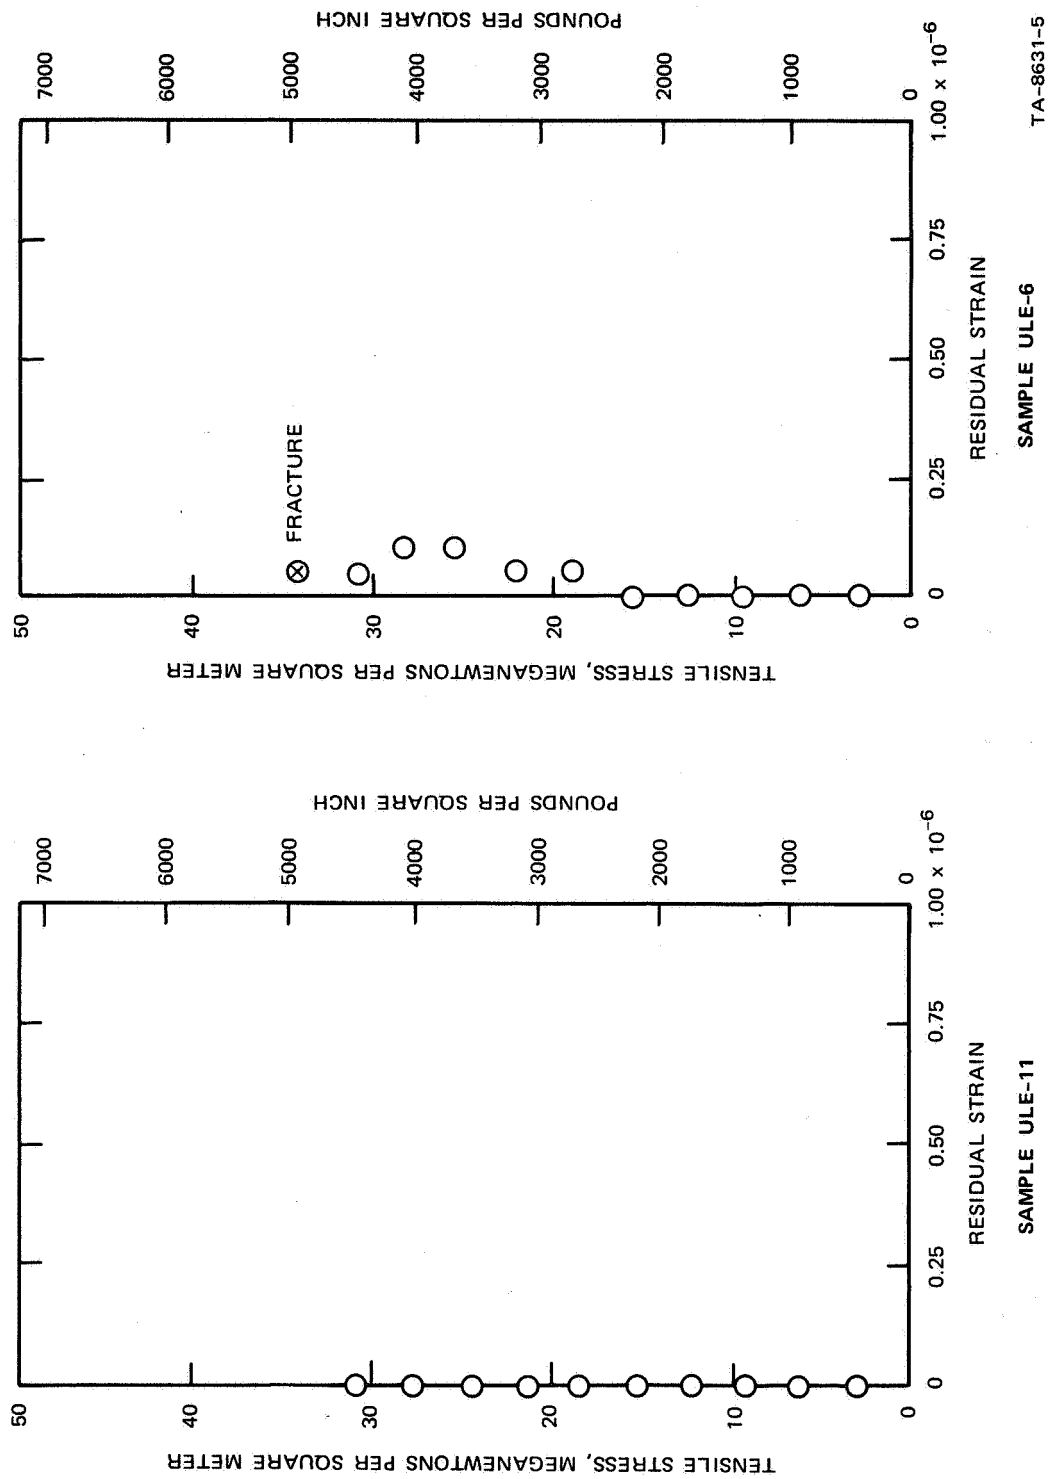
FIGURE 6 MICROSTRAIN MEASUREMENTS FOR TWO ETCHED ULE FUSED SILICA SPECIMENS

Due to the fracture of specimens in final grinding the tests on ULE fused silica were limited to samples whose surfaces had been etched. The results are shown in Figure 6. Sample ULE-11 showed no microyielding when tested to  $31 \text{ MN/m}^2$  (4500 psi). Sample ULE-6 also showed what is concluded to be zero microyielding until it fractured at  $34 \text{ MN/m}^2$  (5000 psi). These results are effectively identical with the results from etched fused silica.

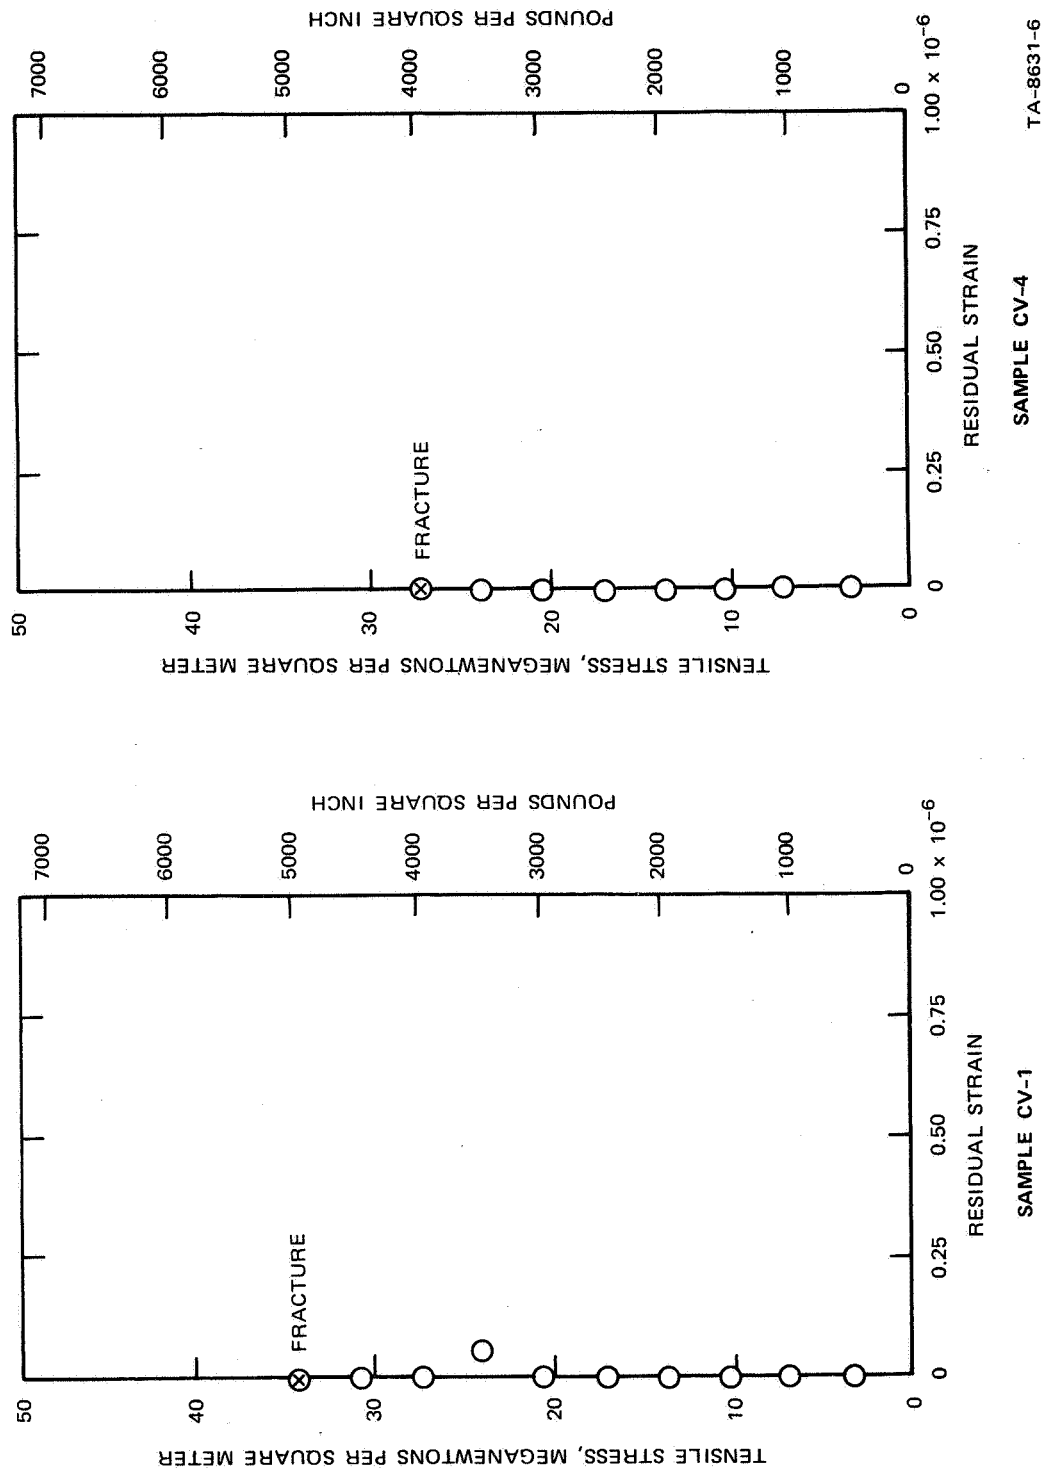
FIGURE 7 MICROSTRAIN MEASUREMENTS FOR TWO UNETCHED CER-VIT SPECIMENS

Etched and unetched Cer-Vit samples were also elastic. However, one unetched Cer-Vit sample failed at  $34 \text{ MN/m}^2$  (5000 psi); the second, at  $28 \text{ MN/m}^2$  (4000 psi). See Figures 7 and 8. This was somewhat surprising inasmuch as the initial fracture test specimen of this material (unetched) didn't break until  $76 \text{ MN/m}^2$  (11,000 psi). This again shows that these fracture strengths are not indicative of the true fracture strength of the material, but more a measure of the surface quality (microcracks).

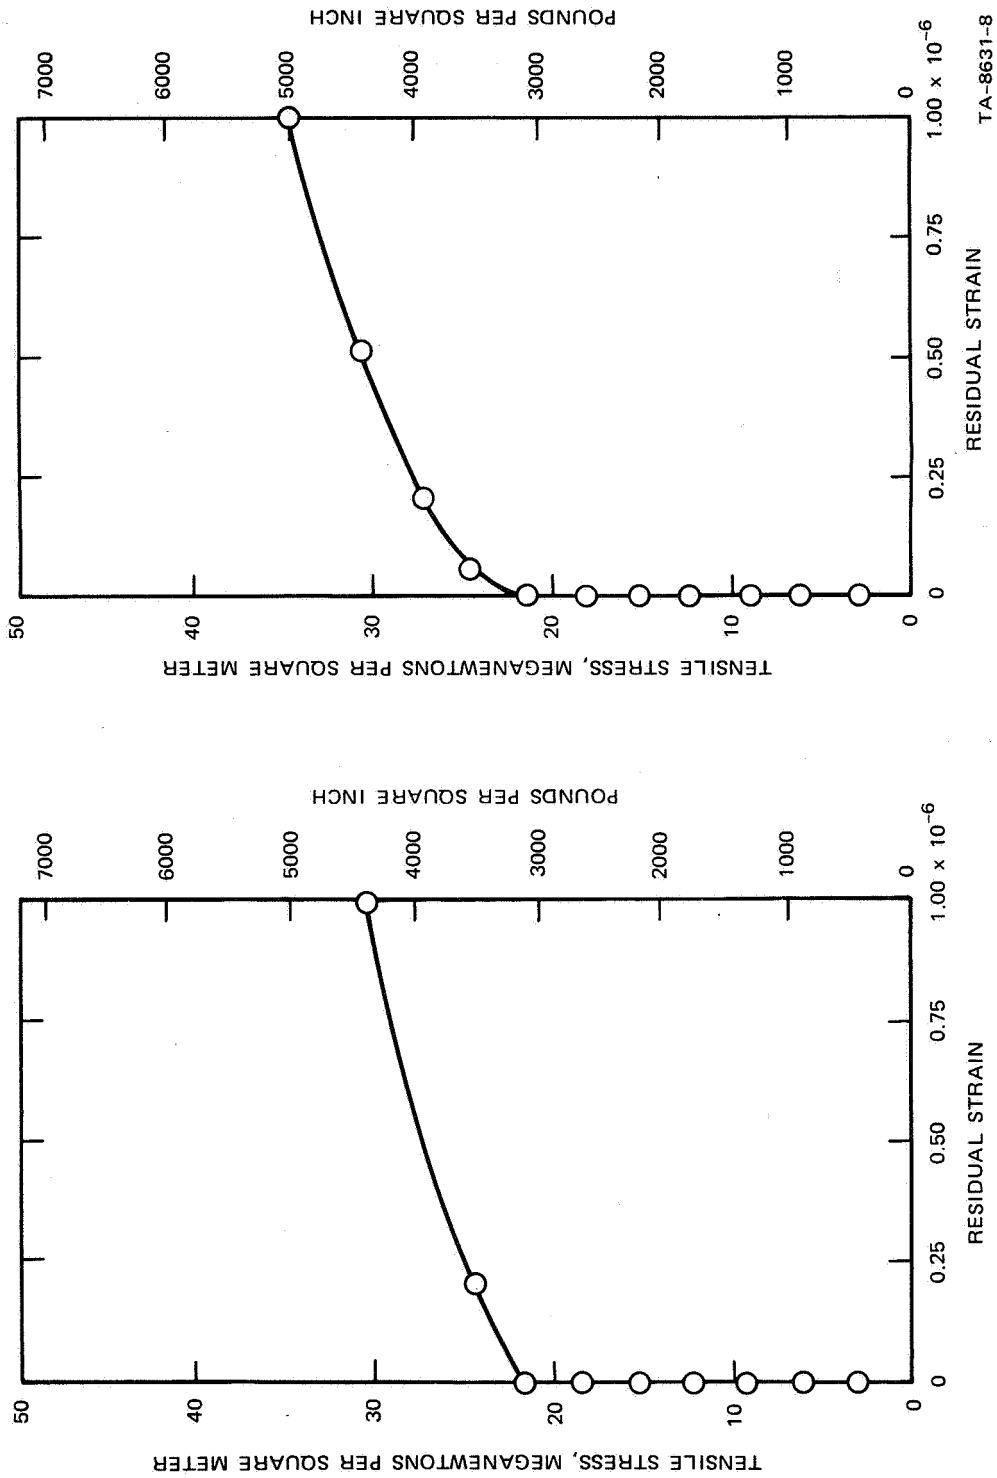
FIGURE 9 MICROSTRAIN MEASUREMENTS FOR TWO BERYLLIUM PLUS 5 WT % COPPER ALLOY SPECIMENS

Two samples of an alloy of beryllium plus 5 wt% copper were tested. After fabrication and machining, the specimens were etched with a mixture of hydrofluoric and nitric acids to remove 0.10 mm (0.004 in.) from all surfaces. The results of the microstrain tests are shown in Figure 9. No microyielding was recorded for either specimen up to  $21 \text{ MN/m}^2$  (3000 psi). A strain of  $10^{-6}$  was then measured after loading to 31 to  $34 \text{ MN/m}^2$  (4500 to 5000 psi). This behavior is characteristic of sintered beryllium.

The results observed for the alloy of beryllium plus 5 wt% copper is in close agreement with previous tests at SRI on other samples of the same composition. Permanent deformations were first measured at 24 to 28 MN/m<sup>2</sup> (3500 to 4000 psi), the specimen then showing substantial deformations at slightly higher stress. This trend is nearly identical to the results of Woods (Ref. 2) who tested a similarly fabricated alloy of beryllium plus 0.2 wt% iron. With the iron alloy the stress for onset of microyielding was about 10 MN/m<sup>2</sup> (1500 psi). The effect of the alloying additions is to raise the critical resolved shear stress for slip, thereby increasing the microyield stress of alloy.
