FUNDAMENTAL MECHANISMS OF TENSILE FRACTURE IN ALUMINUM SHEET  
UNIDIRECTIONALLY REINFORCED WITH BORON FILAMENT

Thesis submitted to the Graduate Faculty of the  
Virginia Polytechnic Institute and State University  
in partial fulfillment of the requirements for the degree of

DOCTOR OF PHILOSOPHY

Materials Engineering Science

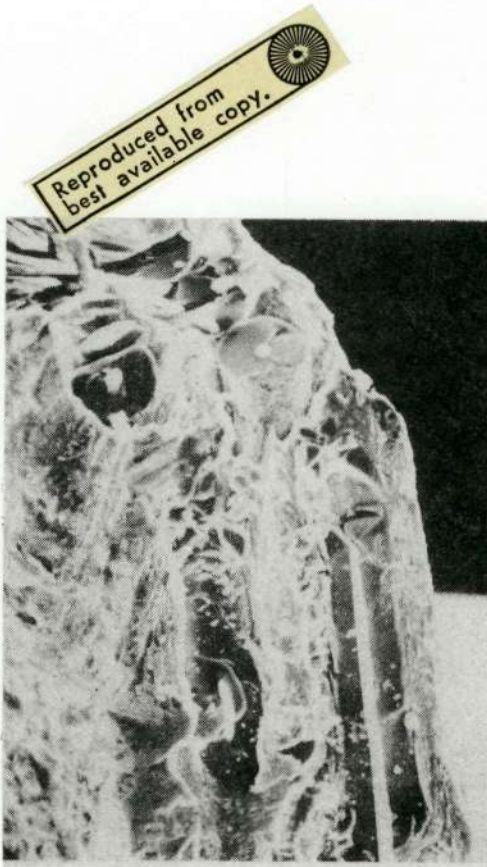
Figure 23. - Details of axial fracture surface containing split filament, 3.9 mils filament diameter.
