ALUMINIDE COATINGS FOR NICKEL-BASE ALLOYS

H. C. Fiedler and R. J. Sieraski

METALLURGY AND CERAMICS LABORATORY
RESEARCH AND DEVELOPMENT CENTER
GENERAL ELECTRIC COMPANY
SCHENECTADY, NEW YORK 12301

NASA Lewis Research Center
Contract NAS 3-14300
John P. Merutka, Project Manager

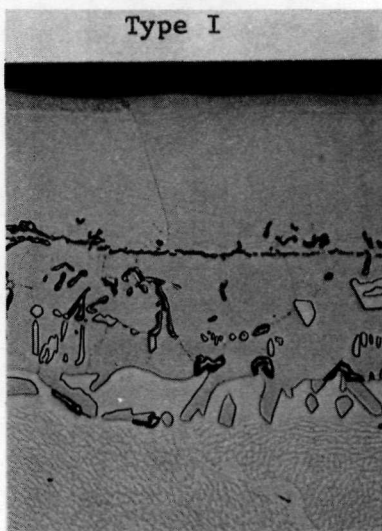
Fig. 8 The different mode of formation of coatings at low and high deposition rates results in inward and outward movement, respectively, of original surfaces. (Disk I1 at top and F1 at bottom.) 500X

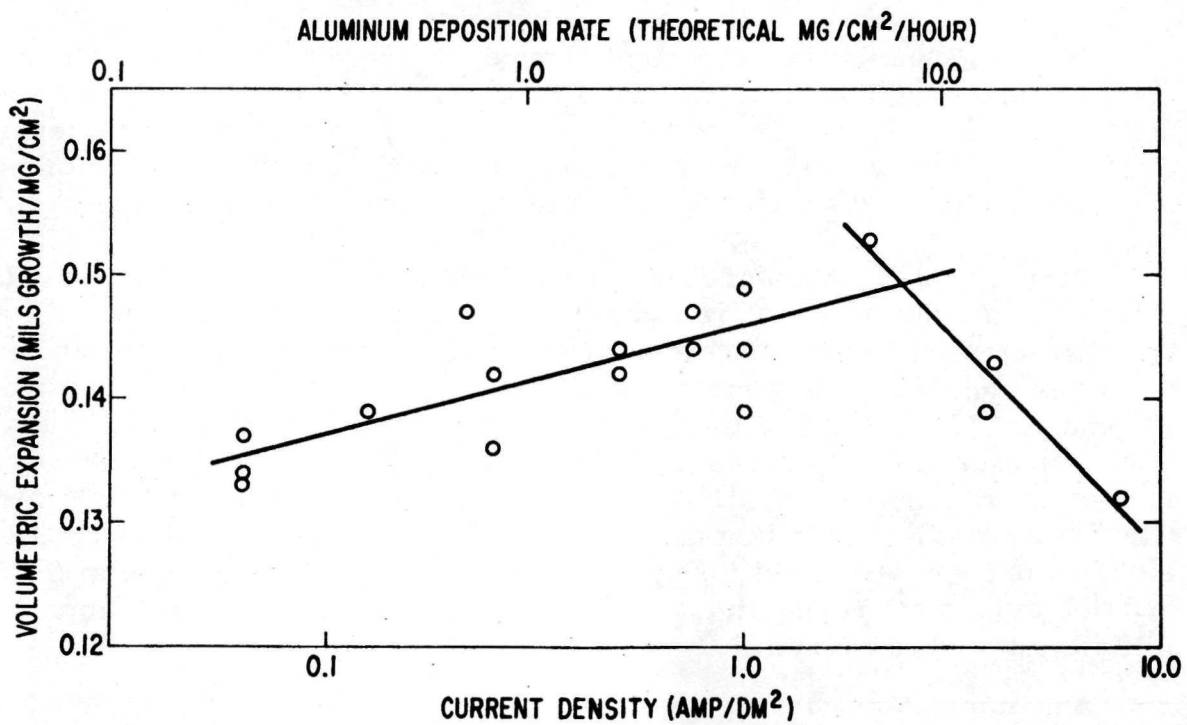
Fig. 12 Specific volumetric expansion vs aluminum deposition rate on IN-100.

expansion does not greatly change with aluminum deposition rate as seen in Fig. 12. The addition of 1 mg of aluminum/cm² causes a net expansion of about 0.14 mils ± 0.01. The more useful function, the growth/penetration (or expansion/coating thickness) ratio is Fig. 13. It can be used to predict surface growth when an aluminide coating of a specified thickness is formed on IN-100.

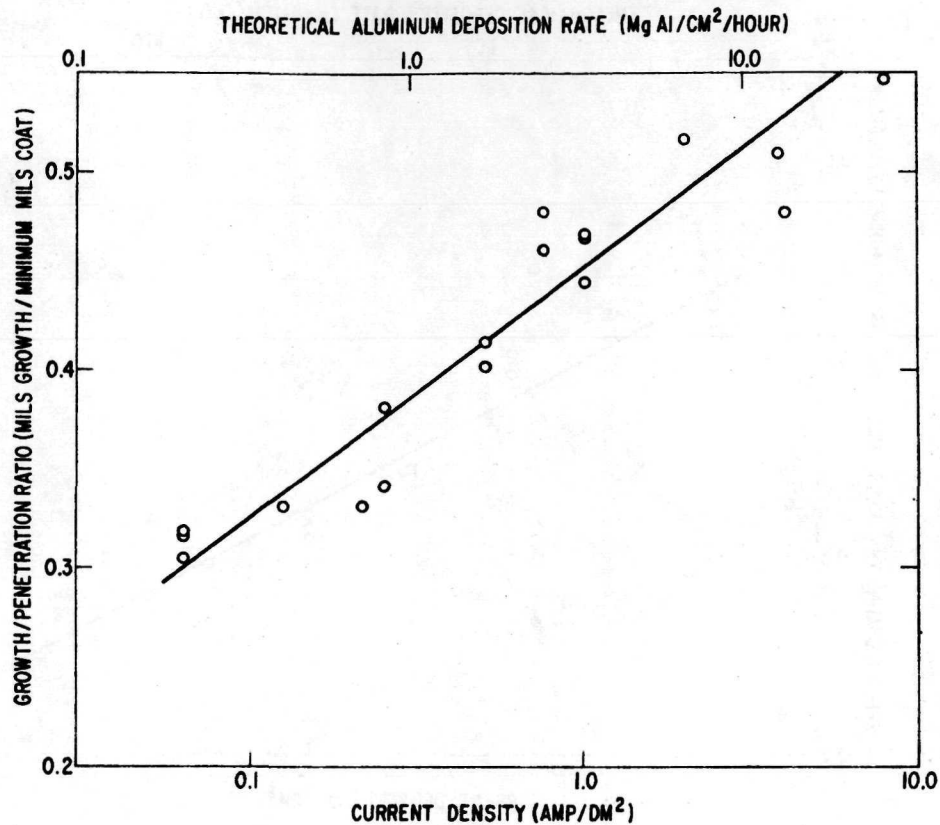
Fig. 13 Growth/coating thickness ratio vs aluminum deposition rate on IN-100.
