# EVALUATION OF COATED COLUMBIUM ALLOY HEAT SHIELDS FOR SPACE SHUTTLE THERMAL PROTECTION SYSTEM APPLICATION

PHASE I + ENVIRONMENTAL CRITERIA AND MATERIAL CHARACTERIZATION

NASA CR-112119

Prepared by  
CONVAIR AEROSPACE DIVISION OF GENERAL DYNAMICS  
San Diego, California

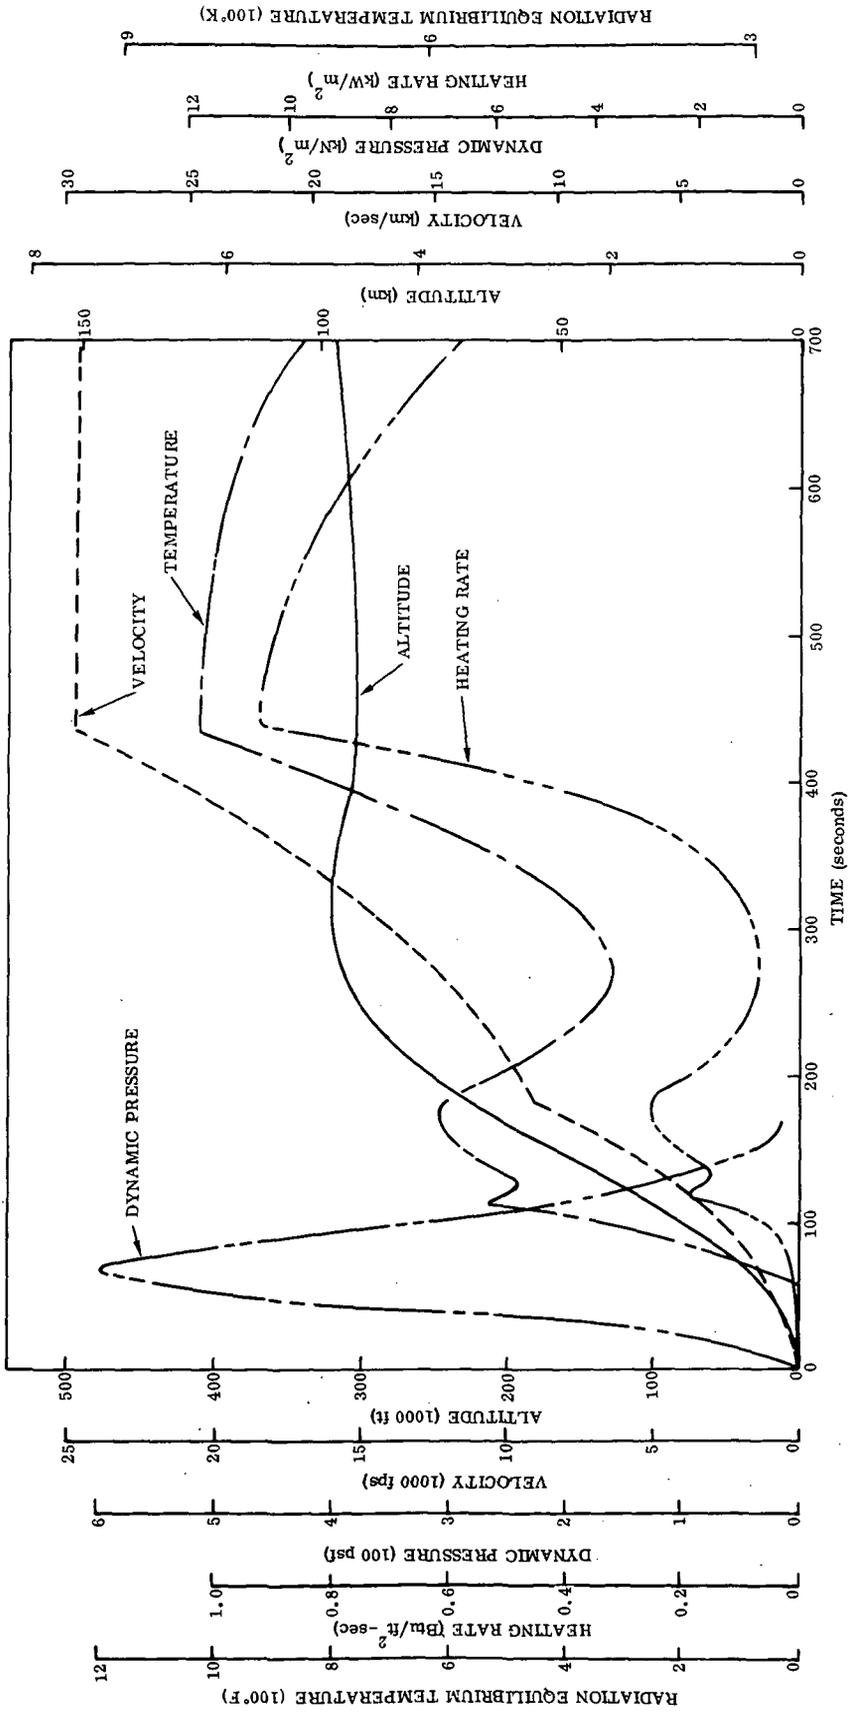
Figure 3-4. Selected Boost History — Lower Surface  $X/L = 0.025$

3.2.1 Boost. — The boost parameters, dynamic pressure, heating rate, and temperatures are presented in Figure 3-4 for a vehicle location of  $X/L = 0.025$ . It assumes a zero-lift ascent to separation at 183.5 seconds followed by a coast of 2.5 seconds between stages. Optimum pitch-plane steering of the powered orbiter continues until 434 seconds when the orbiter reaches the insertion orbit of 50 by 100 n. mi. (9.26 by 18.52 km) at a  $55^{\circ}$  inclination. After the orbit is circularized at 100 n. mi. (18.52 km), an additional burn is made to place the orbiter into a 100 by 270 n. mi. (18.52 by 50 km) path that is subsequently circularized into a nominal 270 n. mi. (50 km) by  $55^{\circ}$  inclination orbit. The maximum acceleration of the 3,500,000-pound (1,589,000 kg) fixed-gross-weight configuration was limited to 3 g.

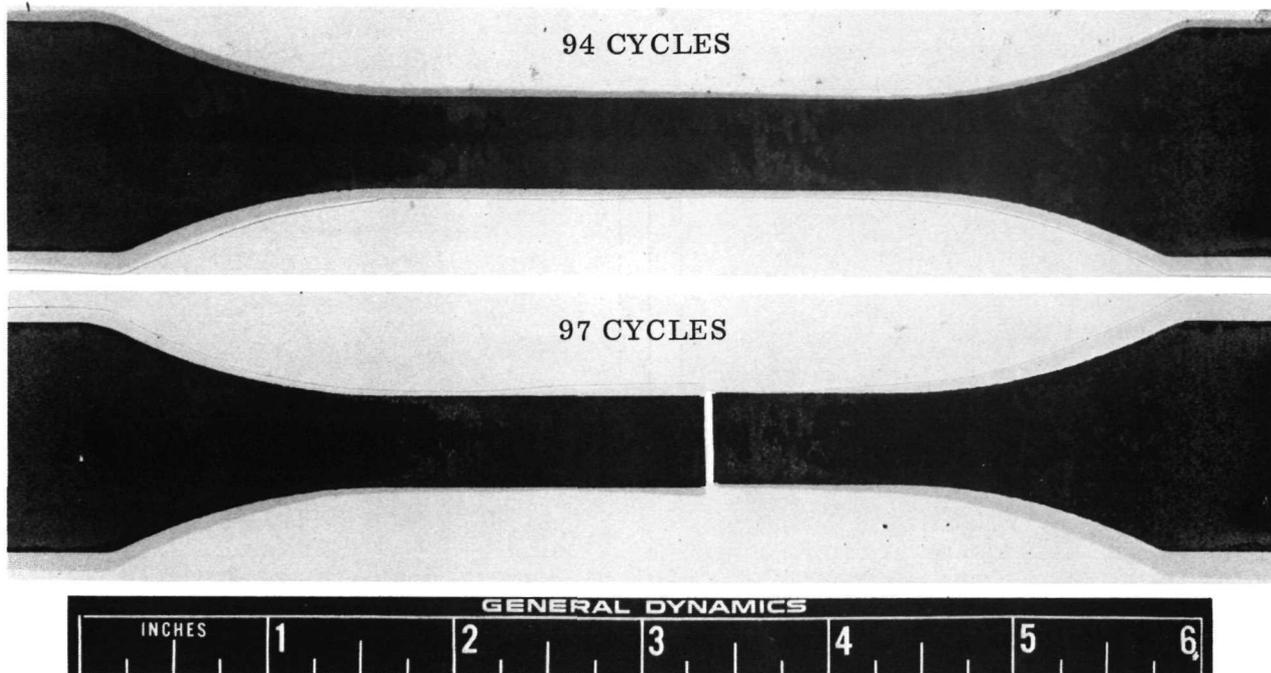
Figure 4-17. Cb-752/R-512E After Flight Simulation  
Exposure — Specimen BSE-10

Group 2, Cb-752/R-512E, electron beam weld: The specimens in this group behaved very much like those in group 1 with the exception of one that failed during the ninety-seventh cycle. Failure occurred about 3/8 inch (0.95 cm) from the weld and did not appear to have been caused by oxidation. Figure 4-17 shows the specimen after 94 cycles and after failure (97 cycles). An enlargement of one of the failed ends is presented in Figure 4-18. No evidence of coating failure or severe oxidation is visible in either figure. The typical coating spall can be seen along with what appears to be some transverse coating cracks. The five specimens that survived 100 cycles exhibited slight coating spall and color changes very similar to those in group 1. The weld areas did not appear to have been affected any differently than the adjacent material, which gives an indication of the suitability of electron beam welds for this application. As was the case in the previous group, one specimen had a small area of coating failure at one of the loading pin holes. Photographs of a typical specimen as it progresses through the 100 cycles are shown in Figures 4-19 and 4-20. Figure 4-21 shows three of the specimens after the completion of 100 cycles.

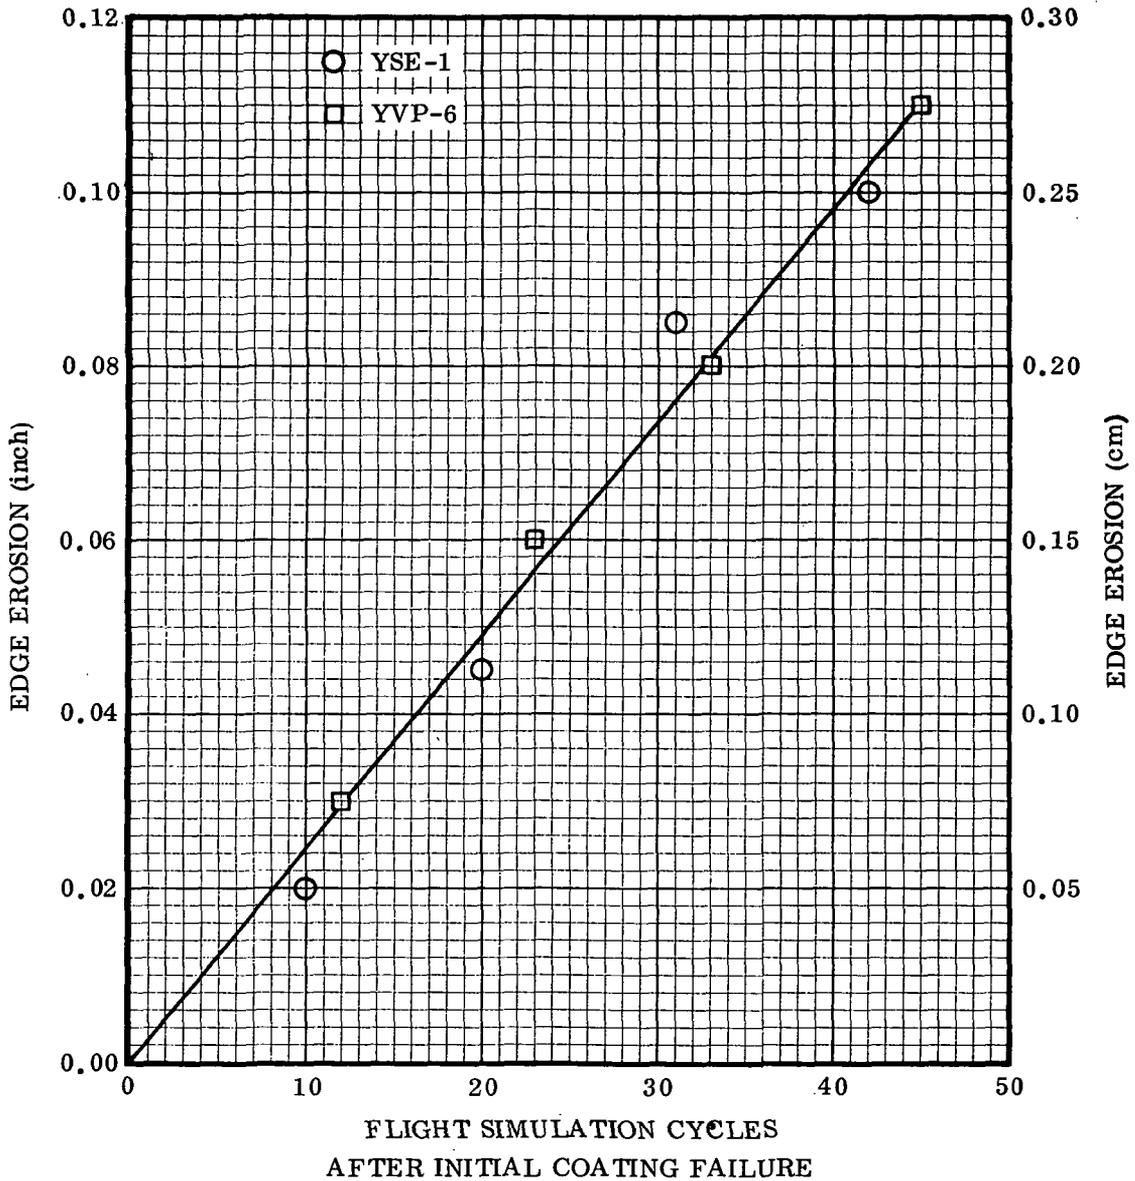
Figure 4-56. Edge Erosion as a Function of Flight Simulation Cycles

R-512E coating, and one with the VH-109 coating. Plotted in Figure 4-56 is the amount of substrate consumption (measured at an edge) as a function of flight simulation cycles. Initial coating failures were visible at 55 and 58 cycles, respectively, for the two specimens. These measurements were not intended to be very precise; hence, the exact shape of the curve cannot be determined. A straight line appears to fit the data quite well giving a linear rate of edge erosion of about 0.0025 inch (0.0064 cm) per cycle for both systems. For a system with an adherent oxide one would expect a parabolic rate of substrate oxidation typical of a diffusion controlled process. On the other hand, for a system in which the oxidation products offered no resistance to further oxidation a

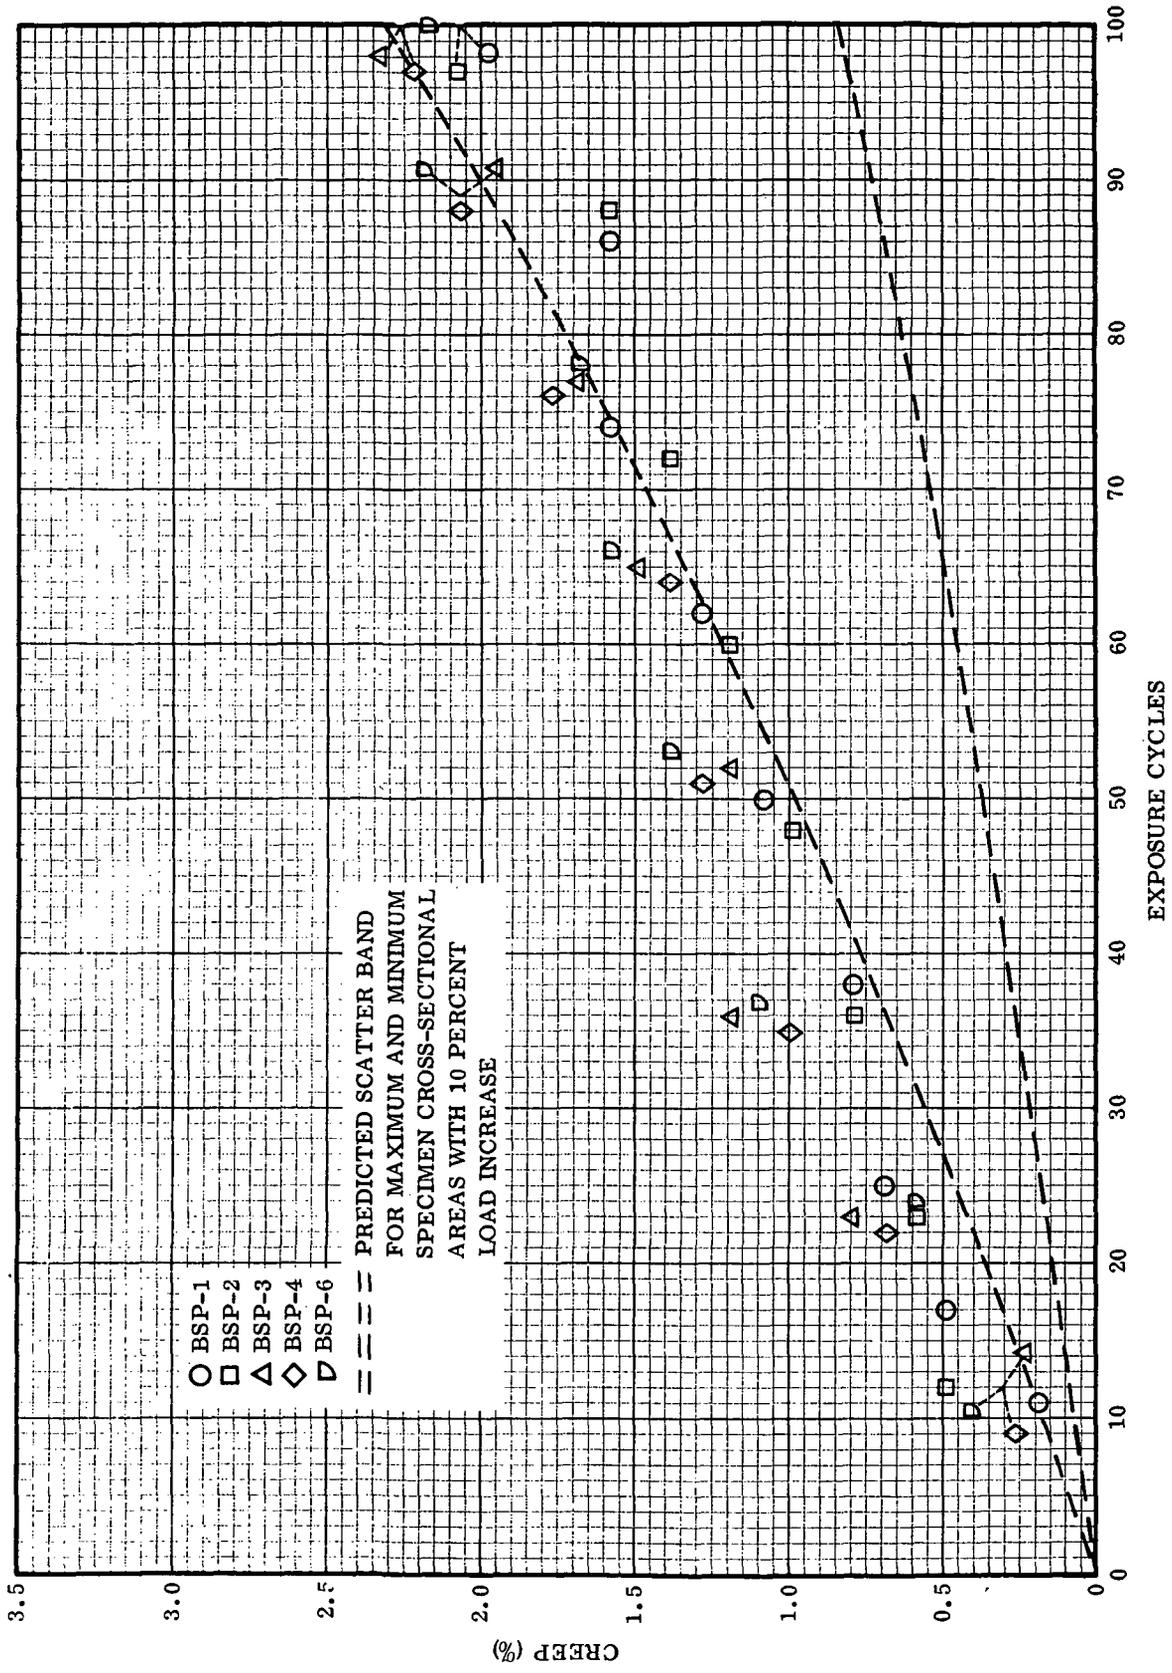
Figure 4-57. Cyclic Creep Data for Cb-752/R-512E Parent Specimens

The scatter in the data arose from several sources. The largest contribution was probably caused by fluctuations in the load levels during simulation testing. A variation of one pound would cause an error of 14 percent in the load level at 2400°F (1589°K). It was during this portion of the flight simulation cycle that the major portion of the creep extension occurred. Other sources of scatter were temperature variations, particularly at 2400°F (1589°K), errors in optical creep measurements, differences in specimen cross-sections, and coating failures. Temperature fluctuations were generally held to ±5°F (± 3°K), but occasionally reached ± 10°F (± 6°K). Errors in optical measurements arose from two sources. The first was the result of limitations of the cathetometer and the finite width of the gage marks. The second was the difficulty of retaining the fiducial marks on many of the specimens because of coating spall. The only system in which coating spall was not a problem was the C-129Y/R-512E. While the thickness of the spall on the Cb-752/R-512E specimens was too small to seriously affect the flight simulation performance, it greatly hampered the creep measurements. New marks could be added from time to time, but the more frequently these were required, the greater became the potential error. The reason for this is that for any set

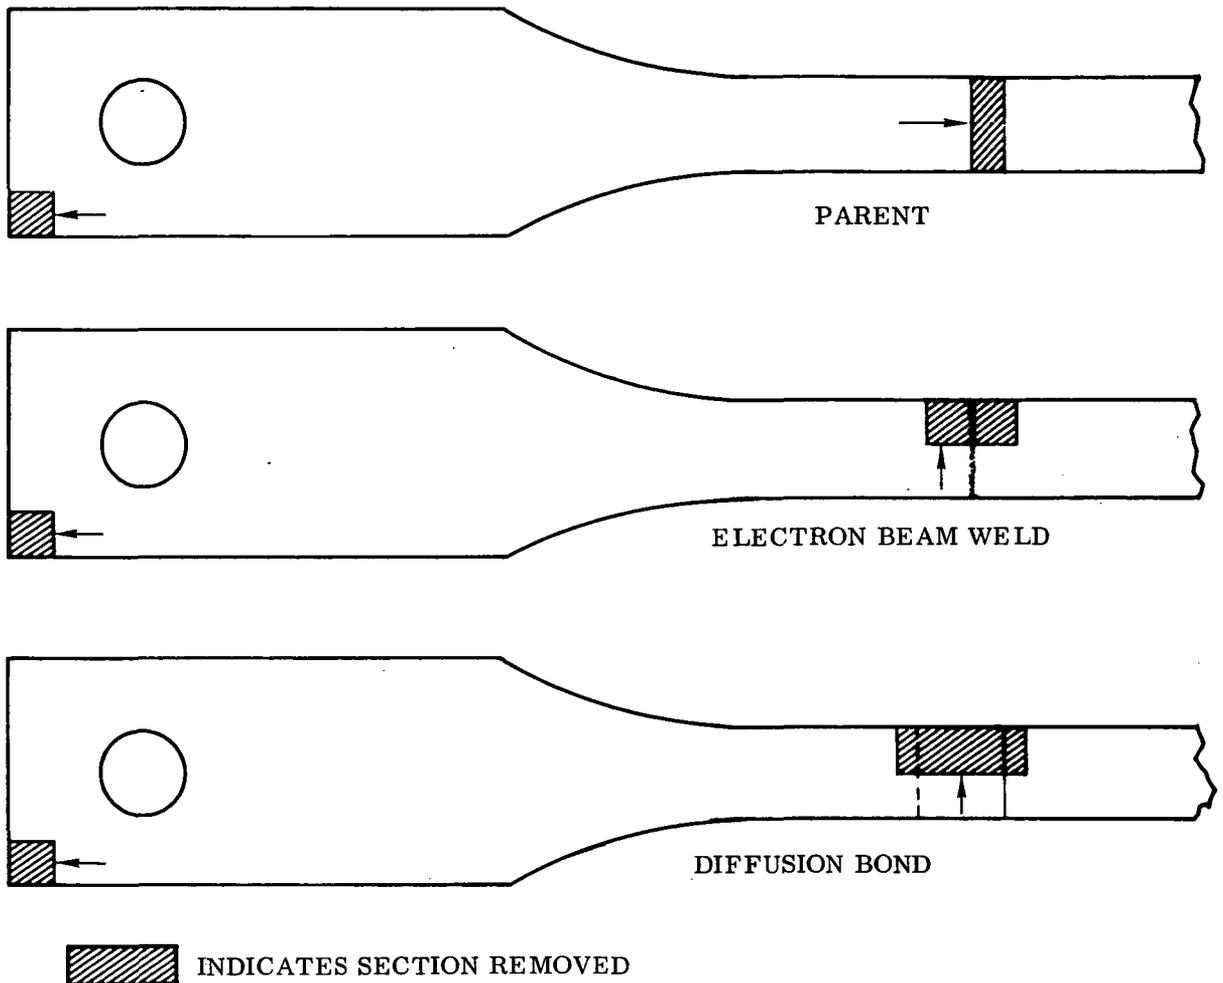
Figure 4-67. Location of Sections for Metallographic Examinations

4.2.5.3.1 Flight simulation exposure: Results of the flight simulation metallographic study presented in the following discussion are divided into four sections by material system, i. e., alloy/coating. This was done because of the similarity in the behavior of the parent metal, electron beam weld, and diffusion bond specimens of the same system. Specimens were examined at the locations shown in Figure 4-67, in both the as-coated condition and after exposure. The as-coated specimens had previously been tensile tested while the exposed specimens had either failed during simulation testing, or were tensile tested after 100 cycles. As a result, considerable cracking of the brittle coating with some loss was evident in many of the polished sections. A typical specimen from each exposure group was chosen for examination according to the plan illustrated in Figure 4-67. In addition, a second specimen was generally selected from each group to study some special effect, e. g., a site of severe coating

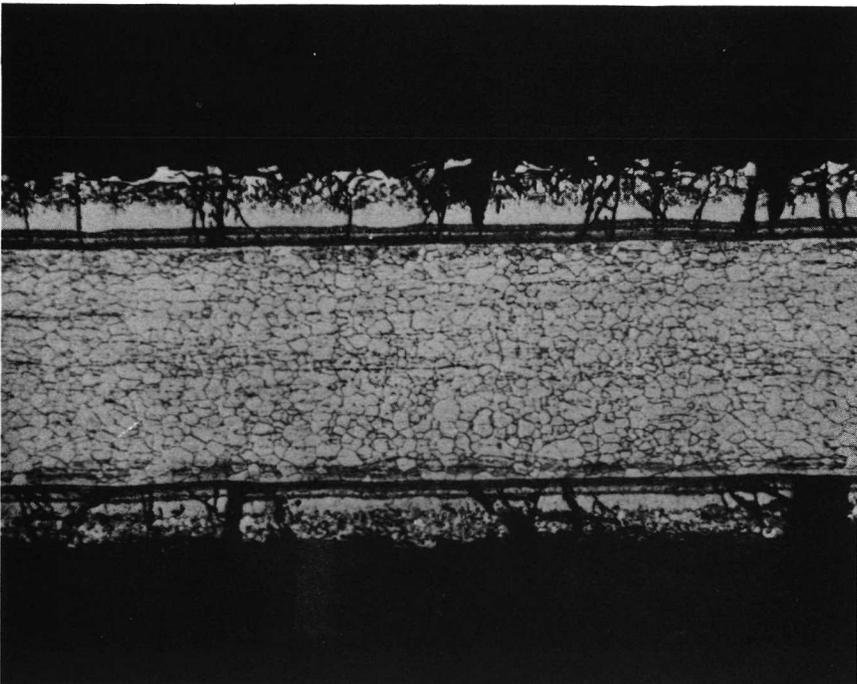
Figure 4-68. Microstructure of Unexposed Cb-752/R-512E  
Parent Specimen — Gage Section

Magnification: 100X  
Etch: Light  
Specimen No.: BSP-21  
Flight Cycles: 0  
Negative No.: D-1143  
Mount No.: 94-0

System 1, Cb-752/R-512E: Photomicrographs for this system are shown in Figures 4-68 to 4-73 for parent specimens, Figures 4-74 to 4-80 for weld specimens, and Figures 4-81 to 4-84 for diffusion bond specimens. The as-coated specimens are shown after a light etch to highlight the coating and diffusion zone, and again after a longer etch to show the grain structure of the substrate and the details of the joint specimens. The light etch used in Figures 4-68, 4-74, and 4-81 reveals the various coating layers and numerous fine cracks typical of a silicide coating. The cracks are larger and increased in number in the weld and diffusion bond specimens as these

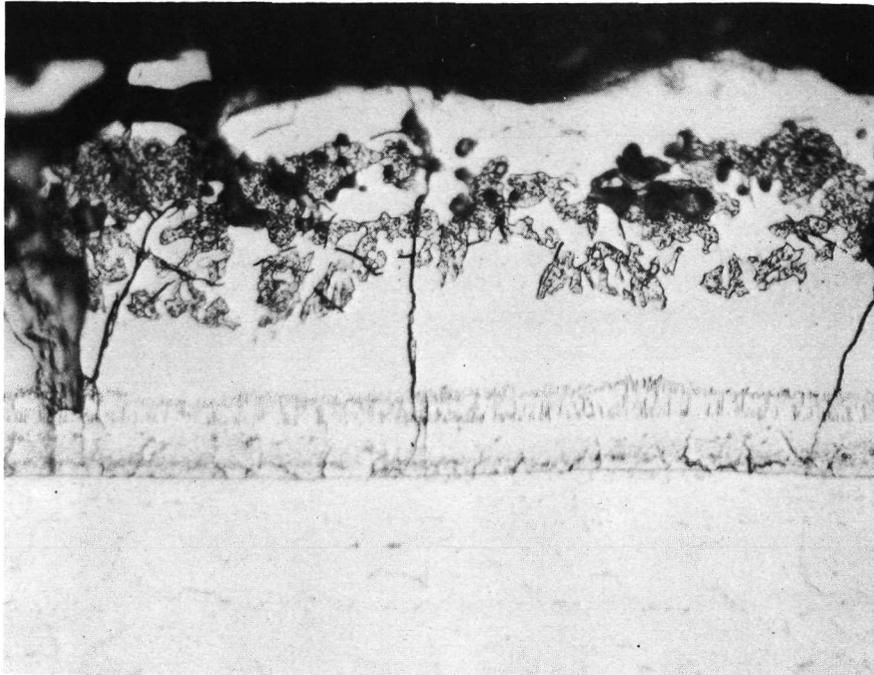
Figure 4-69. Microstructure of Unexposed Cb-752/R-512E  
Parent Specimen — Gage Section

Magnification: 100X  
Etch: Heavy  
Specimen No.: BSP-21  
Flight Cycles: 0  
Negative No.: C-9699  
Mount No.: 94-0

Figures 4-69, 4-75, and 4-84 show the more heavily etched parent, weld, and bond specimens prior to exposure. The longer etch has removed much of the detail of the coating and greatly increased the crack size by chemical attack. The grain structure is generally equiax although not particularly uniform — with the bond sample having a slightly larger grain size. A narrow [0.040 inch (0.102 cm)] trapezoidal shaped weldment is visible in Figure 4-75. The weld appears to be free of cracks, porosity, or gross contamination. The diffusion bond sample, Figure 4-84, shows coating penetration at the lap joint corner with some type of interaction at the titanium inner layer. This is not surprising as titanium reacts readily during the formation of the silicide coating.

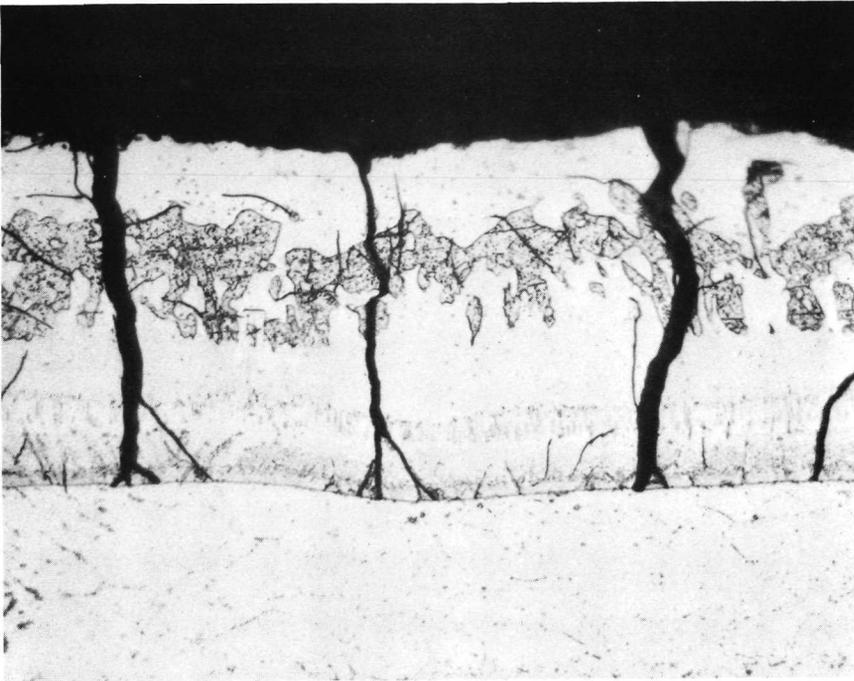
Figure 4-75. Microstructure of Unexposed Cb-752/R-512E  
 Electron Beam Weld Specimen - Gage Section

Magnification: 100X  
 Etch: Heavy  
 Specimen No.: BSE-18  
 Flight Cycles: 0  
 Negative No.: C-9702  
 Mount No.: 93-0

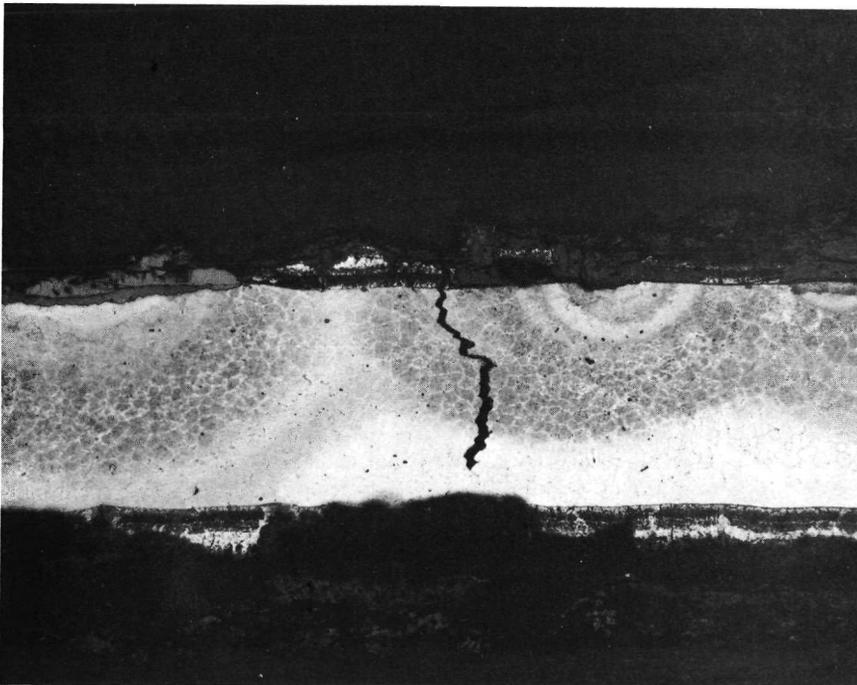
Figure 4-127. Microstructure of Exposed C-129Y/VH-109 Parent Specimen — Gage Section

Magnification: 100X  
Etch: Light  
Specimen No.: YSP-4  
Flight Cycles: 78  
Negative No.: D-1335  
Mount No.: 654-0

the specimen, shows a loss of substrate by diffusion zone growth of about 0.0007 inch (0.0018 cm) per side in 100 cycles. Figures 4-127 and 4-128, taken from specimen YVP-4, reveal severe substrate contamination much worse than in YVP-1, and areas of total coating oxidation with thick oxide buildup. Figure 4-127, viewing the edge of the specimen, shows the complete loss of coating and subsequent oxidation of the columbium alloy (light grey oxide). Another region of substrate oxidation can be seen in Figure 4-128 in an area where the coating and its oxides have completely spalled from the specimen. An intergranular crack is also present in the microstructure.

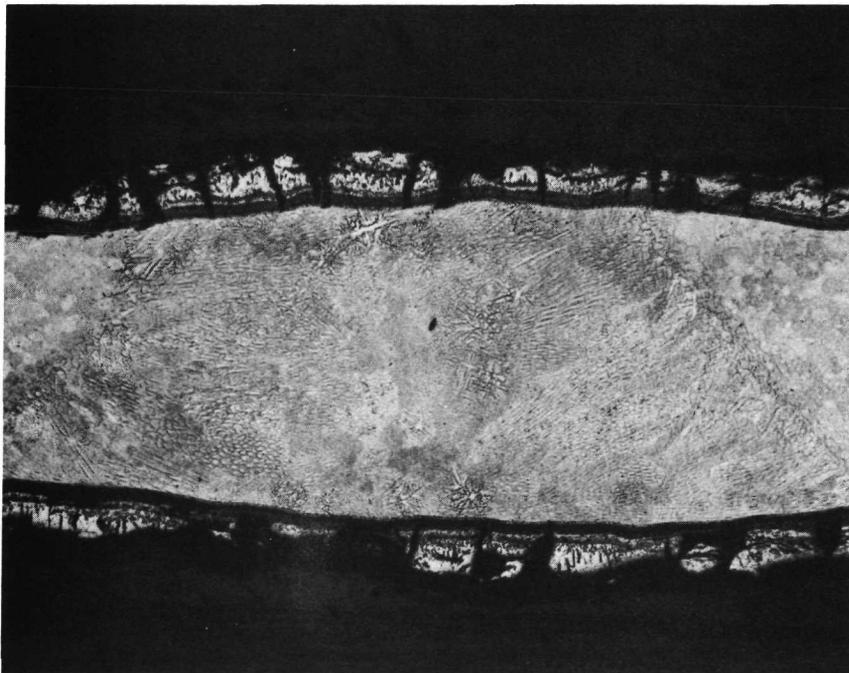
Figure 4-129. Microstructure of Unexposed C-129Y/VH-109  
Electron Beam Weld Specimen – Gage Section

Magnification: 100X  
Etch: Light  
Specimen No.: YVE-20  
Flight Cycles: 0  
Negative No.: D-1131  
Mount No.: 41-0

System 4, C-129Y/VH-109: Photomicrographs for this system are shown in Figures 4-122 to 4-128 for parent specimens, Figures 4-129 to 4-133 for weld specimens, and Figures 4-134 to 4-138 for the bond specimens.

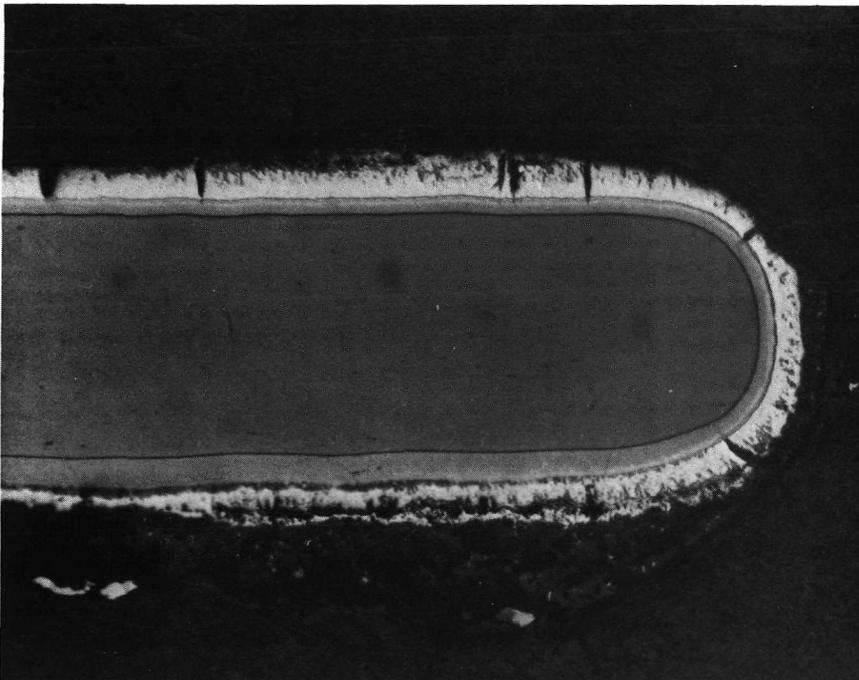
Figure 4-144. Microstructure of Plasma Arc Exposed C-129Y/VH-109 Specimen — Gage Section

Magnification: 100X  
Etch: Anodized  
Specimen No.: YVP-16  
Flight Cycles: 30  
% Edge Erosion: 50  
Negative No.: D-1981  
Mount No.: 600-0

The remaining two VH-109 specimens, Figures 4-144 and 4-145, both experienced considerable edge attack during exposure. Again, however, no substrate contamination was found except at the specimen edges where total coating loss occurred in the plasma tests. In regions removed from the coating failure, these two specimens could not be distinguished from the VH-109 specimen that completed 40 cycles without a coating failure. Figure 4-144, taken near a failure site in a C-129Y specimen, shows a portion of the contaminated region (the dark area). A Cb-752 specimen photographed in a region well removed from a failure site and showing no contamination is presented in Figure 4-145. Again the heavy buildup of oxide on one side can be seen.

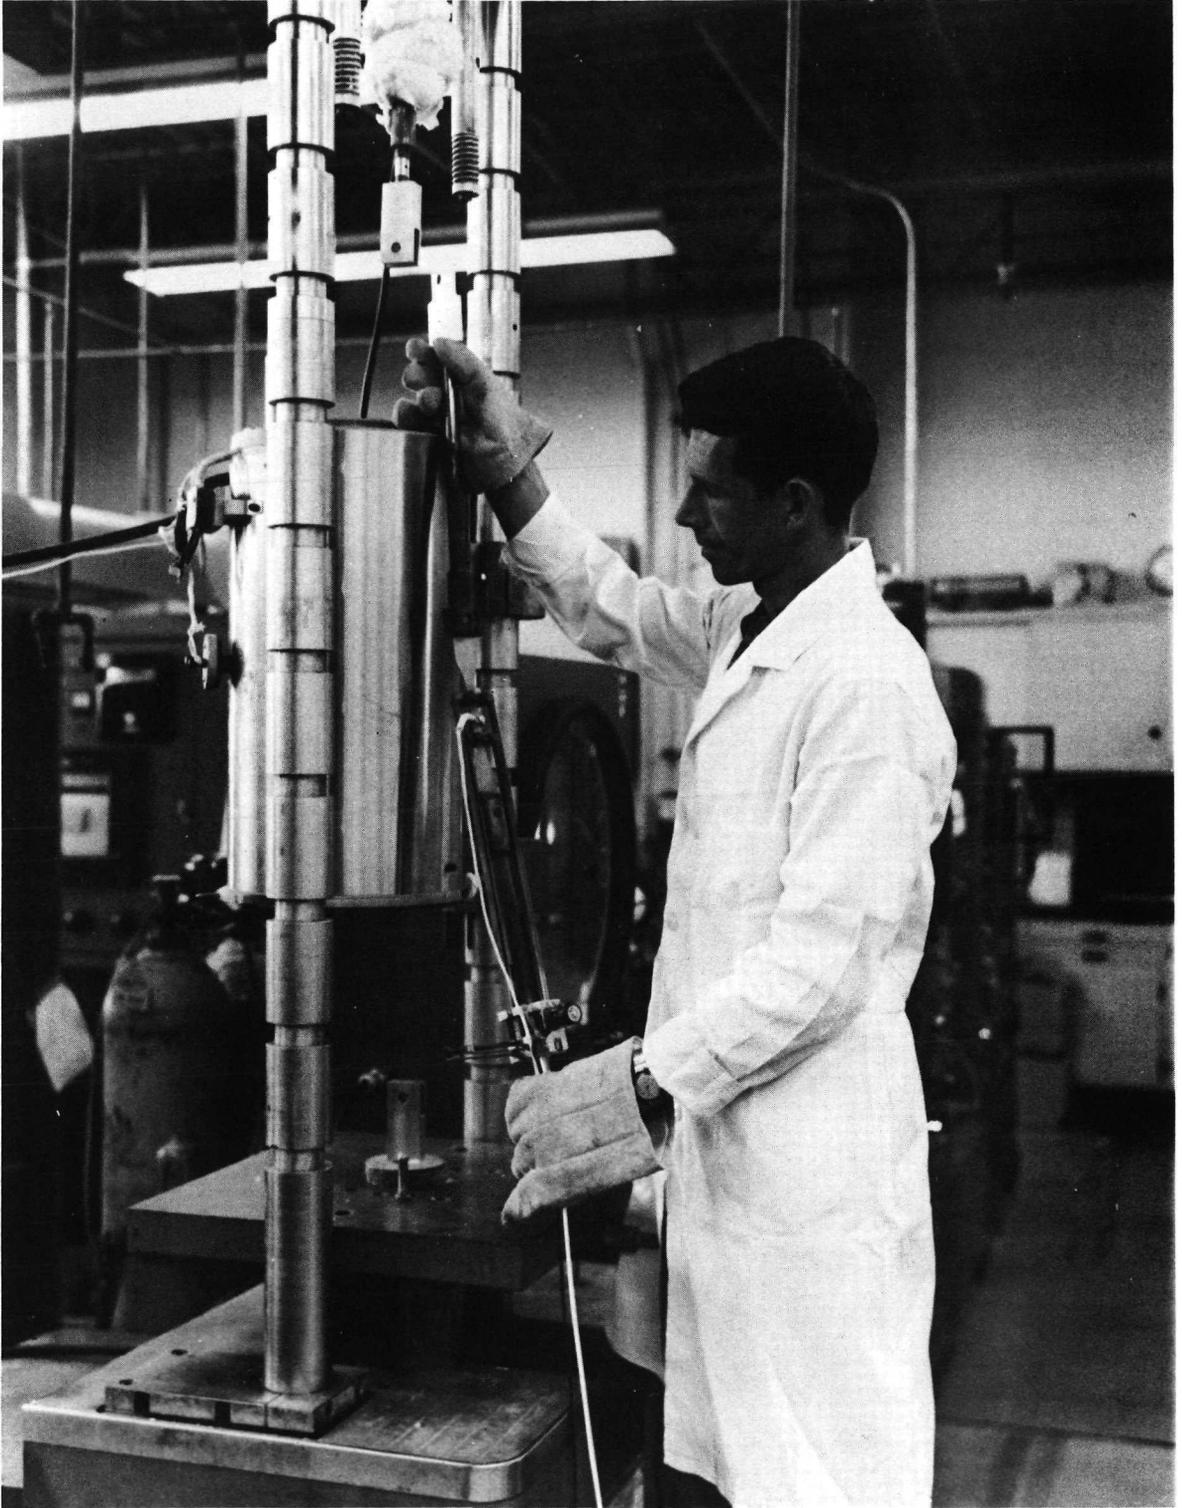
Figure 4-152. High Temperature Tensile Testing Equipment (Photo 91360B)

The furnace has three independently controlled heating zones to control thermal gradients. The test zone is 2 inches (5.08 cm) wide by 2.5 inches (6.35 cm) deep by 4 inches (10.2 cm) high. Three Research Incorporated Thermac and Ignition power regulator systems in conjunction with a Bristol strip chart controller are used to control the test furnace temperatures. The controller can be operated with a programmed input, or manually.

Temperature was measured at four locations. A Pt/Pt + 13 percent Rh thermocouple measured and recorded temperature in the heat zone. This thermocouple also was used as feedback to the power controller. Three chromel/alumel thermocouples

furnace is shown in Figure 4-152. Temperature was measured with a Cr-Al thermocouple wired to the gage section as shown in Figure 4-151.
