NASA TECHNICAL NOTE

NASA TN D-6976

**APOLLO EXPERIENCE REPORT —
BATTERY SUBSYSTEM**

by J. Barry Trout

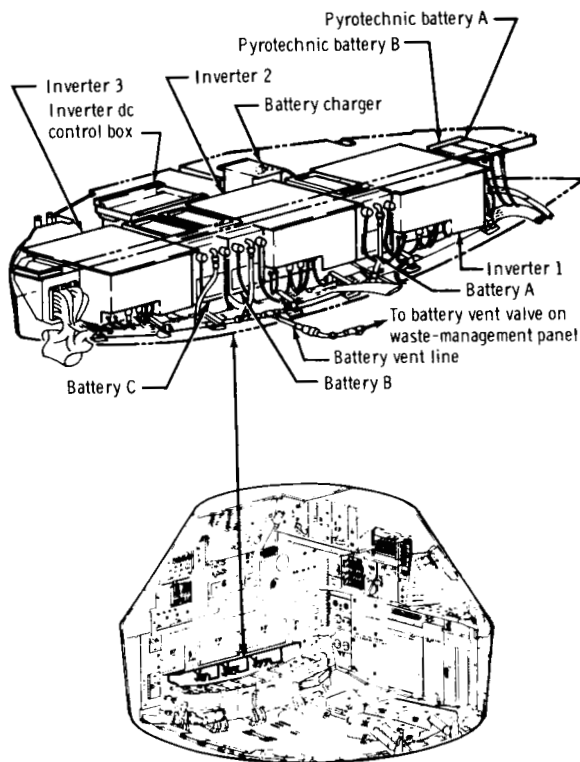
Figure 1. - Command module battery and charger locations in the lower equipment bay (block II).

The unmanned command-service module (CSM) flights used from two to eight entry batteries in the command and service modules, two pyrotechnic batteries in the CM, and two pyrotechnic batteries in the SM to supply power to mission-sequencing control devices and service module (SM) jettison control devices. The manned vehicles used three entry batteries and two pyrotechnic batteries, all in the CM. The mounting locations of the various batteries used in manned missions are shown in figures 1 to 3.

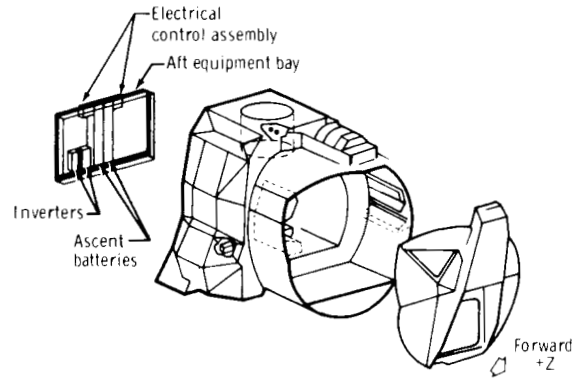
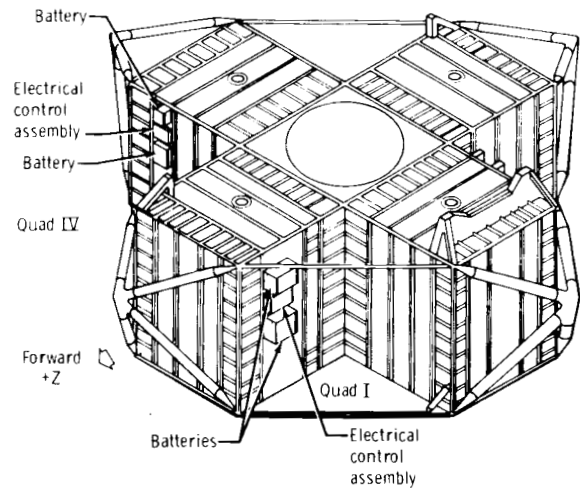
(a) Ascent components.

(b) Descent components.

Figure 2. - Locations of LM main electrical power system components.

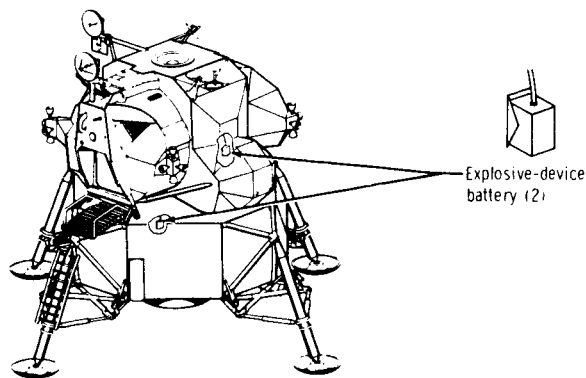
Figure 3. - Locations of LM explosive-device batteries.

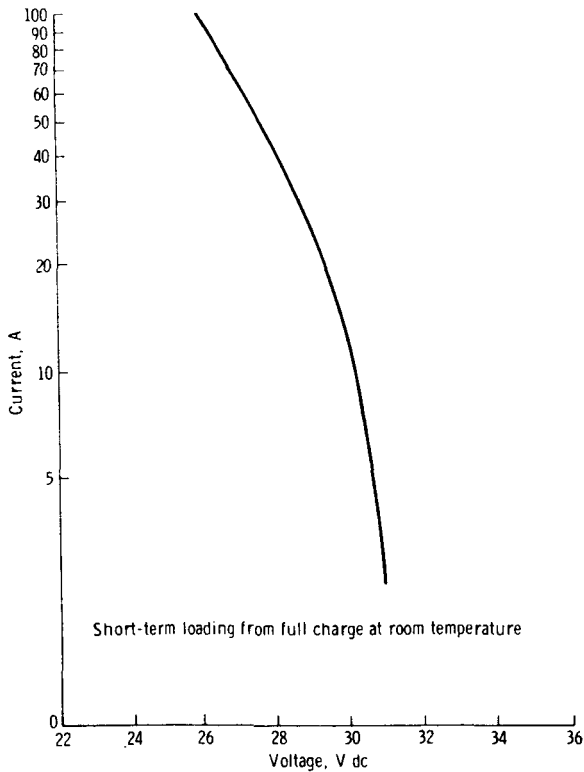
Figure 4. - Characteristics of the Apollo entry and postlanding battery.

The original version of the entry and postlanding battery had a capacity of 25 A-h. The battery had a welded titanium case and a machined, anodized-magnesium cover. A coat of beryllium-aluminum paint was applied for increased emissivity and for corrosion resistance. The plate-separator material in the cells was Permion 307, an irradiated polyethylene film selected because of its thermal resistance. A thermal environment of 250° F in the CM lower equipment bay was expected for approximately 30 minutes because of entry heating. The available energy was 725 W-h per battery at 29 volts or 2175 W-h per shipset of three batteries. The battery had to be capable of six charges and discharges, the discharges consisting of 30 minutes at 35 amperes and then 225 minutes at 2.0 amperes (all at more than 27 volts).

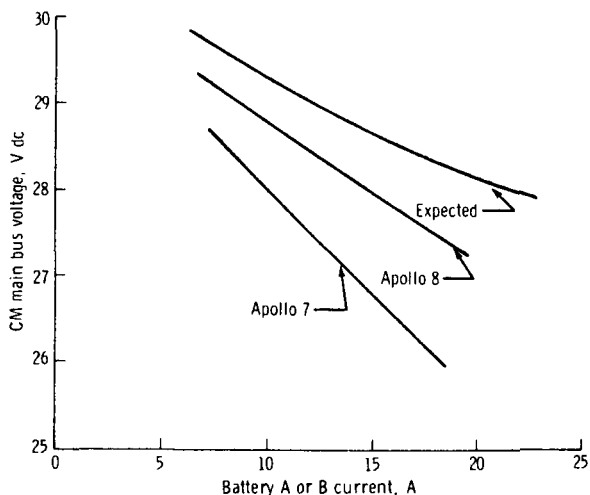
Figure 5. - Entry-battery flight-performance data at the time of CM/SM separation.

Operational performance. - Performance was nominal on all unmanned missions. Each of these missions lasted less than 0.5 day; consequently, the spacecraft underwent very little zero-gravity time. However, in postflight tests of the eight entry batteries in the Apollo 6 spacecraft (spacecraft 020), internal cell shorting was discovered in auxiliary battery 2. Four of the remaining batteries developed cell shorts within one charge/discharge cycle. Soon afterward, two test batteries from spacecraft 007A at the Manned Spacecraft Center (MSC) failed in the same way, as did a battery being used to simulate the Apollo 7 mission performance at a contractor facility. The shorting was the result of zinc dendrites that had pierced the Permion 307 plate-separator material when cells were subjected either to slight overcharge or to slight overdischarge. Because this type of failure had not occurred before in these cells, it was concluded that the separator-material characteristic had changed; however, this conclusion could not be verified. In response to an urgent recommendation by the vendor and based on revised

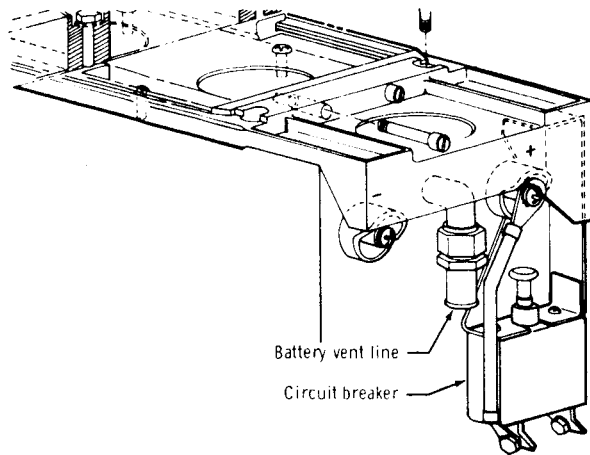
Figure 7. - The 100-ampere circuit breaker and entry-battery mounting adapter.

Mounting. - The entry and postlanding battery was hung from its top surface in the lower equipment bay (fig. 7). Active thermal control was not required because of the mild thermal environment of the CM cabin.

Entry battery. - To provide additional circuit protection, a 100-ampere circuit breaker was added at the battery. The battery mounting-adapter plate was extended downward to provide a bracket so that the 100-ampere circuit breaker could be connected to the battery by a very short cable. The use of silicone-rubber terminal potting was discontinued; instead, a polyimide shield was designed. The shield was

attached to the mounting bracket and contained integrally molded baffles that blocked access of stray materials that might short circuit either the battery or the circuit-breaker terminals.

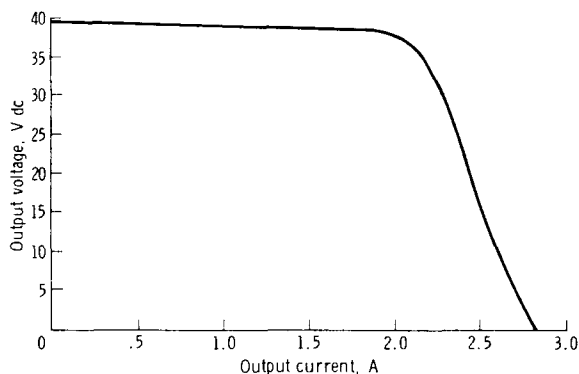
Figure 8. - Characteristics of entry-battery charger.

The salient characteristics of the entry-battery charger were as follows. The alternating-current (ac) input was 115 to 200 volts, 400 hertz, three phase; the dc input was 28 volts. The output is shown in figure 8. The entry-battery charger weighed 4.3 pounds (maximum), and the maximum input power was 55 watts ac and 84 watts dc. A simplified schematic of the charger electronics is shown in figure 9. No problems occurred during the development of this unit. Qualification was completed without complications in February 1966.

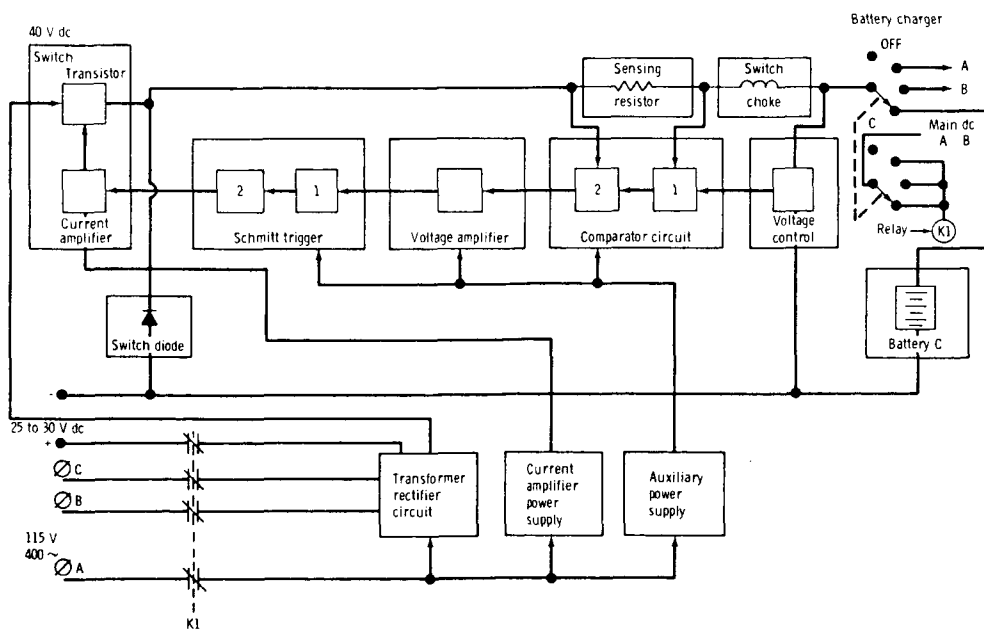
Figure 9. - Battery-charger functional diagram.

Operation. - The charger was operated manually by the crewmen. When a battery was to be charged, the charger was turned on, the battery was removed from the battery relay bus, and charging power was applied to the battery through a selecting switch and the applicable battery bus (fig. 10).

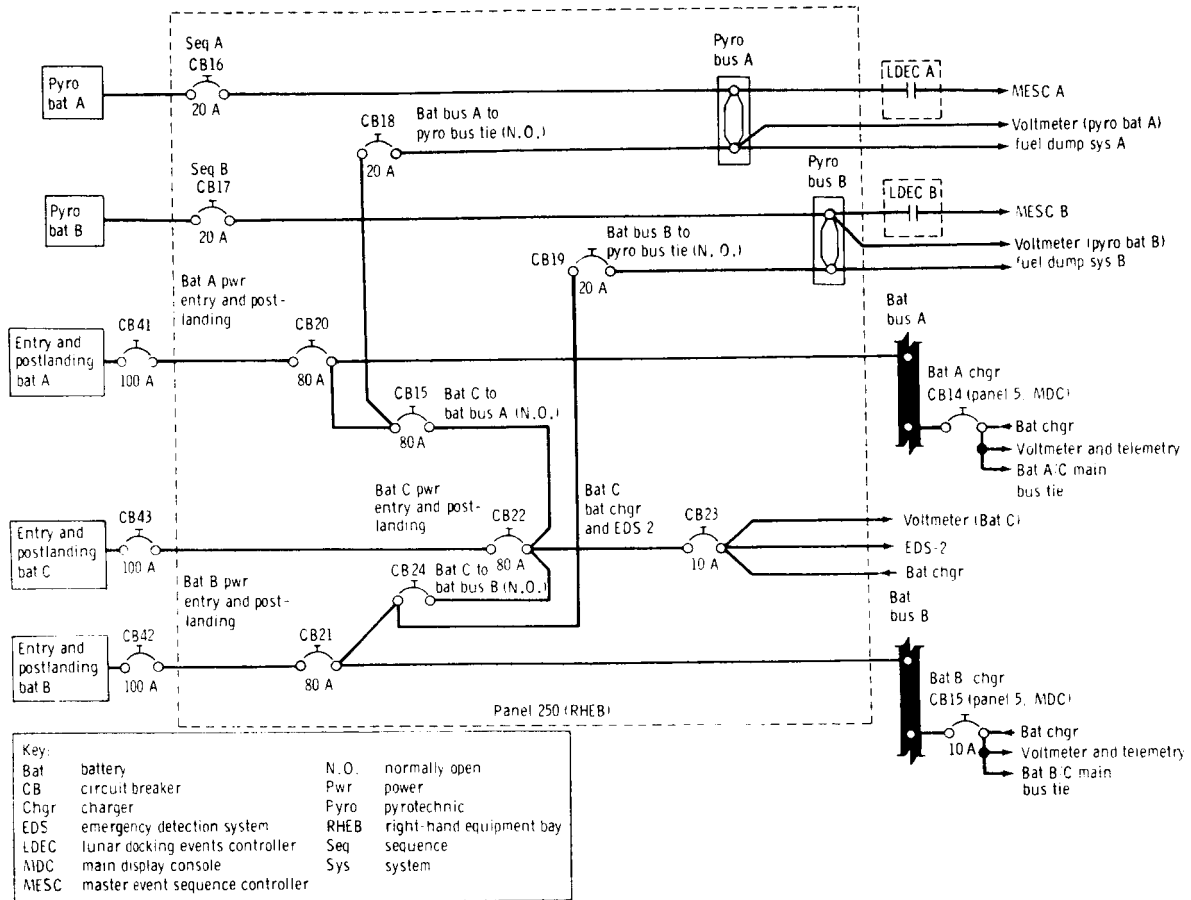
Figure 10. - Battery circuits.

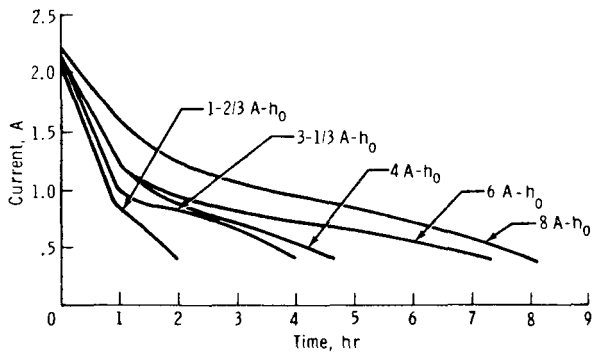
Figure 11. - Entry-battery charging current as a function of prior ampere-hours output.

Flight use. - Extensive testing and evaluation of the charger and entry battery were performed at a contractor facility and at the MSC to define the interdependent characteristics and rules for inflight charging timing and termination. These laboratory tests showed that the charger could recharge the batteries fully in a time approximately equal to $T = (A-h_0/1A) + 0.5$, where T is the time required for charging, in hours, and $A-h_0$ is the ampere-hours removed from the battery. This relationship was based on terminating charges when the charger current decreased to 0.4 ampere. Typical charging curves from these tests are shown in figure 11.

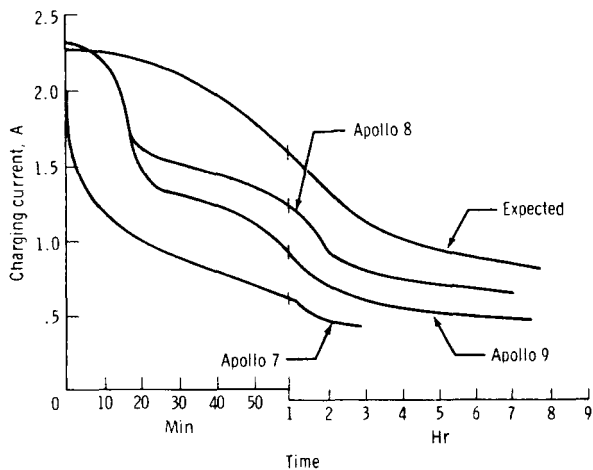
Figure 12. - Charging experience for approximately 10 A-h output.

and installed in the next flight vehicle. This procedure permitted full recharging but required excessively long times (fig. 12). In the Apollo 11 and subsequent vehicles, chargers were used that had adjusted outputs permitting charging at the rates expected before the Apollo 7 mission. The small increase in voltage required to achieve this improvement is shown in figure 13.

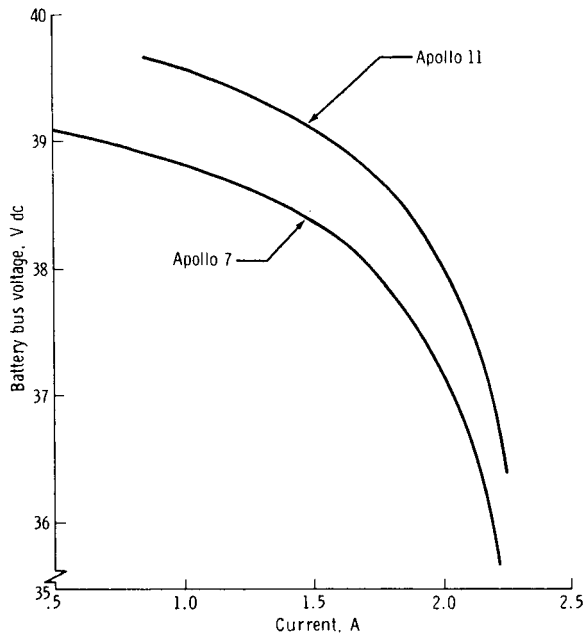
Figure 13. - Characteristics of entry-battery chargers on the Apollo 7 and 11 missions.

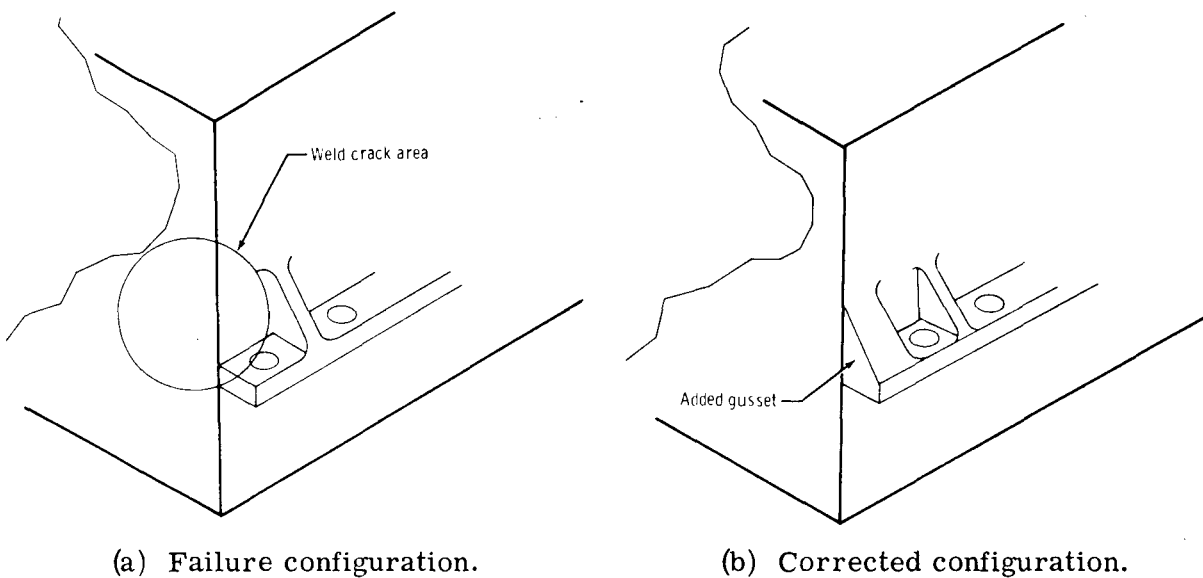
Figure 14. - Failure and corrected configurations of the battery container.

The only significant problem encountered in the development and qualification of the descent batteries was random-vibration-test failures of the magnesium-alloy battery container. Cracks occurred in the area where the ends and sides of the container were welded (just above the mounting rail). The failure mode was eliminated by adding a second gusset at the end of the mounting rail (fig. 14).

Qualification-test failures are summarized as follows. Descent-battery weld cracks occurred during the random vibration testing; the solutions to this problem included the following.

1. On the basis of data obtained from vibration testing of an LM test vehicle, the vibration levels were reduced.
2. The inspection procedures were revised.
3. A gusset was added on the mounting rail.

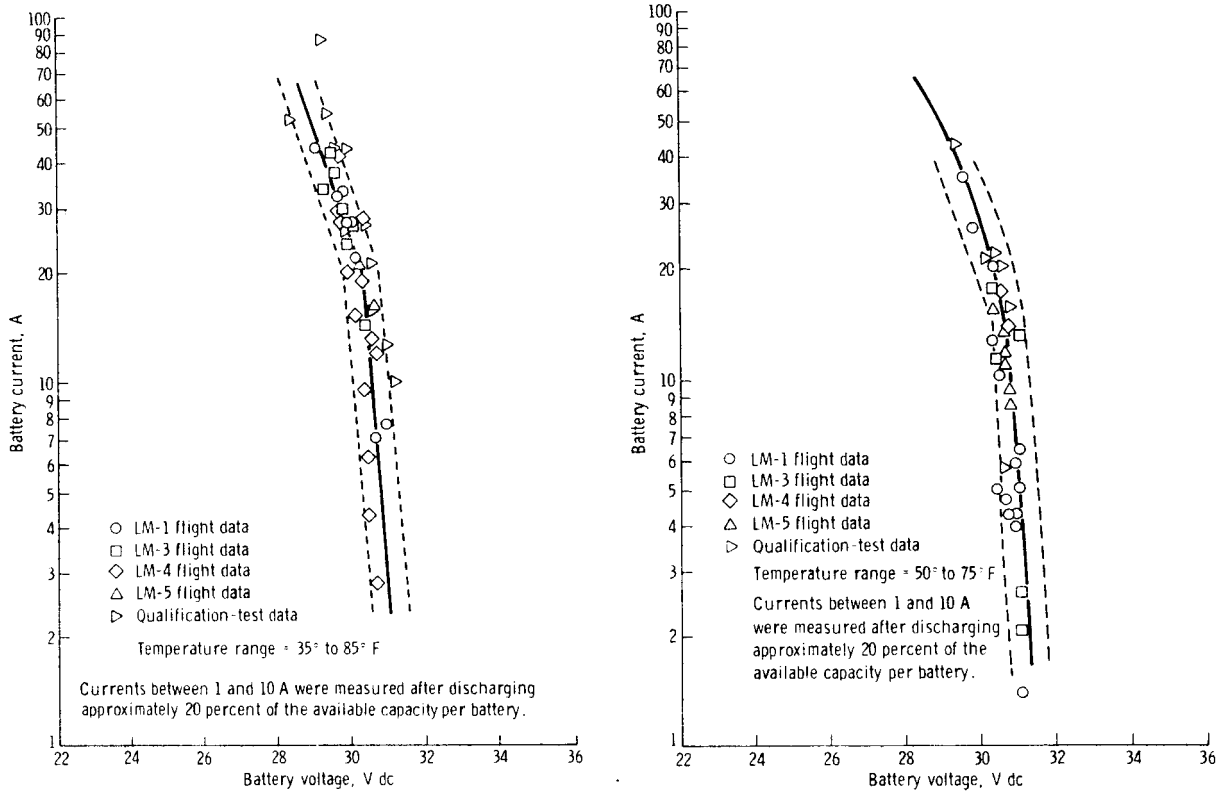
Figure 15. - Lunar module battery characteristics.

The LM ascent, descent, and ED batteries performed in accordance with specifications and satisfied the electrical-energy requirements for all LM flights. The voltage-current characteristics of these batteries are shown in figures 15 and 16. The performance of these batteries was noteworthy during the rescue phase of the aborted Apollo 13 mission. The batteries supplied total vehicle power for 83 hours under conditions for which they had not been qualified or tested; that is, low electrical loads (350 watts compared with a nominal 1000 watts), continuous zero gravity while loaded, and continuous low temperature (approximately 37° F). Telemetry measurements indicated that two of the descent batteries were used 5 to 6 percent above the specified capacity. A CM entry battery was charged from LM battery power in preparation for CM/SM separation and CM entry.

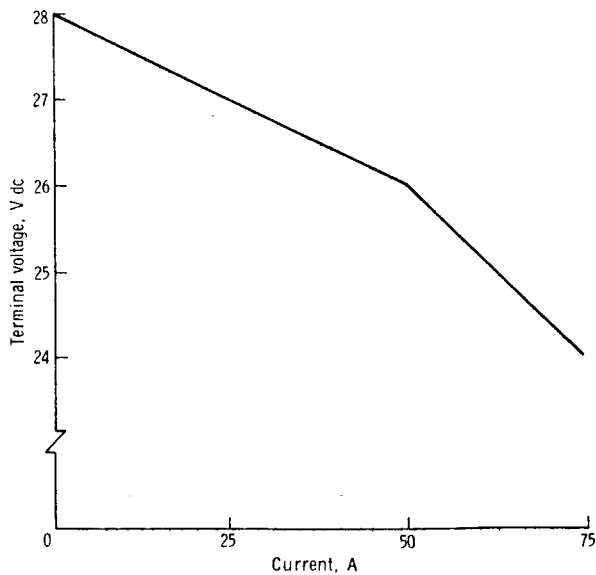
Figure 16. - Characteristics of the pyrotechnic and ED battery.

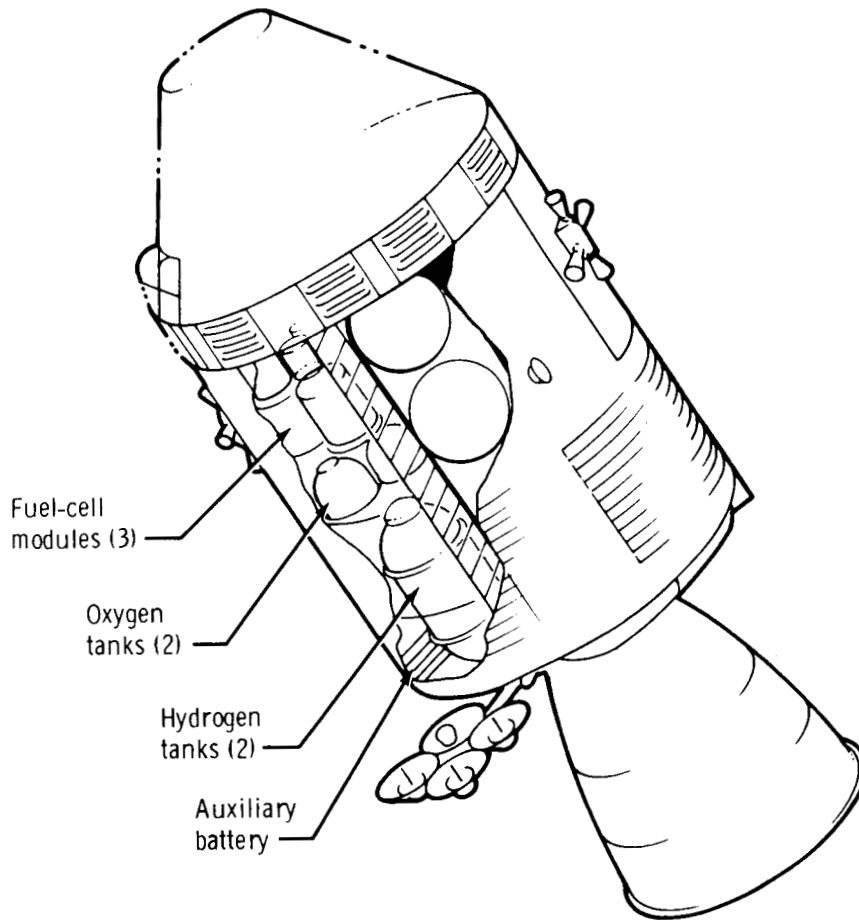
Figure 17. - Location of auxiliary battery in sector IV of the SM.

As an improvement to the overall Apollo spacecraft, an LM descent battery was added to subsequent service modules (fig. 17). This battery could have provided 12 kWh of emergency energy and was designated the SM auxiliary battery. It could be connected to the CM main buses through the distribution system for fuel cell number 2.
