LOCKHEED MISSILES & SPACE COMPANY, INC.
Manufacturing Research Investigation

LASER HOLOGRAPHIC
NONDESTRUCTIVE TESTING
OF
THE NASA X-248 ROCKET MOTOR

NASA Contract: NASI 11419

December 1972

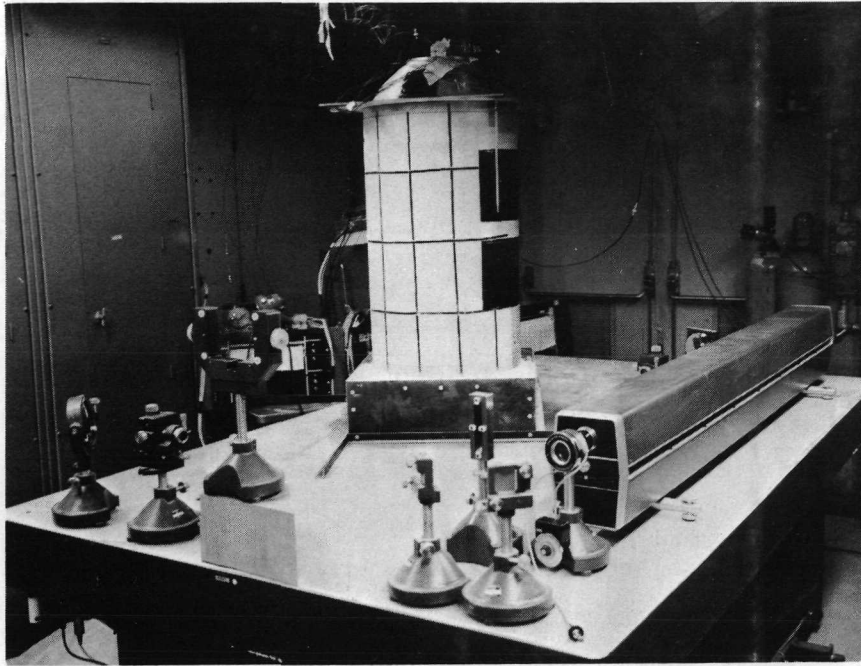
Fig. 1 Motor Case S/N 424 Mounted on Table of Holographic System Located in Utility Room of Test Stand No.3 at Lockheed Santa Cruz Test Facility

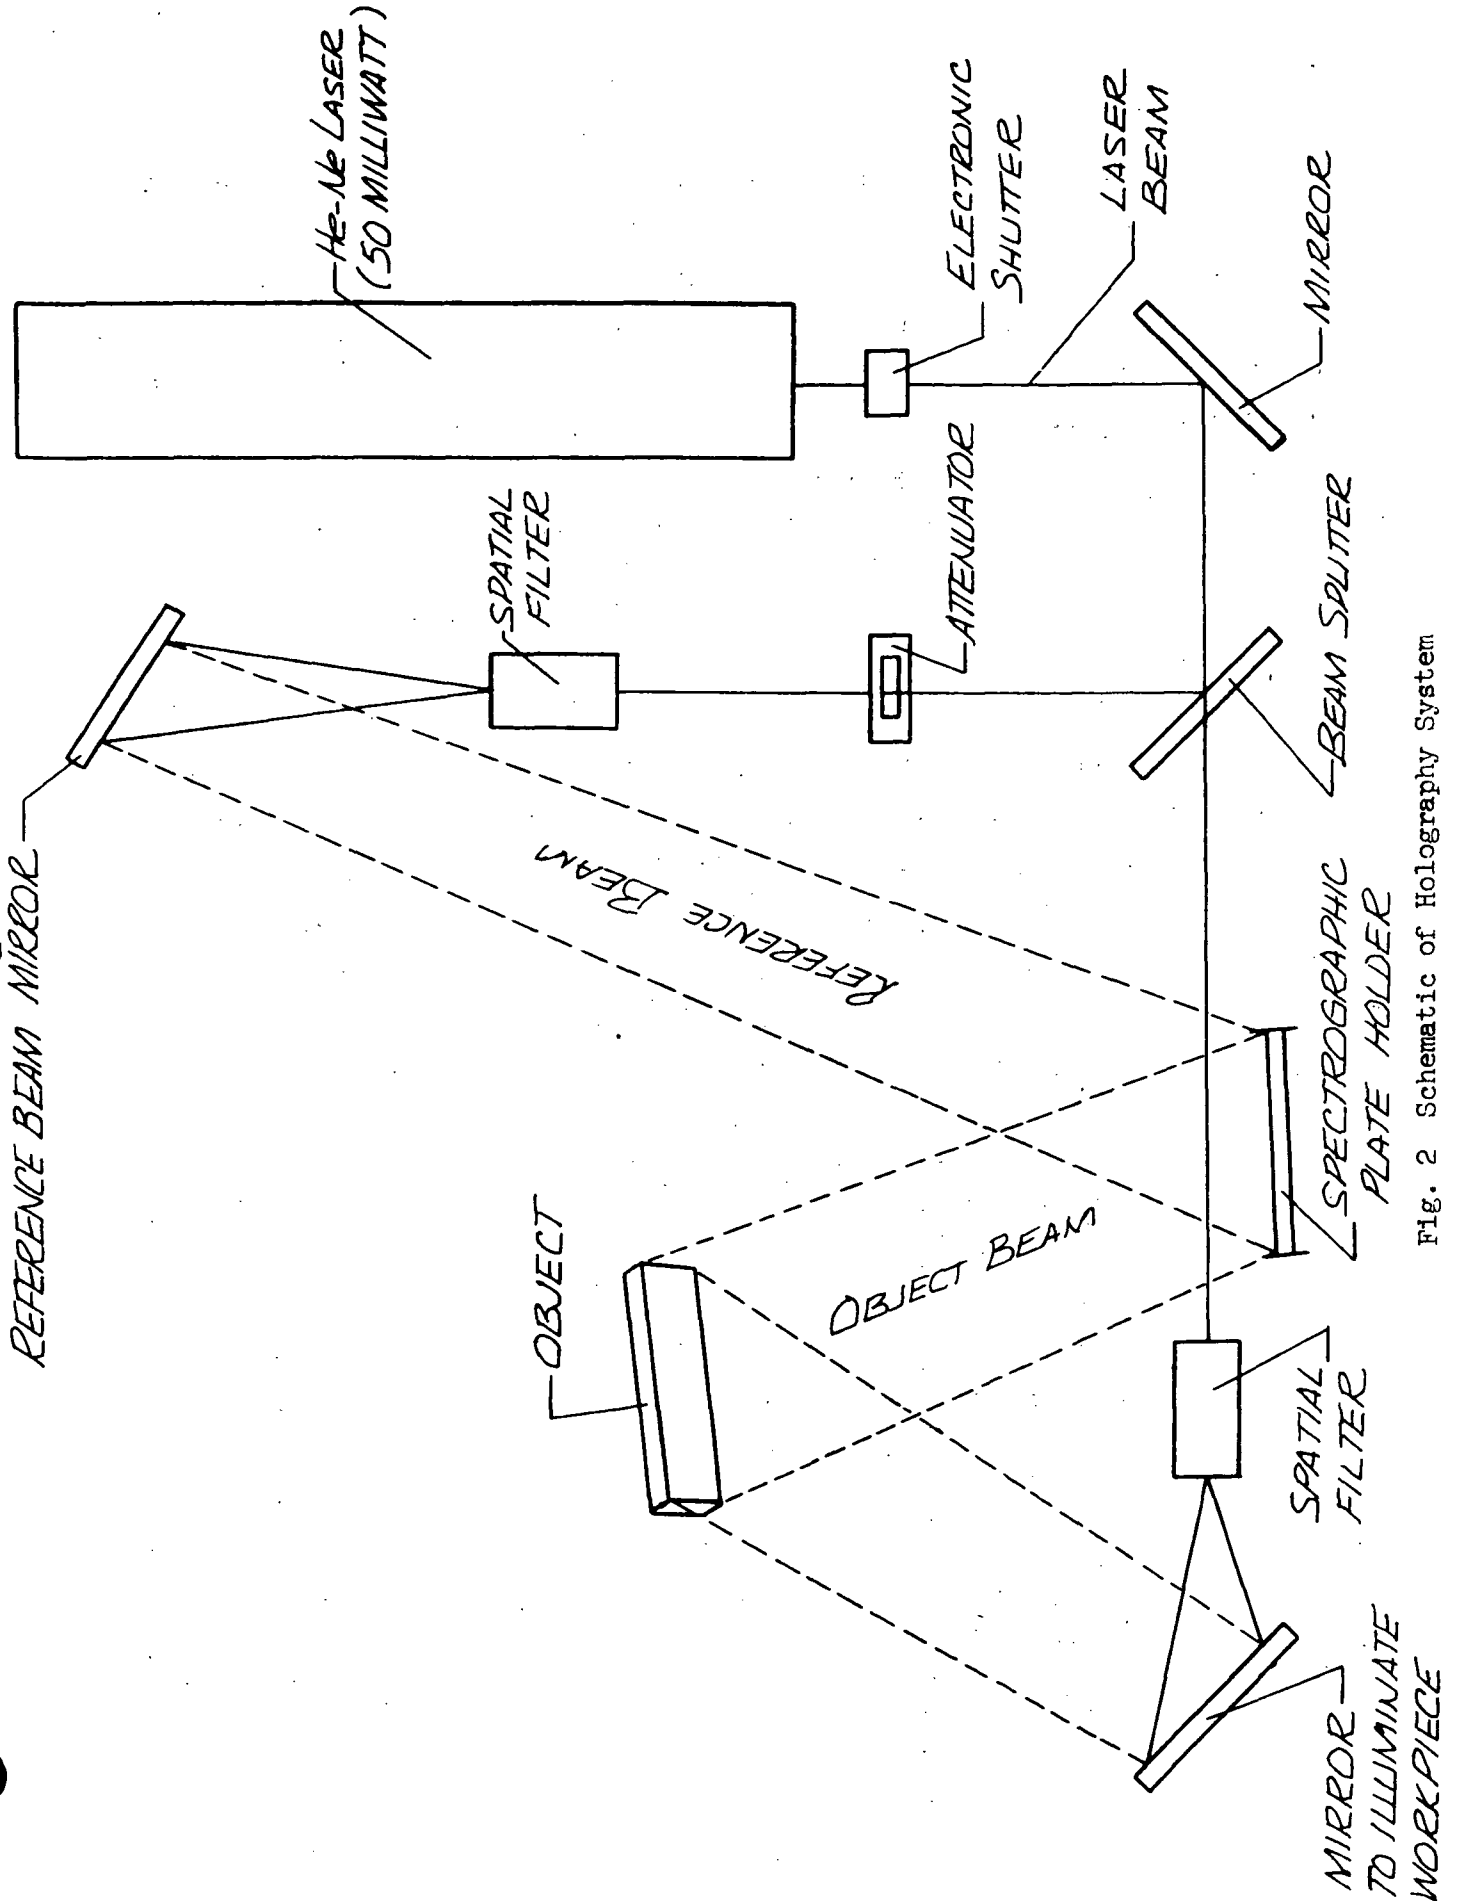
Fig. 2 Schematic of Holography System

The procedure for observing strains consists of superimposing a virtual image onto the workpiece and studying the resultant interference between the two. A schematic of the holographic optical system can be seen in Fig. 2.

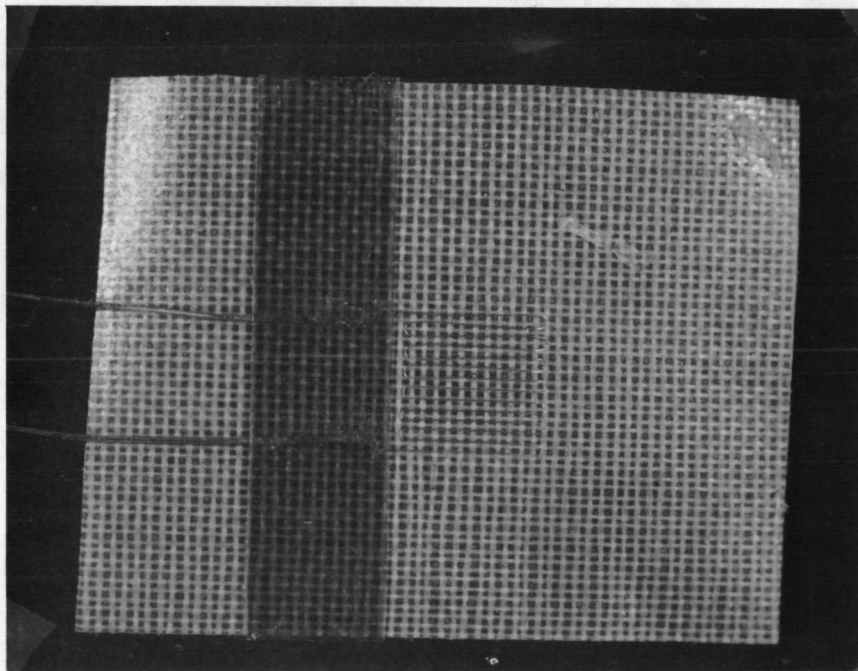
Fig. 3 Grid Type Thermocouple Used for Temperature Measurement on Motor Case (3X)

The thermocouples attached to the motor cases were of the microminiature self-adhering grid type. The chromel-alumel thermocouples were manufactured by the BLH Electronics Company of Waltham, Massachusetts. A photograph of one of these is shown in Fig. 3.

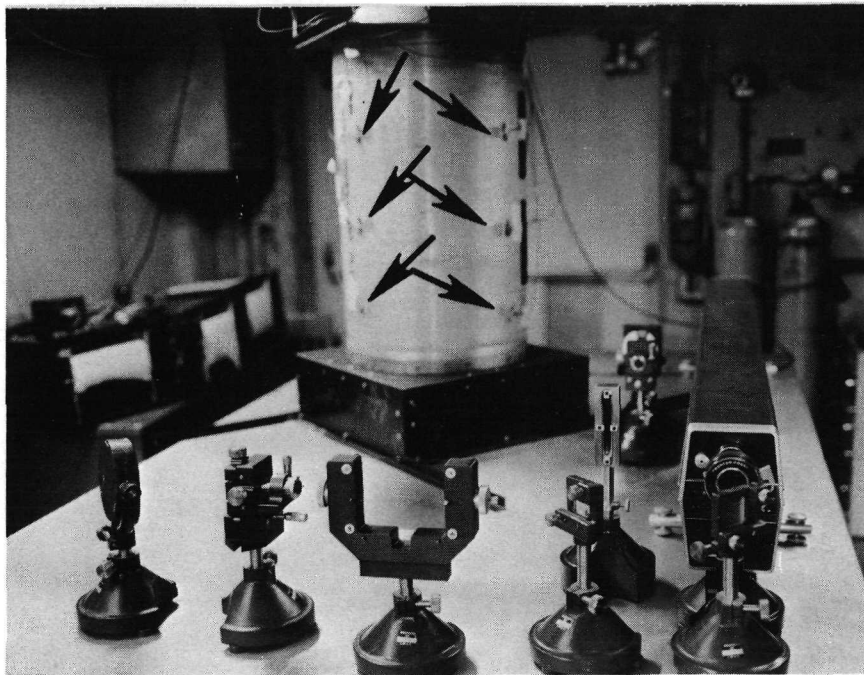
Fig. 4 Motor Case S/N 424 Shown Mounted on the Holographic Air Suspended Table for Testing. Arrows Point to the Position of (6) Chromel-Alumel thermocouples for Temperature Monitoring

The locations of the six grid type thermocouples on a motor case can be seen in Fig. 4. This represents a typical arrangement for testing. They are approximately 90° apart with a 9 in. spacing.

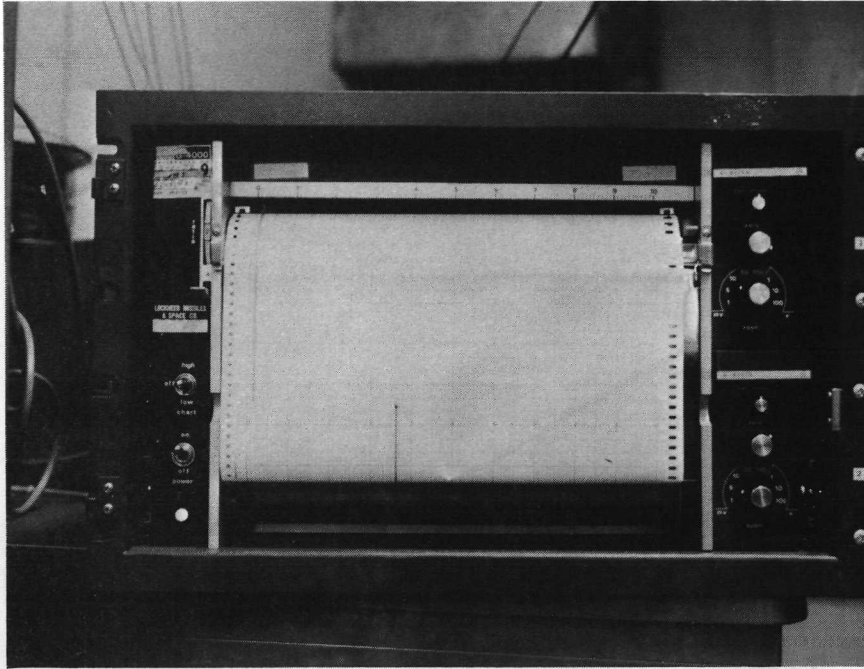
Fig. 5 Dual Pen Recorder Used for Temperature Recording in Thermal Stressing of Motor Cases

For recording temperatures, three Dual Pen Varian Recorders, Model No. G4000, were utilized. One of these is depicted in Fig. 5.

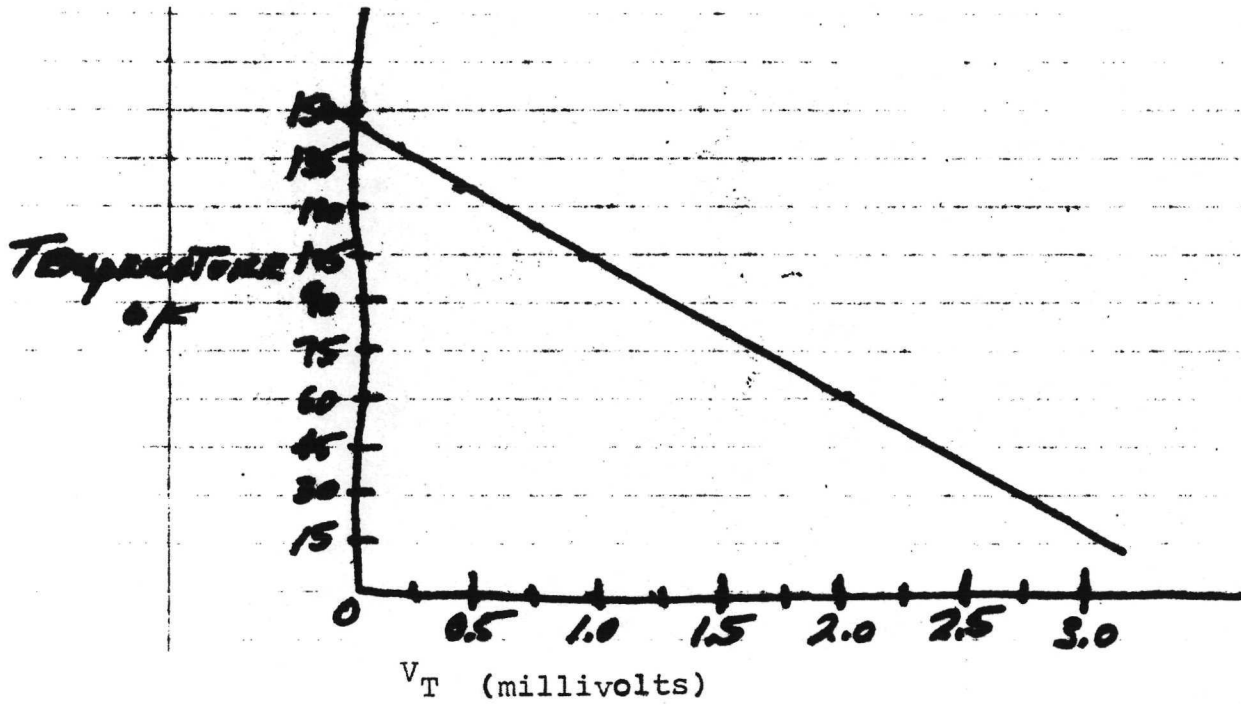
Fig. 6 Conversion Chart for Temperature Measurements with Alumel-Chromel Thermocouples

The on-off switch, shown in the functional schematic, is necessary to zero V_{150} so only V_T is recorded which gives the temperature readings in accordance with the graph shown on Fig. 6.

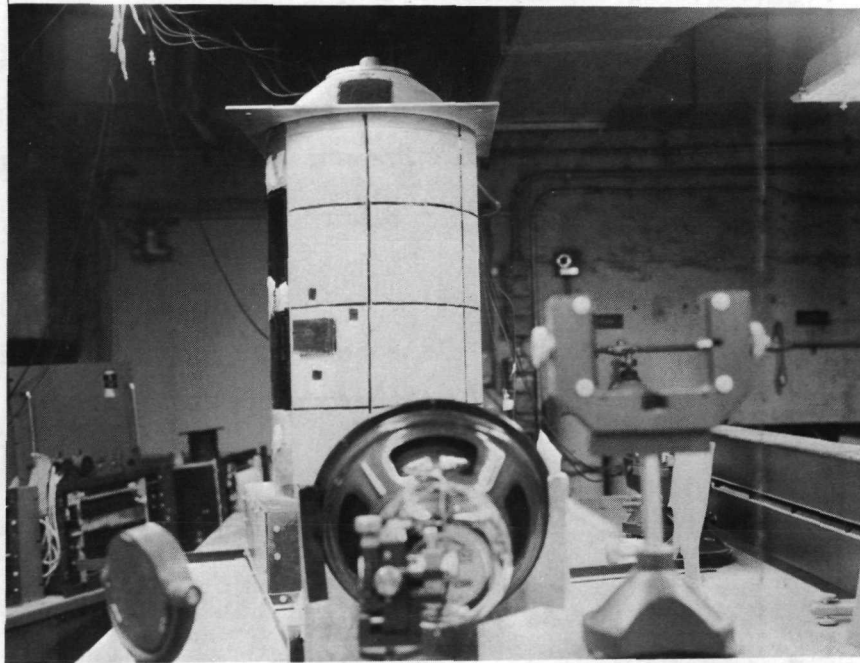
Fig. 7 40-W Speaker Mounted on Air-Suspended Holographic Table Prior to Acoustical Stressing Tests

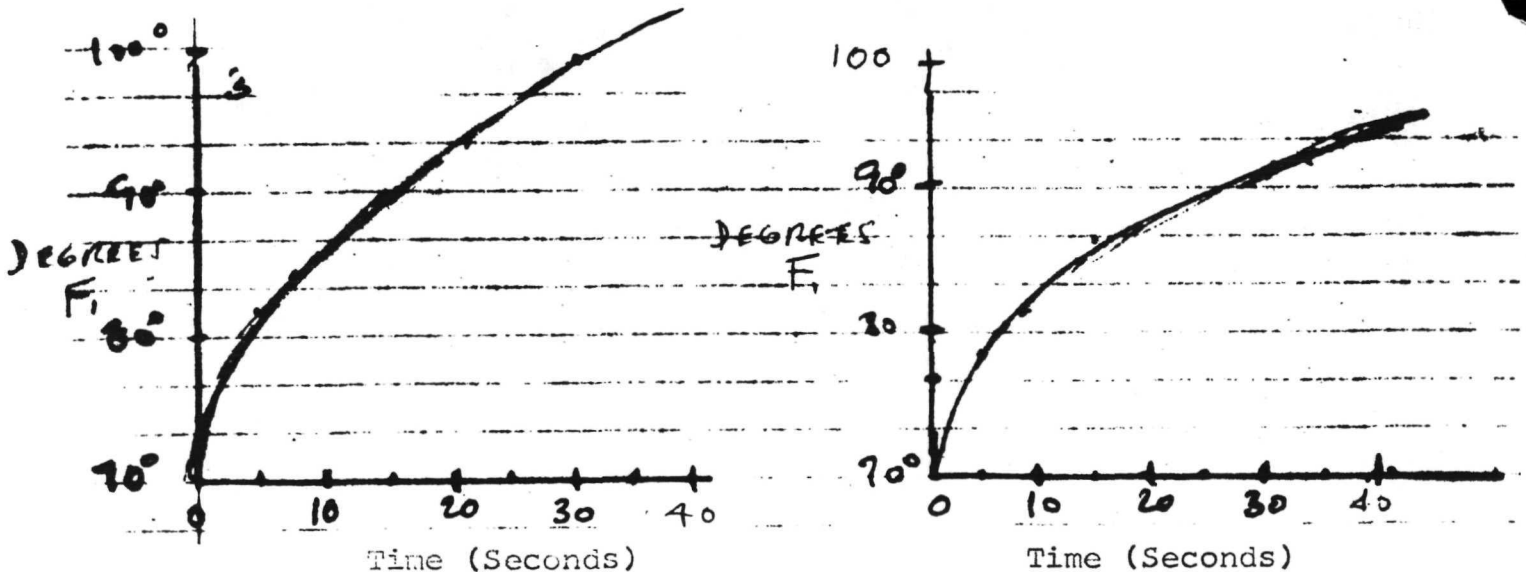
Temperature Rise of Thermocouple Detached from motor casing.

The temperature increases at a function of time were developed by scanning the casing hemi-cylinder, facing the hologram plate holder, from a distance of 8 in. The resultant data are reported in Fig. 8. A thermocouple was also detached from the casing for comparison.

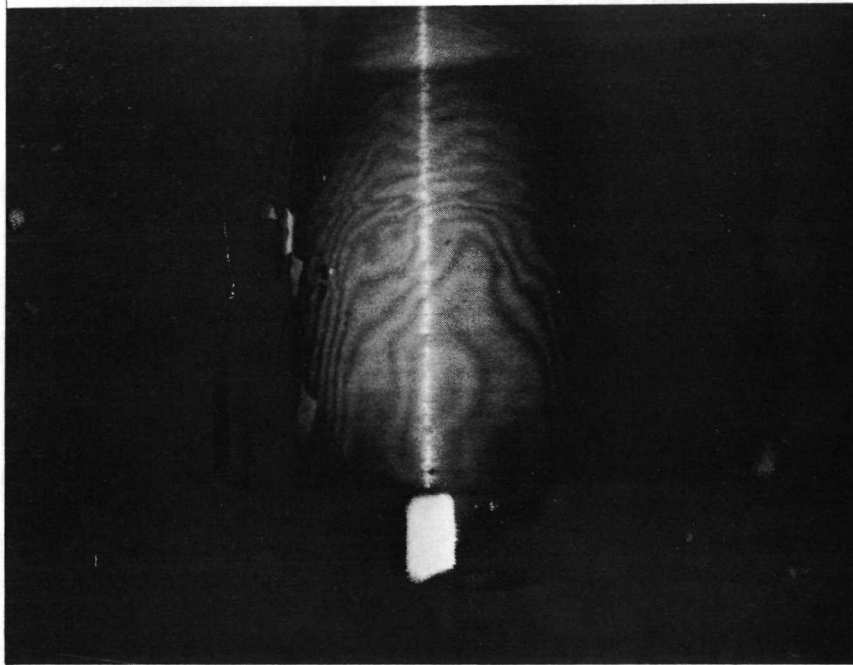
Fig. 13 After 5 min. from Stressing, the Fringe Field Through Holograms No. 22 Appeared as Shown.

About 5 minutes later the motor appeared as shown in Fig. 13. The fringe distortions, rings, bent and spread lines, are numerous. The condition suggested the application of fringe control for defining the size of the area represented by such anomaly.

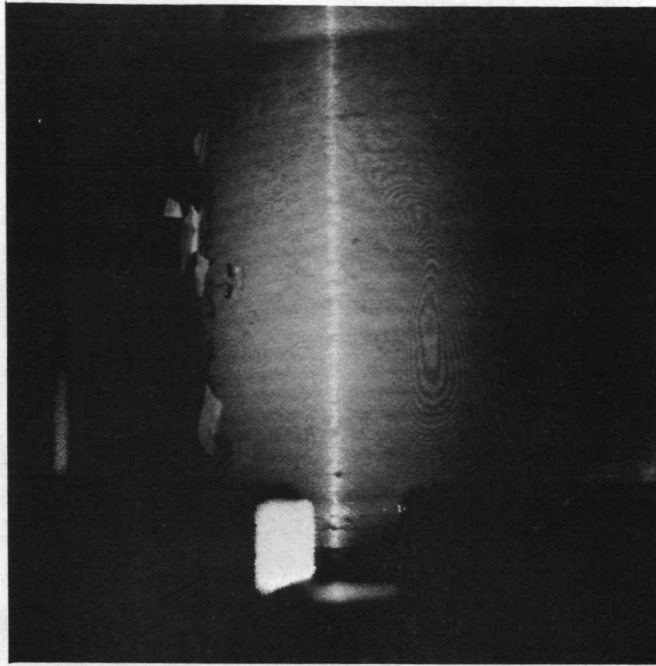
Fig. 14 Photograph Through Hologram No. 22 the Morning After Producing the Hologram. High Fringe Density Resulted from Ambient Temperature decrease (use hand lens for viewing).

To establish the significance of overnight temperature change, the table was left suspended. In observing the motor through hologram No. 22 the following day, the fringe density was found to increase sharply. The density was higher than indicated in Fig. 11. An effort was made to photograph the scene but little success was achieved. The best photograph is shown in Fig. 14.

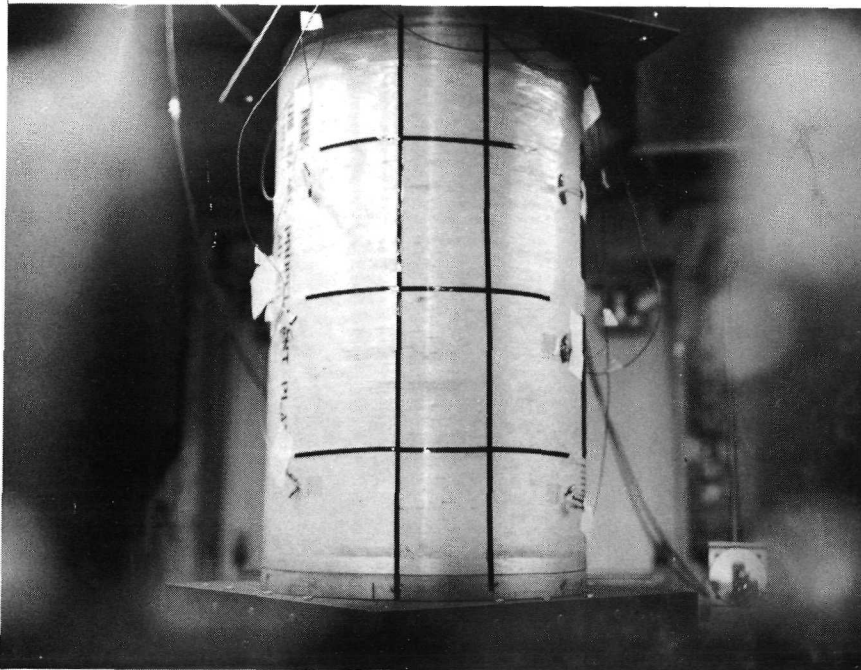
Fig. 18 Location of 1/4 in. wide Tape for Defining Position of Fringe Anomalies. Vertical Line on Left is at 120° and the other at 90°

The interference pattern of Fig. 17 shows an anomaly that suggested an area of bondline separation. To verify the location of an anomaly, on the casing was placed 1/4" wide black tape. A photograph of the taped motor can be seen in Fig. 18.

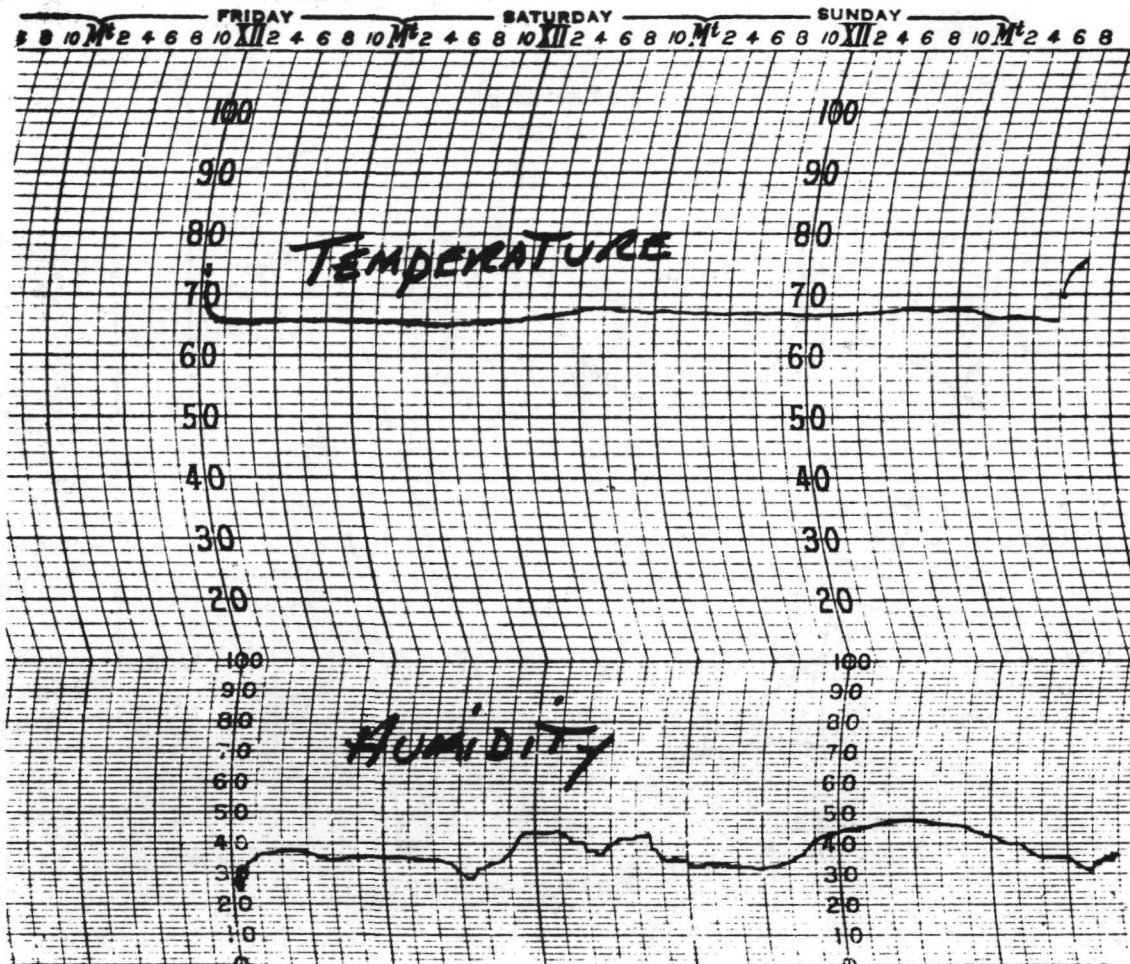
Fig. 19 Traces of Temperature and Humidity in Room Where Holography Was Performed

A temperature recording was also made over a weekend to obtain an estimate on excursions that the motor case experiences over a 24 hour period. A HYGRO-Thermograph was used. The unit also records humidity which can be seen in the graph of Fig. 19.

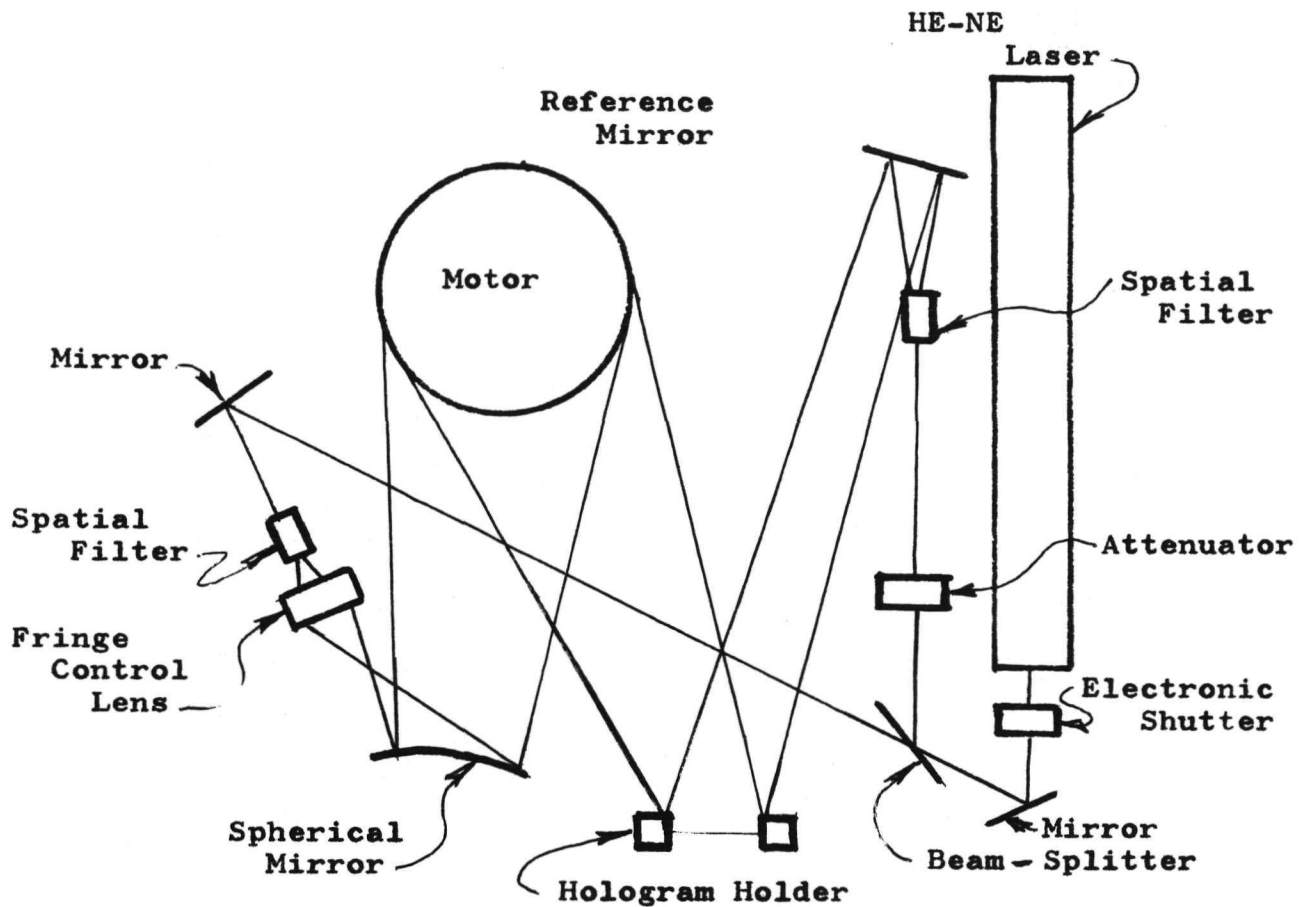
Fig. 20 Arrangement of Optical Components of Holography System to Perform Fringe Control

The optics were manipulated and adjusted to perform fringe control. After numerous trial and error tests to maximize object-beam intensity and area of illumination, the scheme in Fig. 20 was arrived at.

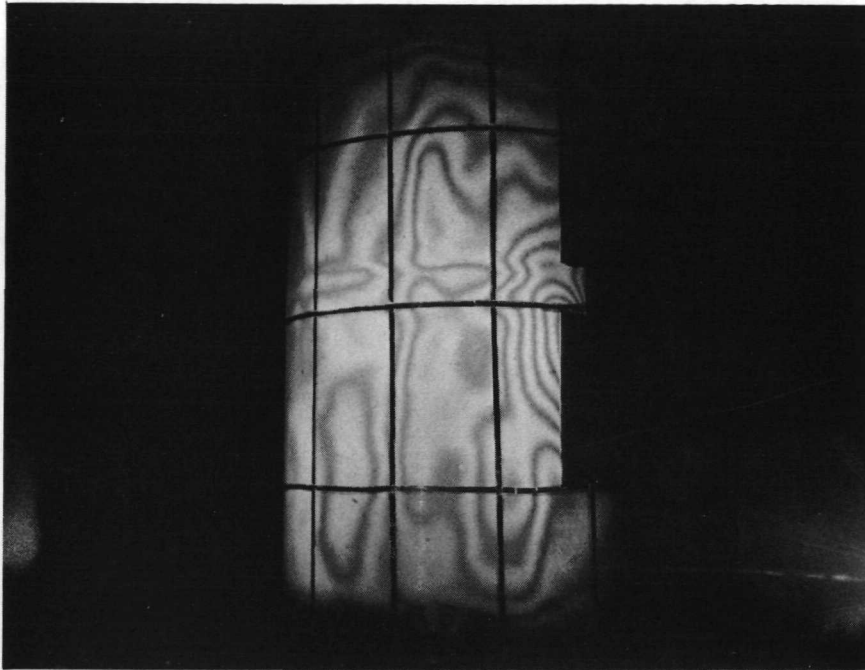
Fig. 23 Increase in Illumination Level Resulted from Application of Reflective Coating. View Through Real-Time Hologram No. 96 Before Stressing

The interference field in Fig. 23 was caused by emulsion shrinkage when the hologram underwent development. Room temperature fluctuations may also have affected the interference field.

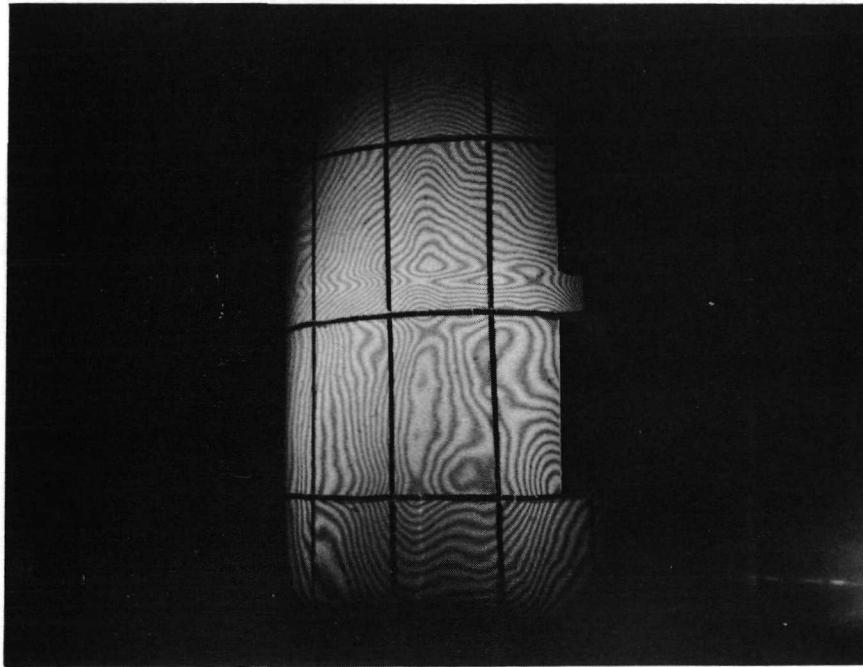
Fig. 24 Stressing for 5 sec Produced this Interference Field.
The Photograph Was Taken 30 sec Later Using Hologram
No. 96

The casing was stressed for varying periods. One of the Polaroids made is shown in Fig. 24.

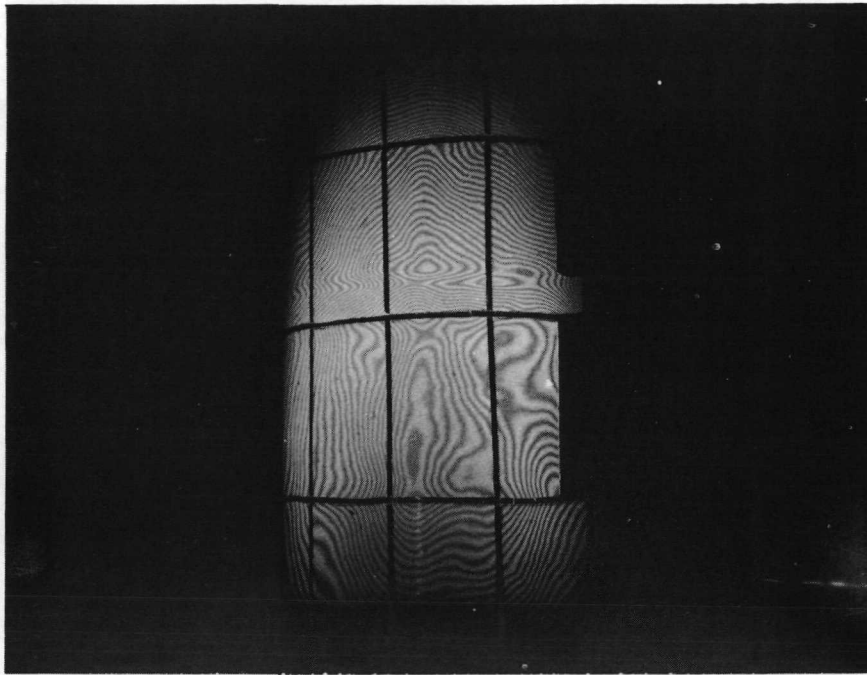
Fig. 25 Stressing for 10 sec Created This Fringe Field.
The Polaroid was Taken About 15 sec Afterwards

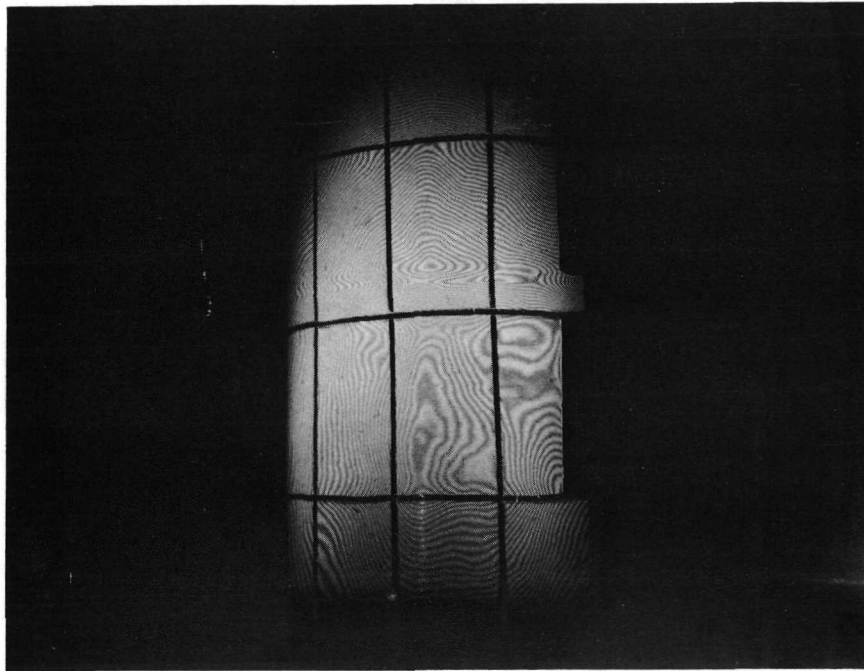
Fig. 26 Interference Field As Seen Through Hologram No. 96
Some 15 sec After Heating the Motor Surface

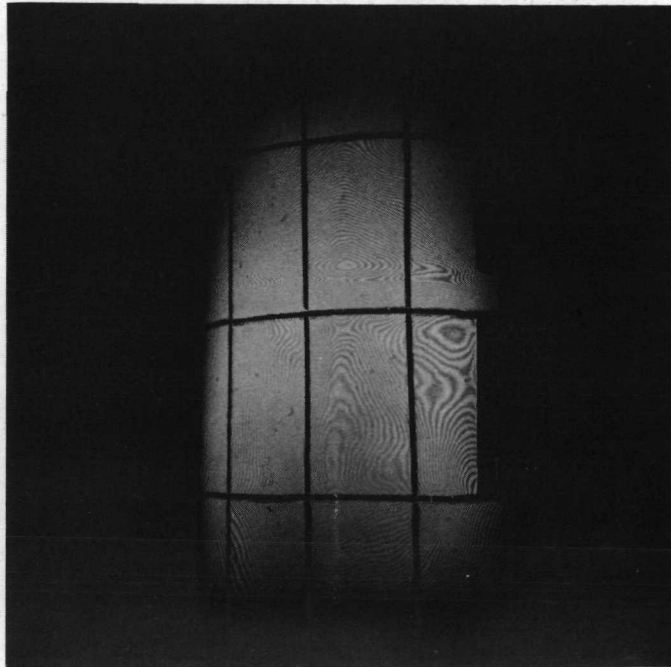
Fig. 27 The Line Density Increase After 20 sec of Stressing.
(Employ hand lens for viewing). The View Represents
the Scene 10 sec Later.

The line density continued to go up but the fringe pattern remained constant. The view after 20 sec of stressing can be observed in Fig. 27

In the previous photograph, it is apparent that 20 sec of stressing almost causes sufficient displacement to destroy first order interference. As the casing cools, as expected, the quantity of fringes decreases. Fig. 28 shows fringes 15 sec after the Polaroid of Fig. 27 was exposed.

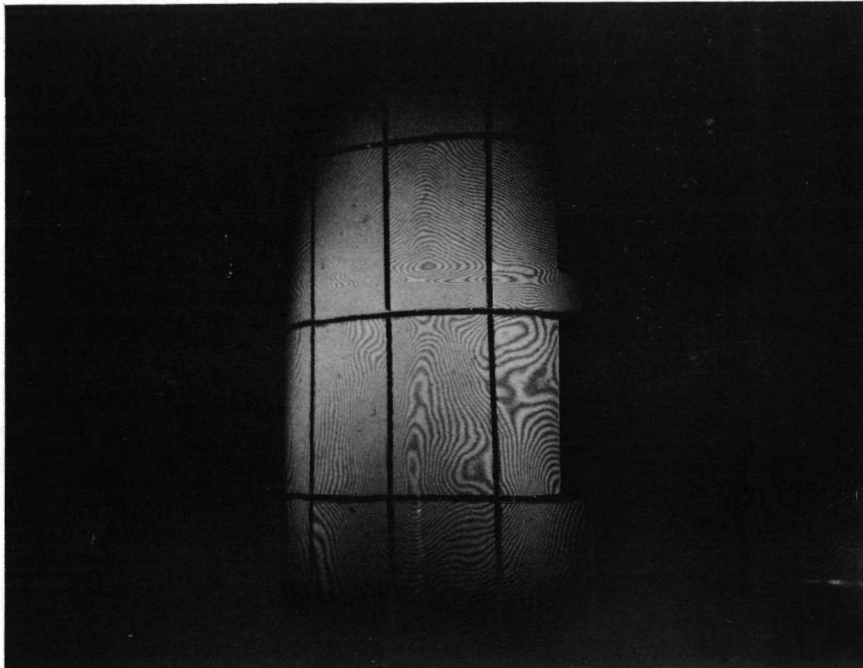
Fig. 28 Polaroid Exposed 15 sec After Taking Fig. 27.
The Time from Stressing the Casing is 25 sec
Camera Settings: f16 - 1-1/2 sec

The advantage of utilizing reverse holograms for photography can be appreciated by contrasting Figs. 28 and 29. Obviously, the casing in a static condition permits long Polaroid exposure times.

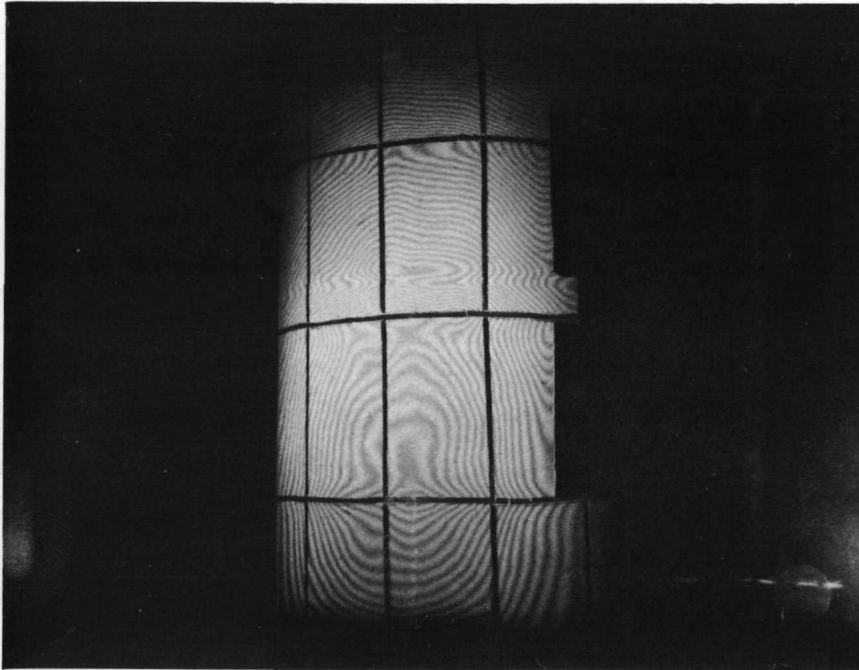
Fig. 29 Scene Through Reverse Hologram No. 98 Which Was Made After Heating the Casing for 20 sec. The Picture was Taken 25 min. later

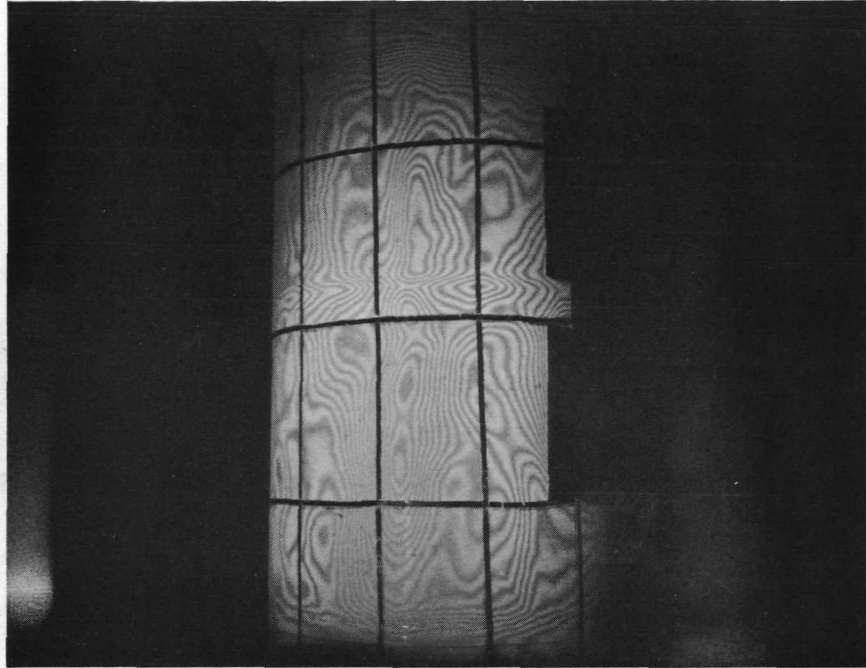
Fig. 30 A View Through Hologram No. 103. It Was Exposed When the Ambient Temperature was at 80°F . The Following Day the Temperature was 73°F . When the Polaroid Was Taken. Vertical Lines From Left to Right: 120° , 90° , 60° and 30°

The three black areas are tape squares placed over holes drilled previously for repair tests. In the center of the squares is the igniter. The repair procedure involved pumping epoxy by regulated air pressure through a flexible tubing into a lower hole which is not visible. Resin flows upward and outward expelling air

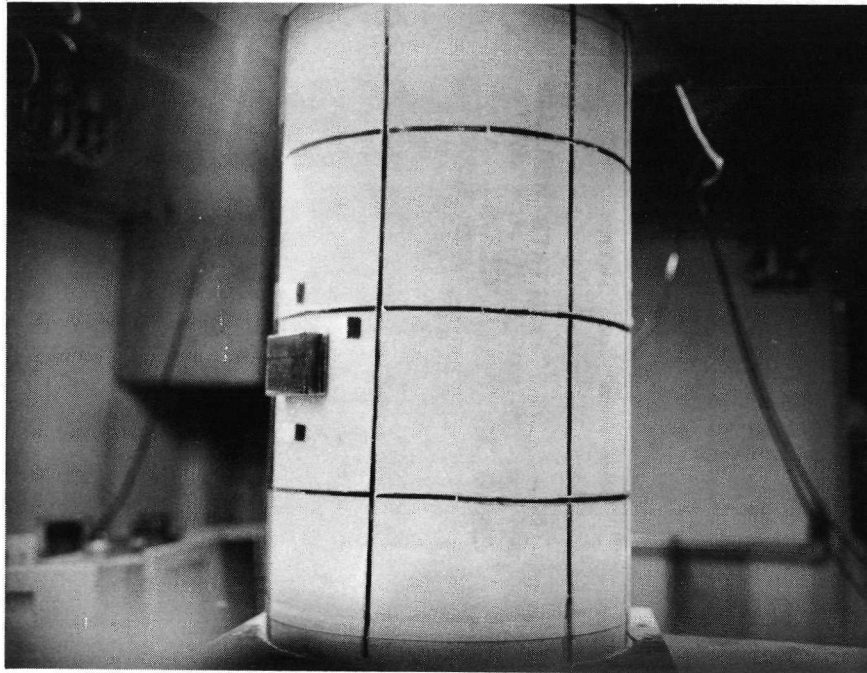
Fig. 32 Motor Case Rotated for Holographic Analysis of Area Reported Separated. Vertical Lines Left to Right: 270° and 210°

from the drilled holes. The repair attempted on this motor was unsuccessful. Ostensibly, epoxy could not be forced through the fill hole. However, after conditioning the motor to a temperature of 40°F it was possible to blow air into all the holes. Therefore, the separation, as reported in the NASA radiography document existed for the holography program. But the accuracy of the documented area of separation did not seem consistent with the hole position seen at the right in Fig. 32. This hole was located at the 304° radial position and the separation reportedly began at 307-1/2°.

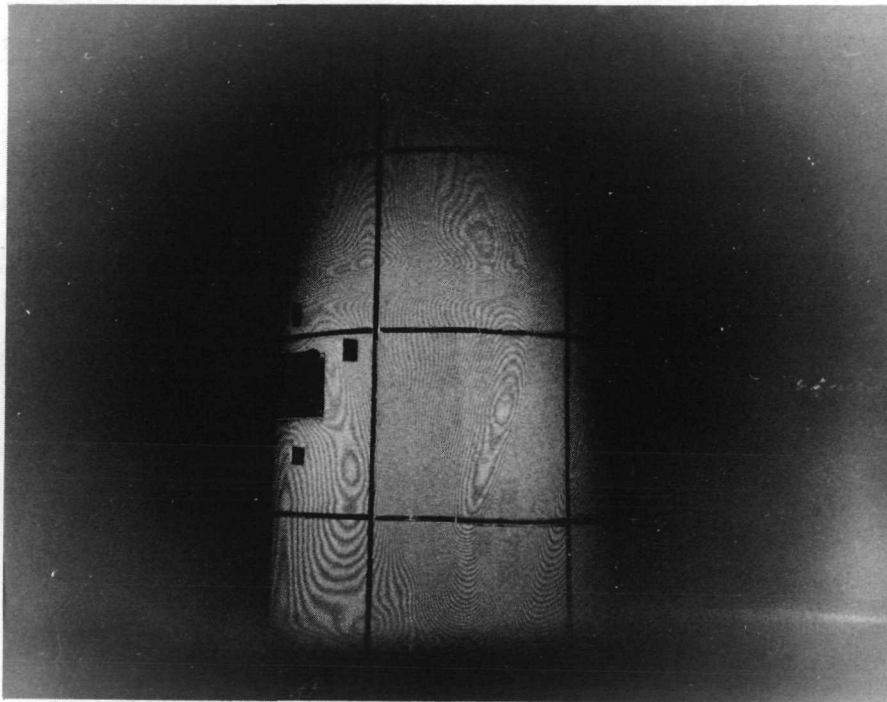
Fig. 33 View in Hologram No. 120 a Day After Exposure.
Ambient Temperature Decreased 2°F.

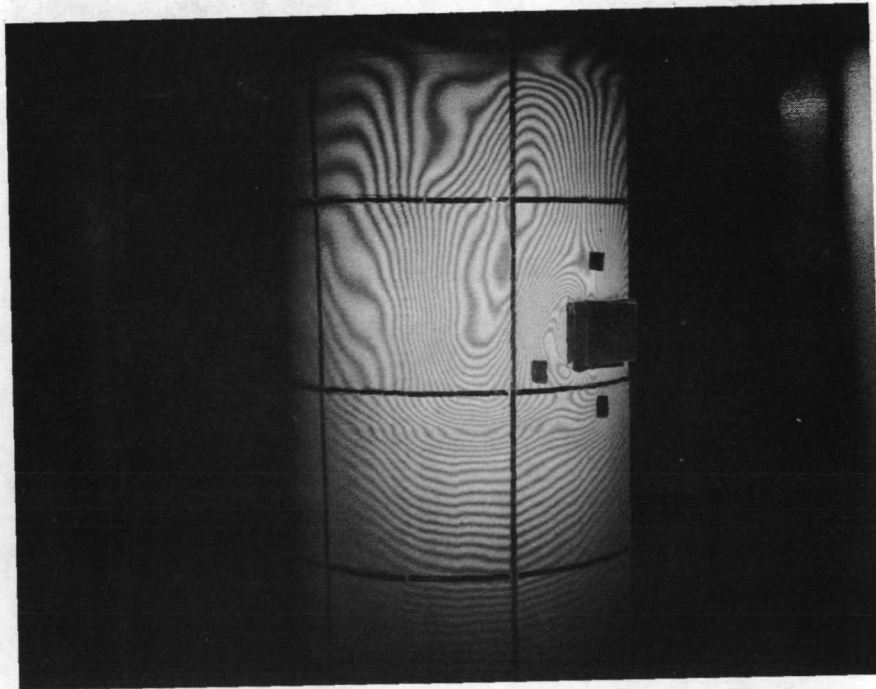
Fig. 38 View in Reverse Hologram No. 12⁴ as it Appeared
20 min. from Cyclic Heating

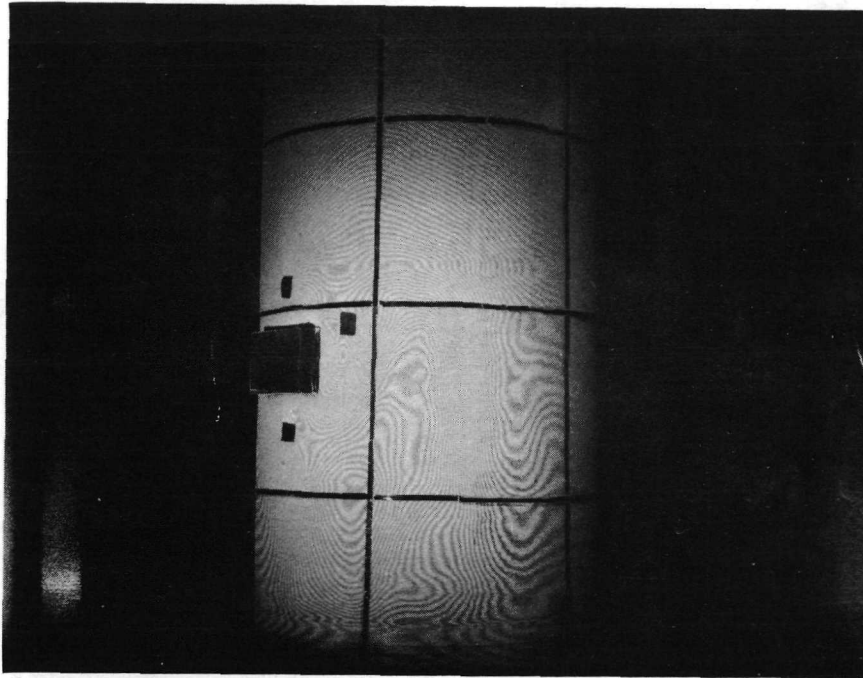
Fig. 39 Fringe Lines Increased in Hologram No. 124 a Day Later. Correlation with Previous Figure Shows Pattern Remained Constant

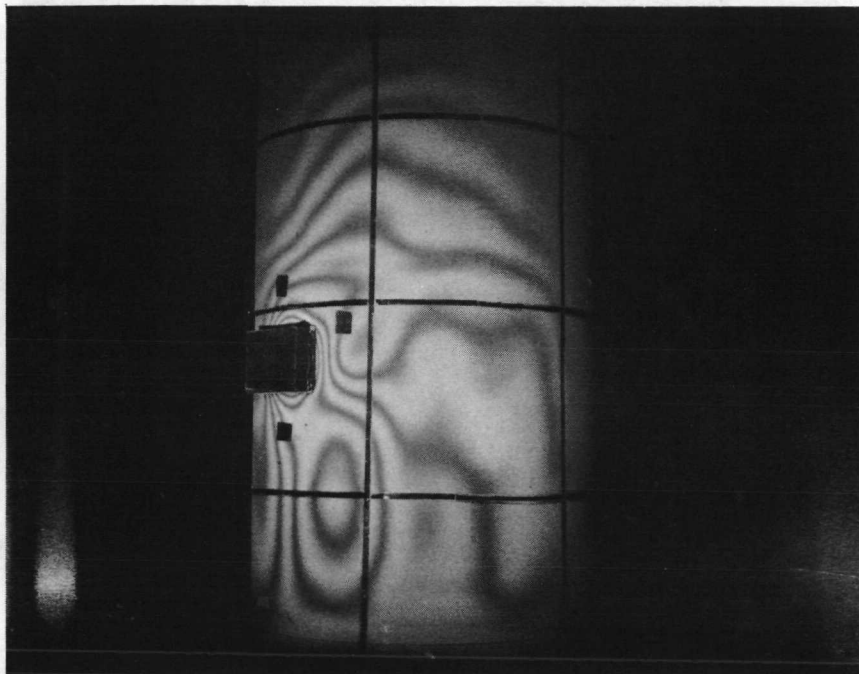
Fig. 40 Real-Time Hologram No. 127 Showing Interference Pattern Prior to Stressing

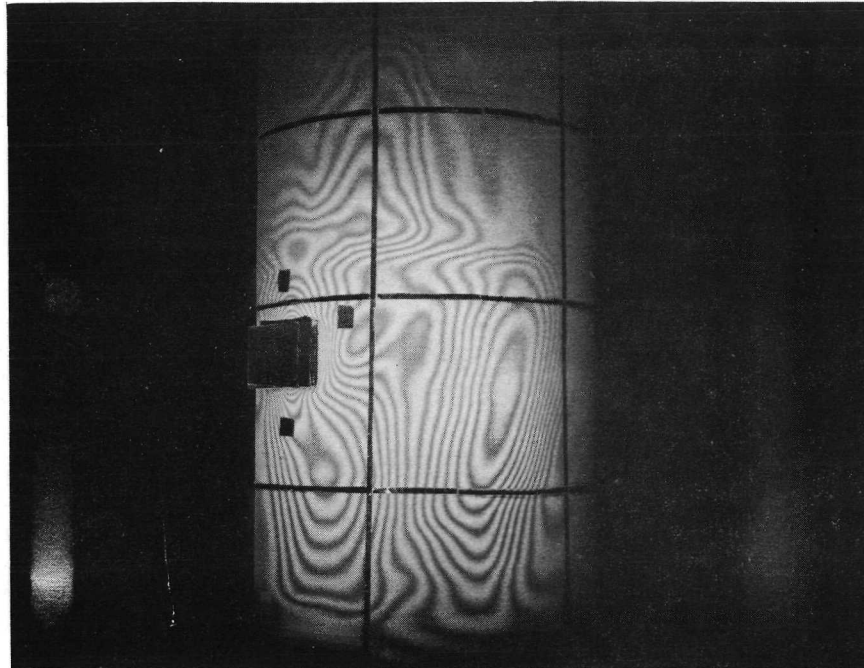
Fig. 48 Photograph Through Real-Time Hologram No. 127 19 min.
After a 40 sec Radiative Stressing of the Cylindrical
Casing

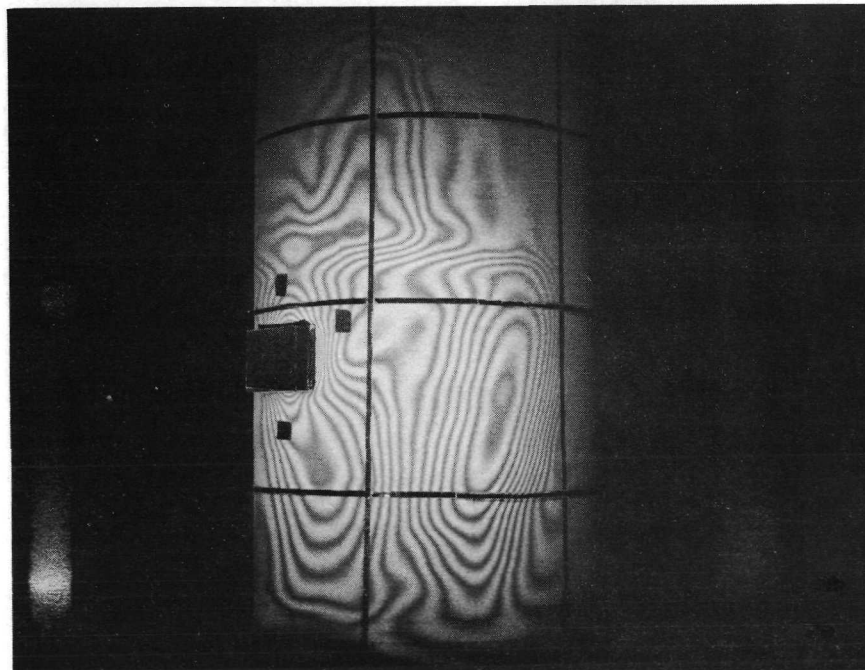
Fig. 49 Photograph Through Real-Time Hologram No. 127 23 min.
After a 40 sec Radiative Stressing of the Cylindrical
Casing

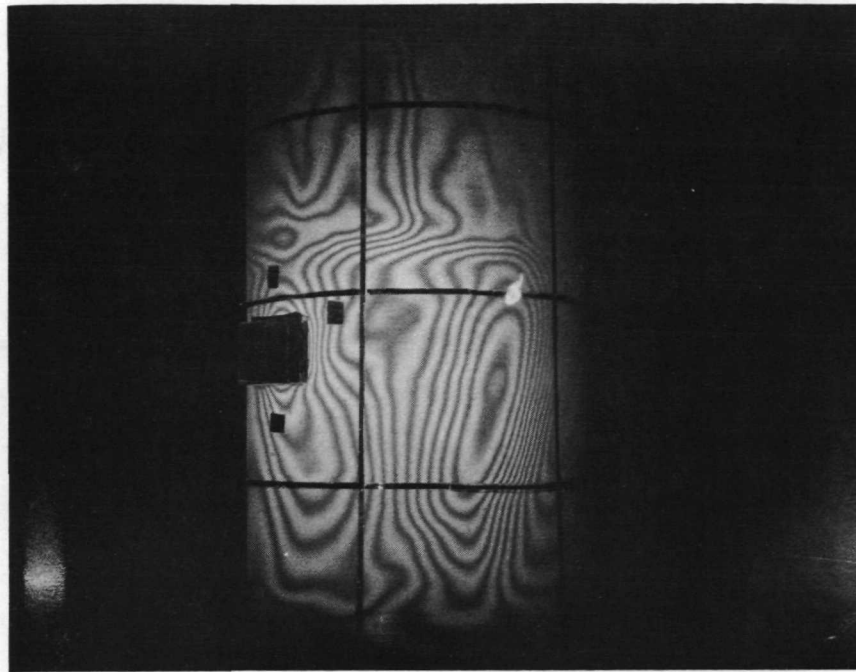
Fig. 50 Photograph Through Real-Time Hologram No. 127 30 min.
After a 40 sec Radiative Stressing of the Cylindrical
Casing
