LOCKHEED MISSILES & SPACE COMPANY, INC.
Manufacturing Research Investigation

LASER HOLOGRAPHIC
NONDESTRUCTIVE TESTING
OF
THE NASA X-248 ROCKET MOTOR

NASA Contract: NASI 11419

December 1972

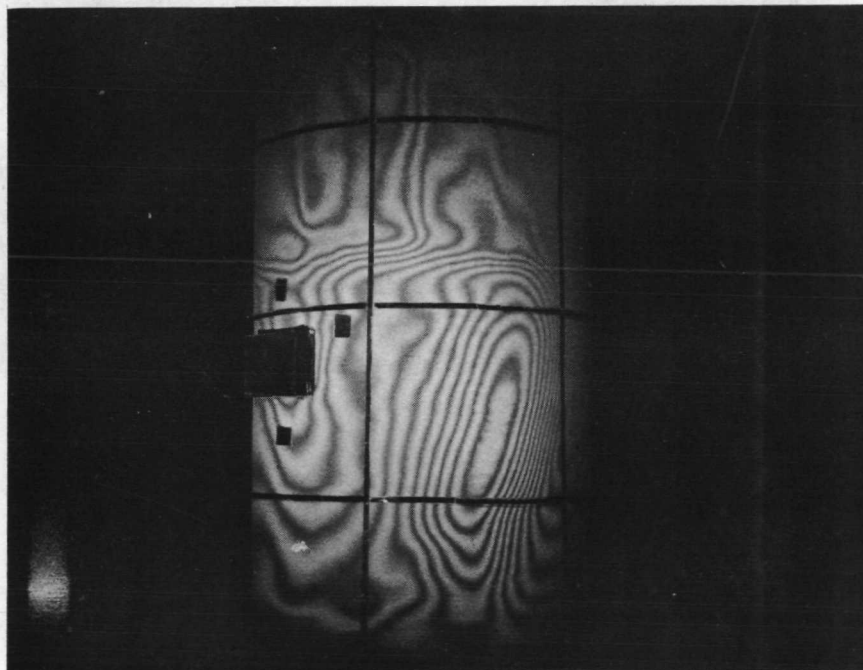
Fig. 51 Photograph Through Real-Time Hologram No. 127 43 min.
After a 40 sec Radiative Stressing of the Cylindrical
Casing

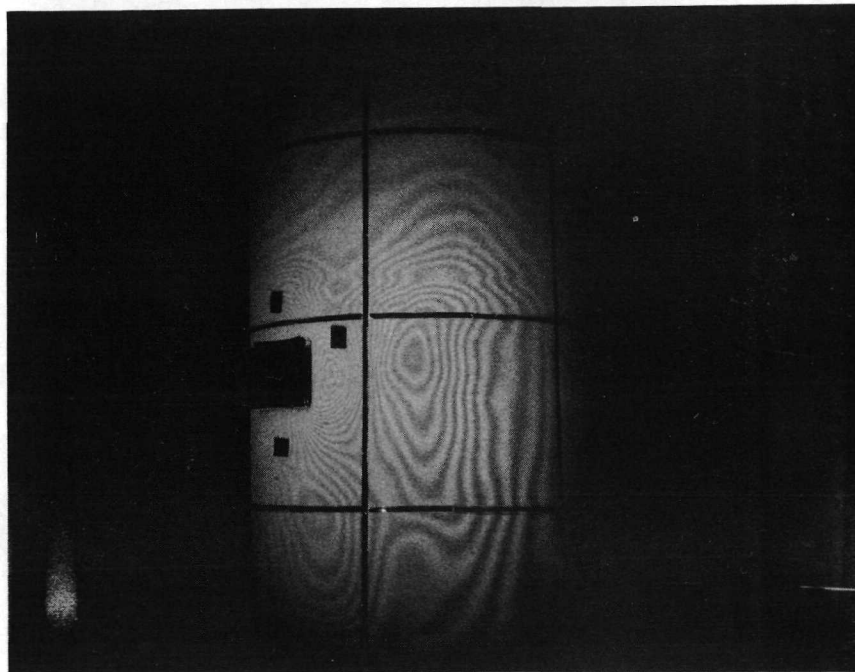
Fig. 52 Fringe Field Seen Through Reverse Hologram No. 128
Entire Casing was Heated for 40 sec and Hologram Made
3 min. Later. 20 min. After, the Photo was Snapped.

Upon examining Figs. 63 and 65 and comparing them to Fig. 52, it seemed that the areas where concentric rings to the left of these in the center may be signalling convex displacement caused by interface disbonding. For comparison then, the technique that produced the result shown in Fig. 52 was applied to the area defined by Fig. 64.

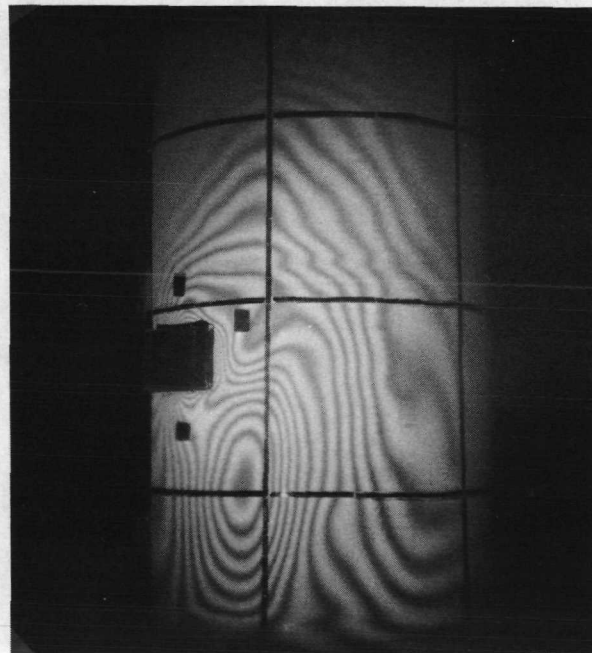
Fig. 53 Interference Field of Hologram No. 131 Which Occurred After Cyclic Heating Test 3T

Hologram No. 131 was developed and observed 24 min. after exposure. It appeared as shown in Fig. 53

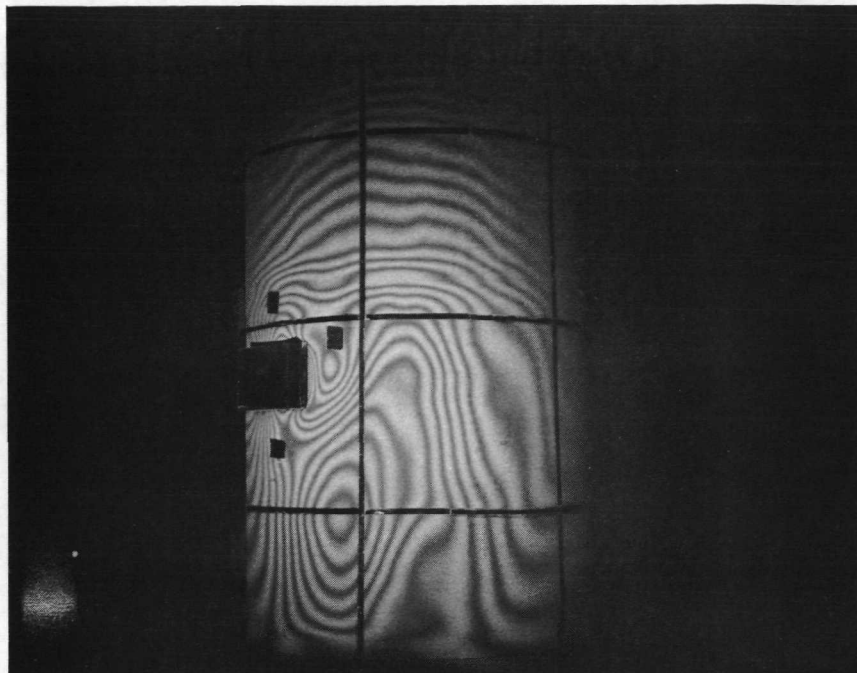
Fig. 55 Photograph Through Hologram No. 138
Camera Settings: f16 - 3.53 sec

<u>Operation</u>	<u>Elapsed Time (minutes)</u>	<u>Average Peak Temperature °F</u>
1. Recorder Turned On	-	65.6
2. 30 Seconds of Heat	0	71.5
3. Exposed Reverse Hologram No. 132	8	66.4
4. " " " No. 133	11	66.2
5. " " " No. 134	15	66.1
6. Photograph of Figure 54 taken	39	65.9
7. Photograph of Figure 55 taken	49	65.7

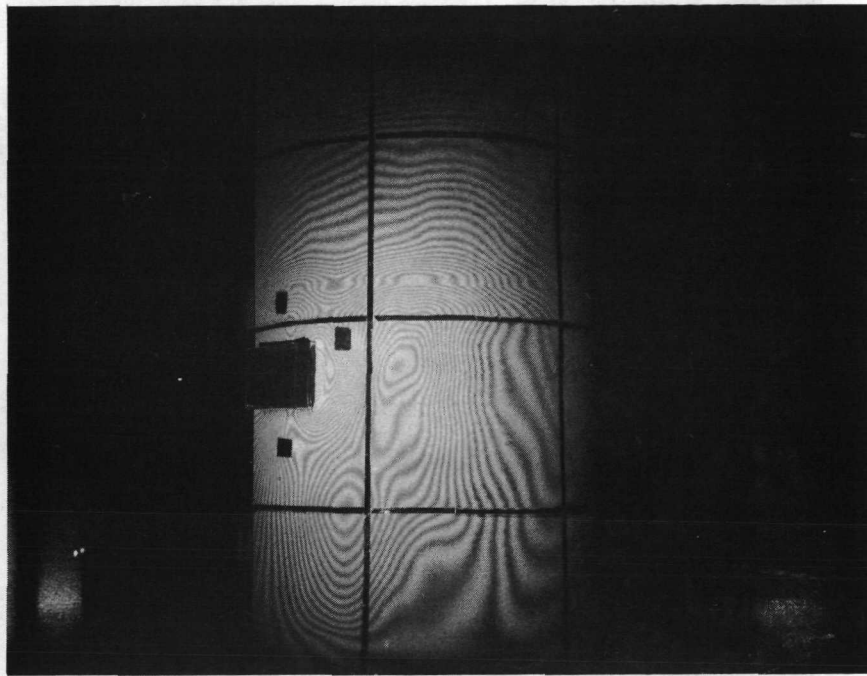
Fig. 57 Fringe Field Photographed Through Hologram No. 139

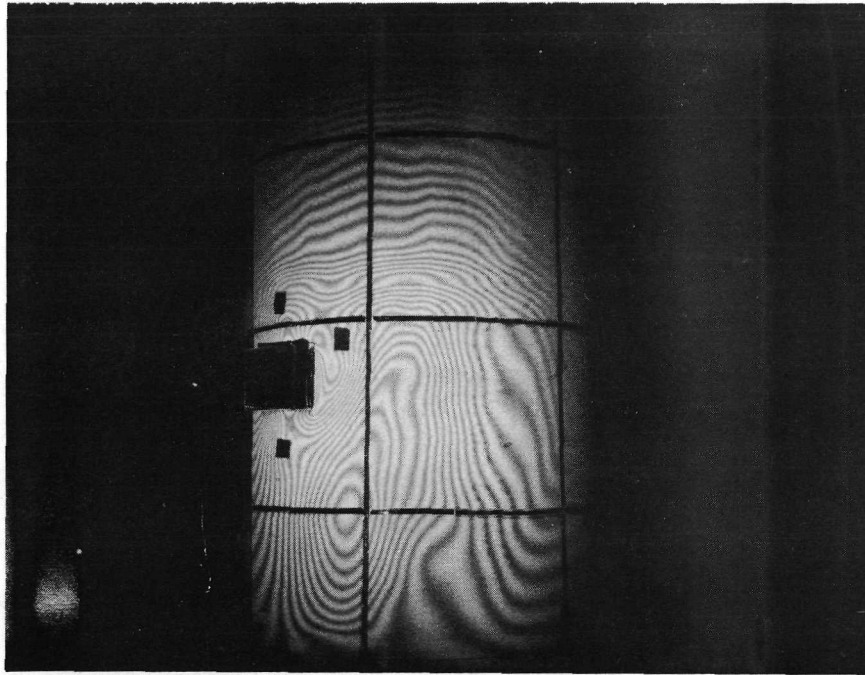
Fig. 58 Fringe Field Photographed Through Hologram No. 140
Camera Settings f19 - 4.0 sec

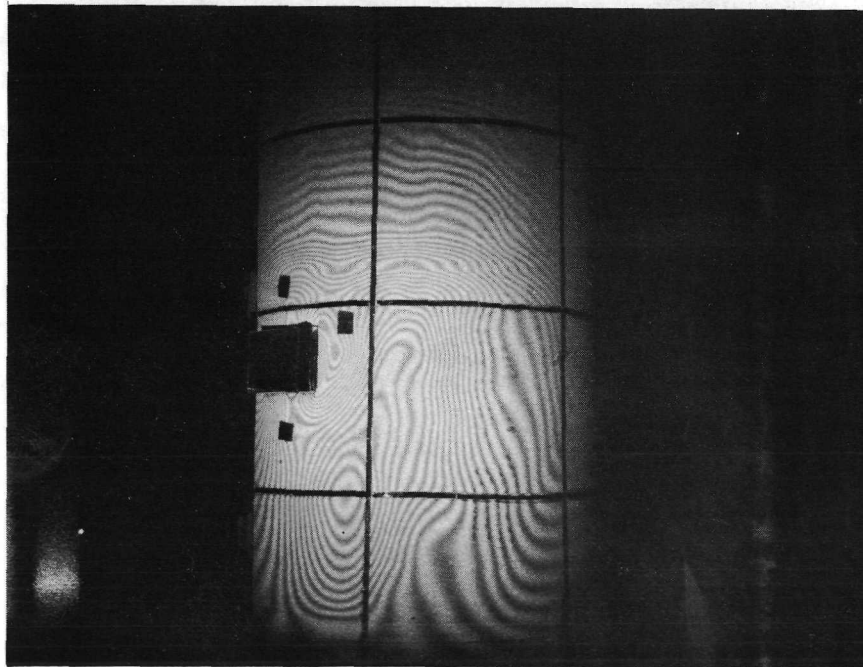
Fig. 59 Fringe Field Photographed Through Hologram No. 141
Camera Settings: f19 - 4.0 sec

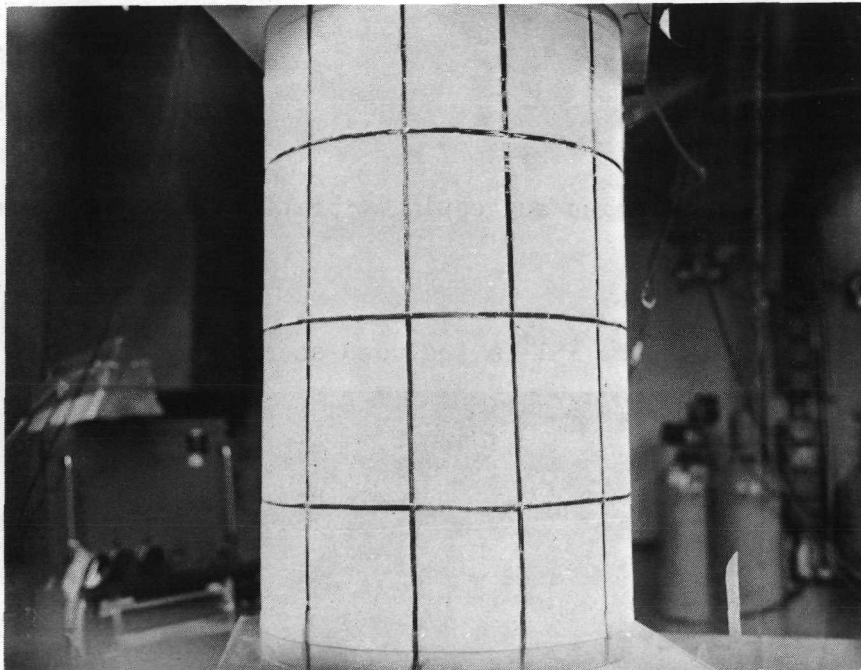
Fig. 60 Position of Motor Case After Rotation
Photograph was Taken Through Plate Holder

To apply heat test, No. 6T, over the total inspectable area of the cylinder, 270°, it was rotated about 120°. The 90° not inspectable has large repair patches that can be seen in Fig. 22. The new position was photographed through the plate holder and it is shown in Fig. 60. The vertical lines from left to right were the 210, 180, 150 and 120 degree lines.

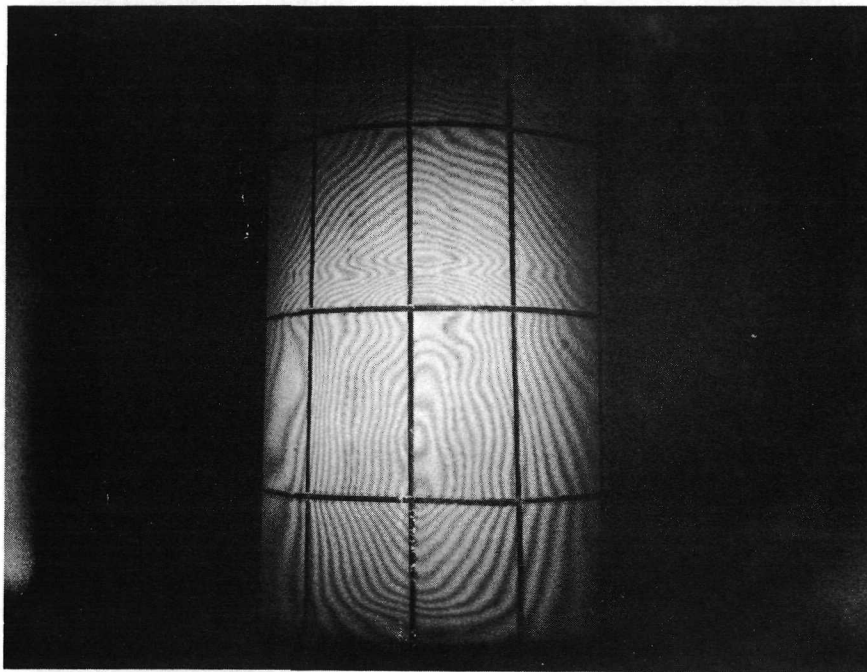
Fig. 63 Polaroid Through Hologram No. 156 Made 3.5 min
After Heating the Casing for 30 sec

To achieve a line density greater than that indicated in Figs. 60 and 61, another test designed to reduce the elapsed time between stressing and hologram exposure was completed. A satisfactory hologram was experienced by exposing it 3.5 min. from the 30 sec stress. The pattern of Fig. 63 was observed some 20 mins. later.

This behavior can be observed in Figs. 63 and 65.

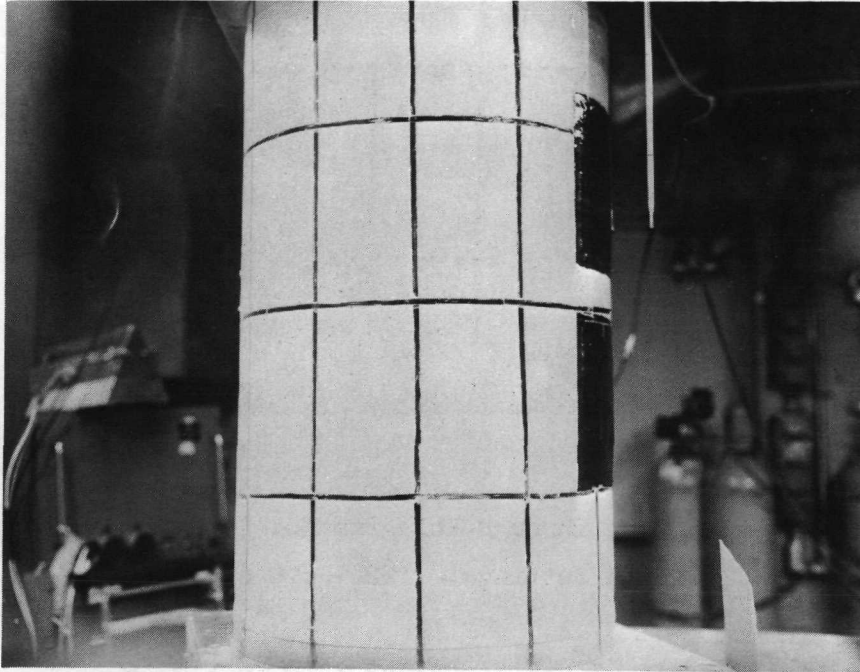
Fig. 64 Position of Motor Case After Second Rotation.
Vertical Line is at 90° Location.

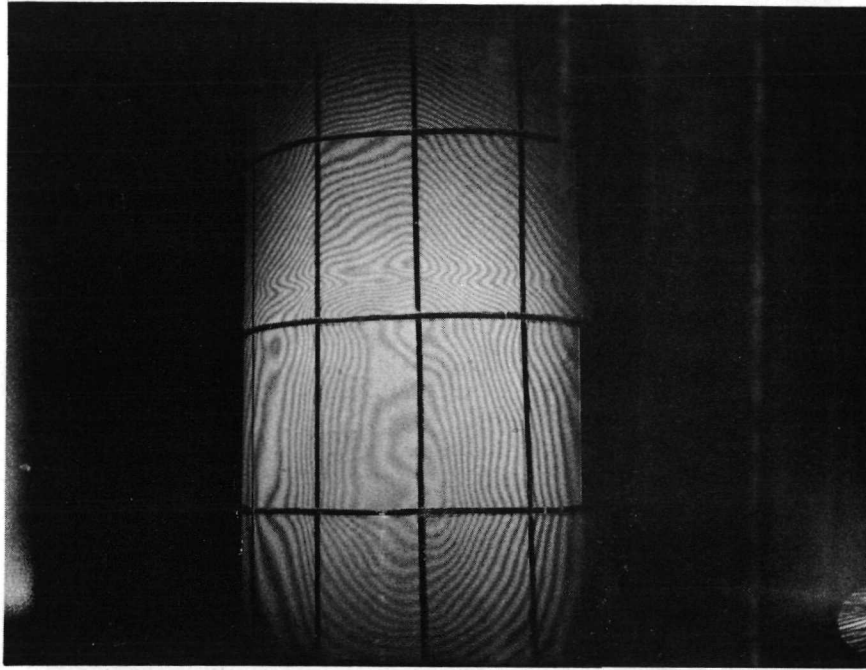
Fig. 65 Photograph Through Hologram No. 158
Camera Settings: f22 - 4.0 sec

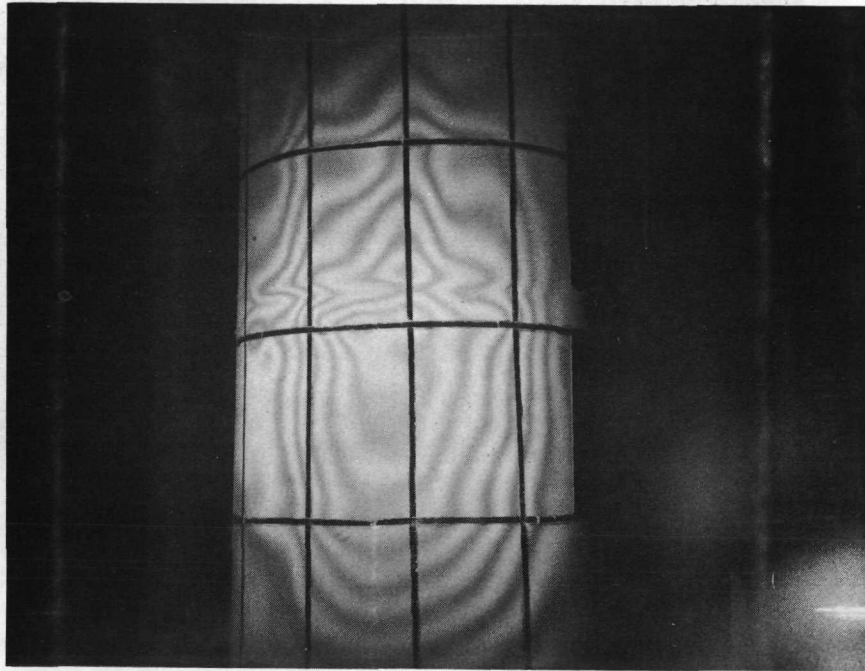
Fig. 66 Interference Pattern Effected by Reverse Hologram
No. 160 Exposed 3 min. After Heating the Total
Casing for 40 sec

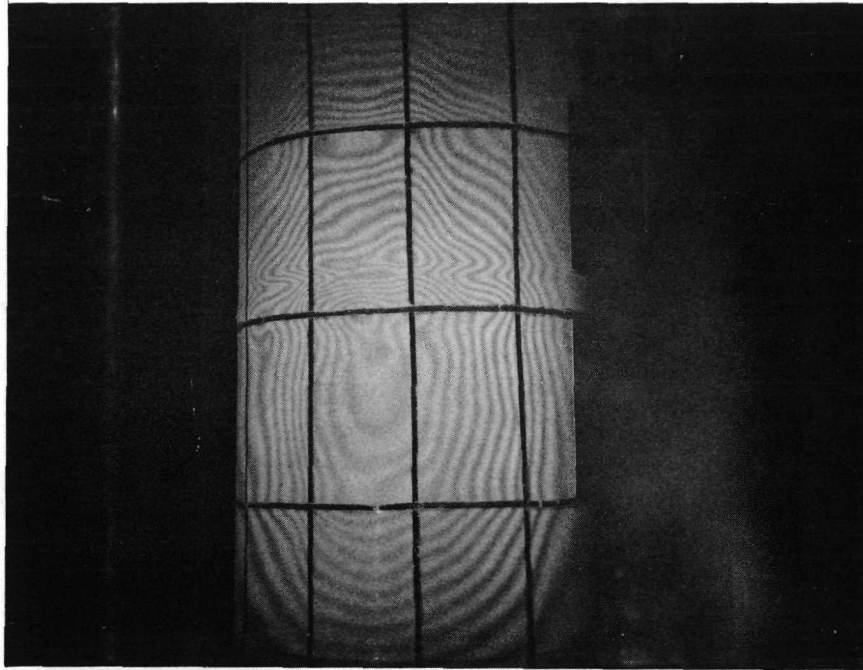
Fig. 67 Line Density Increased from Previous Figure by Making Hologram No. 161, 1.5 min. After Heating the Entire Casing for 40 sec.

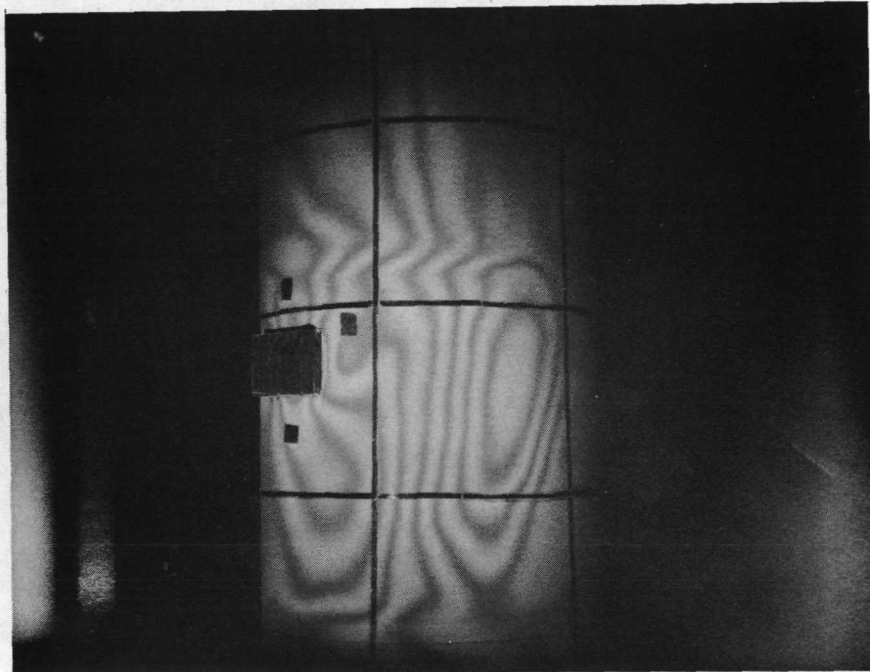
Fig. 68 View Through Real-Time Hologram No. 123 Prior to Application of Static Load

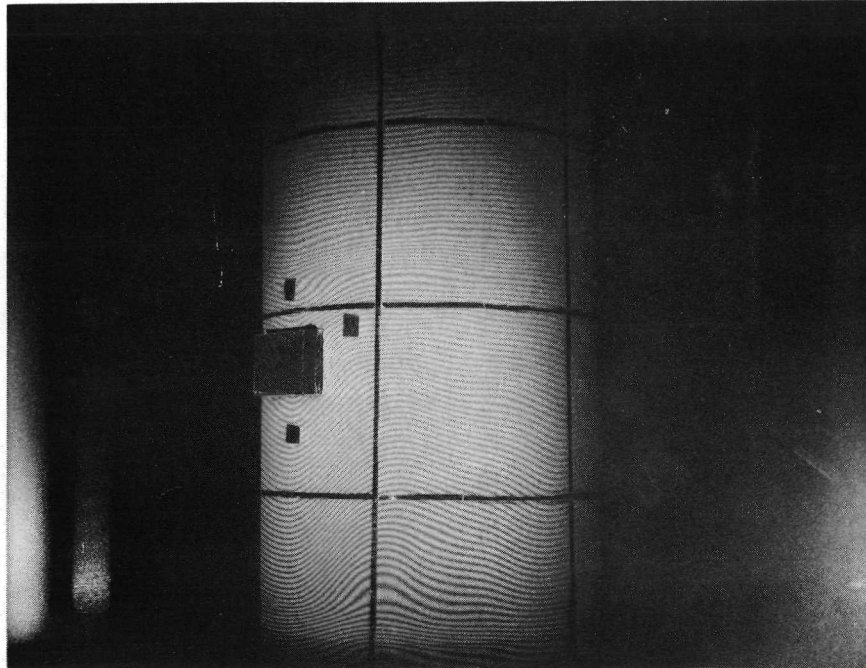
Fig. 69 Fringe Lines Produced by 40 lbs. of Mass Placed Around the Upper Edge of Hemi-Cylinder. Center Line was 270° Position.

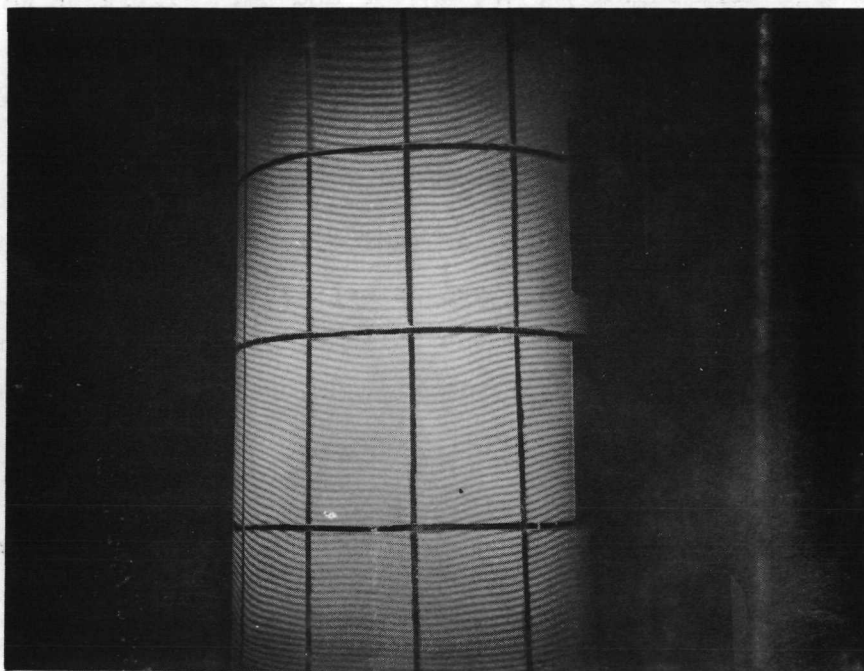
Fig. 70 Fringe Lines Produced by 35 lbs. of Mass Placed Around the Upper Edge of Hemi-Cylinder. Center Line was 90° Position, Lines are 30° Apart.

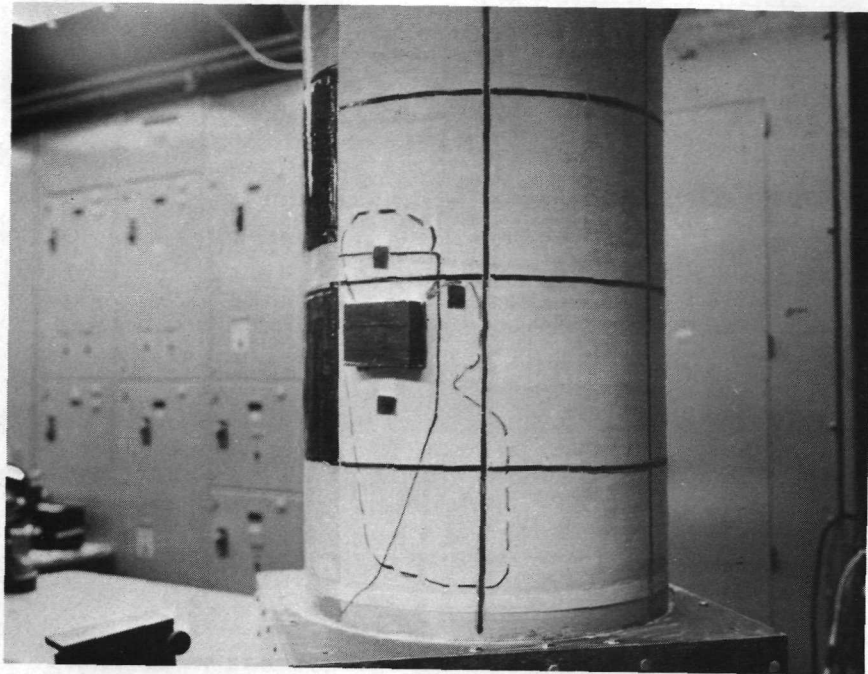
Fig. 71 Solid Dark Line Indicates Area Separated in the Radiograph Record of Motor Case S/N 424. Dashed Line was Closest Approximation as Suggested by Holography

By examining Fig. 80 and Fig. 71, it is obvious that the area of liner/propellant separation was found to be greater than the area reported in the radiographic analysis on motor case NPP-424. Since the x-ray record did not accurately define the boundary of liner/propellant void, an attempt was undertaken to correlate holographic pictures to the void area delineated by destructive tests as depicted in Fig. 80. This, of course, presumes the area in Fig. 80 was present during holography.

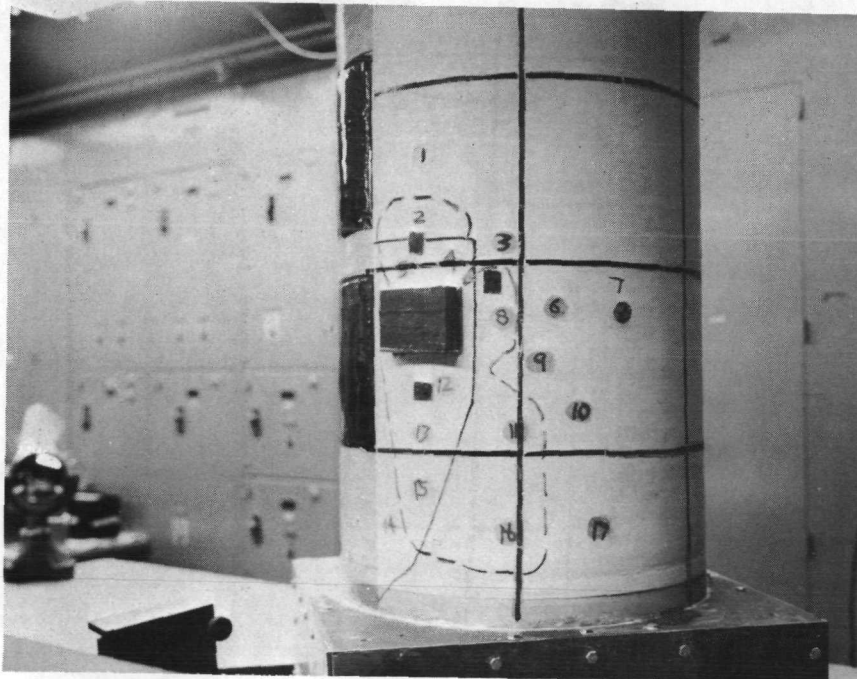
Fig. 72 Circular Areas Marked for Destructive Tests. (17) 1 in. Diameter Circles are Shown. Vertical Line is the 270° Position

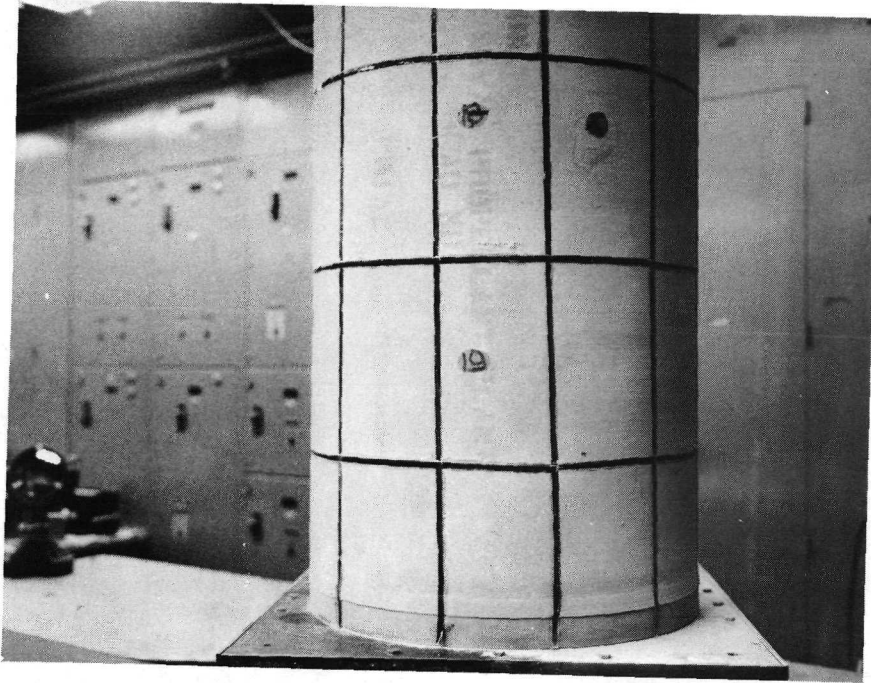
Fig. 73 (2) Circles Marked in Bonded Areas Between 180° and 150° for Destructive Tests

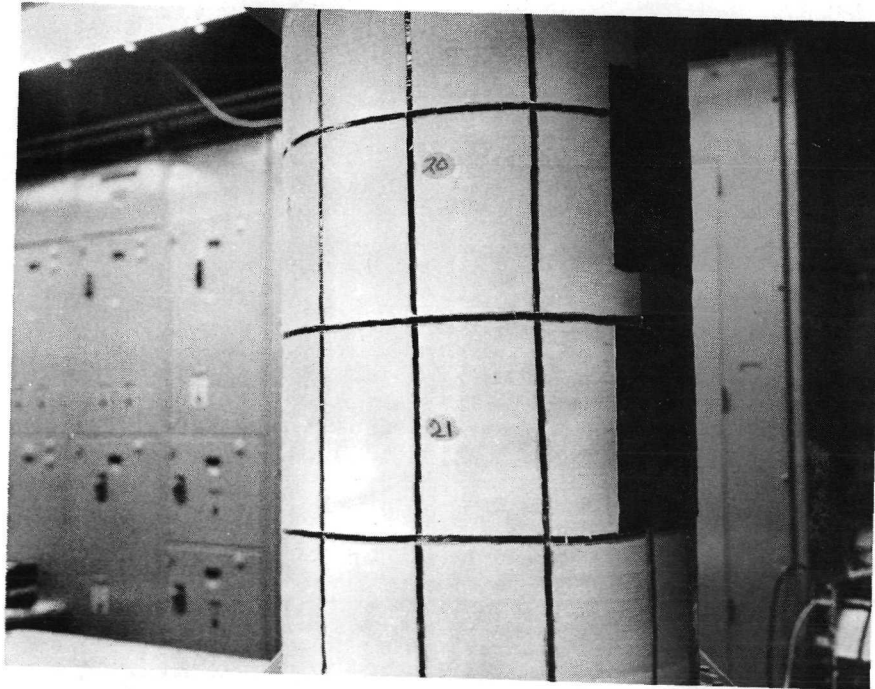
Fig. 74 (2) Circles Placed Near 90° Position for Destructive Tests. Both Areas Were Considered Bonded

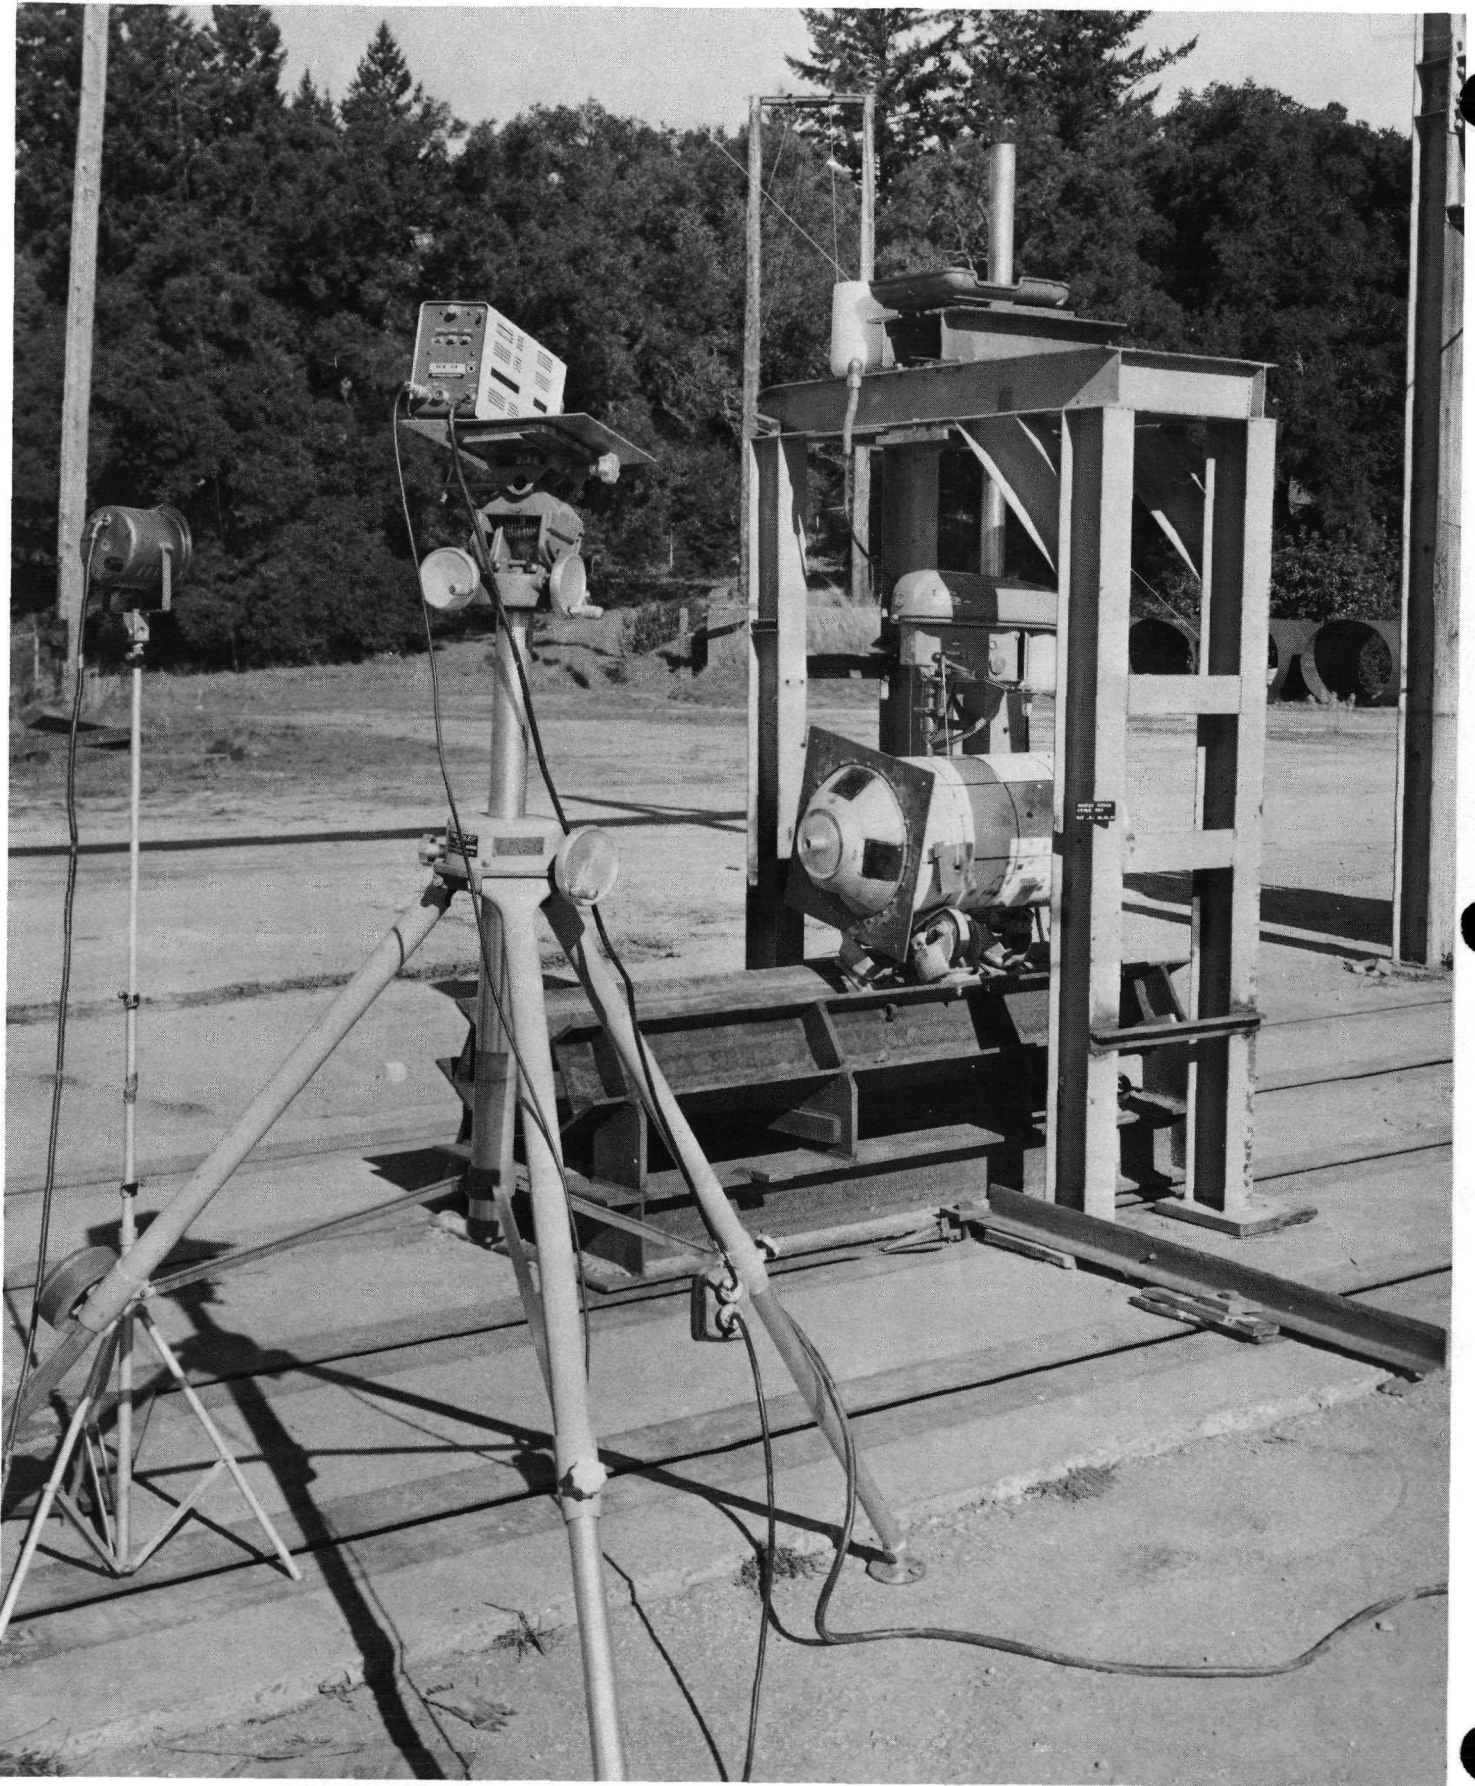
Fig. 75 Destructive Test Arrangement for Cutting 1-in. Diameter Discs from Motor Case S/N 424

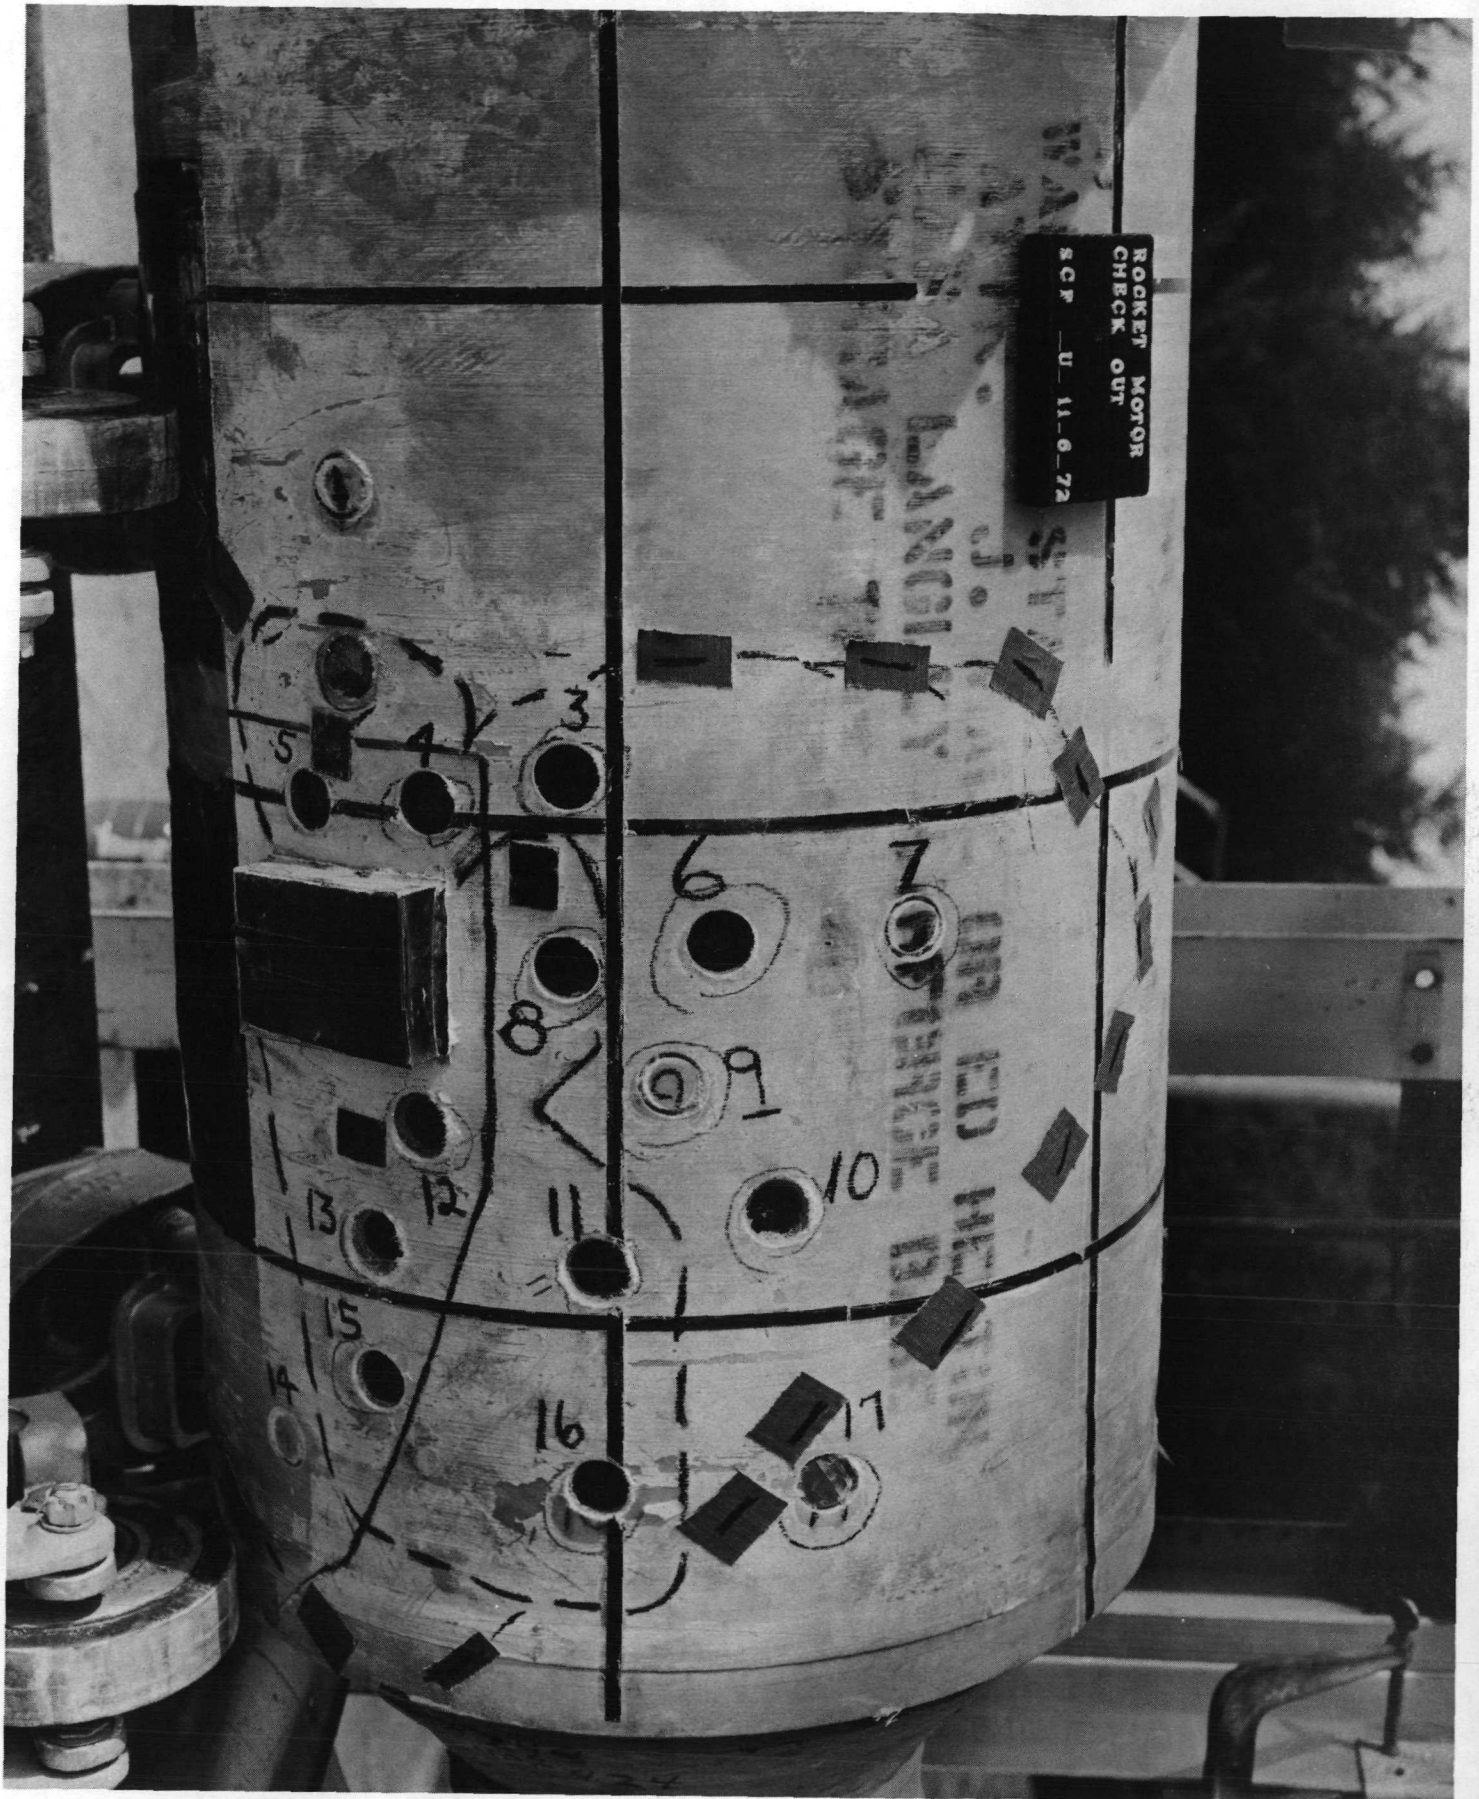
Fig. 76 Photograph of Motor Case S/N 424 After Making Initial 1-in. Diameter Penetration Cuts into Casing to Test for Separation Between Casing/Liner and Liner/Propellant

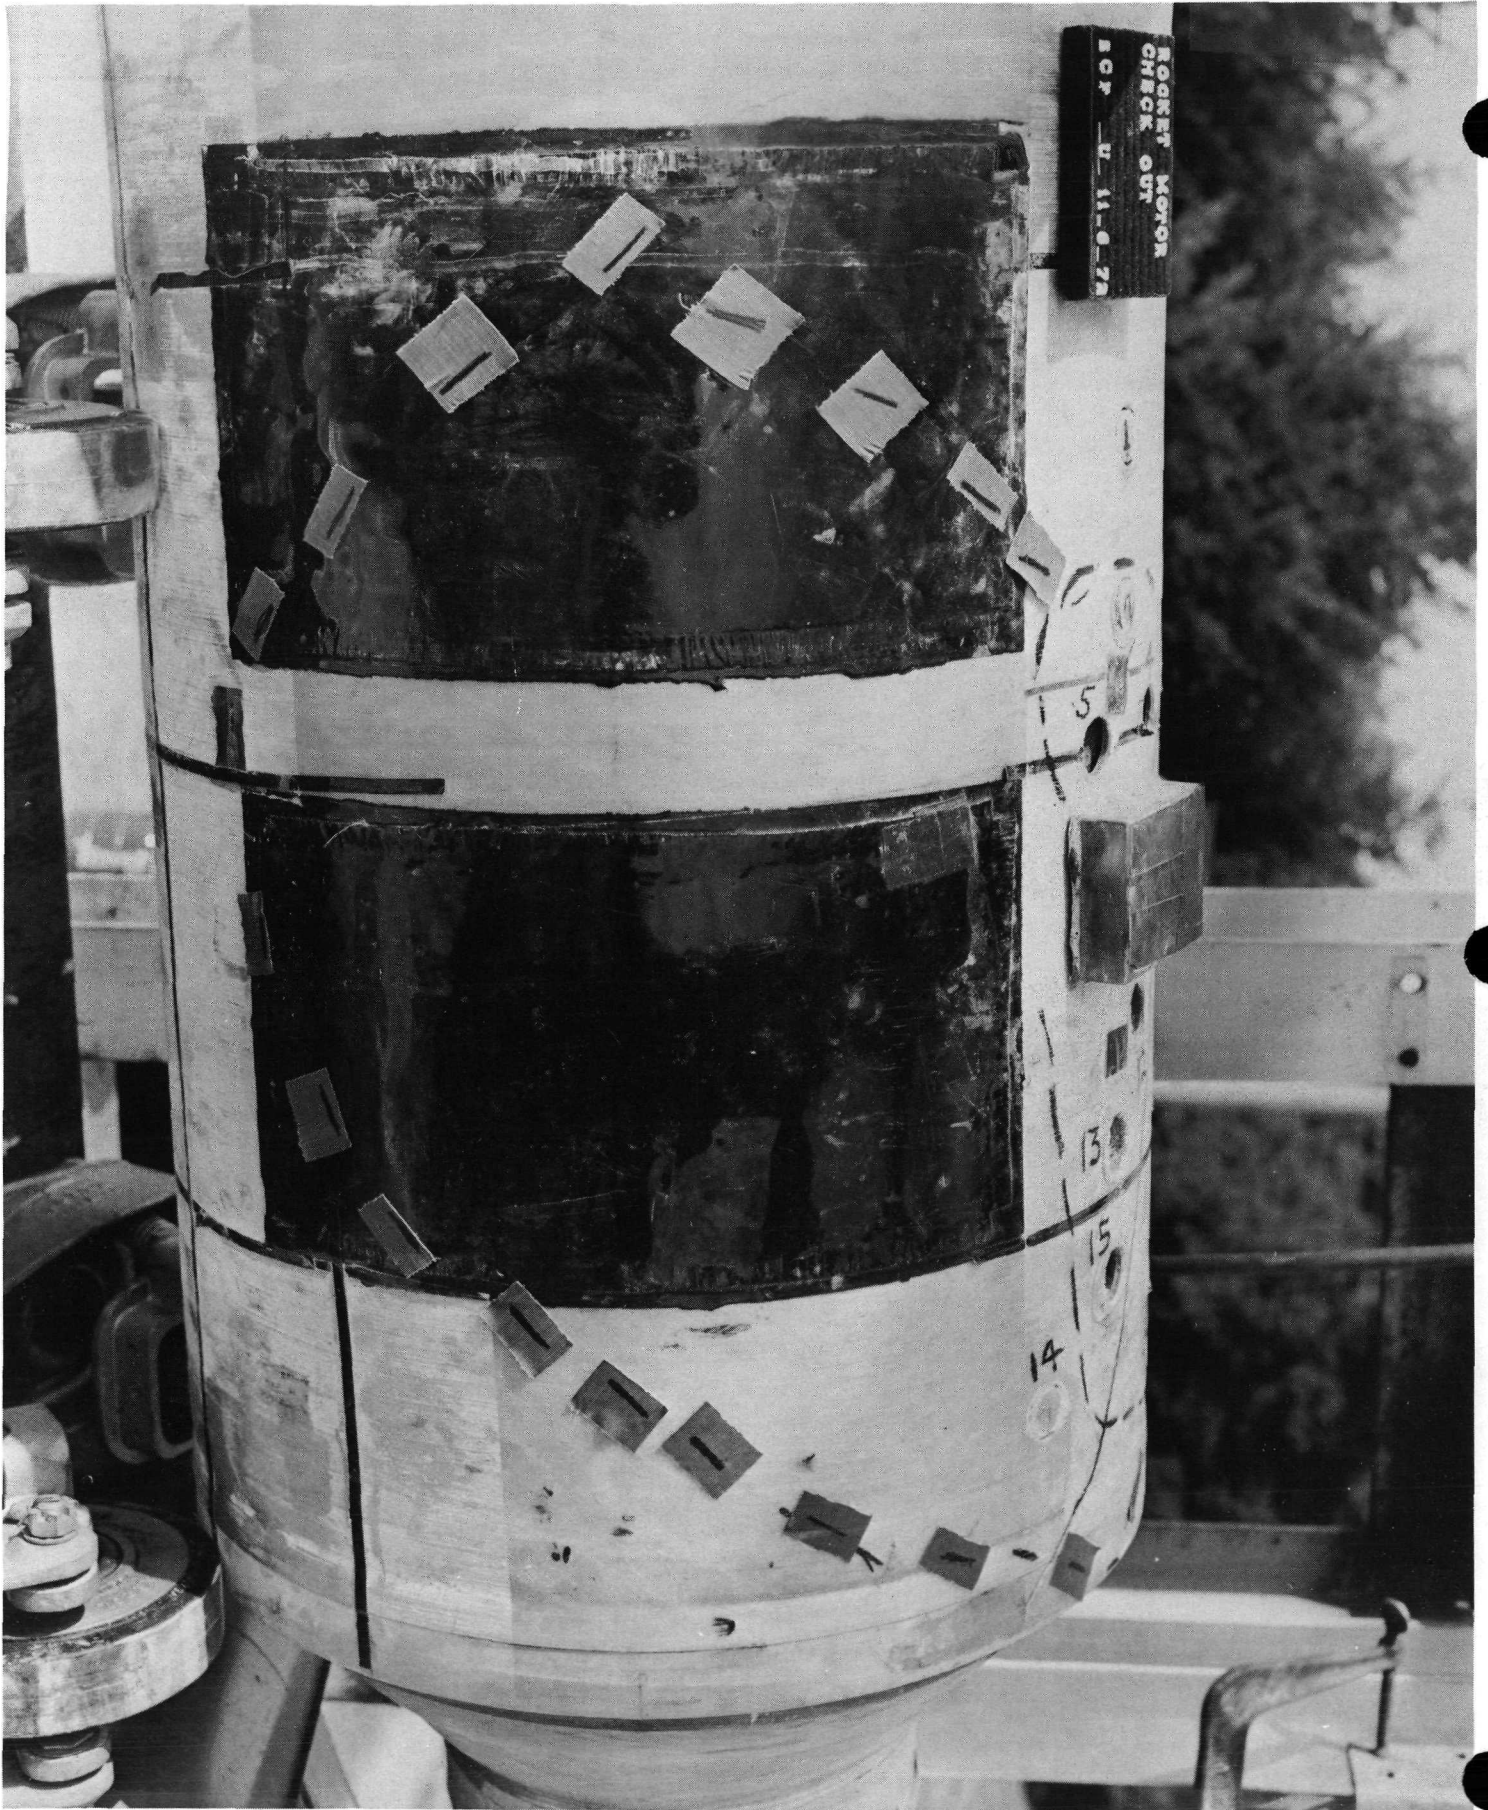
Fig. 77 Trace of Separated Area Between Liner and Propellant Detected by Feeler Gage During Destructive Tests on Motor S/N 424

Since the majority of the designated penetration cuts actually revealed physical separation between liner and casing, as great as $3/16$ of an inch, it was found possible to insert a flexible feeler gage, .010 in. thick, into each of the holes and plot on the casing surface the extremity of separation. This was done and the border was traced. This can be seen in Figs. 76 and 77 as a broken line drawn on, and adjacent to, pieces of $3/4$ in. wide paper tape.

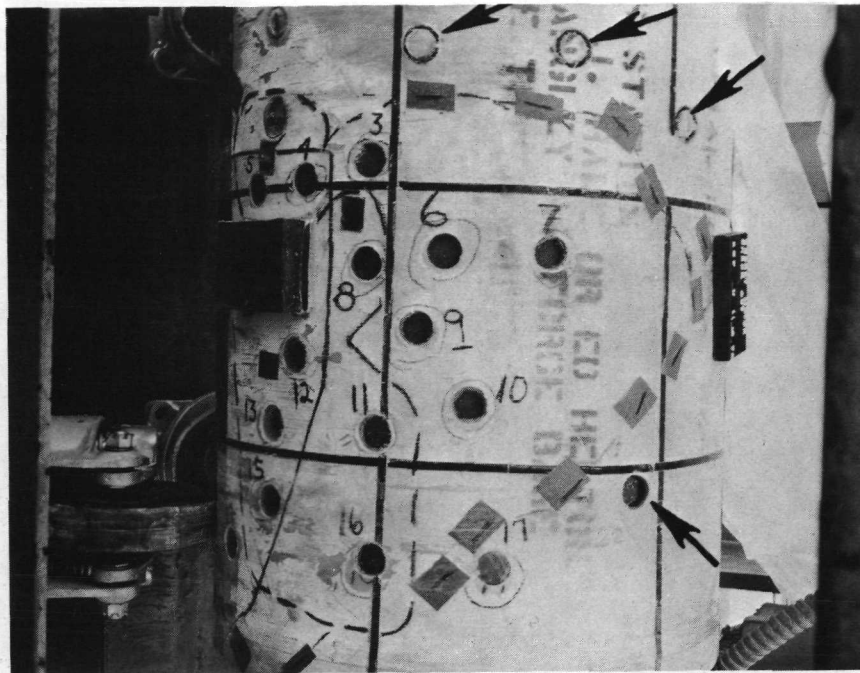
Fig. 78 Locations of Additional Penetration Cuts (Arrows) Made to Check Size of Separated Area Found by Inserting Feeler Gage into Holes Previously Cut. Top (3) were Bonded but Bottom Cut Revealed Void Between Liner and Propellant

Figure 78 shows, correlation at the top of the separated area was corroborated. However, the lower penetration cut did reveal separation between liner and propellant but it had not the typical gap. To pinpoint the boundary of the separation in the lower area, (2) additional cuts were sawed and their positions are indicated in Fig. 79.

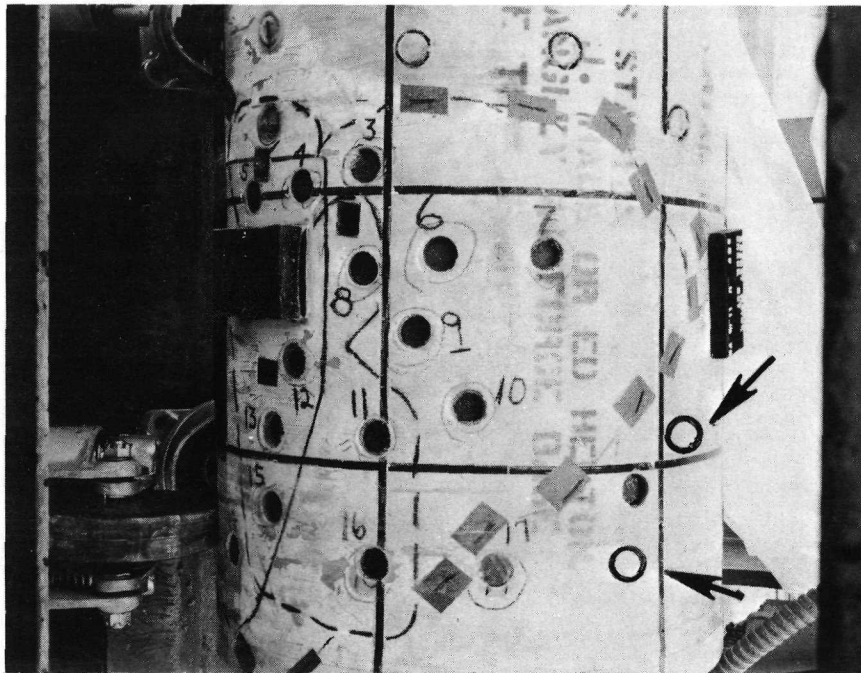
Fig. 79 Final (2) Penetration Cuts Made in Motor Casing to Check Extent of Liner/Propellant Separation

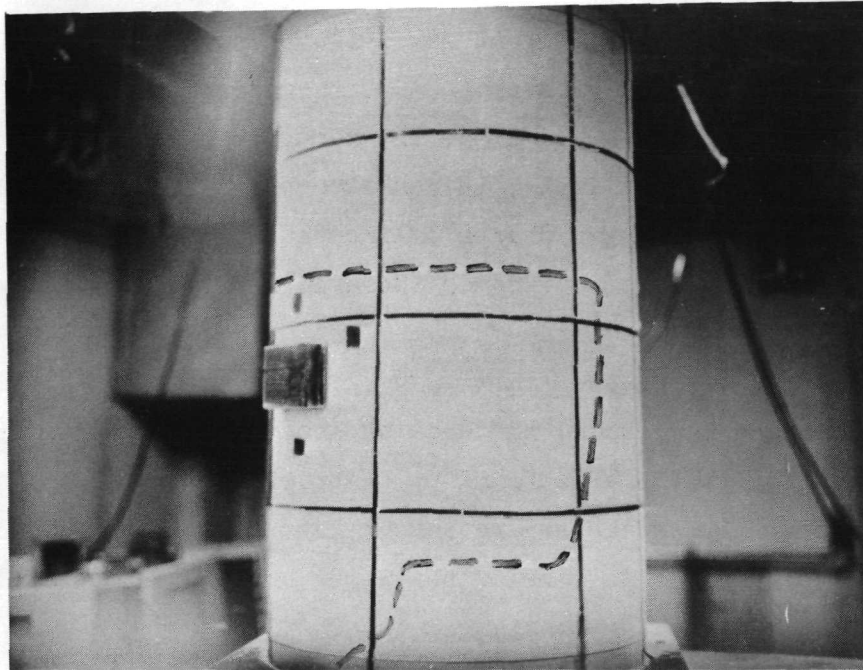
Fig. 80 Extent of Separated Line - Propellant Interface as Determined by Feeler Gage, Penetration Cuts and Surface Tapping of Motor Case S/N 424 in Area Studied by Holography

The actual disbonding condition cannot accurately be defined as a liner/propellant separation but should be considered a propellant void at the liner interface.
