LOCKHEED MISSILES & SPACE COMPANY, INC.
Manufacturing Research Investigation

LASER HOLOGRAPHIC
NONDESTRUCTIVE TESTING
OF
THE NASA X-248 ROCKET MOTOR

NASA Contract: NASI 11419

December 1972

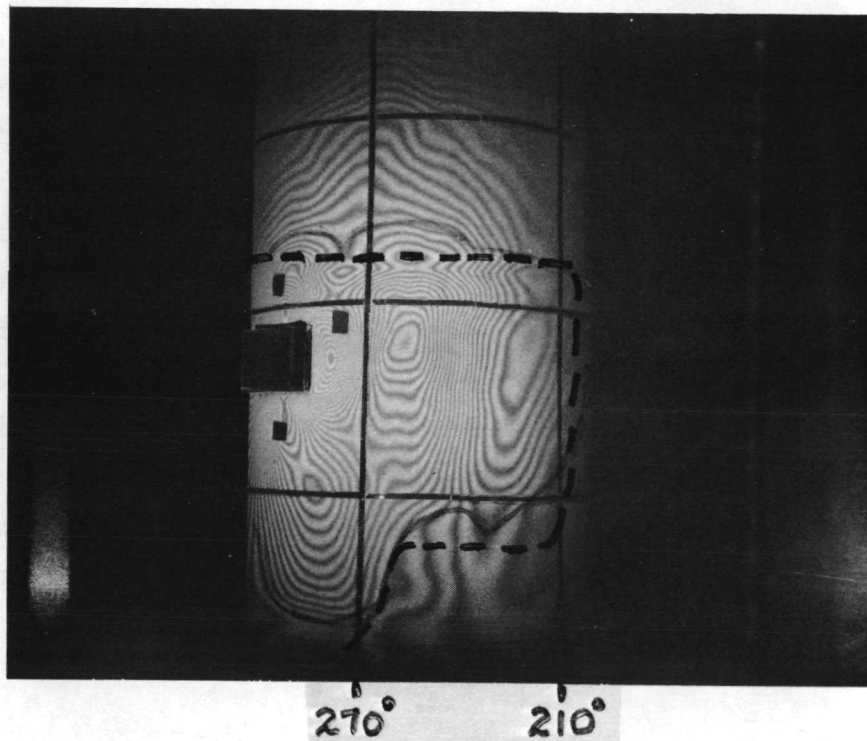
Fig. 81 Separated Area in Motor Casing Drawn in Dashed Line as Detected by Destructive Testing. Solid Line is Area Suggested As Separated by Fringe Pattern. Interference Field Resulted 2 min. After Radiating the Casing With A Quartz Lamp for 20 sec.

One of the holograms suggesting the area of separation is shown in Fig. 81. The dashed line represents the area found by destructive testing and the solid line indicates the boundary of the separation implied by the interference pattern. The acutely bent fringe lines just below the upper horizontal dashed line locate the termination of the liner.

Although the instantaneous strain pattern approximates the separated area found in destructive testing, an analysis of the cooling behavior in real-time viewing

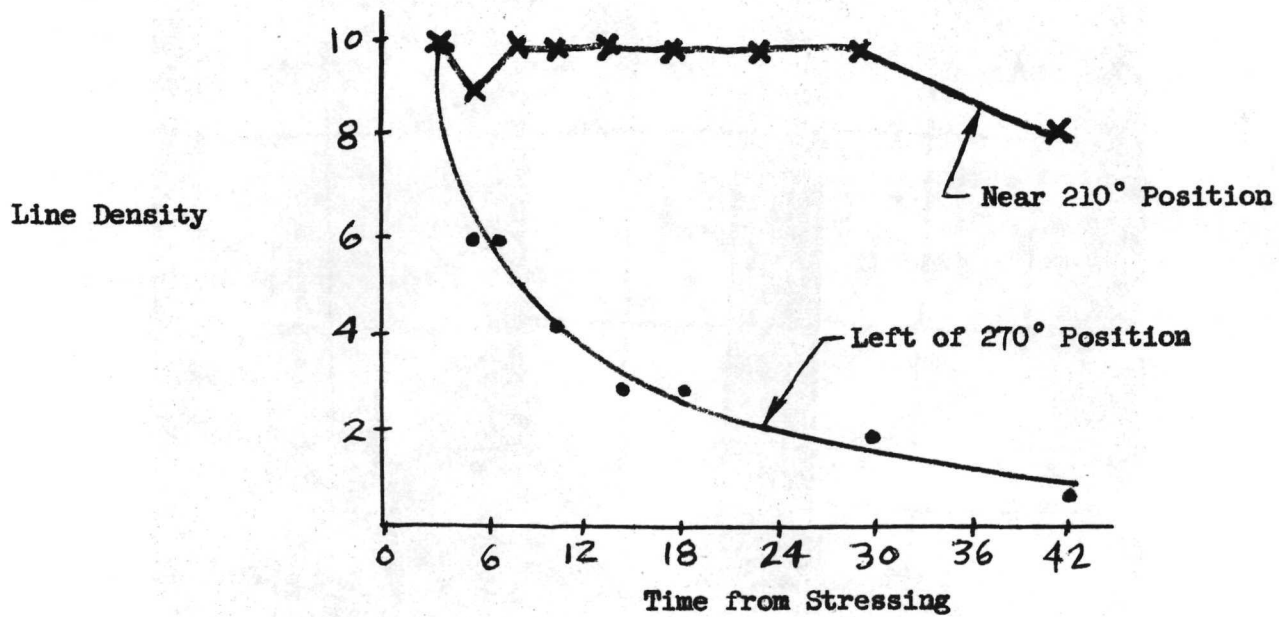
Fig. 82 Fringe Line Behavior With Cooling Time At Two Positions Found To Be Separated At the Liner/Propellant Interface In Destructive Testing

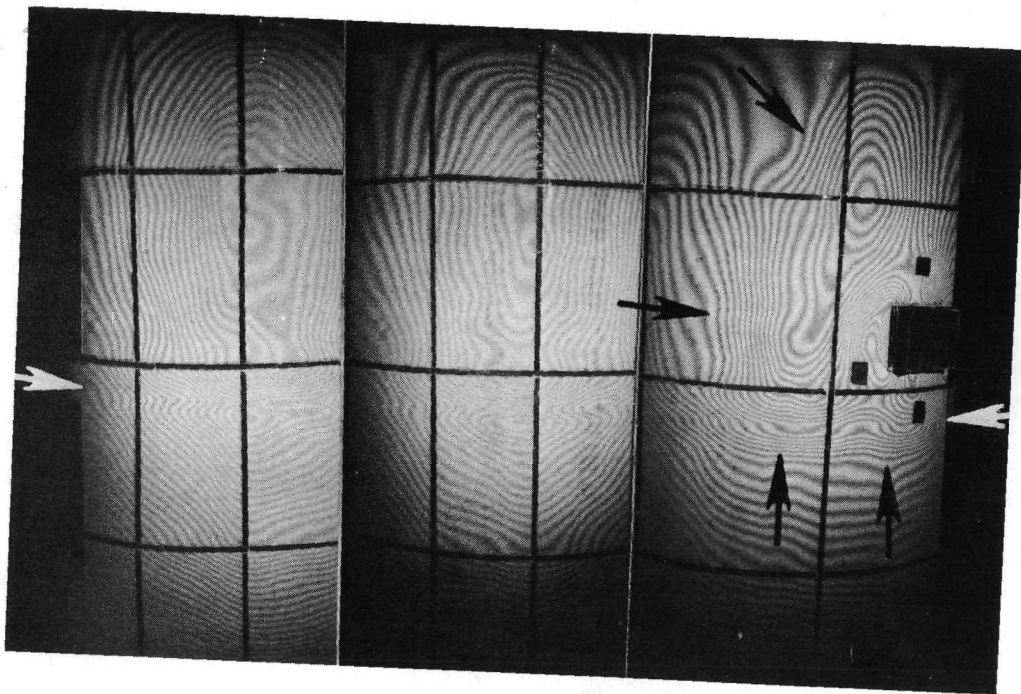
Fig. 83 Composite of Photographs Made Through Reverse Holograms.
Area Defined by Black Arrows Suggest SubSurface Separation
Centered At the 270° Position of Motor Case S/N 424.
White Arrows Show Plane of Liner Termination

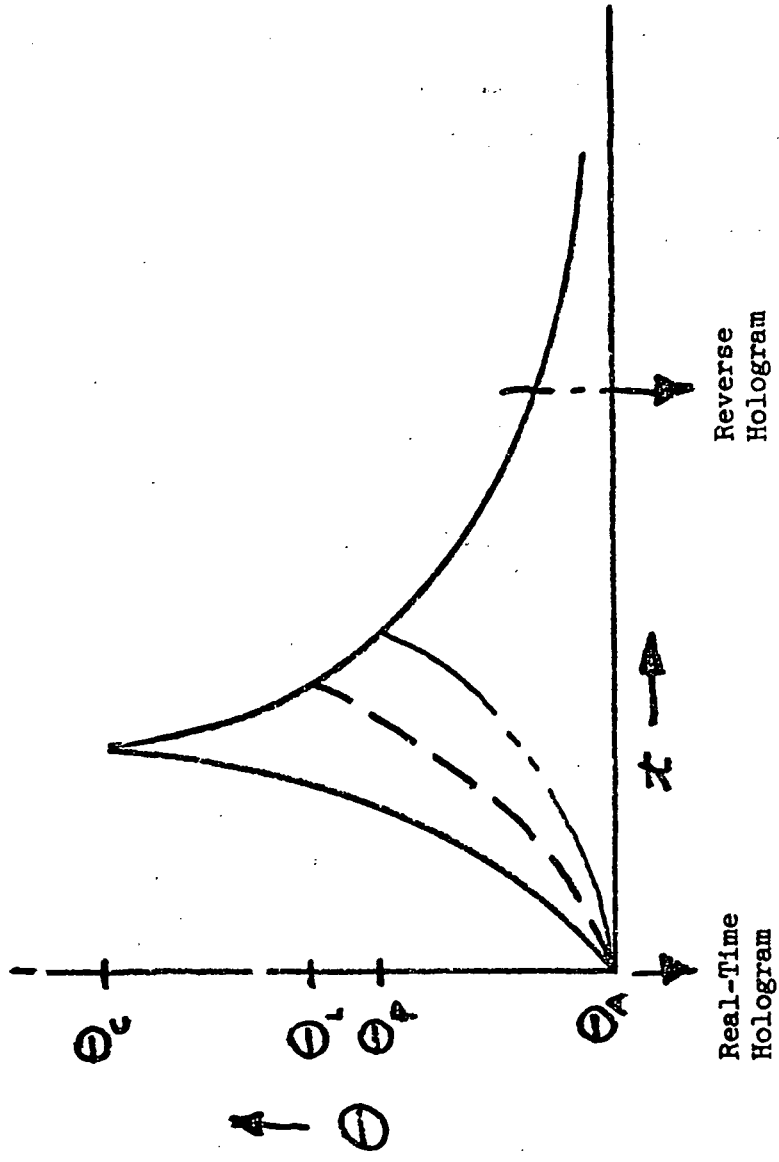
Fig. 87 Approximate Behavior of Temperature Vs Time in Motor Case and Estimate of Times When Real and Reverse Holograms are Made

Real-time holograms were exposed prior to stressing with the quartz lamp. After developing real-time holograms the motor was radiatively stressed and then the resulting interference patterns were observed through holograms. The interference fields observed were a function of the casing temperature at that instant. Since the casing temperatures generated surface displacement, the view or photograph through a real-time hologram is an instantaneous picture of displacement.

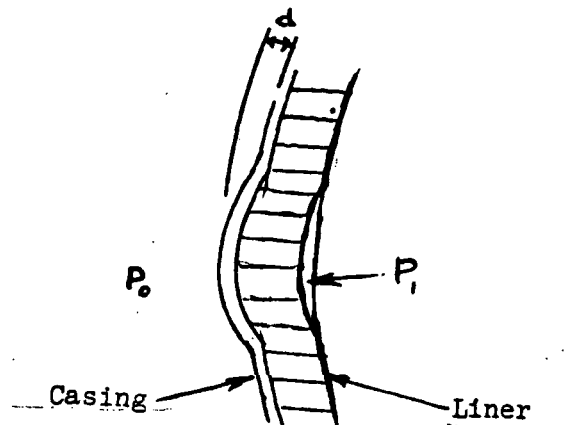
A second model involves the deflection of a disc caused by a pressure differential produced from a temperature rise.

In this model $P_1 > P_0$ results from the temperature rise in the entrapped air in the disbanded volume. The derived equation for deflection of a disc of radius R is:

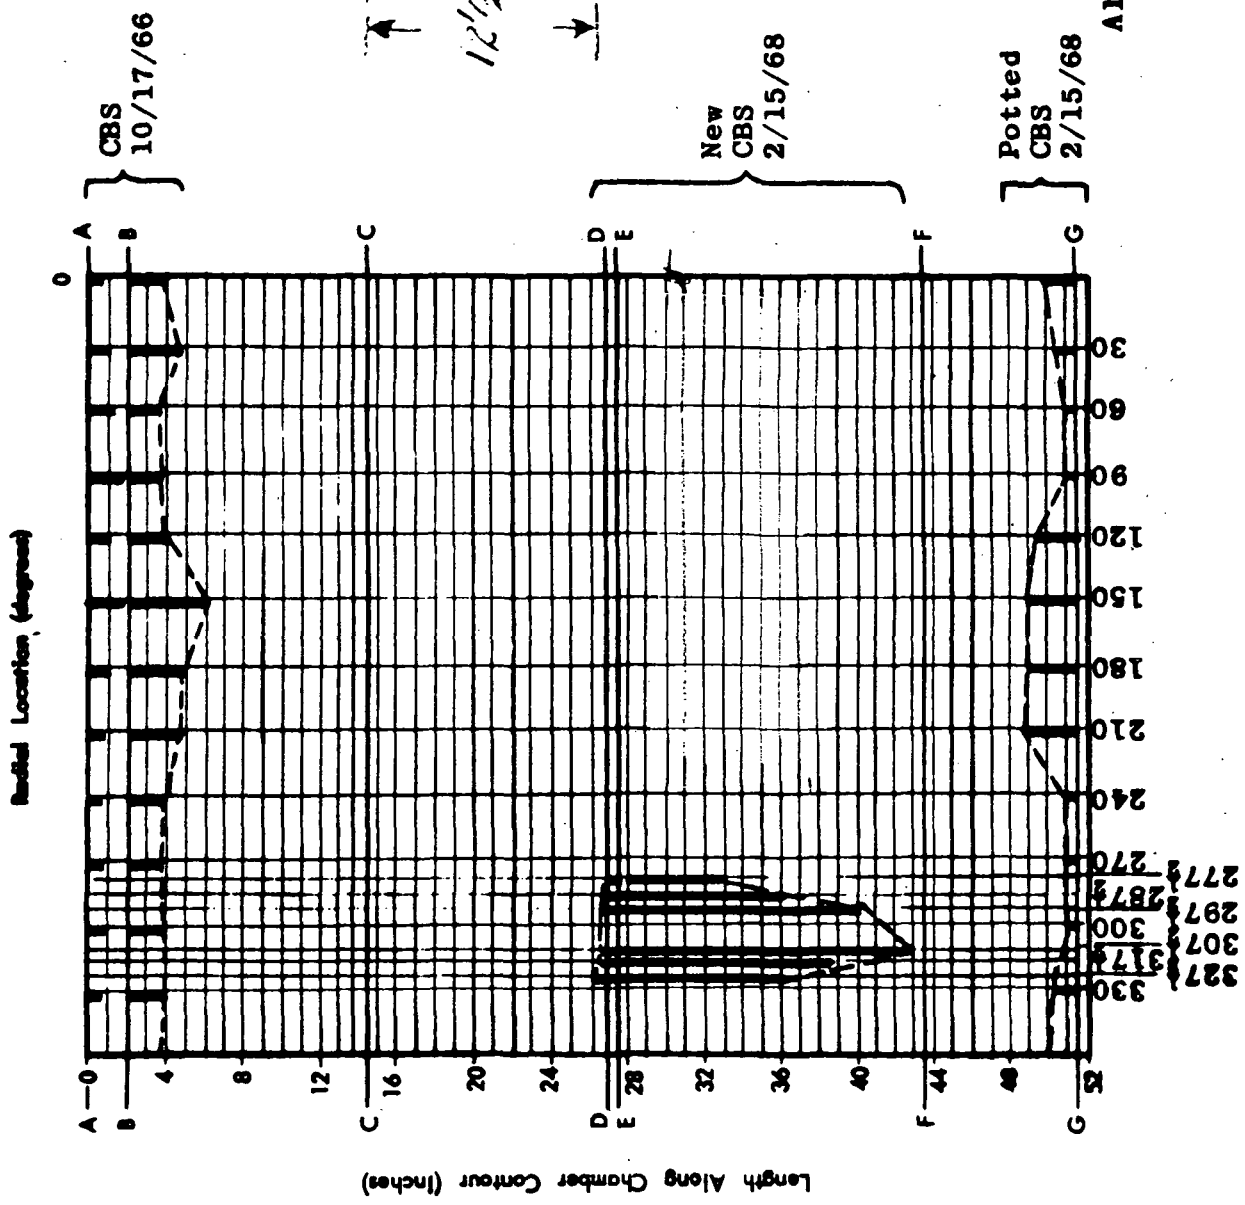
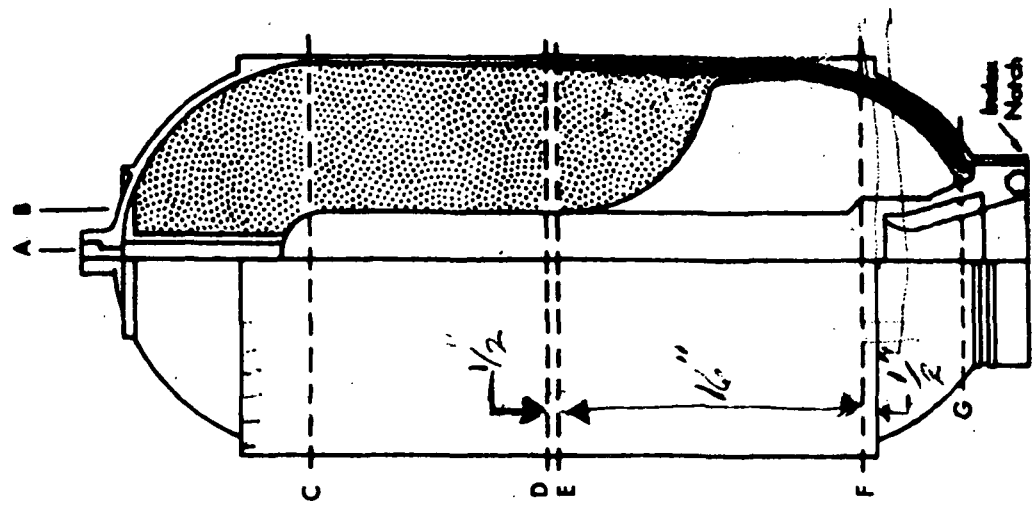
Figures 88 and 89

Motor No. **NPP-424**
 Date Inspected **As noted**

All measurements as seen on film.

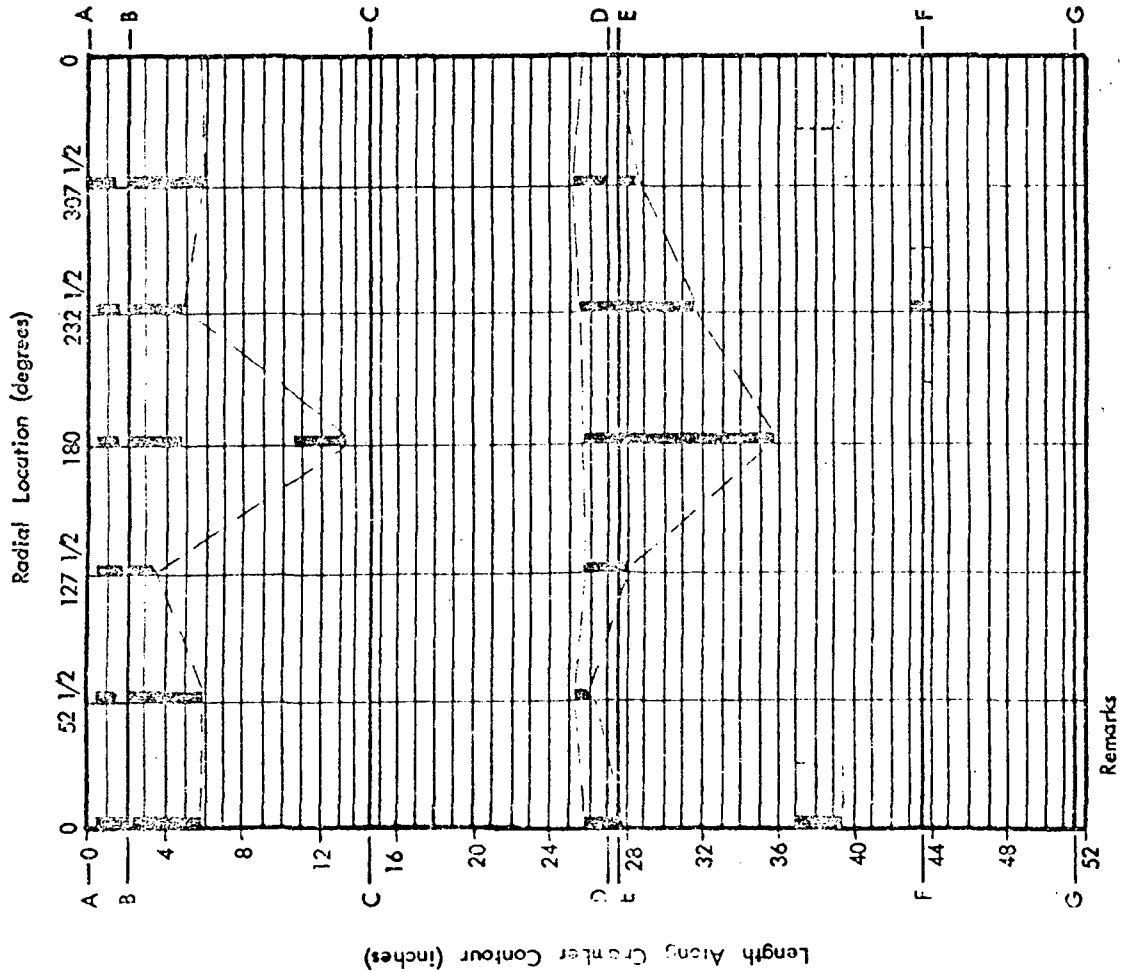
Fig. 89 Radiographic Inspection Record of Motor Case NPP-426
 Showing Areas of Liner/Propellant Separations
