DEVELOPMENT OF GAS-PRESSURE BONDING PROCESS
FOR AIR-COOLED TURBINE BLADES

K. E. Meiners, Program Director

BATTELLE
Columbus Laboratories

FINAL REPORT

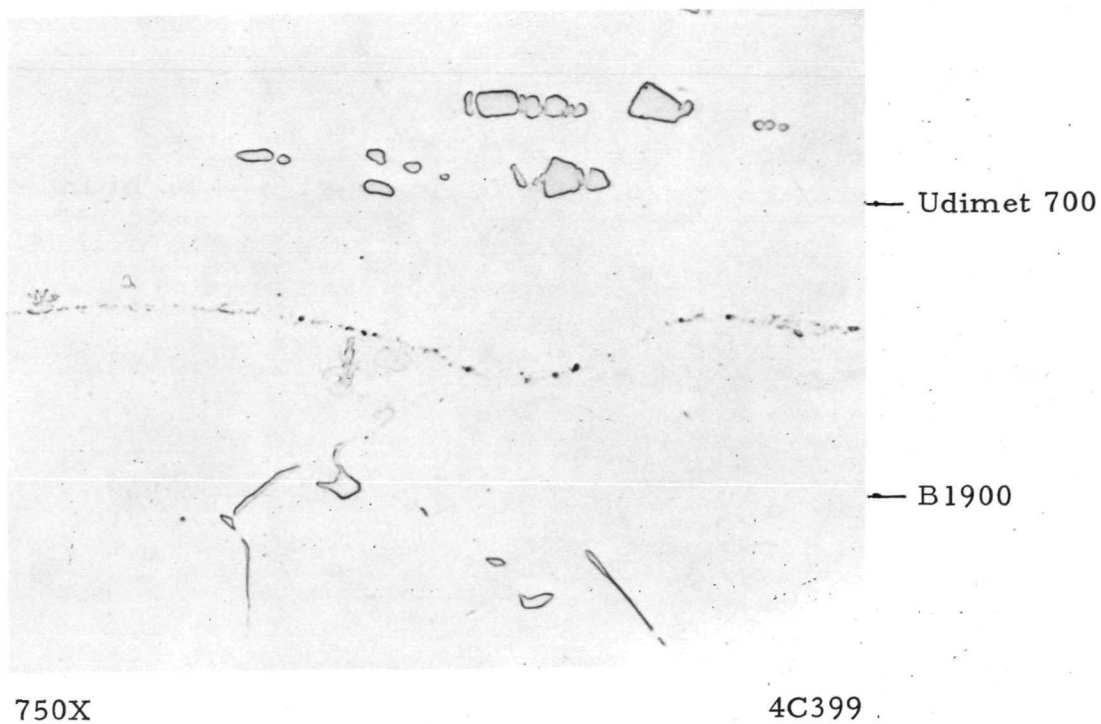
a. As Polished

b. Marble's Etch

FIGURE 27. B1900/UDIMET 700 DIFFUSION BOND PRODUCED AT
CONDITIONS OF 2200 F/10,000 PSI/3 HR

c. As-Polished View at Higher Magnification
