APOLLO 17 MISSION REPORT

LYNDON B. JOHNSON SPACE CENTER  
HOUSTON, TEXAS  
MARCH 1973

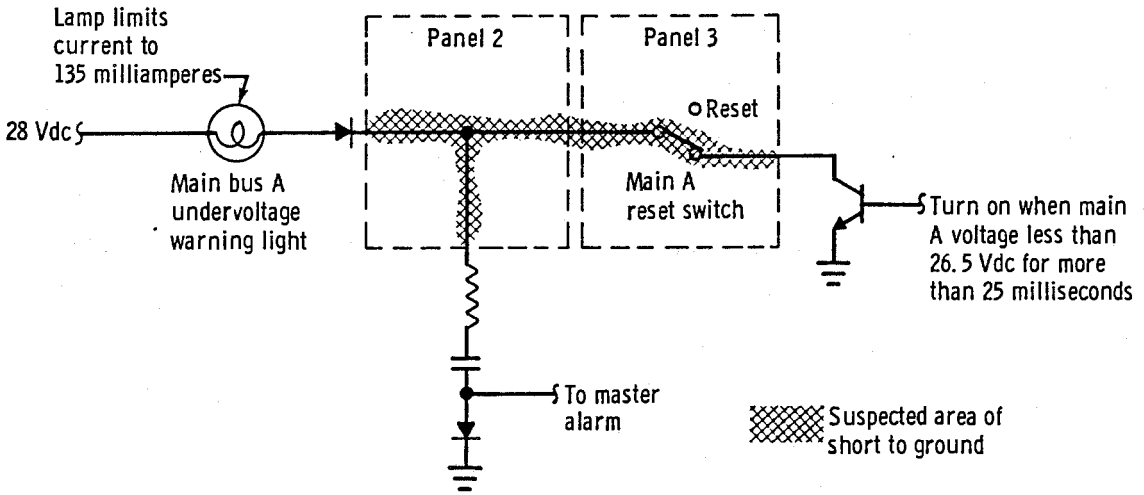
Figure 15-1.- Main bus A undervoltage warning circuit.

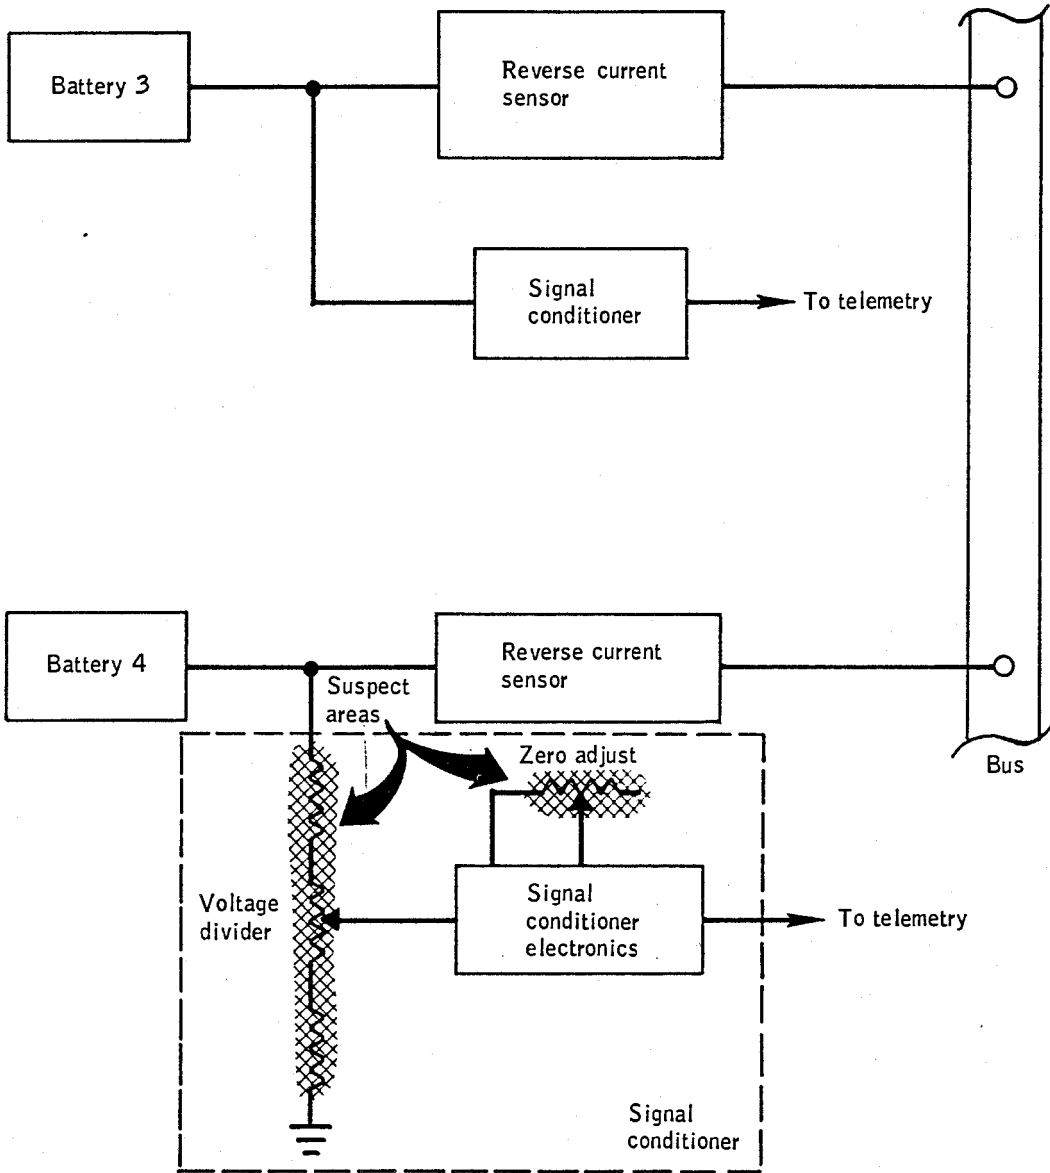
Figure 15-16.- Voltage measurement circuitry.

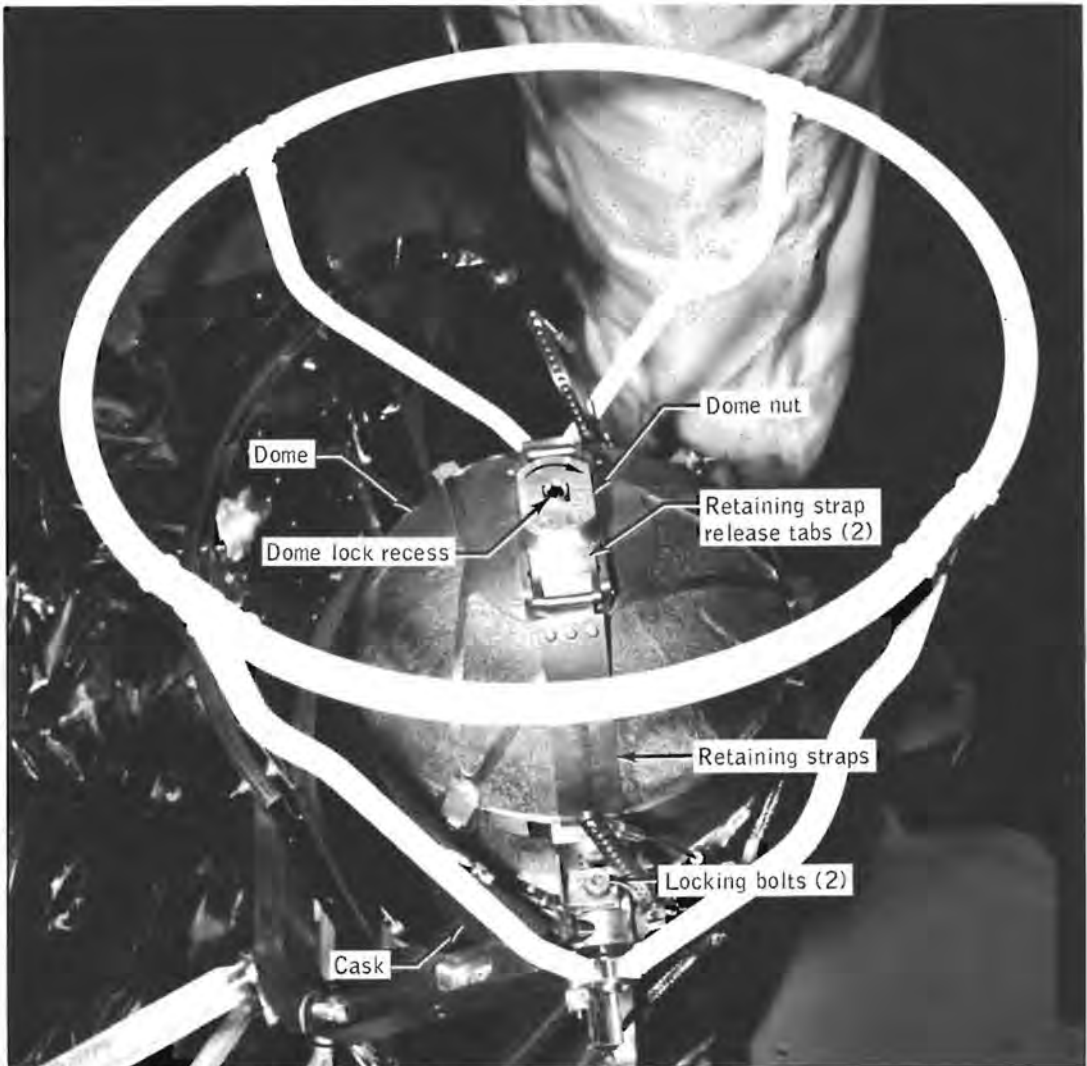
Figure 15-22.- Fuel cask dome release mechanism.

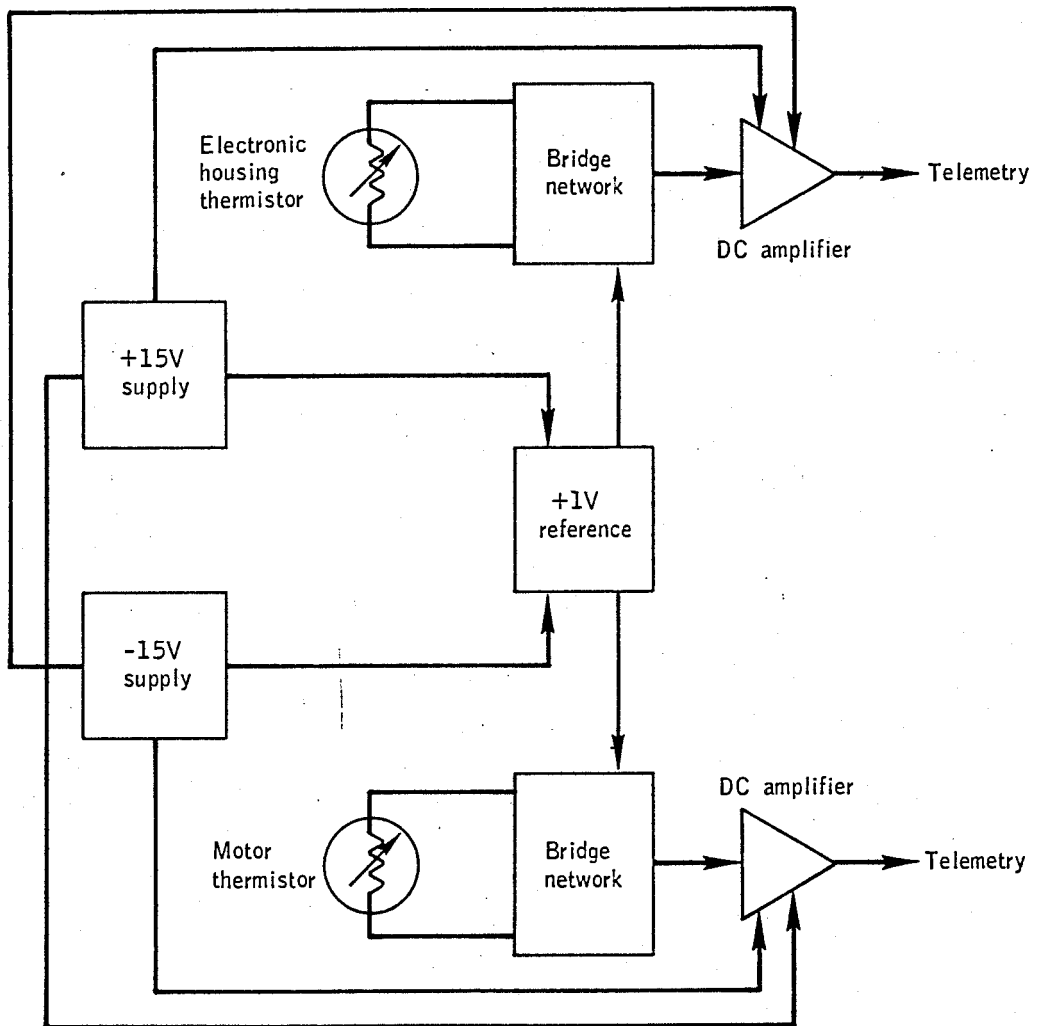
Figure 15-29.- Block diagram of ultraviolet spectrometer temperature sensing circuits.
