*Technical Memorandum 33-615*

*Mariner 9 Solar Array Design, Manufacture,  
and Performance*

*E. A. Sequeira*

**JET PROPULSION LABORATORY  
CALIFORNIA INSTITUTE OF TECHNOLOGY  
PASADENA, CALIFORNIA**

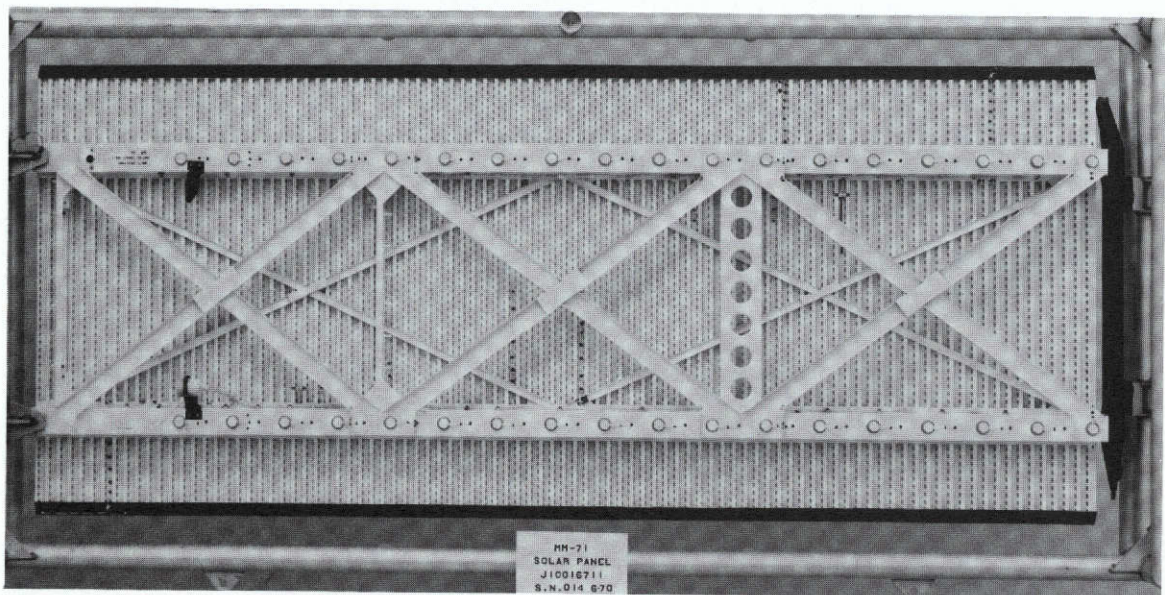
Fig. 1. MM-71 Solar Panel

The Mariner 9 solar panels were similar in construction to Mariner 6 and 7 panels except for a minor modification of attachment hardware to accommodate extended outriggers that were required to extend the solar panels further from the spacecraft bus. Maintaining the basic Mariner 6 and 7 design permitted the Mariner '71 program to utilize solar array spare hardware remaining from the Mariner '69 program. A total of seven new solar panel substrates were fabricated by Zero Manufacturing Company of Los Angeles, California. Two Mariner 6 and 7 residual panels were refurbished and requalified for the Mariner 9 program. A photograph of the panel structure is shown in Fig. 1. The substrate consists of (0.127 mm) aluminum alloy facing reinforced with lateral (0.0762 mm) corrugations which provide rigidity across the panel. Two spar assemblies extended across the length of the panel along with cross members, which was required for increased torsional rigidity, make up the main structural support of the units. The face sheet and the corrugations are bonded to the spar assembly with Shell Epon 913 epoxy adhesive. The spar beams supported the zener diodes and provided the heat sink necessary for diode temperature dissipation. During launch the four panels of the Mariner 9 solar array are tip-latched together as shown in Fig. 2. After injection into space, the latches are released through pyrotechnic activation and the panels are deployed through a deployment damper mechanism located on the panel outrigger assembly.

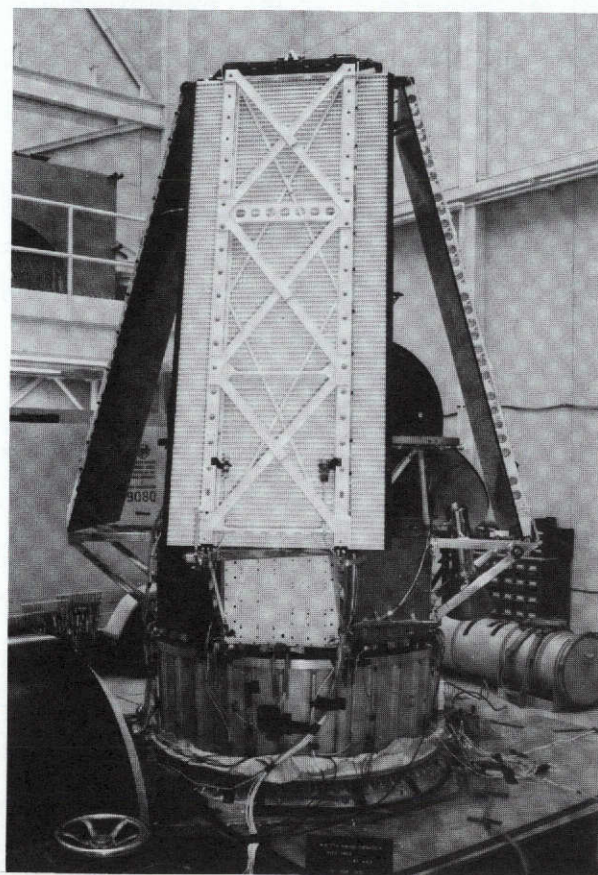
Fig. 2. Spacecraft With Solar Panels Tip-Latched

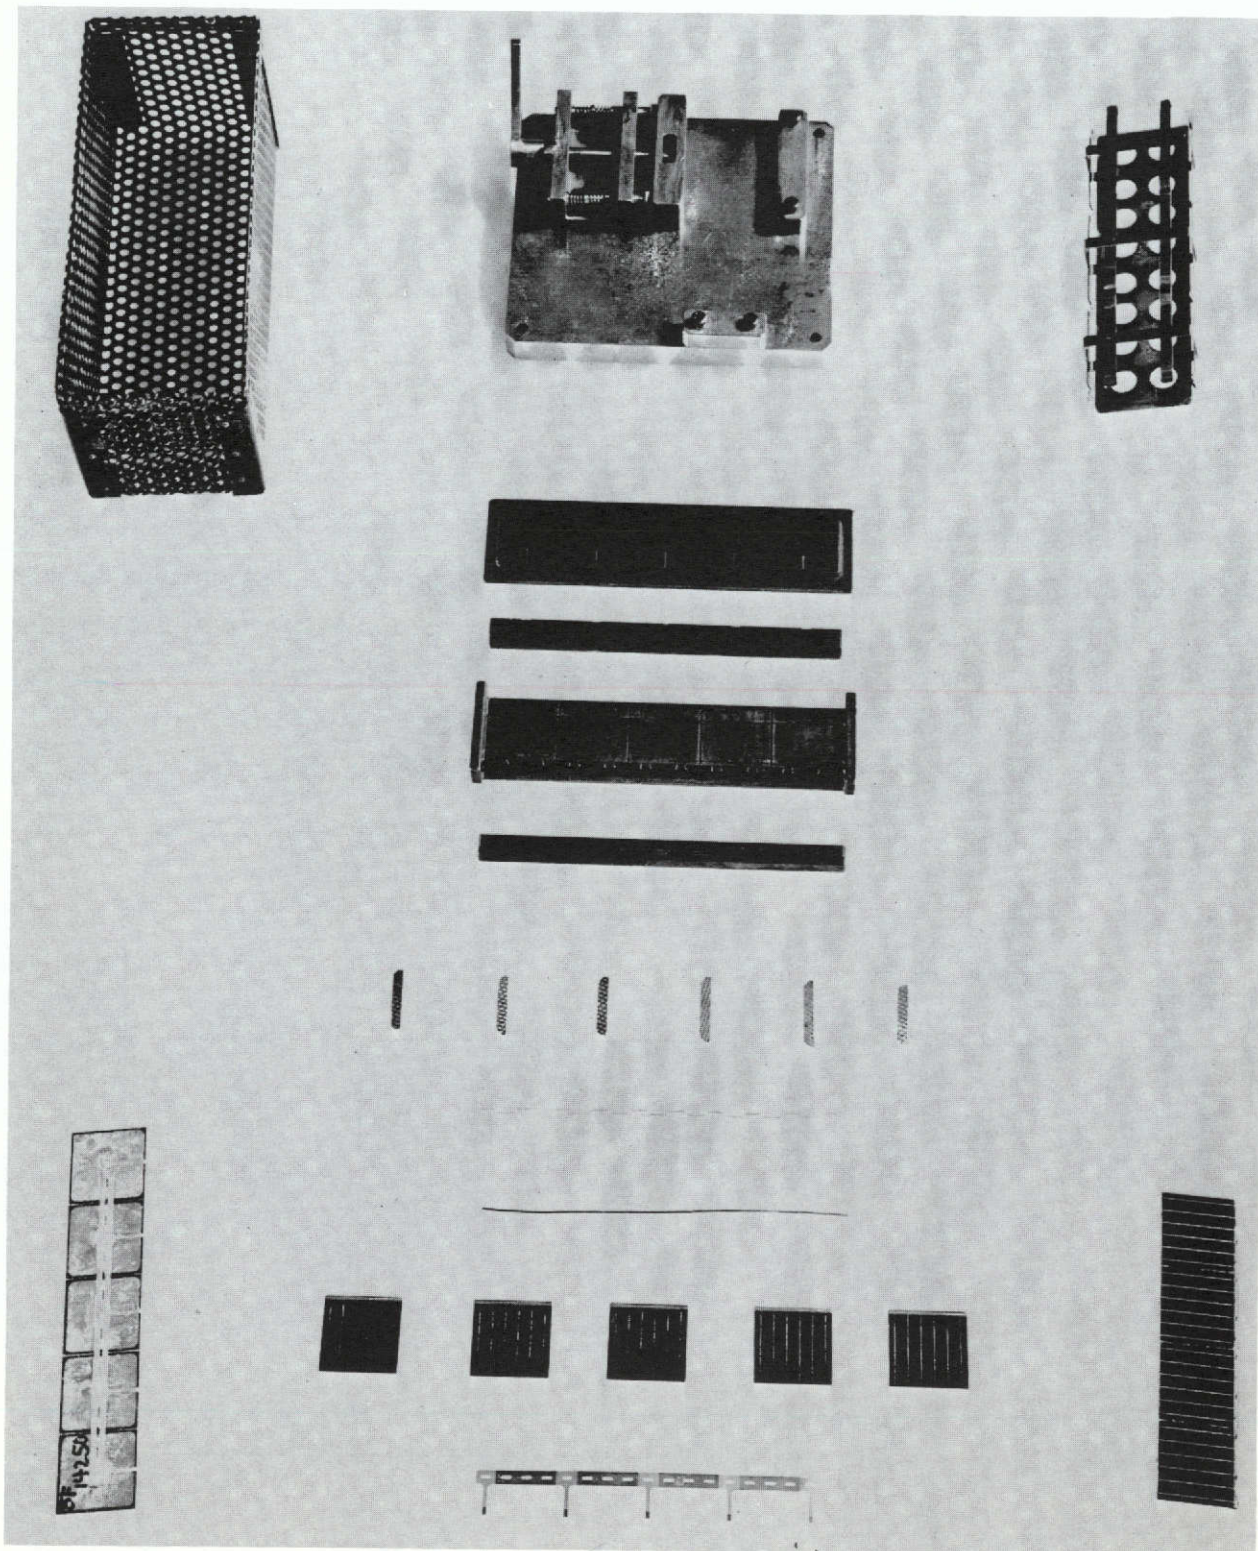
Fig. 3. Soldering Fixture and Submodule Assembly

One of the more significant differences between the Mariner 9 and the previous Mariner program was the redesign of the soldering fixture which was greatly improved and simplified. The following improvements were incorporated into the Mariner 9 tunnel oven submodule soldering fixture design:

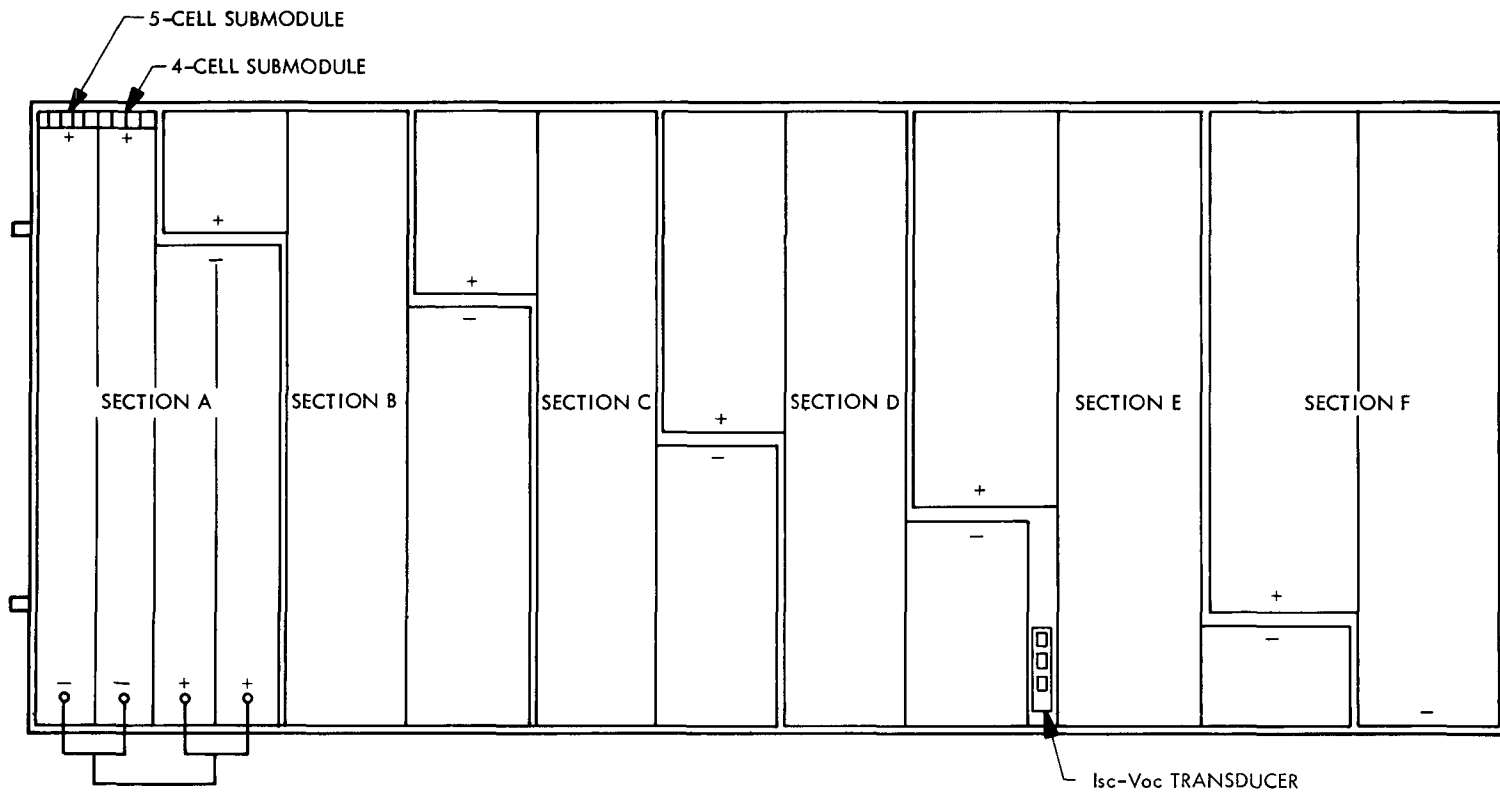
Fig. 4. Solar Panel Layout

The Mariner 9 solar panel was fabricated by Electro-Optical Systems of Pasadena, California. The solar panel layout is shown in Fig. 4. The layout is identical to the solar panel layout of Mariners 6 and 7. The selected configuration utilizes the maximum available panel area, provides increased reliability by employing the string folded concept and a decrease of magnetic fields by placing adjacent current paths to flow in opposite directions. The solar array

of the four solar panels were designed into 24 isolated electrical sections. Connected in parallel were 224 cells and 78 cells connected in series. The individual panel was configured in six isolated electrical sections. Each section consisted of two strings made up of 4- or 5-cell submodules. Silicone rubber adhesive RTV-41 manufactured by the General Electric Company was used to bond the submodules to the substrate. The end wires of the electrical sections were soldered to specially designed terminal circuit boards. The boards consisted of a flat copper conductor produced by chemical etch, bonded to the fiber glass epoxy boards. Feedthrough holes in the substrate directed the wires to the backside of the panels and were routed to the Bendix type DS311-22-55S connector. The wiring harnesses of the solar panels were prefabricated on a mock-up board. This approach was used to reduce possible damage to the panel substrate. The harness was installed on the panel and secured to the main spars by cable clamps.

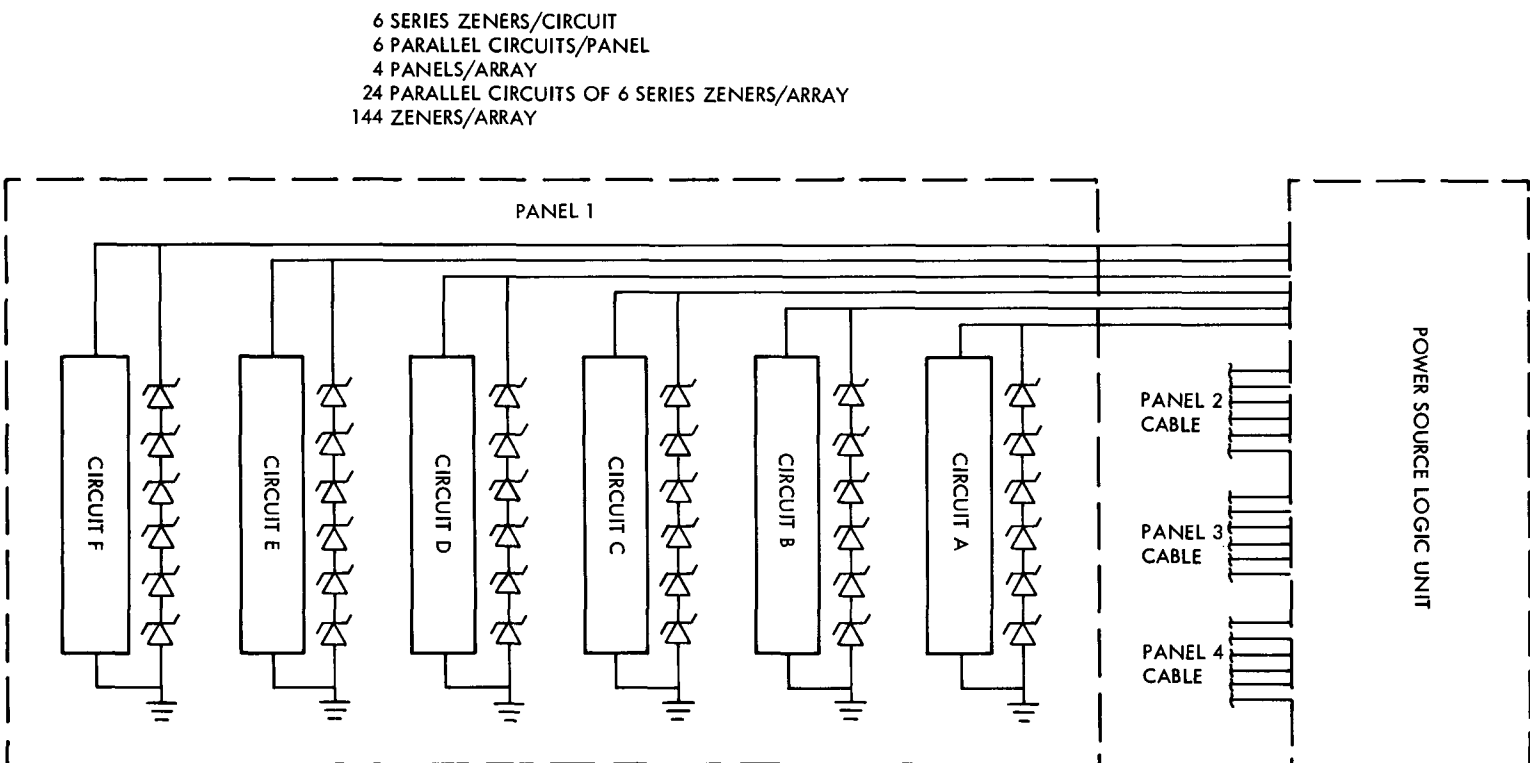
Fig. 5. Mariner 9 Solar Array-Zener Diodes Schematic

The flight configuration of the Mariner 9 solar array shunt regulator required six Dickson DZ30808G zener diodes connected in series for each electrical section of a panel as shown in Fig. 5. Since there are six parallel sections per panel and four panels per array, there are a total of twenty-four parallel circuits of six series zeners per circuit or a total of 144 zeners per array. The diodes are mounted and torqued to the underside of the panel box beam spars that provide the heat sink for diode temperature control. The diodes are screened to provide a rated value of 8.25 volts plus or minus 2 percent at one ampere and 90°C stud temperature. A series string of 6 of these zeners was utilized to limit the voltage output of each panel electrical section to less than 51 volts. The thermal and electrical characteristics of each six zener diode series string, developed using composite I-V characteristics of the twenty-four parallel circuits of zeners as a function of spar temperature at one ampere, are seen to be 0.0213 volts/°C. Thermal analysis of the Mariner 9 solar panel design shunt has shown that the spar temperature (where the zener diodes are mounted) would be lower than the solar cell temperature by approximately 15 degrees and that the difference will vary as a function of solar intensity incident on the solar cells. This relationship is presented in Fig. 6.

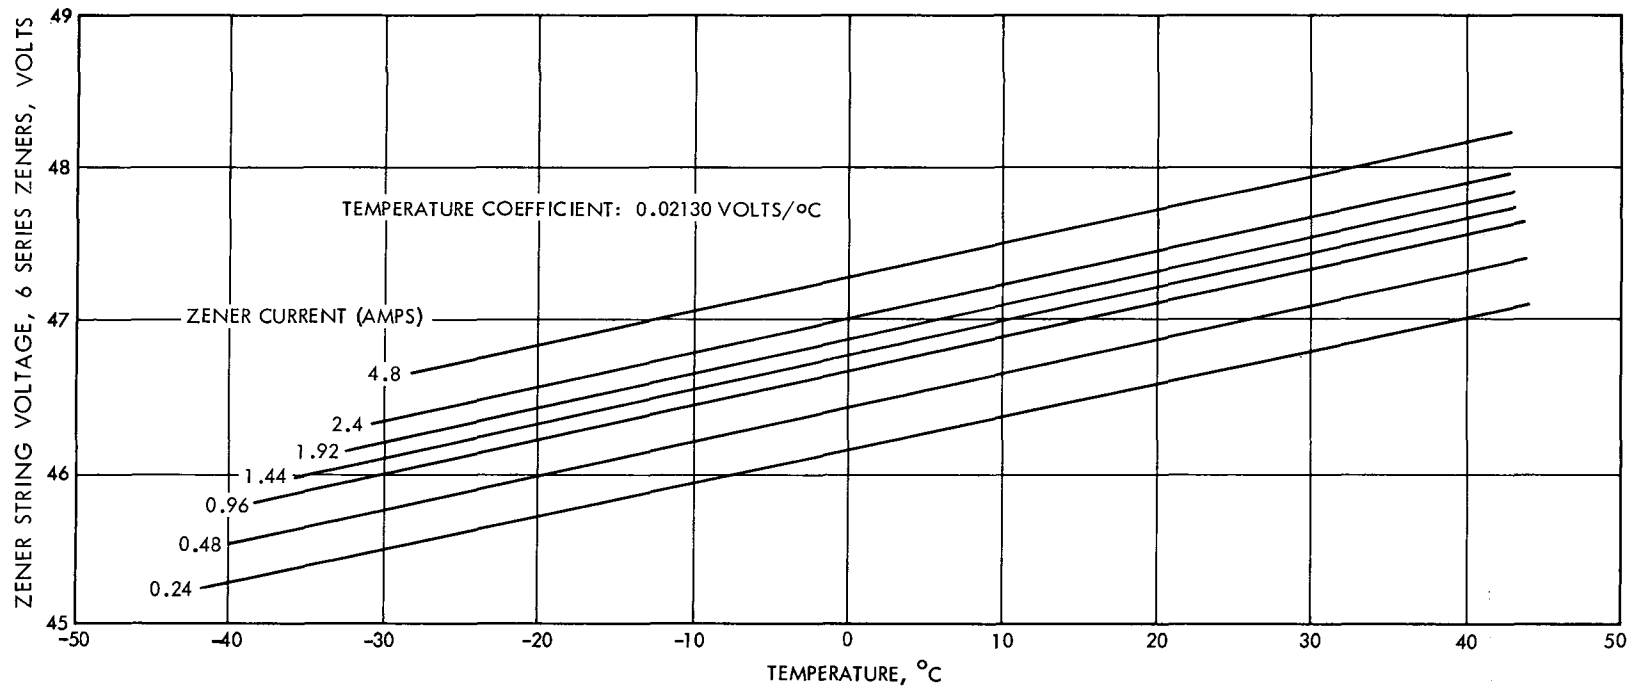
Fig. 6. Zener Diode String Voltage as a Function of Spar Temperature for Different Zener Currents

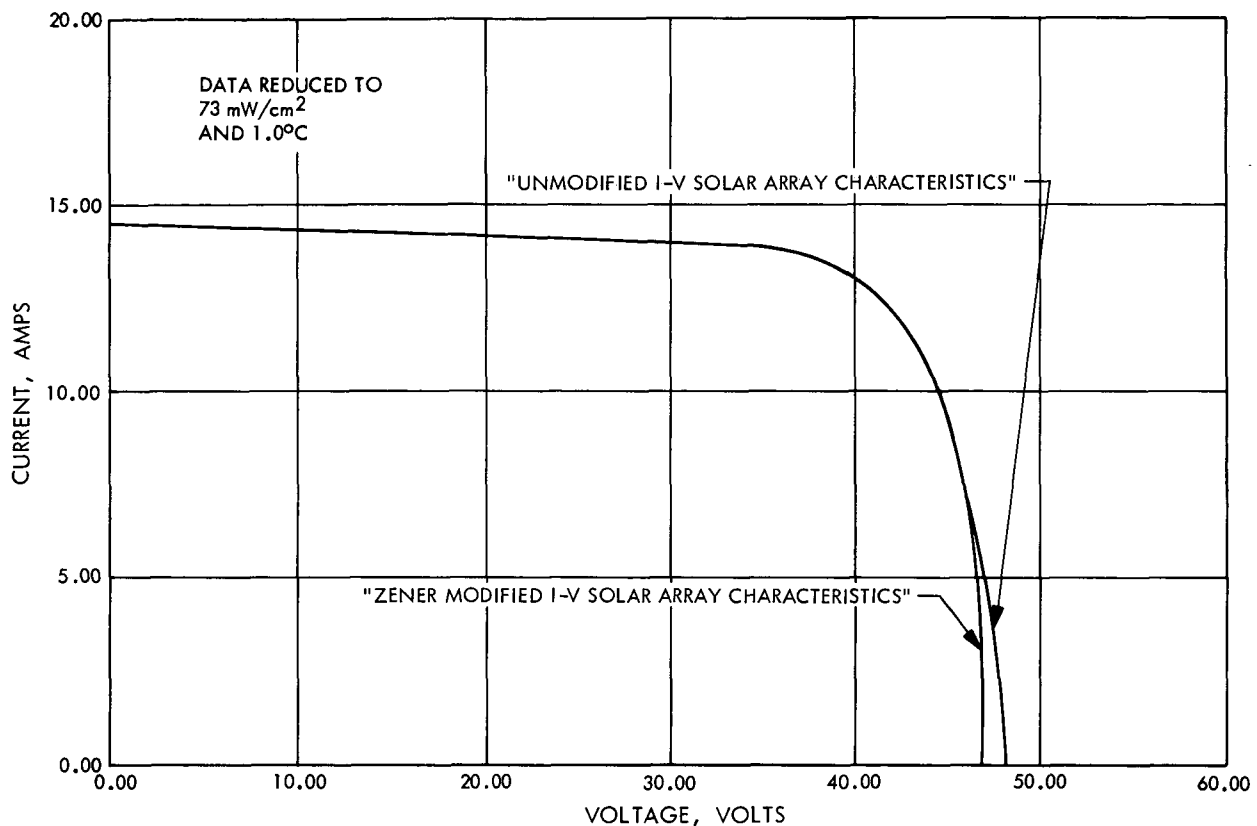
Fig. 7. Mariner 9 Anticipated Array Performance for Day 141 of Mission Showing Effects of Zener Regulation on I-V Characteristics

Figure 7 shows an example of the effects of zener regulation on the solar array I-V characteristics. This example would correspond to the anticipated electrical output characteristics of the Mariner 9 array on day 141 of the mission.

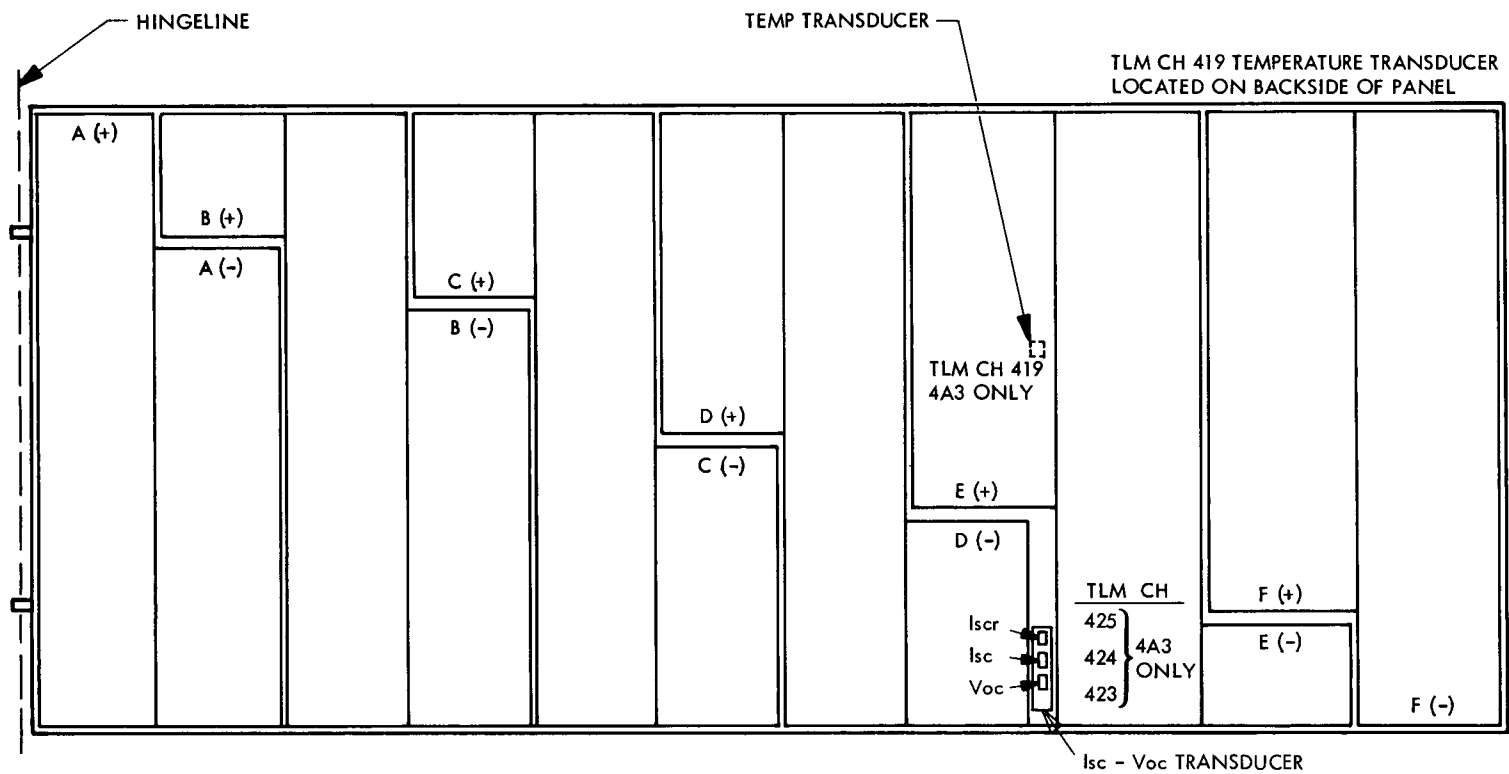
Fig. 8. Locations of Isc-Voc and Temperature Transducer on Mariner 9 Solar Panel

- (1) Temperature transducer. Transonic T-4242 transducer located on the backside of the plus Y solar panel provided information on the solar panel temperatures. The location of the transducer is shown in Fig. 8. Due to the similarity of Mariner 9 to Mariners 6 and 7 and the knowledge gained from Mariner 6 and 7 flight, the Mariner 9 solar array temperatures were predicted to within 2°C of actual flight data. Figure 9 shows predicted panel temperatures versus actual flight temperatures. The Mariner 7 solar panel had two transducers, one located on the inboard and the other on the outboard section of the panel. Measurements from the transducers indicated that the thermal excursion across the panel was approximately 2°C. It is assumed that Mariner 9 panels experienced the same type of temperature spread.

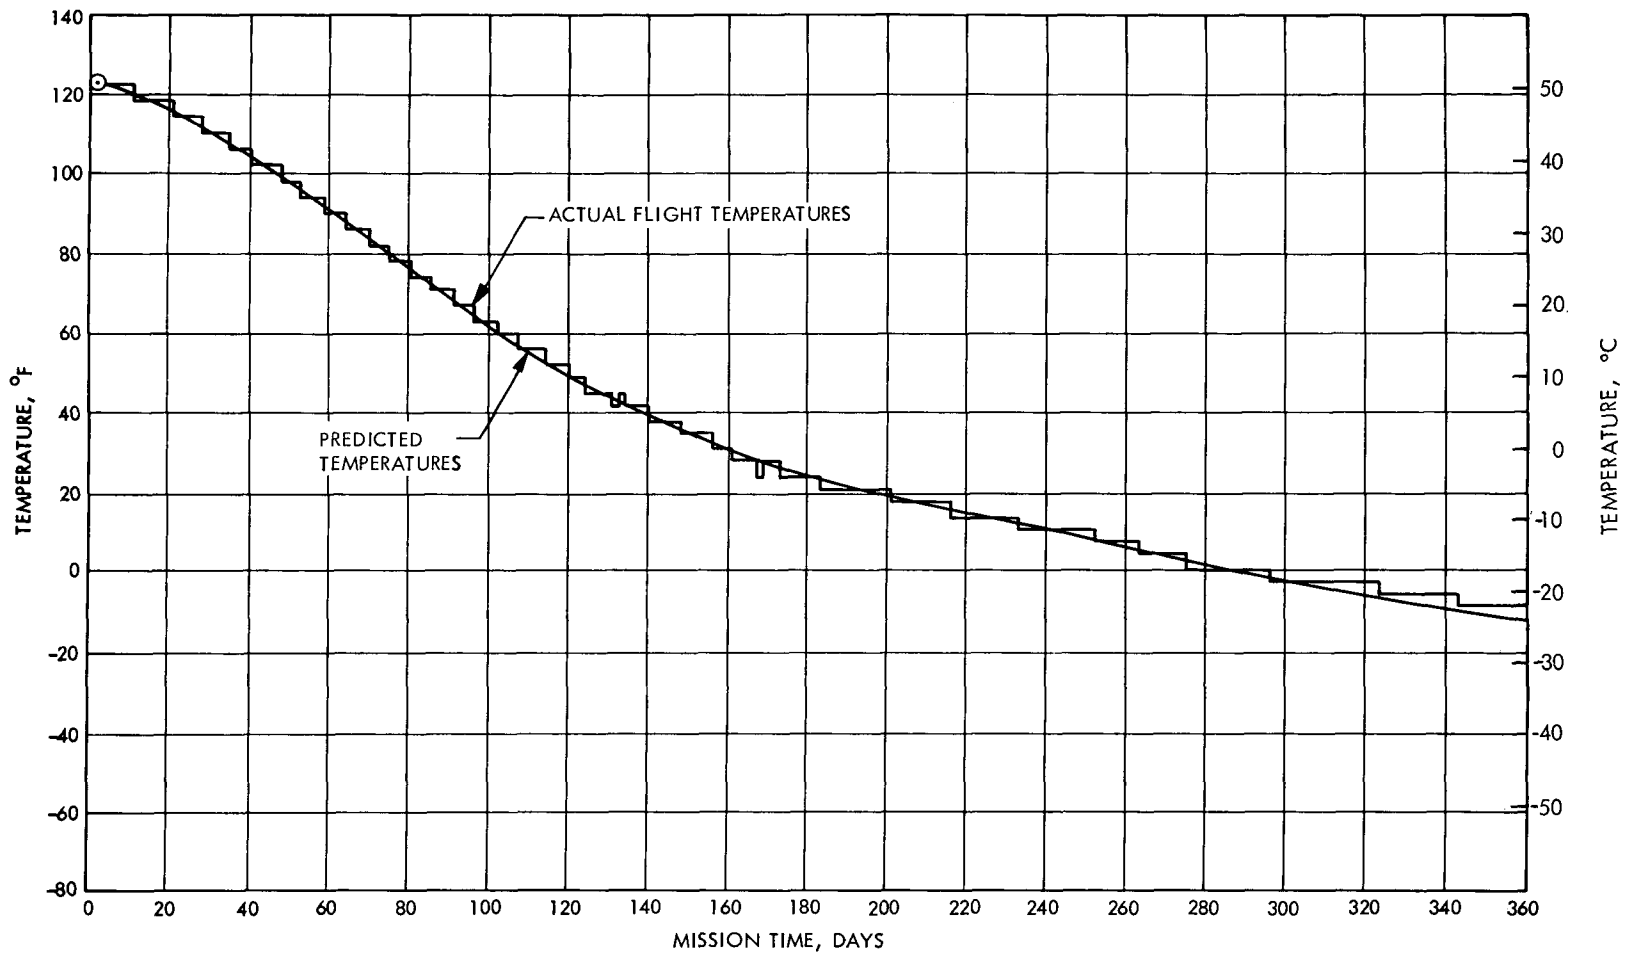
Fig. 9. Solar Panel Temperatures Recorded by Channel E419 Outboard Temperature Transducer

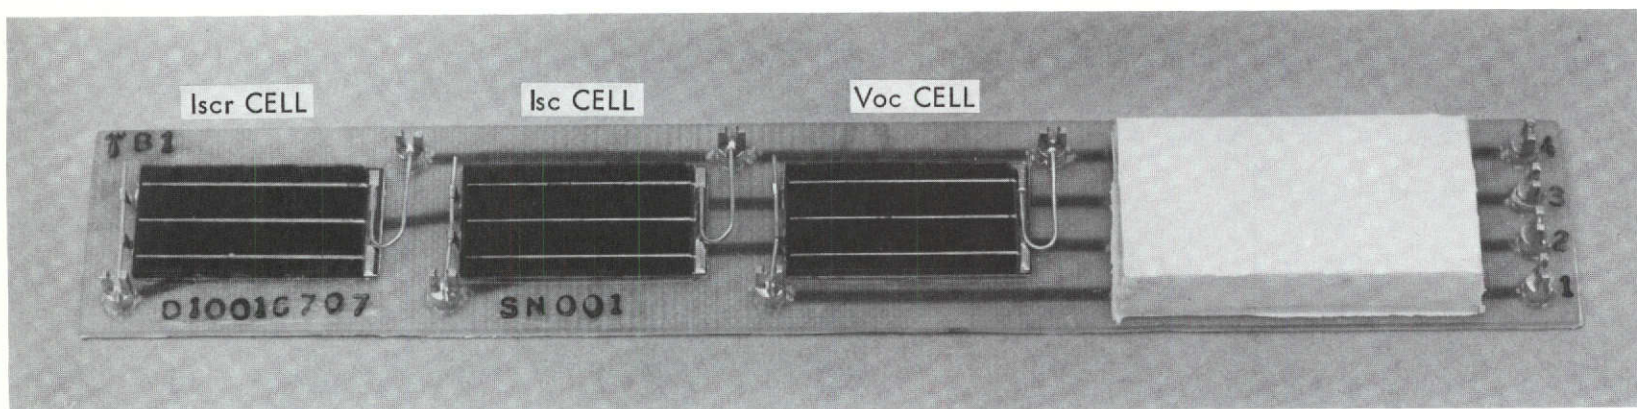
Fig. 10. Mariner 9 Isc-Vco Transducer Assembly

- (2) Isc-Voc Transducer. The Isc-Voc transducer provided pertinent engineering information utilized in evaluating solar array performance during the mission. The utilization of Isc-Voc transducers on solar panels dates back to the Mariner 64 mission. The transducer consists of three standardized solar cells representative of the cells used to fabricate the solar panels. A number of improvements were made since Mariner 64 transducers, both in fabrication and calibration techniques. Prior to Mariners 6 and 7, the transducer resistive loads were located on the backside of the panels. Mariner 9 Isc-Voc transducer, like Mariners 6 and 7, incorporated all components on one fiberglass printed circuit board and the resistors were encapsulated in RTV 41 for protection against UV radiation damage. Figure 10 shows a photograph of this Isc-Voc transducer assembly.

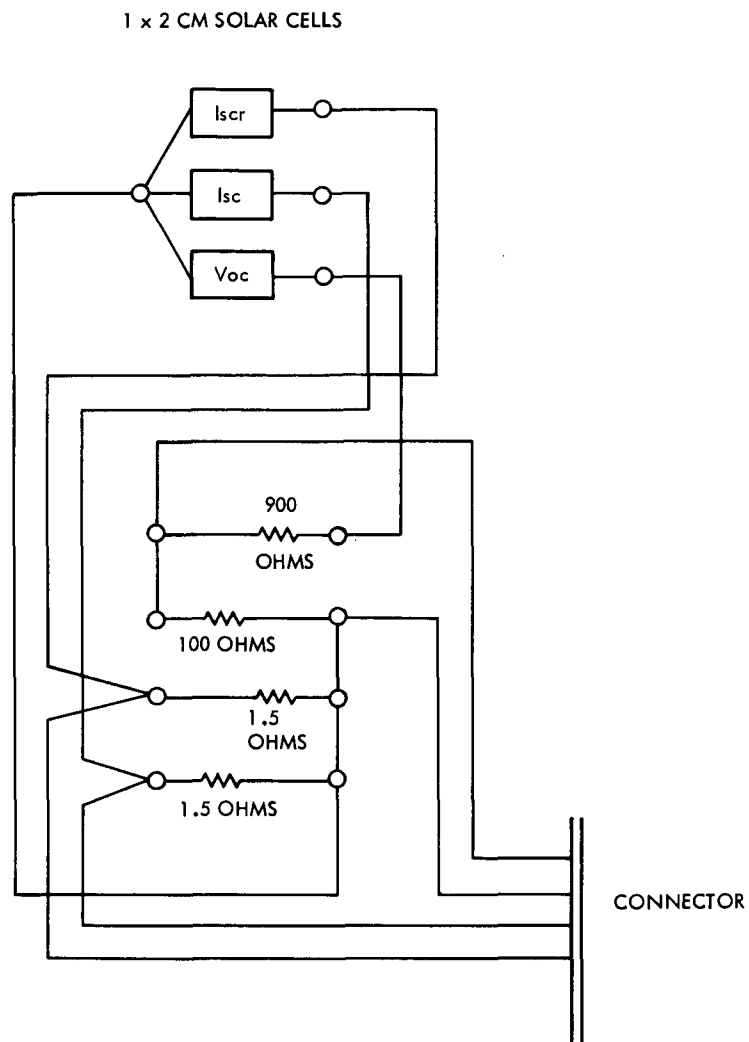
Fig. 11. Schematic Diagram of I<sub>sc</sub>-V<sub>oc</sub> Transducer

The cell resistors load two of the cells near their short circuit current (1.5 ohms) and one cell near its open circuit voltage point (1000 ohms). A schematic of the electrical connection is shown in Fig. 11. The two current cells differ in that before launch one cell is exposed to a dose of  $1 \times 10^{16}$  e/cm<sup>2</sup> 1 MeV electrons which degraded the short circuit current output of the cell by approximately 50 percent and render it relatively impervious to further radiation damage as may be generated in flight by solar flares. Observation of the undegraded Isc and Voc cell then gives an indirect technique to aid in the assessment of the array short circuit currents and open circuit voltage. Comparison of performance between the degraded and the undegraded Isc cell provided information on space environments which may be degrading the array.

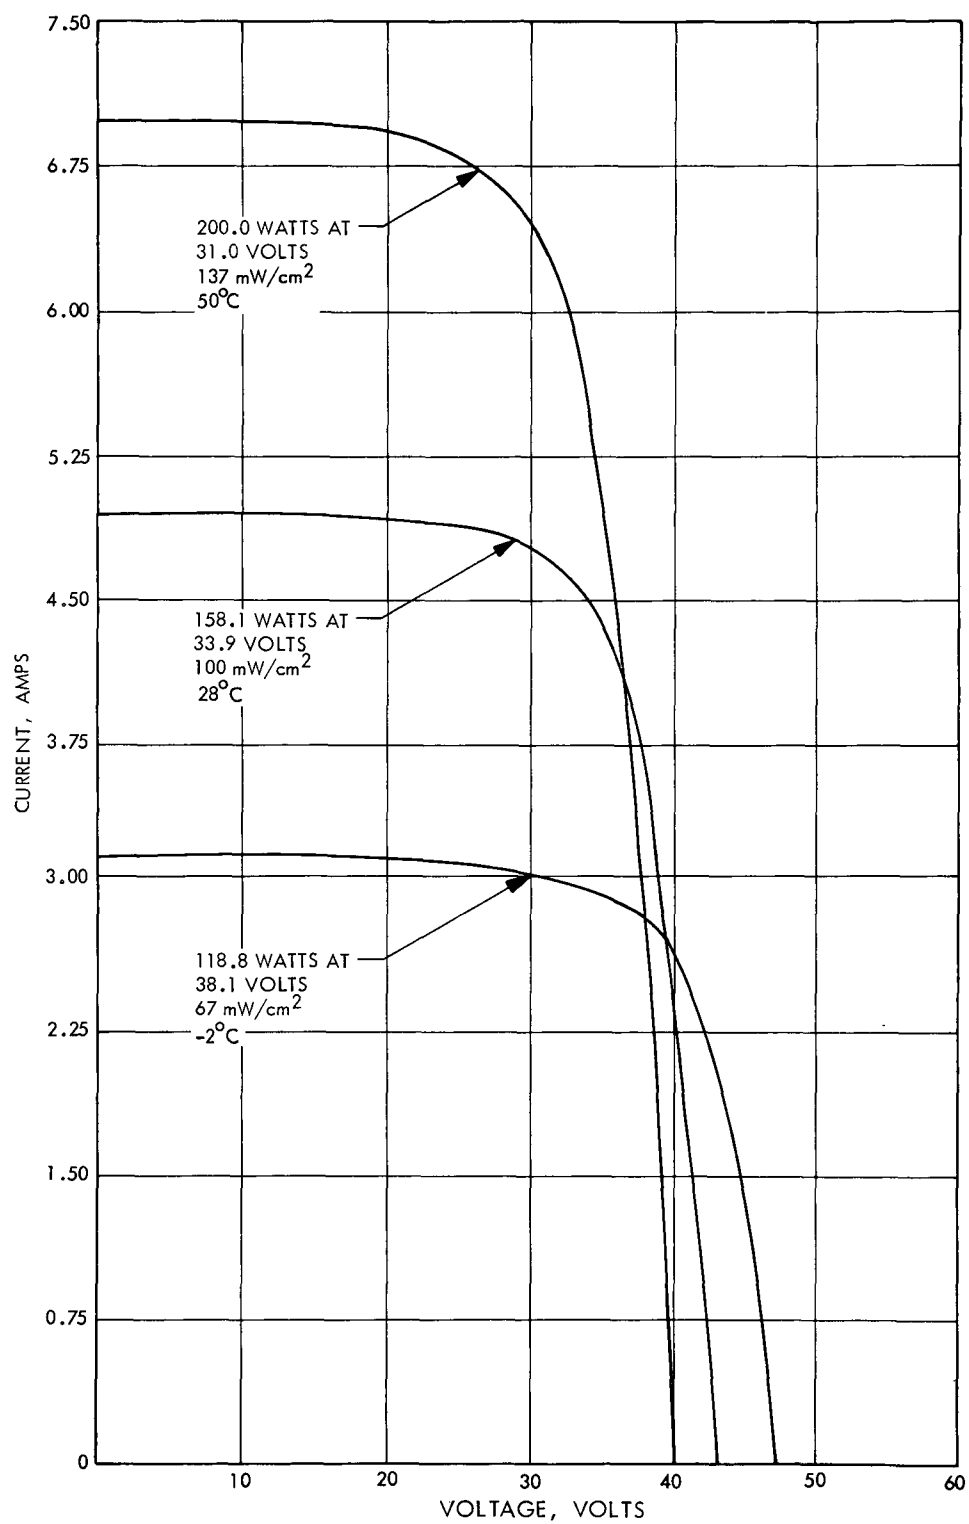
Fig. 12. Predicted Solar Panel Output for Launch, Midcourse and Mars Encounter

The estimated solar panel outputs when measured at Table Mountain with the data reduced to launch, midcourse and Mars encounter conditions are shown in Fig. 12. The actual test results of the panels measured before and after the environmental qualification tests are presented in Table 4.

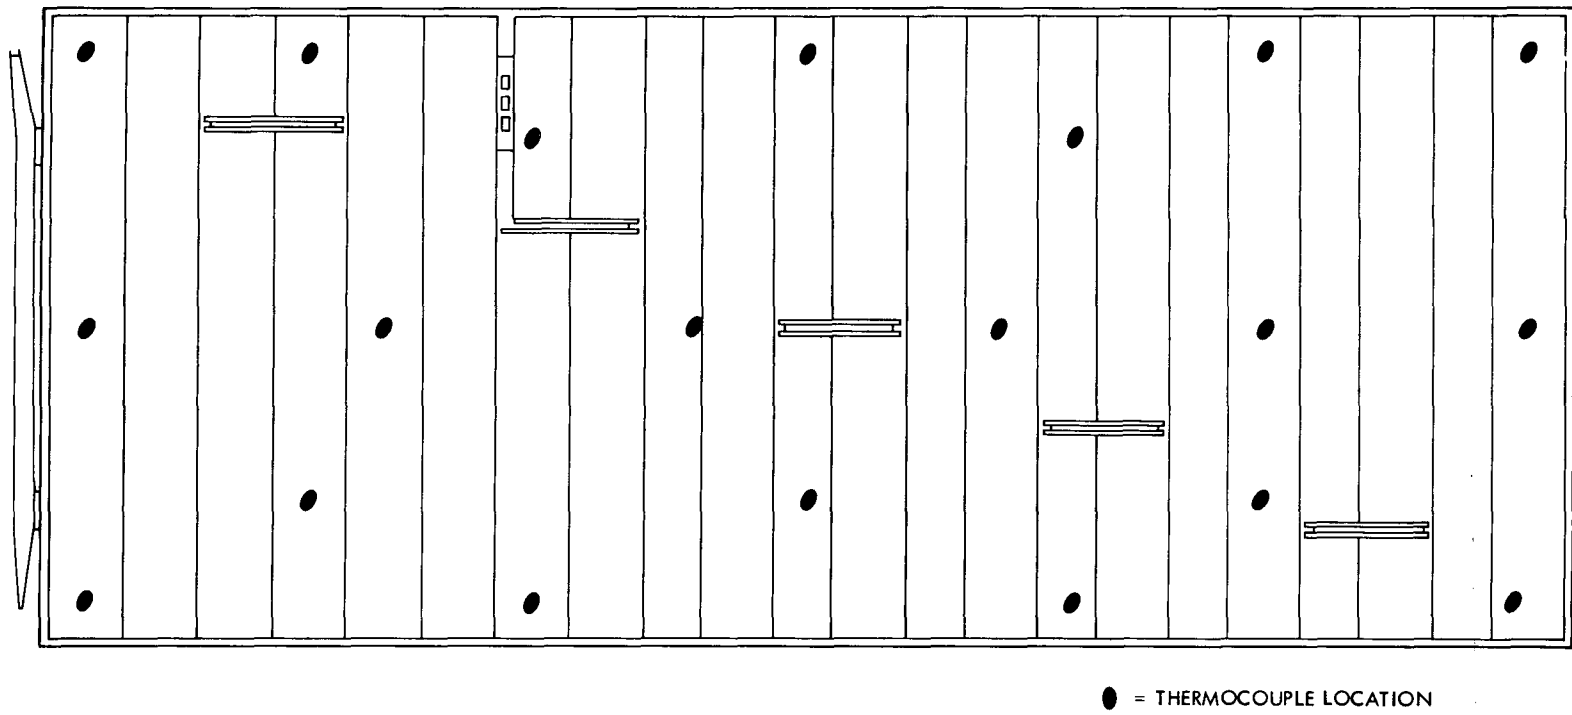
Fig. 13. Thermocouple Locations on Solar Panel

During the thermal cycle period the zener diodes voltage and current and the temperature transducers were measured both at the low and the high temperature periods. The temperature rate change was maintained within  $5^{\circ}\text{C}$  per minute. Heating and cooling of the solar panels was accomplished by the use of radiative heat transfer from the thermal shroud only.

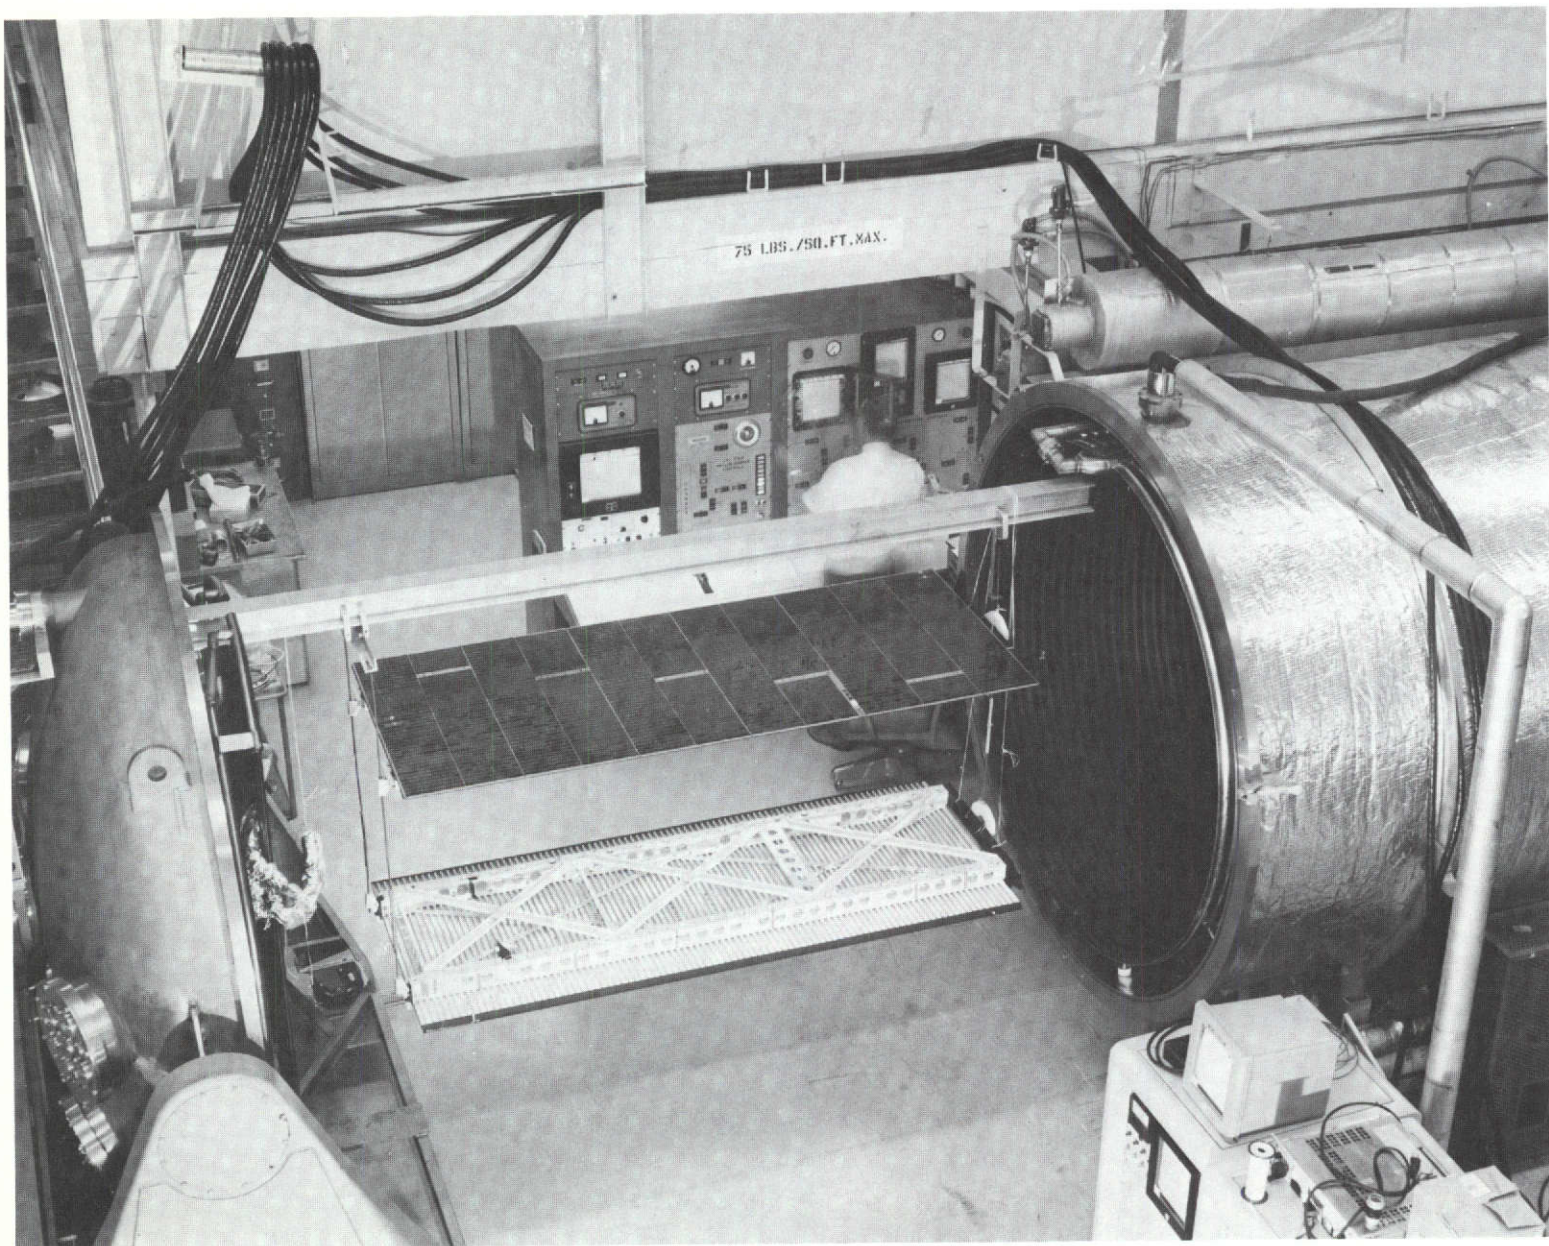
Fig. 14. Installation of Solar Panel in Thermal Vacuum Chamber

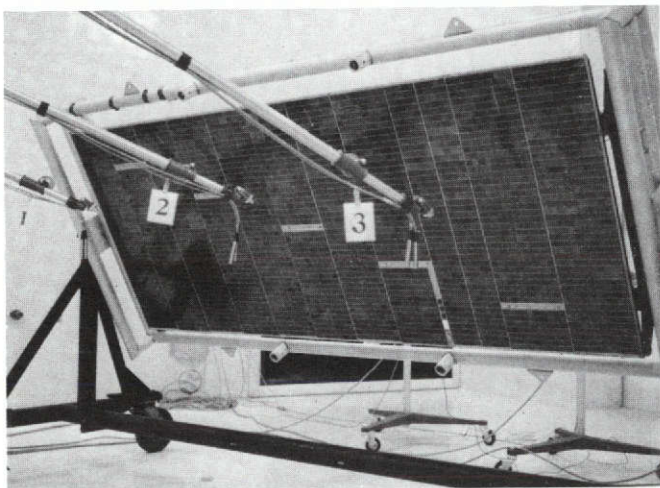
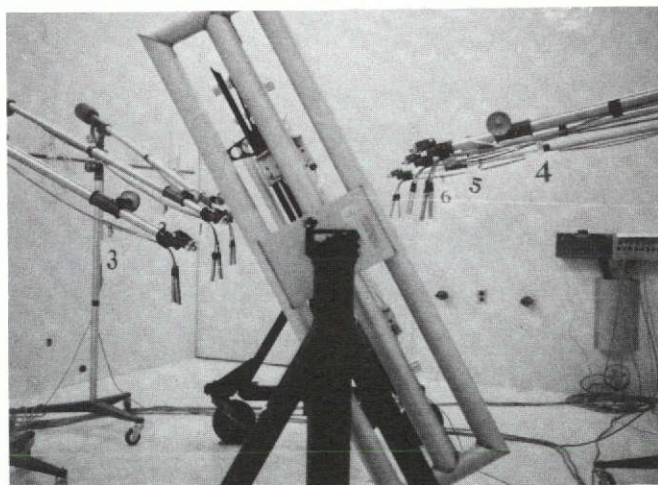
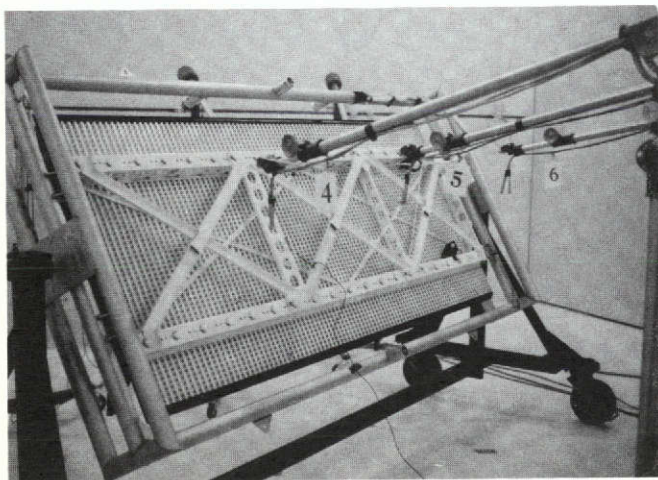
FRONT OF PANEL

SIDE VIEW

BACK OF PANEL

Fig. 15. Location of Microphones for Acoustic Test

The second phase of the flight qualification test consisted of subjecting the flight panels to acoustic tests conducted in accordance with JPL detail specification 504713. On previous Mariner programs it was necessary to perform the test while the panels were suspended in a cage-like fixture. The Mariner 9 panels were placed in an acoustic chamber recently constructed which reduced the hazards associated with handling the fragile solar panels. Prior to test start, the chamber equilization test was performed using a Development Test Model. The locations of the microphones were identified so that they could be used in an identical manner during the tests of the flight panels. Six monitoring microphones were used during the flight panel tests to record the acoustic signals which were analyzed on a 1/3 octave analyzer after the test. The test was completed successfully. Figure 15 shows the locations of the microphones relative to the panel. The solar panels electrical performance was measured at Table Mountain before and after the environmental test program. A compilation of this data is presented in Table 4. The data is reduced to the anticipated performance conditions of post launch, cruise intensity-temperature conditions and the Mars encounter intensity-temperature conditions. The data suggests that the environmental testing program may have caused an array degradation of approximately one percent. However, since the repeatability of the Table Mountain test is estimated to have about the same uncertainty, there can not be confidence that this degradation number is correct.

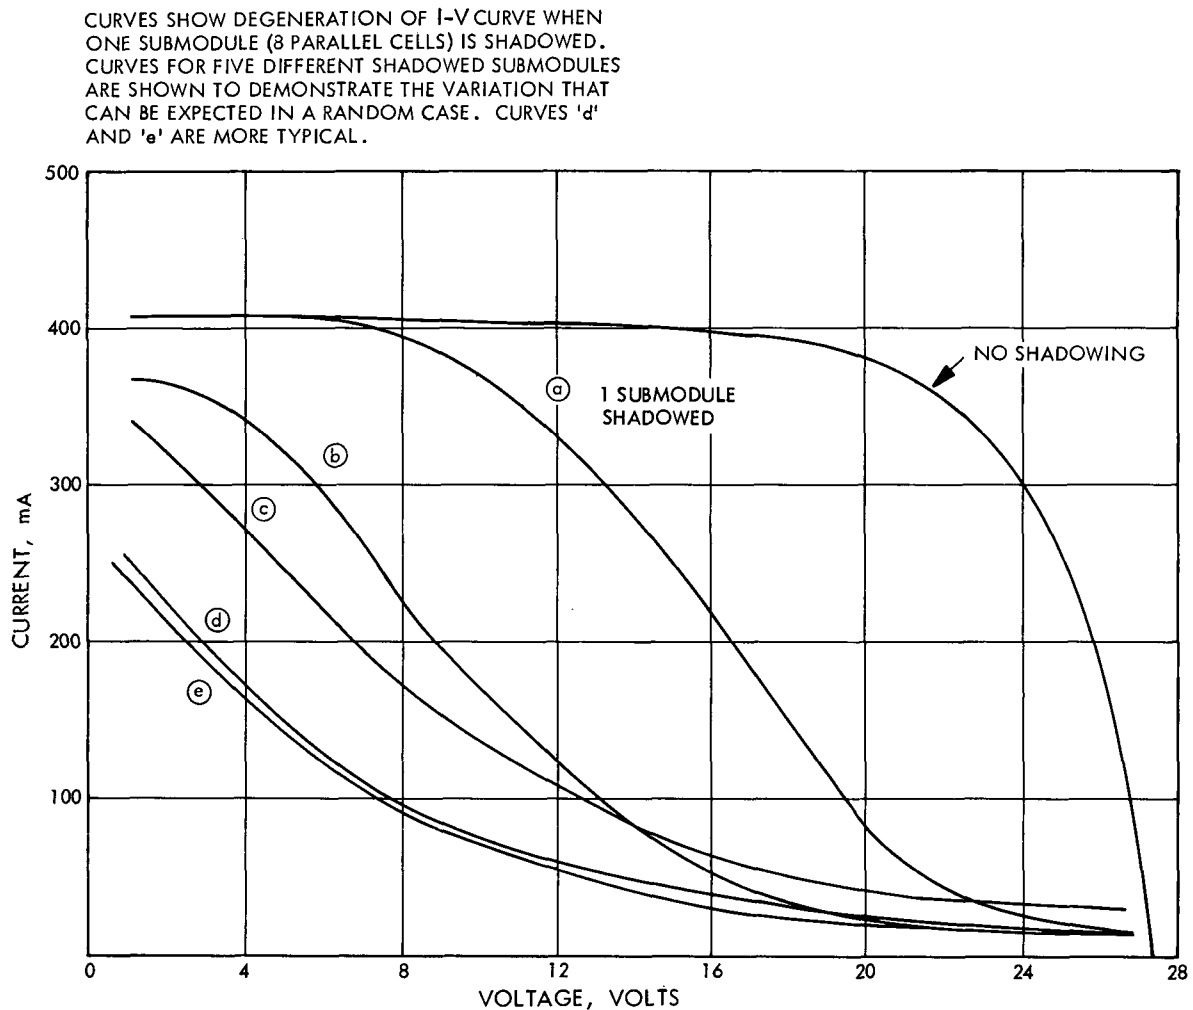
Fig. 16. Effect of Completely Shadowing Several Different Submodules (Rows of eight parallel cells)

The array power degradation is dependent upon the size of the shadow and the geometrical and electrical layout of the cells in the array. The loss in array power is not proportional to the shaded area of the panel, but greater. The effects of shading vary considerably, depending on which submodule in the string was shaded. This variance is due to the reverse characteristics of the individual submodules. Figure 16 shows the I-V characteristics of several individually shaded submodules. In general, because of the transient nature of shadowing and because of the difficulty of analysis in predicting Mariner 9 array space degradation because of shading, a worst case model was applied. This model considered that any shading of a string of solar cells effectively eliminate the electrical contribution of that string. The M'71 solar array cell layout minimized the effects of shadows in that the strings of cells were run normal to the solar panel length axis. Through this technique, the loss in solar array performance is directly correlated with shadow length. Whereas, if the strings of cells were run parallel to the length axis, relatively short shadows could cause a disproportionate amount of degradation.
