*Technical Memorandum 33-615*

*Mariner 9 Solar Array Design, Manufacture,  
and Performance*

*E. A. Sequeira*

**JET PROPULSION LABORATORY  
CALIFORNIA INSTITUTE OF TECHNOLOGY  
PASADENA, CALIFORNIA**

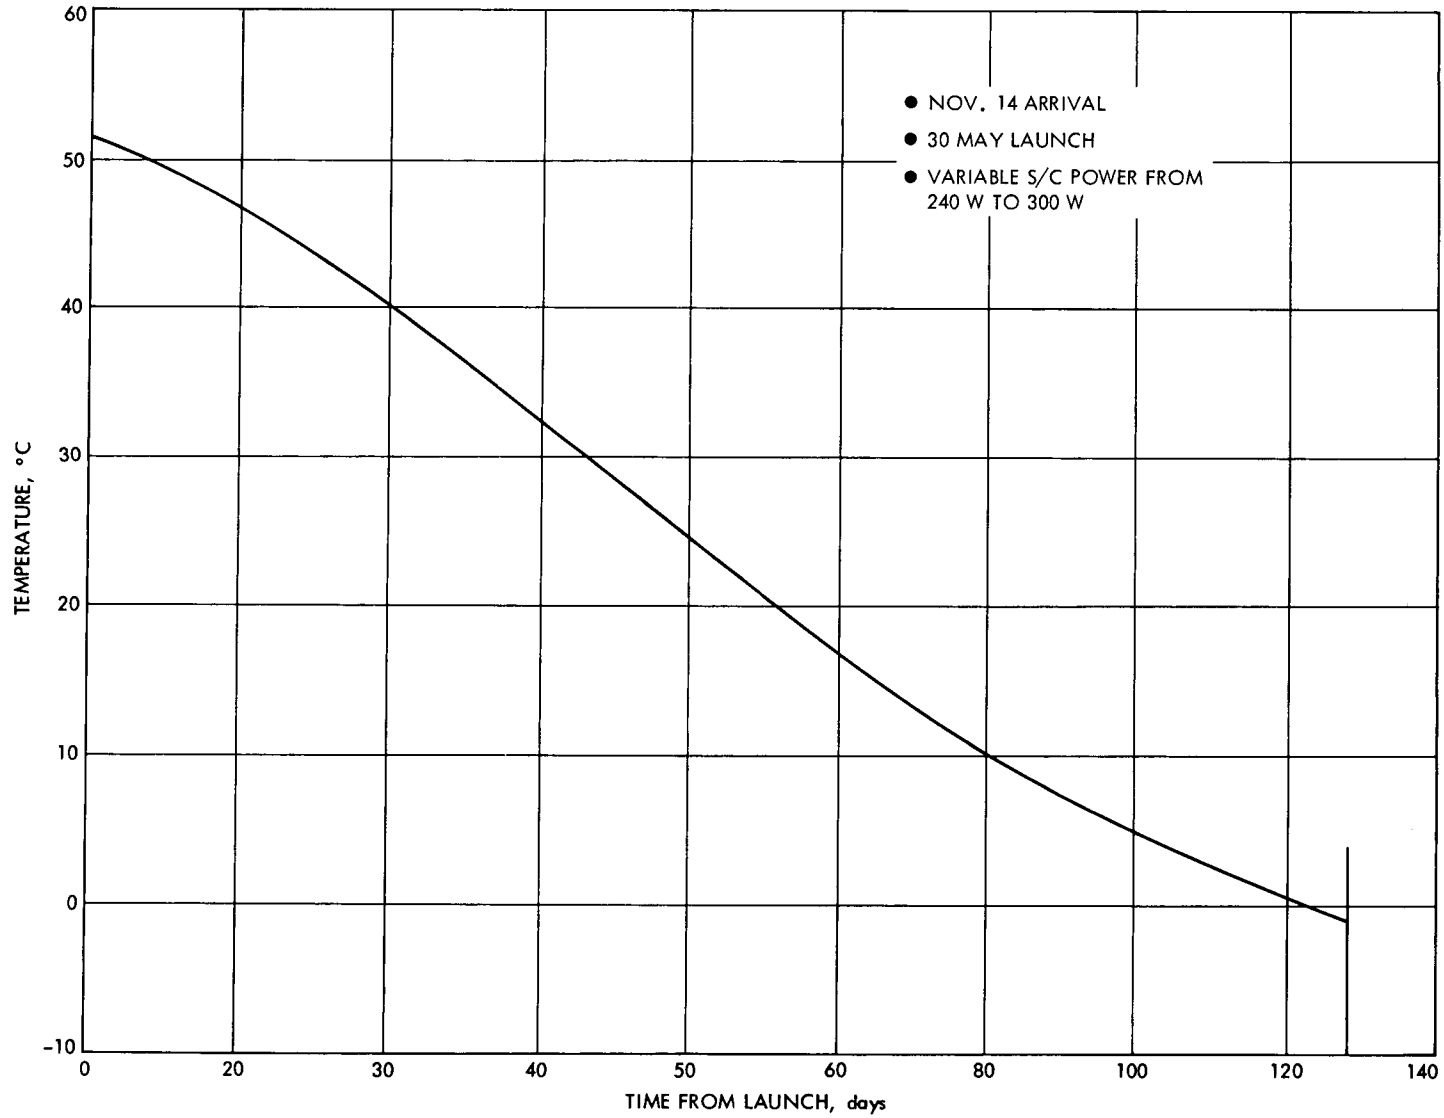
Fig. 17. Prelaunch Estimated Solar Panel Temperature Versus Mission Time

The Mariner 9 spacecraft was launched on May 30, 1971. The solar panels were deployed and the spacecraft acquired the Sun 28 minutes after launch. The solar panel temperature derived from the temperature sensor, telemetry channel 419, located on the rear of the +Y solar panel, indicated an initial space panel temperature of 11.2° C. The temperature gradually increased and finally stabilized at 50.2° C and remained at this condition for approximately ten days from launch. Figure 17 shown estimated solar panel temperatures versus mission time from launch to Mars encounter. On the same curve actual flight temperatures are plotted versus data obtained from +Y temperature transducer, telemetry channel 419. Nominal temperature performance was recorded throughout the standard Mariner 9 mission.

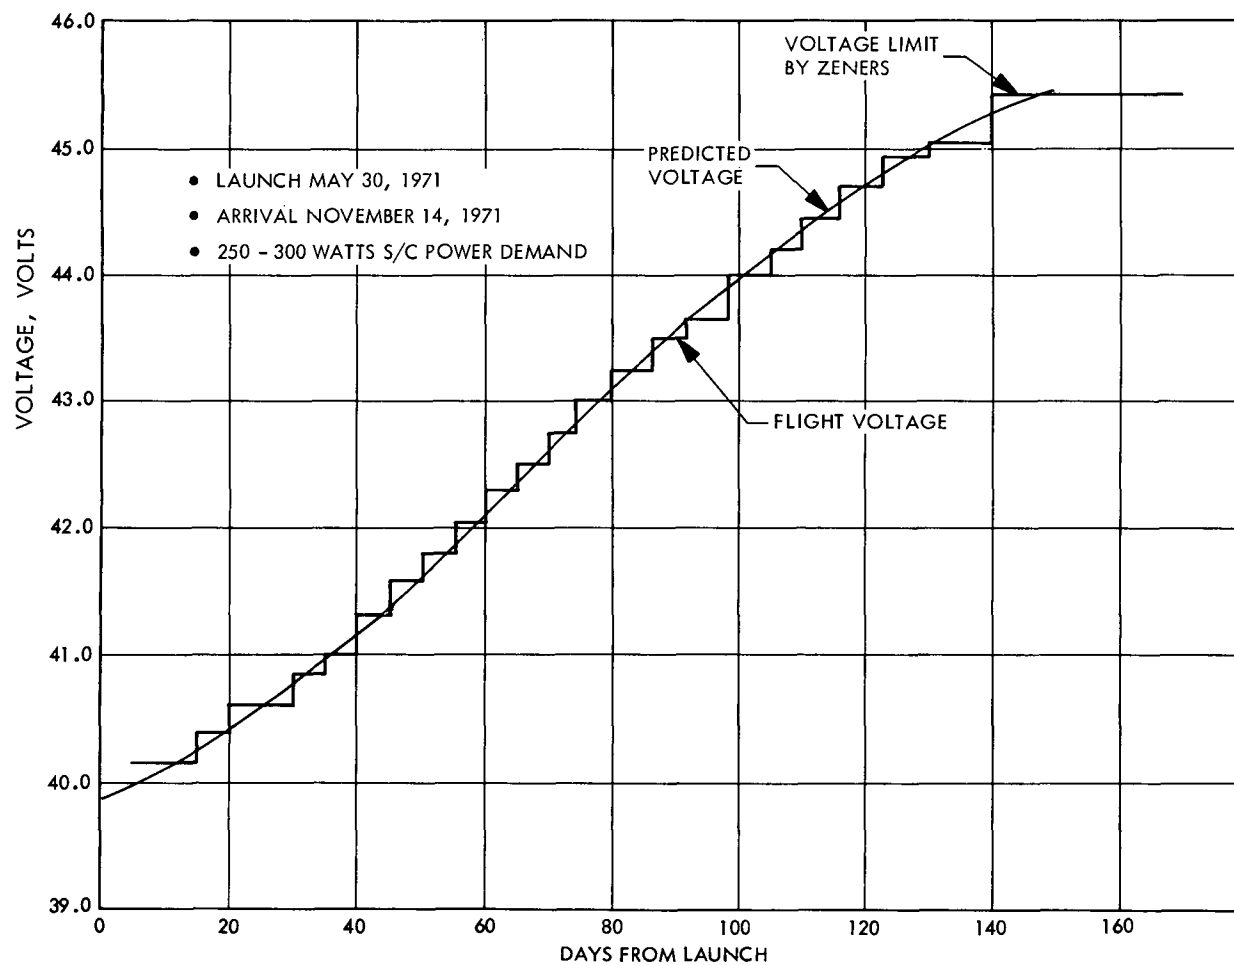
Fig. 18. Mariner 9 Solar Panel Performance Voltage Versus Time (PS and L, Channel 116)

45.4 volts, approximately 140 days from launch and continued to be so limited except during maneuvers and special events. Figure 18 shows array actual flight operating voltage from launch to Mars encounter. Zener limitation of solar array output prevents direction evaluation of operating characteristics; hence, after day 140, more reliance had to be placed on the Isc-Voc transducer in evaluating the array performance. On day 140 the transducer indicated that the array had degraded approximately 1.5 percent from launch. This measurement is believed to be outside the limit of telemetry data resolution and hence confidence in this value is not justified. This amount of change, however, corresponds very well with the performance of the Isc-Voc transducers flown on Mariners 6 and 7. Extrapolation of this data to encounter suggested that this array would be only 3.5 percent lower than the prelaunch predicted performance curves developed, assuming no solar flare degradation. It appeared the array had not experienced great space degradation and was performing close to its predicted characteristics. The Isc-Voc transducer and the solar array performance appeared to be tracking each other and future estimates of array performance would reflect the Isc-Voc operation. Based on flight transducer data, a revised encounter prediction was made 27 days before encounter. Shown in Fig. 19 is a plot of the I-V characteristics of the array assuming 3.5 percent current degradation. Plotted in Fig. 20 is the degradation experienced by the Isc-Voc transducer from launch through Test No. 2. It illustrated the 1.5 percent current degradation noted on day 140 and shows the 3.5 percent current degradation at encounter.

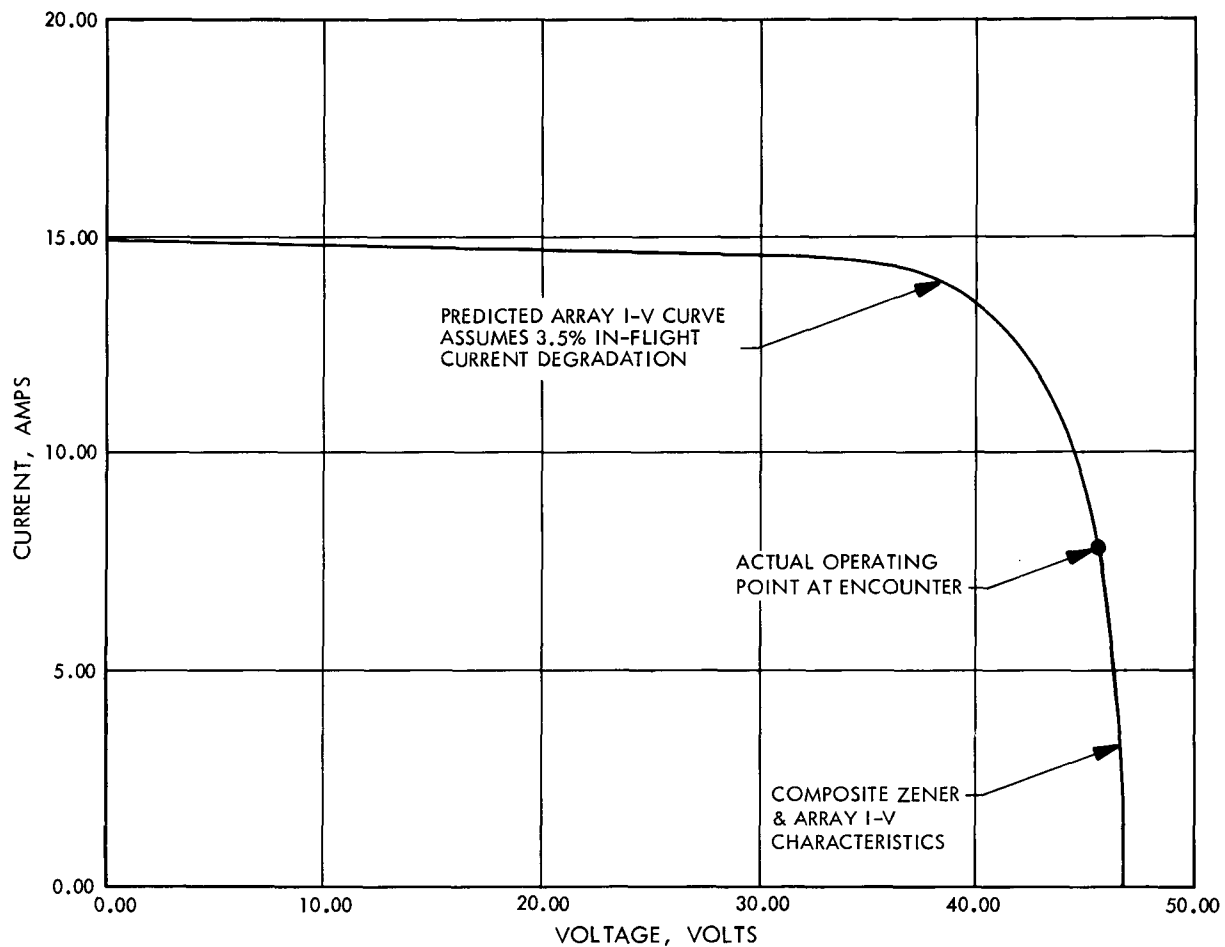
Fig. 19. Solar Array Predicted Performance at Encounter.  
Curve Degraded to Reflect Isc-Voc Transducer Telemetry  
Data (Prediction made 27 days before Encounter)

On November 14, 1971, the spacecraft was injected into orbit. The solar array current-voltage performance characteristics on November 14 are shown in Fig. 19. Solar array temperature was  $-2.3^{\circ}\text{C}$  and the Sun intensity was  $70.0\text{ mW/cm}^2$ . The first orbit trim maneuver was successfully conducted on November 15, 1971. On December 30, a second orbit trim was made to correct the orbital period coordinating the periapsis timing with the view period of the antenna at the Goldstone tracking station in California. The maneuver also changed the periapsis altitude from 1387 to 1650 kilometers. The spacecraft remained in that orbit for the rest of its operational life. The estimated array output power performance at orbital apoapsis and periapsis for the 90-day standard

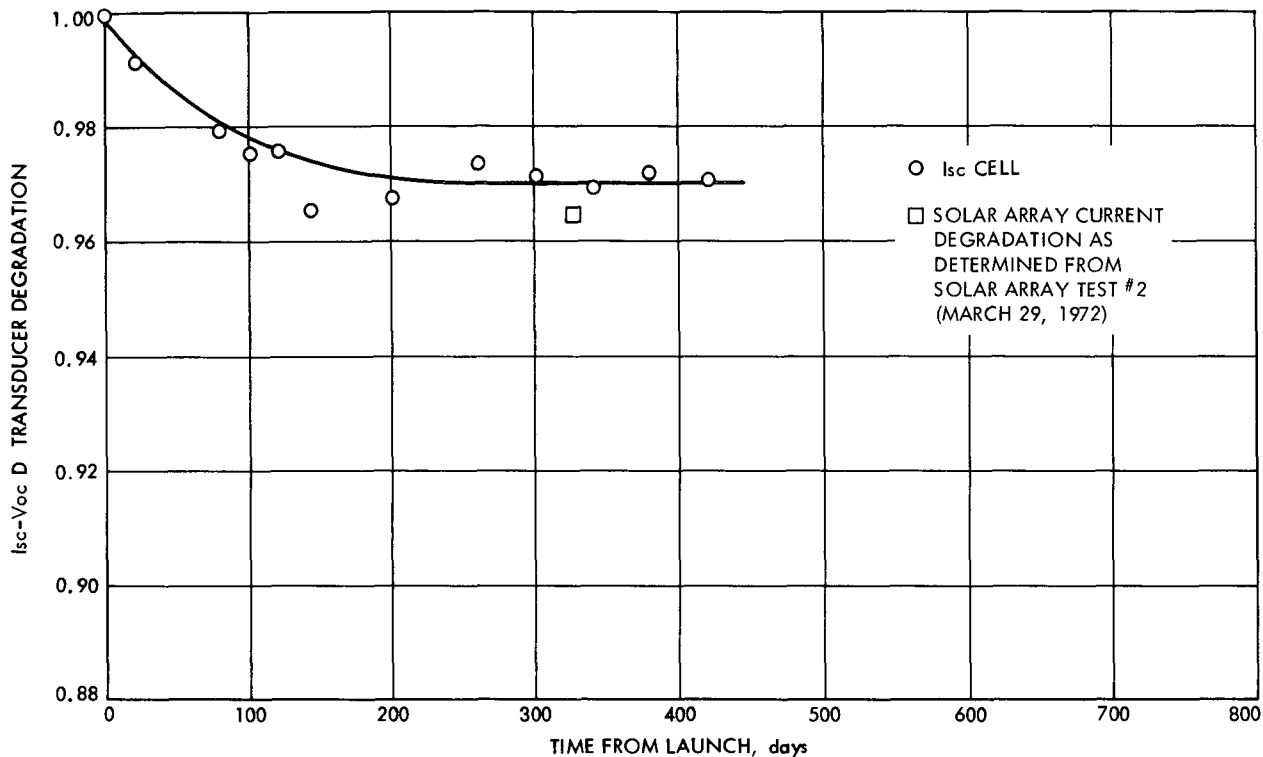
Fig. 20. I<sub>sc</sub>-V<sub>oc</sub> Transducer Degradation as a Function of Mission Time

The Isc-Voc transducer provided pertinent engineering information utilized to determine the status of the solar array performance capability. At day 0 it was observed that the Isc transducer cells indicated 1.0 percent lower output than had been predicted before launch. During this phase of the mission the array is operated near its open circuit voltage. This does not permit detailed evaluation of the current-voltage characteristics of the array. This operating point is relatively insensitive to intensity or current loss effects. Detailed analysis of the array at this time indicated array performance to be close to predicted, however, the accuracy of the analysis was limited because of the array performance resolution. The Isc-Voc transducer performance supported this analysis. The main deviation being the 1 percent lower current transducer performance than anticipated. Potential reasons for this deviation could include calibration accuracy, prediction uncertainty and telemetry accuracy.

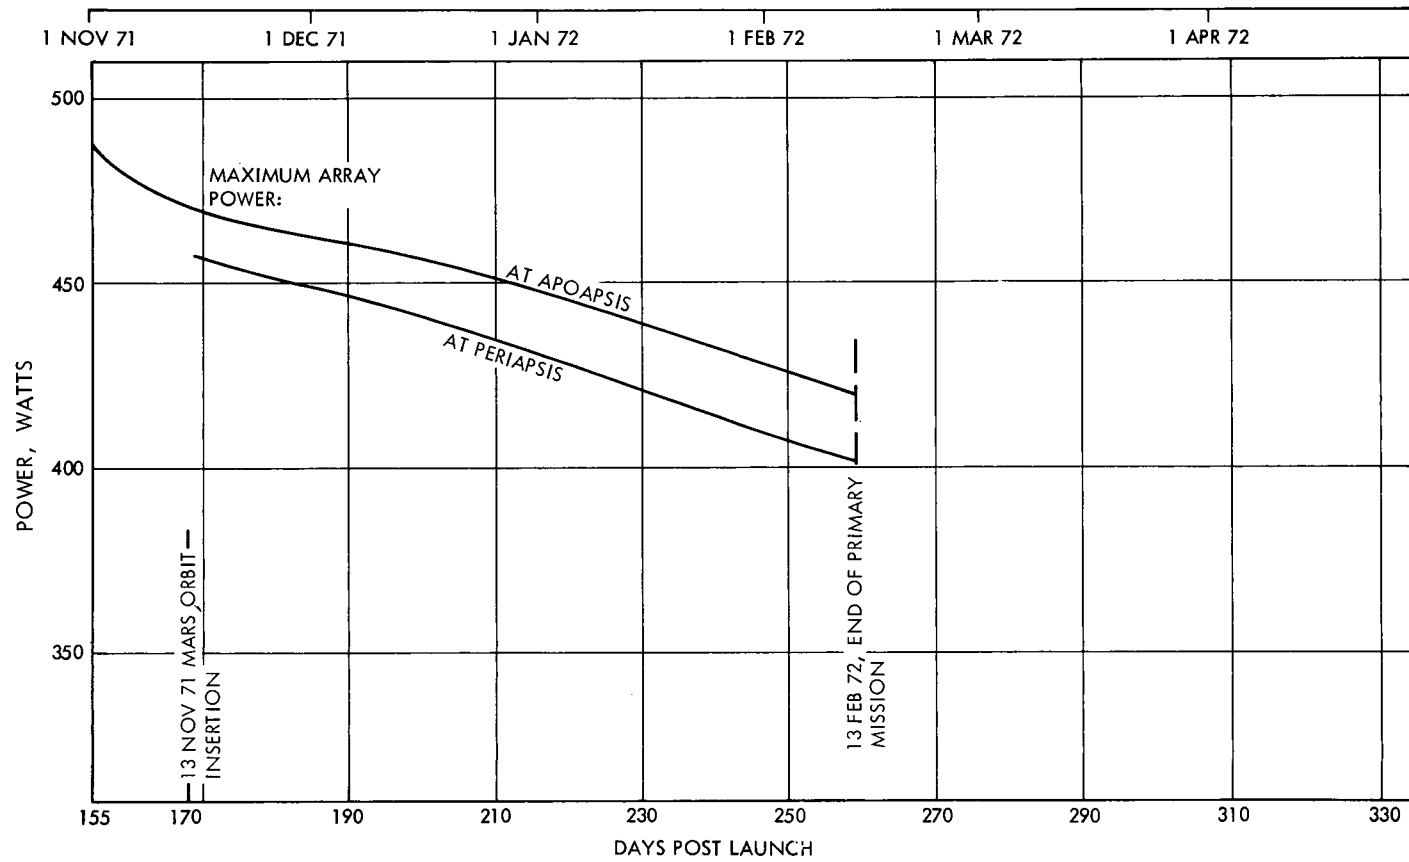
Fig. 21. Predicted Solar Array Performance for 90-Day Primary Mission

mission is shown in Fig. 21. The solar array temperature profile for the initial mission orbits is shown in Fig. 22. The high array temperature is caused by planet albedo during the periapsis phase of the orbit point. The low array temperature at apoapsis was approximately at  $-2.2^{\circ}\text{C}$ . At periapsis the array temperature is expected to rise to  $5.6^{\circ}\text{C}$ . This temperature profile continues to change as the planet moves further away from the Sun. The final orbit of the 90-day mission, orbit 180, is shown in Fig. 23 and indicates a low array temperature of  $-13.9^{\circ}\text{C}$ , and rise to  $-1.1^{\circ}\text{C}$ . Temperature telemetry data showed very good correlation with the temperature profiles indicated. During this orbital phase of the mission between April 2, 1972 and June 3, 1972, the spacecraft was subjected to 124 solar occultations created by the obscuration of the Sun by the planet. The longest of these occultations lasted 97 minutes and resulted in the array temperature decreasing to  $-158^{\circ}\text{C}$ . As will be discussed later this occultation period occurred between the special array

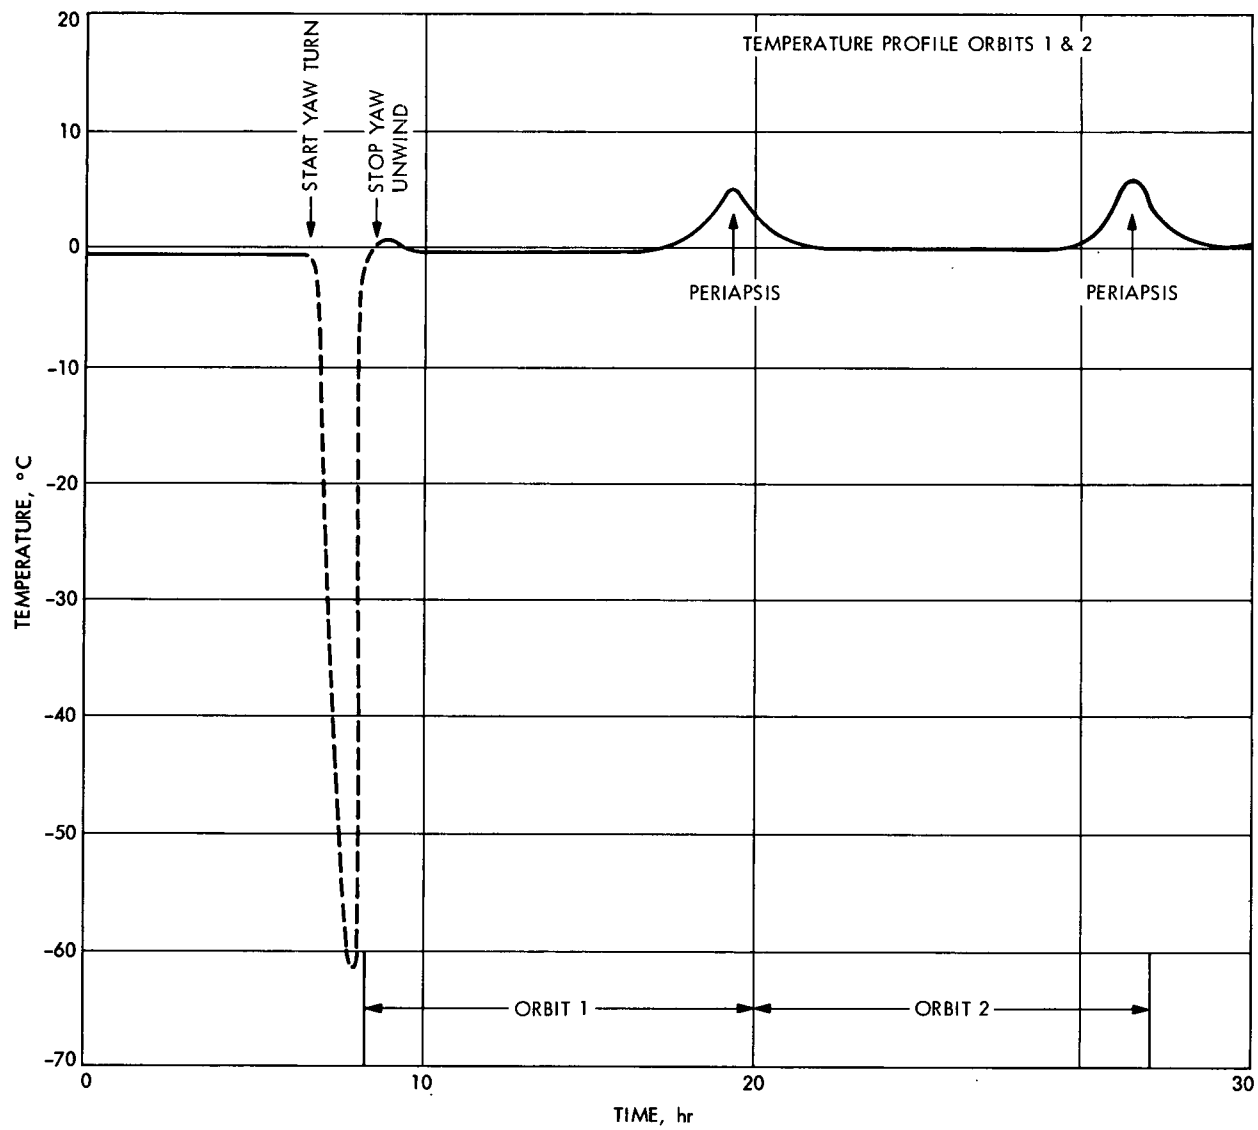
Fig. 22. Temperature Profile Orbits 1 and 2

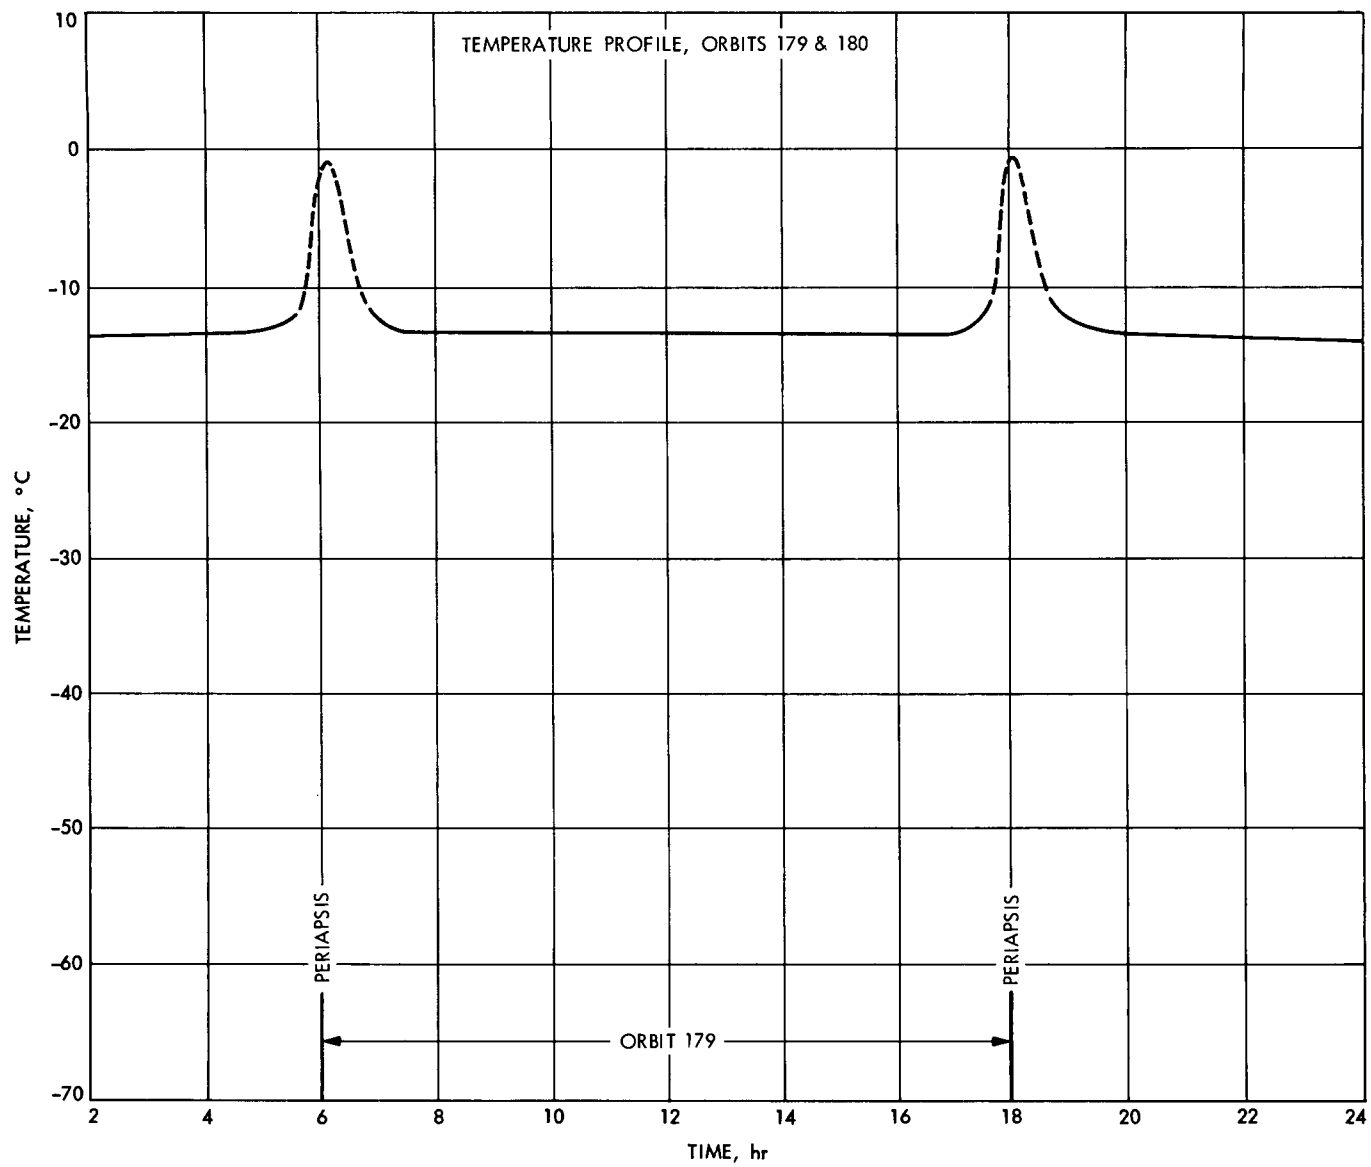
Fig. 23. Temperature Profile, Orbits 179 and 180

in-flight electrical test 2 and test 3. The tests indicated that no observable performance degradation resulted that could be attributed to thermal cycling. Later in the mission, starting on October 2, 1972 and lasting to mission termination on October 27, 1972, the spacecraft experienced 38 more occultations and hence thermal cycles. Although there was no detailed array performance measurement just prior to the end of the mission, it is not believed that these additional cycles did any damage to the solar array performance.

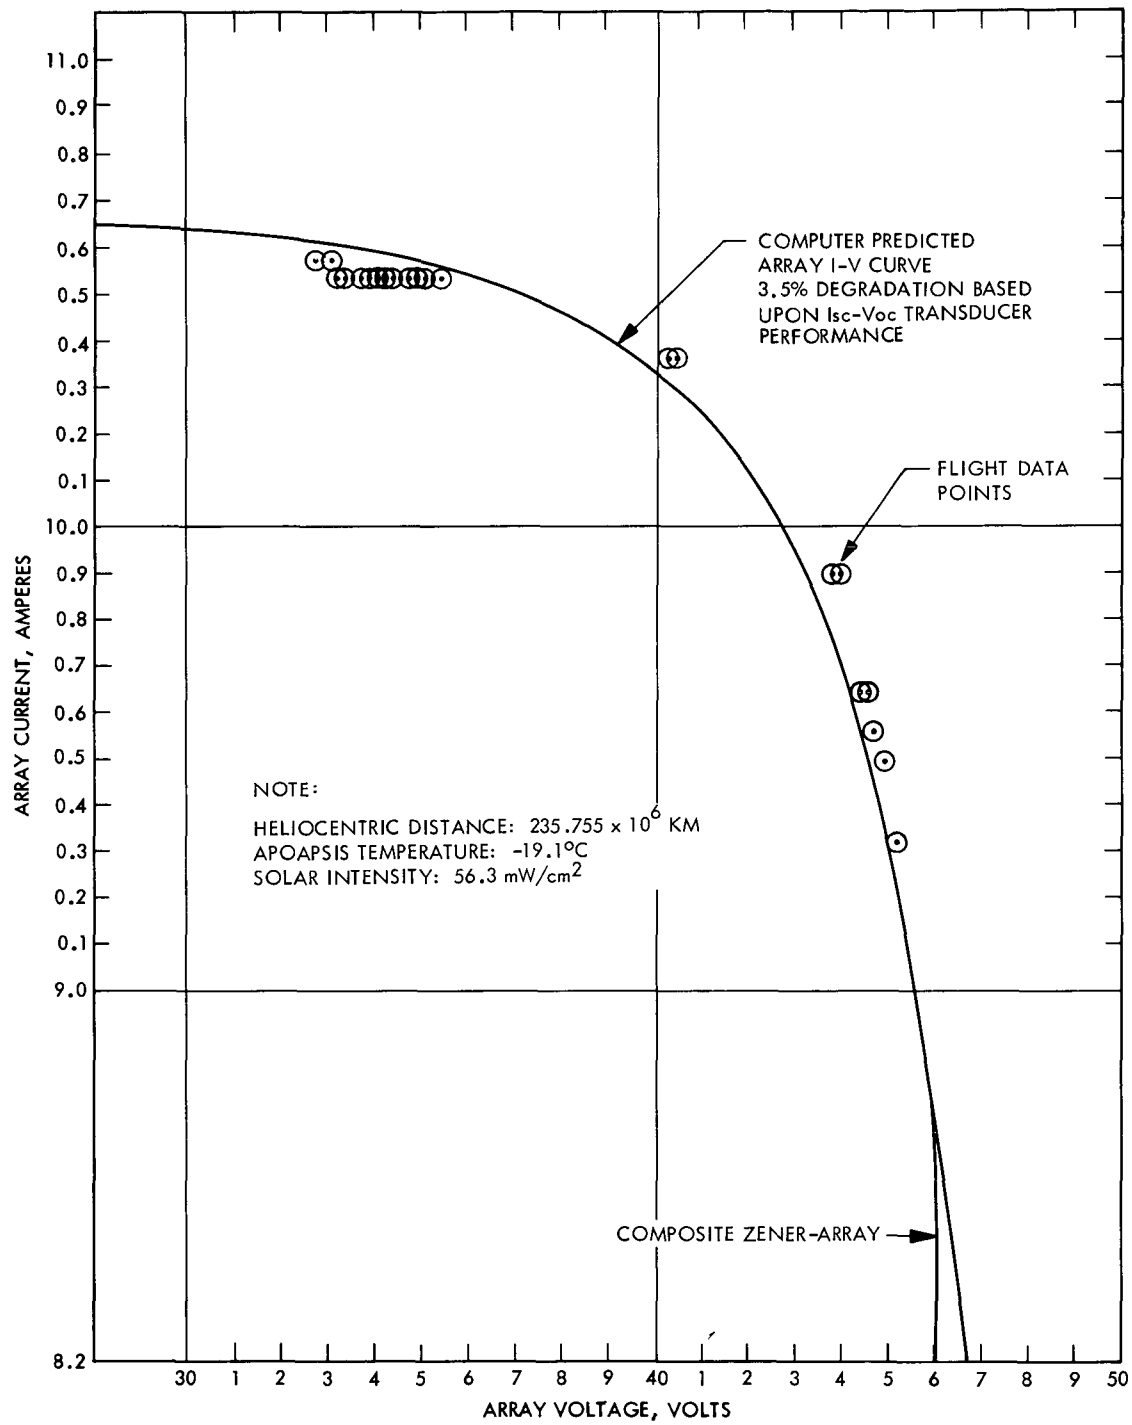
Fig. 27. Solar Array Performance During Array Test No. 2, March 29, 1972

degradation factor of 3.5 percent. The degradation of 3.5 percent is based on Isc-Voc transducer performance. The difference in maximum power determined from the flight data compared with the analytical model was 1.5 percent (Flight test indicated 434 watts vs analytical data of 427 watts).

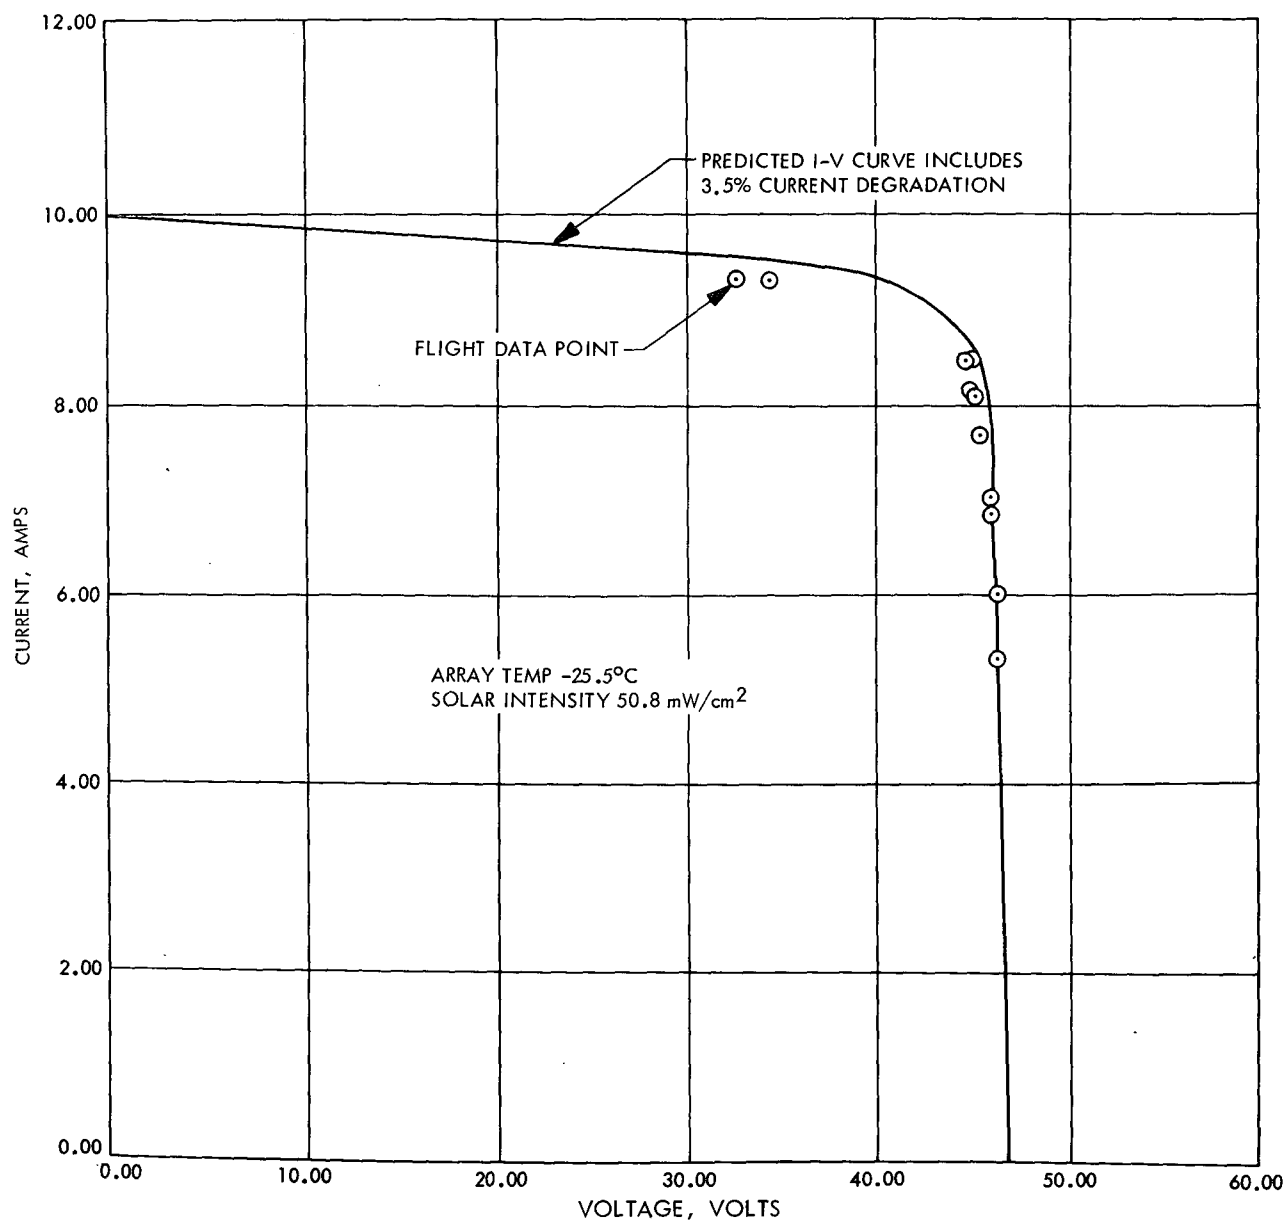
Fig. 34. Solar Array Performance During Test No. 4, October 2, 1972

The final special array test was conducted on October 2, 1972. The telemetry flight data as a function of time is shown in Fig. 32. Current-voltage points were selected to generate array I-V characteristics as shown in Fig. 33. The flight data in Fig. 33 were plotted on the predicted array performance curve as shown in Fig. 34. Again 3.5 percent current degradation factor was assumed from a study of the Isc-Voc transducer data. The resulting curve shows good agreement with the flight data.
