NASA TM X-68257

THE RESTORATION OF OBLITERATED STAMPED SERIAL
NUMBERS BY ULTRASONICALLY INDUCED
CAVITATION IN WATER

by Stanley G. Young
Lewis Research Center
Cleveland, Ohio

TECHNICAL PAPER proposed for presentation at
Twenty-ninth Semiannual Seminar of the
California Association of Criminalists
Palo Alto, California, October 17-19, 1973

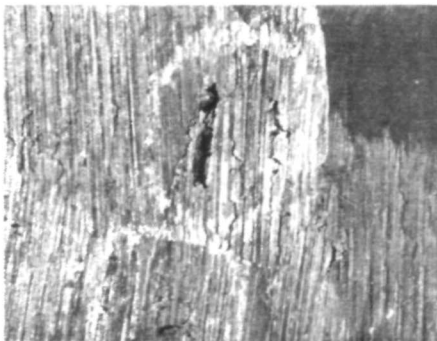
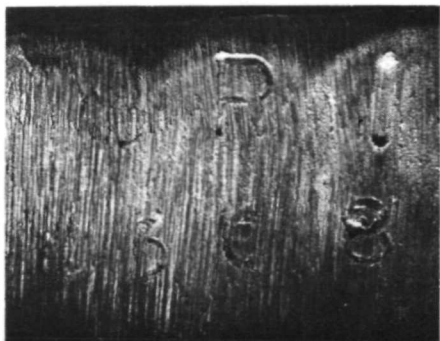
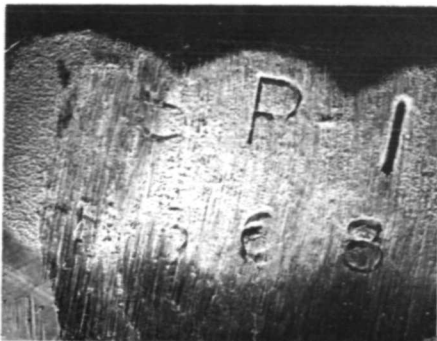
Figure 7. - Photomicrographs of copper specimen subjected to cavitation, showing the restored letters and numbers at various exposure times. - X6.

Figure 5 shows $\times 1$ photomicrographs of the copper specimen. Observations of this specimen before the restoration process indicated that grinding was not too deep; however, all letters and numbers except the I had been obliterated beyond immediate visual recognition. In very short times (3 to 5 min) some of the numbers were recognizable and in 20 minutes all the obliterated numbers and letters were restored enough to be recognized. The numbers and letters are more easily seen in figure 6 at $\times 2$ and figure 7 at $\times 6$. Various methods of oblique lighting helped to highlight the numbers and letters.

In figure 7 the number 3 that was restored after 5 minutes is starting to be obliterated by the cavitation attack (see the pitted region on the 20-minute photomicrograph of fig. 7). For this reason care must be taken to start the restoration process in very small time increments at first, so as not to destroy the numbers and letters restored in the early phases of the test. On this specimen and on some of the other materials,

penciled circles were drawn around suspected locations of numbers, and these show up on some of the 0 minute photomicrographs (white circles on fig. 7 - 0 min). These pencil markings were automatically removed during the first few seconds of cavitation attack.

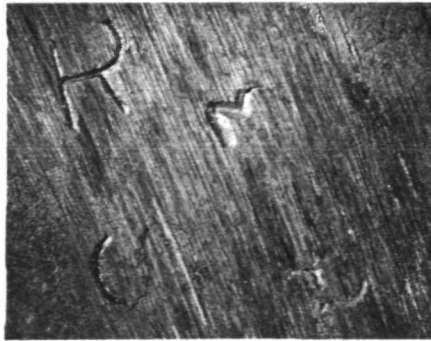
Figure 12. - Photomicrographs of steel specimen subjected to cavitation, showing the restored letters - S, R, 8, and 3, at various exposure times (letters highlighted on dark background by oblique light - X8).

Many different types of lighting were used to try to show up the letters and numbers. Figure 12 shows the restored letters and numbers S, R, 8, and 3 at times from 0 to 70 minutes. The letters and numbers are highlighted by oblique light to show up light on a darker background. In figure 13, at the same magnification, the letters are dark on a lighter background. This was caused by using a sharper oblique lighting angle and rotation of the specimen to allow light reflection from the original grinding marks. Both methods, however, show up the letters quite clearly. Smeared metal was removed from the grooves of the stamped numbers and letters.

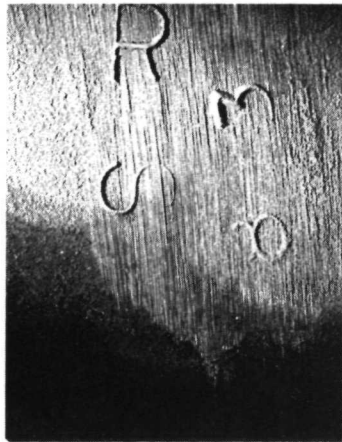
Figure 15. - Photomicrographs of restored letters and numbers on steel specimen at end of experiment - X6.

Figure 14 shows the partially restored numbers 6 and 8 at $\times 8$, at times to 70 minutes. Because these numbers were not clearly visible, when all other numbers were obvious, much longer test times were allowed over this specific region of the specimen. Figure 15 shows the results on the steel specimen at the end of the test. Attack was discontinued on the region of the S, R, 8, and 3 after 120 minutes, but the test was continued to 220 minutes over the region containing the 6 and 8. From the bottom photomicrograph of figure 15 at $\times 6$, the 6 can now be

seen almost in entirety as a light haze. The 8 is still only partially visible, but better than before.

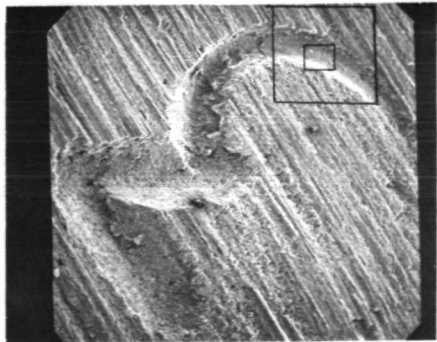
Figure 16. - Scanning electron microscope photomicrographs of restored number 3 on steel at various magnifications after 120 min. exposure to cavitation.

A SEM study was made on the number 3 of the steel specimen and the photomicrographs from this study are shown in figure 16. Magnification range is from $\times 30$ to $\times 9000$. At the high magnification, the steel has a very jagged, torn appearance as a result of the cavitation attack, indicating that even in steel, cavitation is starting to attack the surface of the restored number after long test times.
