**SPUTTER EROSION AND DEPOSITION IN THE DISCHARGE
CHAMBER OF A SMALL MERCURY ION THRUSTER**

by John L. Power
Lewis Research Center
Cleveland, Ohio 44135

TECHNICAL PAPER proposed for presentation at
Tenth Electric Propulsion Conference sponsored
by the American Institute of Aeronautics and Astronautics
Lake Tahoe, Nevada, October 31-November 2, 1973

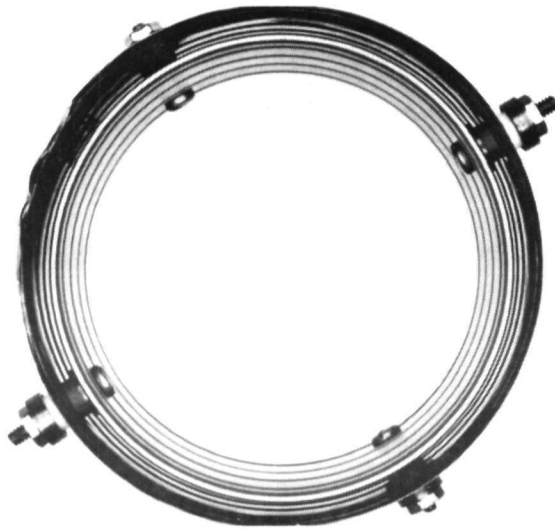
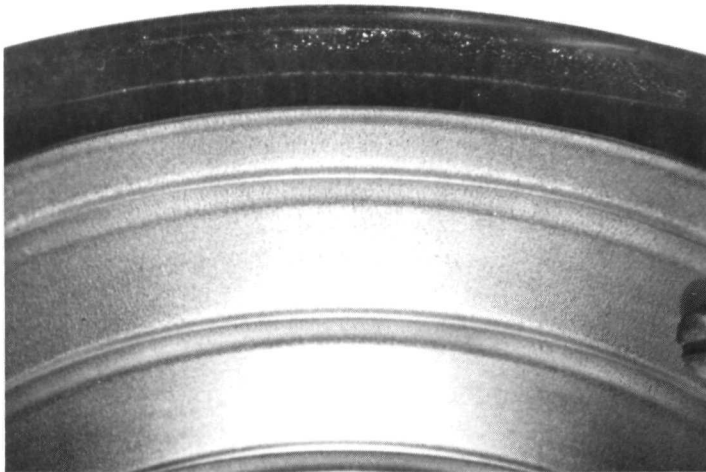
(A) LOOKING DOWNSTREAM.

(B) UPSTREAM END.

Figure 9. - Anode assembly of thruster body after final ΔV_I test.

The thruster body-anode assembly (304 stainless steel) is shown in Figure 9(a) as viewed looking downstream. The photograph was taken following the final test. This assembly was the only discharge chamber component to gain weight during the tests (see Table II). The weight gain clearly was due to a coating of sputtered material on the interior of the anode. Figure 9(b) shows an upstream portion of the coated anode following the final test, with the engine body in the background. The anode coating always displayed the very dull, uniform mat gray appearance which can be indistinctly seen in the figure. No inhomogeneities or flakes were visible even across the anode stiffening indentations or at the tightly folded-over upstream end.

irregular, lumpy deposits of sputtered material, Figure 9(b). Samples were collected from both ends of the thruster body interior surface. Small amounts of loose metallic chips were also found on the thruster body interior following both the first test at $\Delta V_I = 39.6$ V and the final test at $\Delta V_I = 42.6$ V. These closely resembled in appearance the scraped-off deposits described above. Figure 10 shows a magnified view of some of the approximately 0.5 mg of chips collected, ranging in size from <0.025 mm to >0.50 mm across.

Also consistent with the highly peaked, radial ion density profiles presumed to exist through most of the discharge chamber is the observed lack of erosion of the interior thruster body surface, which forms the outermost boundary of the discharge chamber. The erosion rate was low enough at this surface, in fact, that the sputter deposition rate over most of the surface was greater than the erosion rate and a net deposition of sputtered material took place on these surface areas. (See Fig. 9(b).)

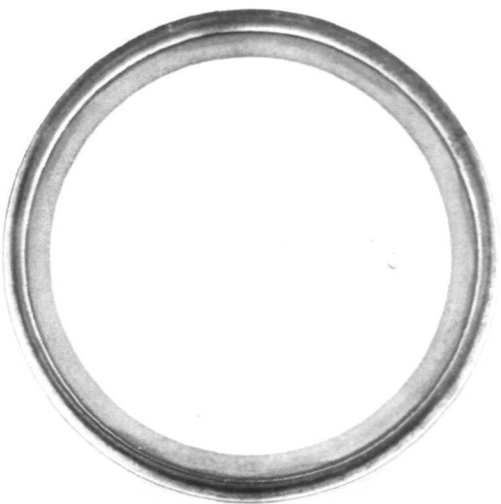
Figure 11. - Anode pole piece insert viewed from downstream side, after final ΔV_I test.

The anode pole piece insert (type 1010 mild steel plated with nickel) showed little erosion damage although it had a splotchy, tarnished appearance on both its upstream and downstream surfaces (Fig. 11) throughout the tests. The erosion did not penetrate the nickel plating, and no substrate iron corrosion was ever observed on the insert.
