CHARACTERIZATION OF RSI COATINGS

A.D. Miller, S.H. Garofalini, L.W. Smiser, and J.I. Mueller

Ceramic Engineering Division  
University of Washington

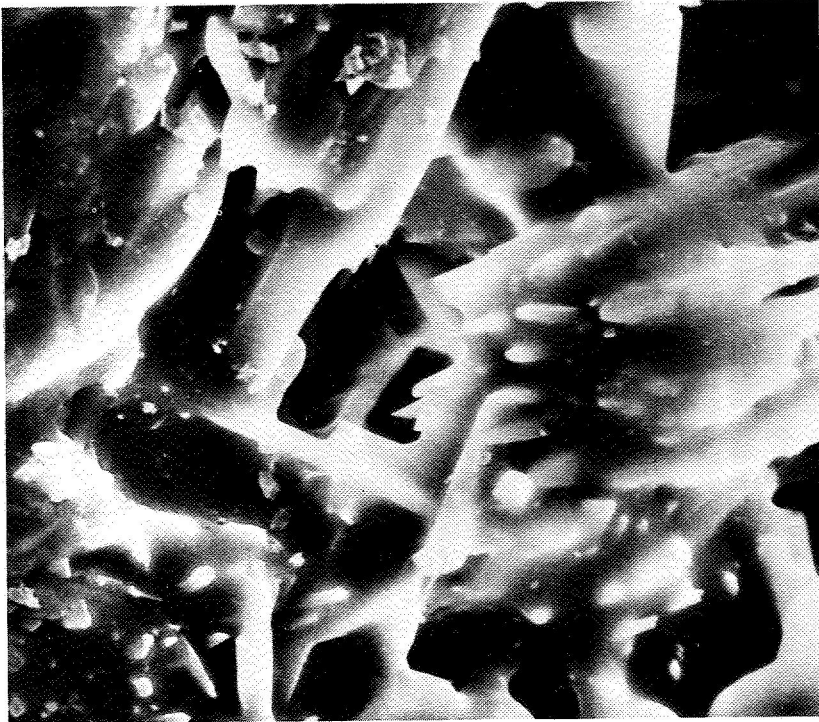
Figure 2 shows the surface of the MOD I coating at two different magnifications. The coating appears porous in figure 2(a), but at the higher magnification (2(b)) it is seen that the crystals are well sealed by the glassy phase.

GE Mod I Coating  
As Received  
SEM View of Surface

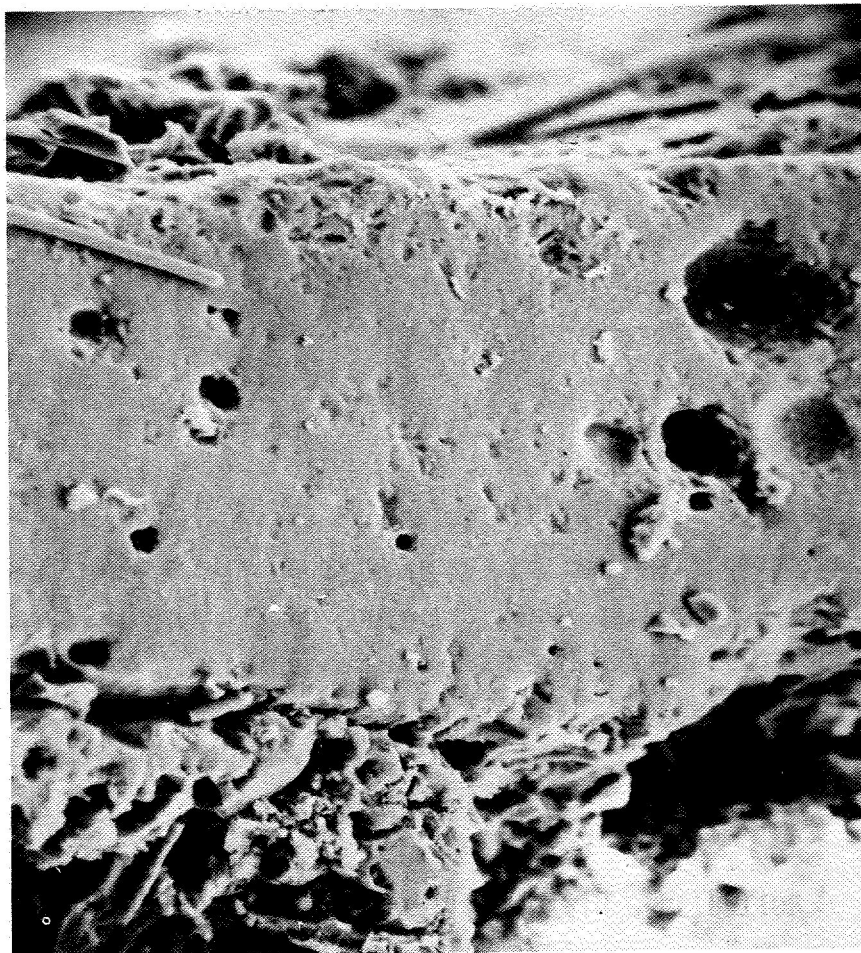
**Figure 3**

Figure 3 shows a cross-section of the MOD I coating. It appears reasonably dense, with only occasional large porosity.

**GE Mod I Coating  
As Received  
Cross-section of Coating and Interface**

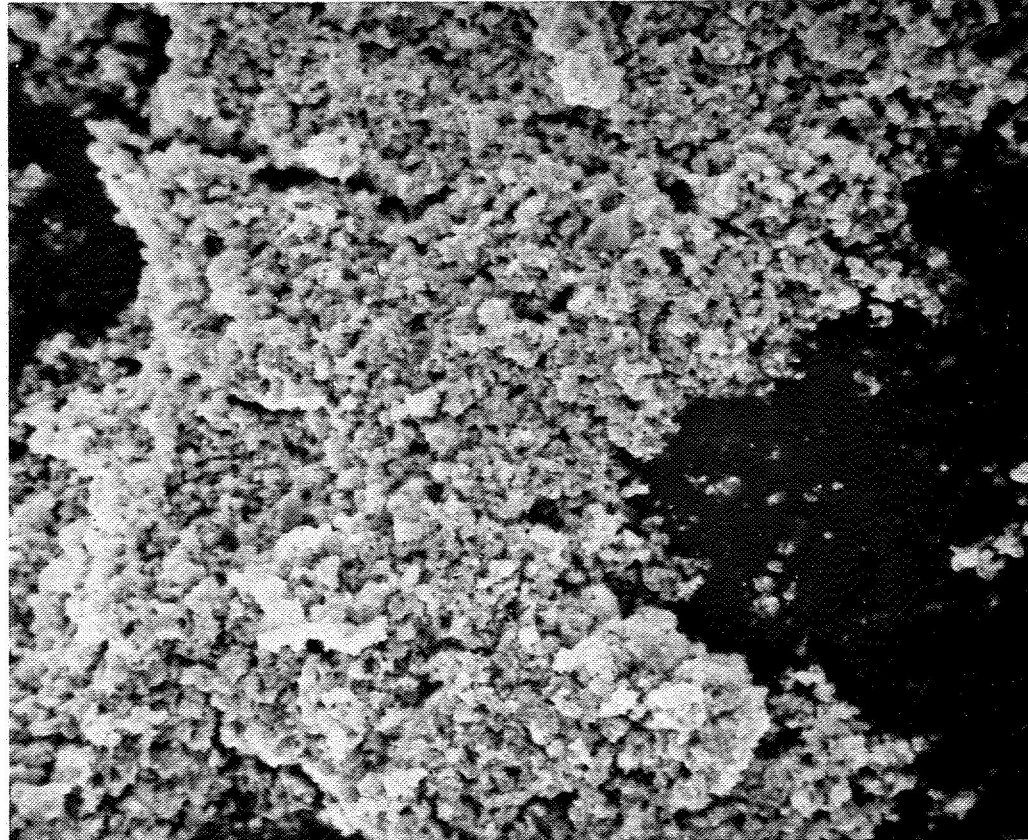
Figure 16 shows the coating surface after exposure to 10 cycles to 1250°C. It appears that much of the glassy phase present in the as-received material is absent here.

MDAC Mod III Coating  
10 Cycles to 1250°C (2300°F)  
Remnant of Surface Layer

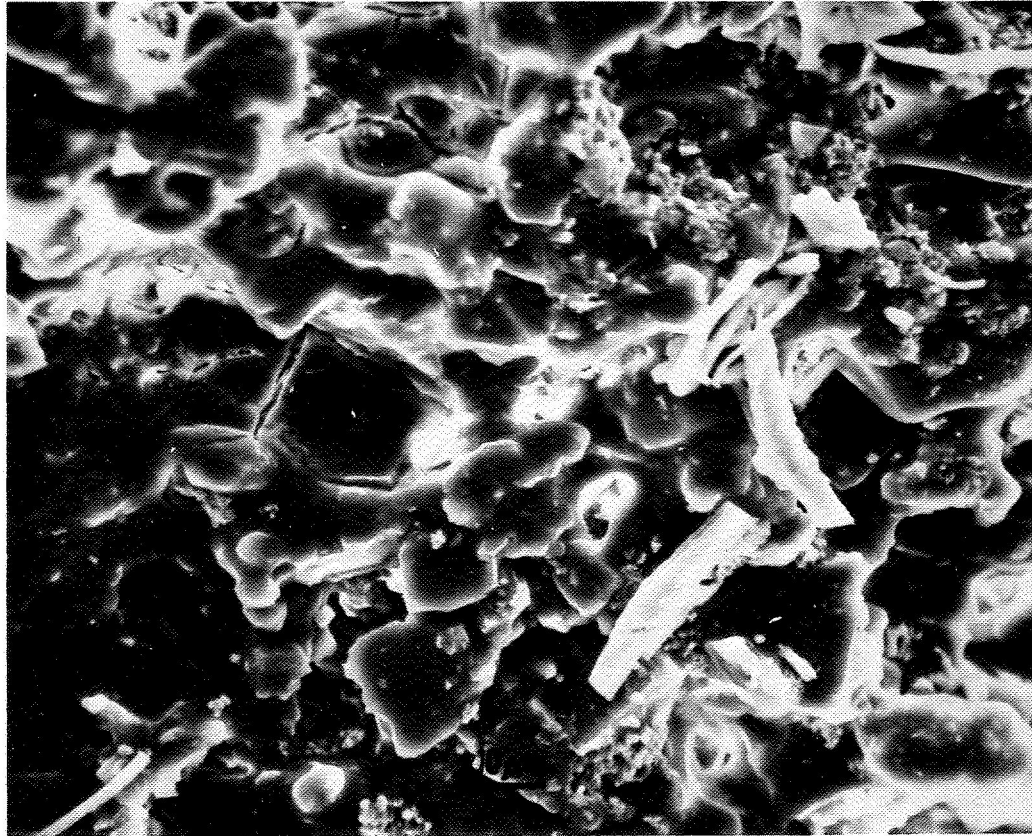
**Figure 21**

Figure 21 is a view of the LI-1525 surface. The surface appears well sealed by the glass phase.

**LMSC LI-1525 Coating  
Surface of As-received Coating**
