**HIGH GAS VELOCITY BURNER TESTS ON SILICON CARBIDE  
AND SILICON NITRIDE AT 1200° C**

by William A. Sanders and Hubert B. Probst  
Lewis Research Center  
Cleveland, Ohio 44135

TECHNICAL PAPER presented at Army Materials  
Technology Conference on Ceramics for High Performance Applications  
Hyannis, Massachusetts, November 13-16, 1973

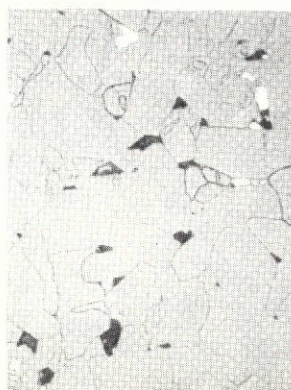
NORTON, 2 μm EQUIAXED GRAINS

A. C. E., 5 μm EQUIAXED GRAINS

AVCO, 14 μm x 40 μm TABULAR  
GRAINS

CERADYNE, 7 μm x 20 μm TABULAR  
GRAINS

Figure 6. - Microstructures of as-received hot pressed SiC materials. Etched, X750.

Microstructures of the as-received hot pressed SiC materials are shown in figure 6. The Norton material was equiaxed and had a grain size of about 2 micrometers and a rather homogeneously dispersed dark etching constituent. The A.C.E. SiC material also had equiaxed grains but the grains were larger with a size of about 5 micrometers. Dark areas, either porosity and/or pull-outs are evident in the A.C.E. material. Both the Avco and Ceradyne SiC materials had microstructures

consisting of tabular grains. The Avco SiC material was coarser grained than the Ceradyne by a factor of two, typically 14 micrometer x 40 micrometer tabular grains for Avco and 7 micrometer x 20 micrometer tabular grains for Ceradyne. Avco and Ceradyne microstructures also exhibit fairly large pores compared to either A.C.E. or Norton. The light etching phase apparent in Avco and Ceradyne are probably associated with the use of densification aides. The Norton SiC as-received microstructure is also shown by electron micrography in figure 7. Here the dark etching areas shown in figure 6 have the same shade and texture as the larger grains, however, they appear to be comprised of clusters of small grains with individual grain diameters usually less than 1 micrometer. Thus the "dark etching" areas of figure 6 would appear to be ultra fine grained SiC appearing dark because of the heavily etched grain boundaries, rather than being a separate phase.

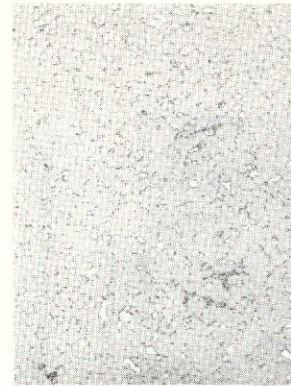
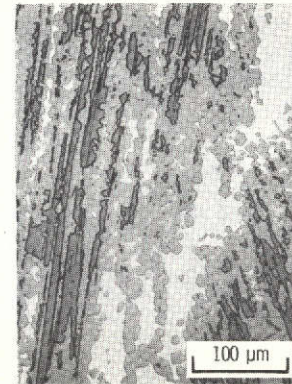
REFEL, 9 μm EQUIAXED GRAINS

KT, 40 μm EQUIAXED GRAINS

Si-SiC-C - STRIATED

Figure 10. - Microstructures of as-received reaction sintered SiC materials. Etched, X250.

As-received microstructures of the five reaction sintered SiC materials are shown in figures 10 and 11. The Refel SiC in figure 10 is a very homogeneous material with 9 micrometer equiaxed SiC grains and a uniform dispersion of free Si. KT SiC is a much less homogeneous material characterized by a wide range of grain sizes and large islands of free Si. The Si-SiC-C material has a striated structure which one would expect since the material results from the molten silicon infiltration of a carbon fiber preform. In the Si-SiC-C microstructure the

dark stringers are unreacted carbon, the light gray material is SiC and the white material is free Si. These three phases were identified by x-ray diffraction. In figure 11 the Norton low-fired and high-fired SiC materials can be compared. Both materials are prepared in the same way up to the point of firing a slip cast compact of bimodal powder particle size distribution. In the low-fired SiC, a duplex grain structure with very fine porosity is clearly evident. As a result of higher firing temperature the high-fired SiC microstructure appears as a material in the process of grain growth--the large grains growing by surface bonding with small grain clusters but with the formation of large pores.

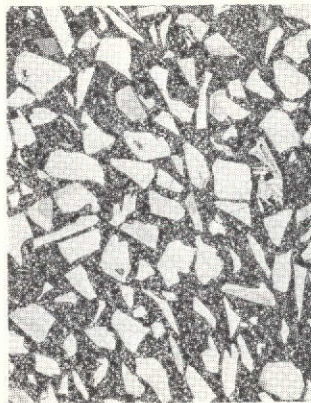
NORTON LOW FIRED SiC  
 DUPLEX GRAIN SIZE: 100  $\mu\text{m}$ , 4  $\mu\text{m}$

NORTON HIGH FIRED SiC

Figure 11. - Microstructures of as-received reaction sintered (recrystallized) SiC materials. Etched, X100.

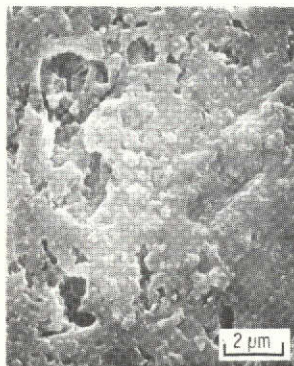
(a) NORTON (LEFT) AND A. M. E.

(b) A. M. E.

Figure 18. - (a) Microstructures of as-received reaction sintered  $\text{Si}_3\text{N}_4$  materials, unetched, X750. (b) Scanning electron micrograph of as-received A. M. E. reaction sintered  $\text{Si}_3\text{N}_4$ , 10 000.

Microstructurally, the two as received reaction sintered  $\text{Si}_3\text{N}_4$  materials were similar as shown in figure 18(a). Etched microstructures of the Norton material could not be obtained due to severe attack by the boiling  $\text{HF-H}_2\text{O}_2\text{-HNO}_3$  etchant. For this reason, the figure 18(a) microstructures are in the as-polished condition. The A.M.E. material was more amenable to etching and figure 18(b) is a scanning electron
