NASA TM X-2981

**OFF-DESIGN TEMPERATURE EFFECTS ON
NUCLEAR FUEL PINS FOR AN ADVANCED
SPACE-POWER-REACTOR CONCEPT**

*by Kenneth J. Bowles
Lewis Research Center
Cleveland, Ohio 44135*

NATIONAL AERONAUTICS AND SPACE ADMINISTRATION • WASHINGTON, D. C. • MARCH 1974

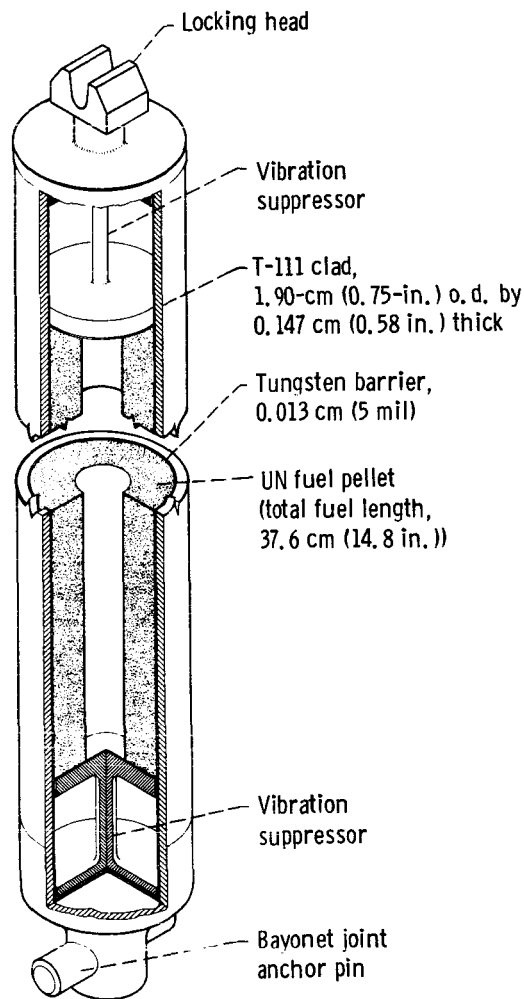
Figure 1. - Advanced power reactor concept fuel pin.

Nuclear reactors for space-power application must be designed to incorporate a high degree of safety and reliability. One space-power system concept investigated at the Lewis Research Center uses a fast-spectrum, lithium-cooled nuclear reactor (ref. 1). The reactor core is made up of cylindrical fuel pins consisting of uranium mononitride (UN) fuel clad with tungsten-lined T-111 (Ta-8W-2Hf alloy). These fuel pins must perform at a nominal cladding temperature of about 990°C for at least 50 000 hours. A schematic of the reactor concept fuel pin is shown in figure 1. The UN fuel is incompatible when in direct contact with tantalum alloys at the temperature of operation ($\sim 990^{\circ}\text{C}$) specified for this reactor (ref. 2). For this reason, a thin tungsten liner is interposed between the fuel and the cladding. T-111 alloy caps seal the helium filled pins. T-111 vibration suppressors and tungsten disks separate the UN fuel from the end caps.

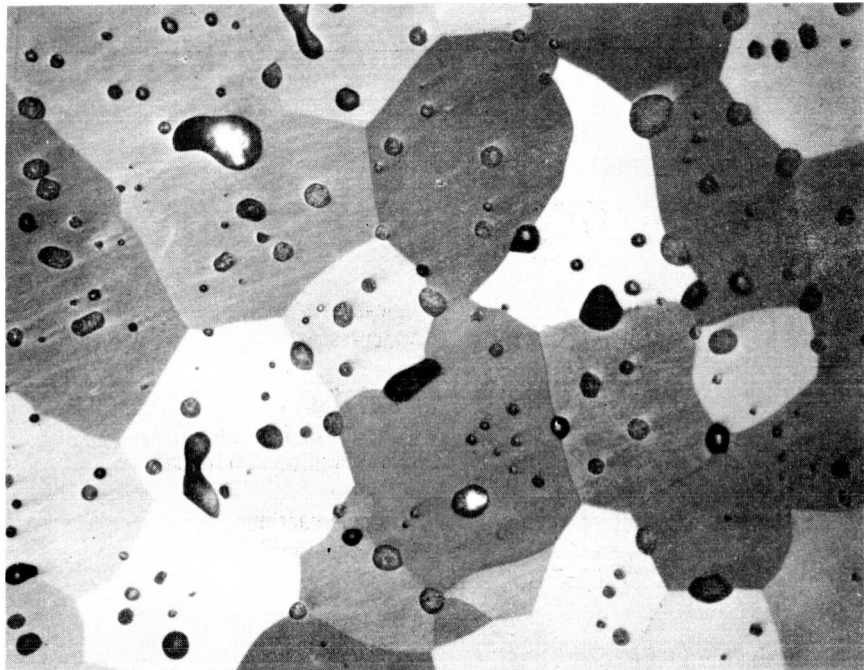
Figure 2. - Microstructure of as fabricated 95 percent dense UN fuel. X 500.

Figure 2 shows the microstructure of the fuel as fabricated. No second phases are visible at a magnification of ×500.

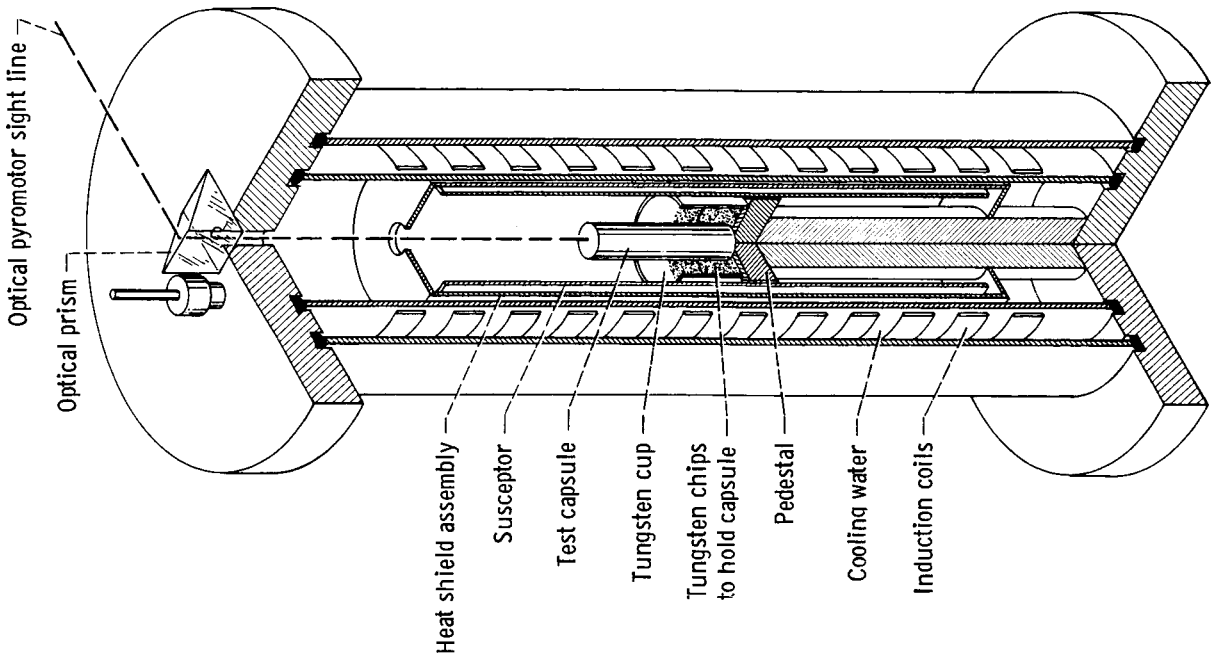
Figure 4. - Capsule test apparatus.

Figure 4 shows a sketch of the vacuum induction furnace with the test capsule in place within it. The test furnace is a vacuum (1.33×10^{-3} N/m² (10^{-7} torr)) induction furnace with a water-cooled quartz tube as containment. Temperature measurements were made with an optical pyrometer which was calibrated with a National Bureau of Standards standard lamp. The estimated accuracy of the temperature readings is about ± 0.5 percent. The cup with the capsule was positioned on the furnace pedestal so that direct line of sight between the pyrometer and the blackbody hole in the top of the capsule could be made through a glass prism on the top of the furnace.

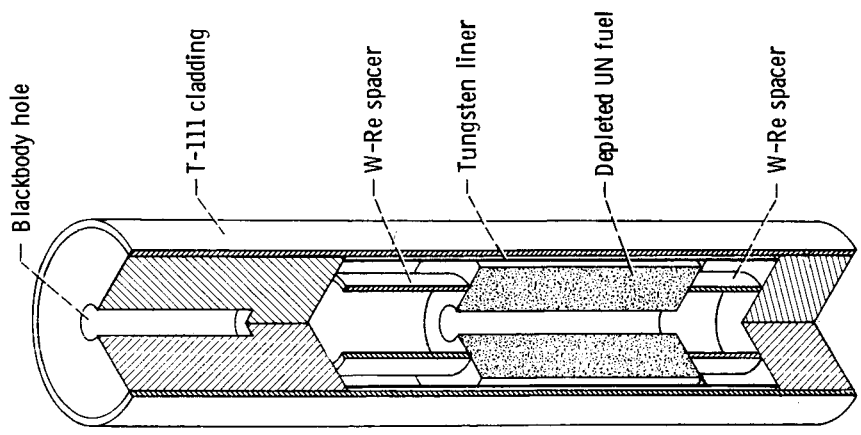
Figure 3. - Test capsule configuration.

The simulated fuel pins (capsules) prepared for these tests were all basically identical. A sketch of the test capsule is shown in figure 3. Each capsule contained one

cylindrical UN fuel pellet measuring 0.787 centimeter (0.310 in.) in diameter and 0.958 centimeter (0.377 in.) long with a 0.254-centimeter (0.100-in.) diameter axial hole. The cladding was made from a 3.17-centimeter (1.25-in.) long piece of T-111 tubing, 0.952 centimeter (0.375 in.) in diameter with a 0.069-centimeter (0.027-in.) wall thickness. To prevent direct contact between the UN and the T-111, a loose wrapping of 0.0030-centimeter (0.0012-in.) thick tungsten foil was inserted into the tubing. This loose cylinder was 1.91 centimeters (0.75 in.) long. For six of the capsules, one layer of tungsten was used to line the cladding inside diameter. In the remaining two capsules, two layers of tungsten were used.

To prevent the fuel pellet from moving axially within the capsule and touching the T-111 end plugs, a thin-walled piece of 0.64-centimeter (0.25-in.) diameter by 0.318-centimeter (0.125-in.) long tungsten - 26-percent rhenium (W-26Re) alloy tubing was used as a spacer at each end of the pellet. Tungsten spacers were not used because tungsten tubing was not readily available for this series of tests and the W-26Re tubing served the purpose. The end plugs were machined from T-111 rod to fit snugly within the cladding. The top end plug was 0.960 centimeter (0.378 in.) long and contained a 0.152-centimeter (0.060-in.) diameter by 0.762-centimeter (0.300-in.) long blackbody for pyrometer sightings.

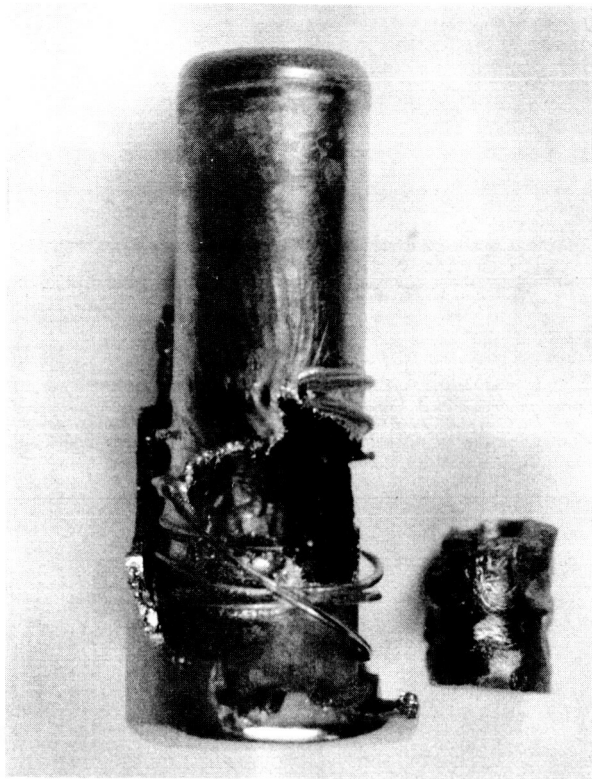
Figure 5. - Damaged test capsule after heating to 2700°C for 1 minute.

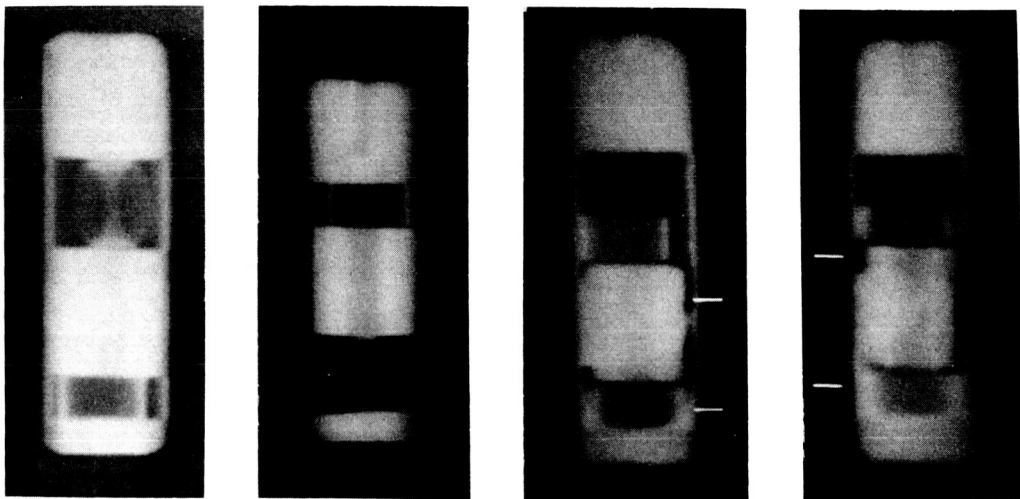
(a) Untested capsule.

(b) Capsule 4; heated 8 hours at 2400°C.

(c) Capsule 6; heated 1 hour at 2520°C.

(d) Capsule; heated 10 minutes at 2600°C.

Figure 6. - Radiographs of test capsules showing effect of increasing temperature and time on fuel pin damage.

From an examination of the posttest radiographs of capsules 4, 6, and 7 (fig. 6), the progression of the reaction between the UN fuel and the cladding with increasing temperature (and decreasing time) appears as (1) a thinning of the cladding, (2) a decrease in the diameter of the fuel, and (3) the presence of a meniscus (showing solidified material which apparently was liquid at the test temperature) at the bottom of the capsule.

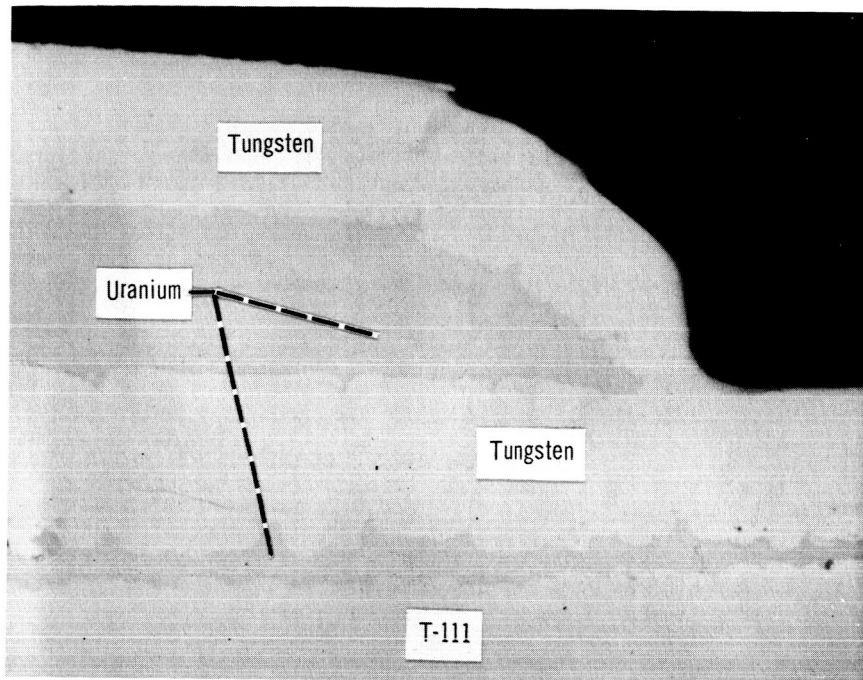
Figure 7. - Fuel transport into tungsten liner overlap. Capsule heated to 2500°C for 10 minutes. X500.

of reaction observed at this temperature. This was at the overlap in the layers of tungsten liner (see fig. 7). Uranium was transported from the fuel to the overlap area where it penetrated into both the tungsten liner and the T-111 cladding. This penetration was very slight, and a ductility test indicated no apparent decrease in the ductility of the T-111. A part of the area where reaction was observed in capsule 5 is shown in the electron-micrograph of figure 8. This area is adjacent to the overlap area shown in figure 7. The uranium phase has penetrated the T-111 alloy cladding and separated a 0.0013-centimeter (0.0005-in.) layer of the T-111 from the rest of the wall. This uranium phase also is present on the fuel side of the tungsten liner as a thin 0.0003-centimeter (0.0001-in.) layer. No tungsten or tantalum was detected in the uranium phase. No uranium was detected in either the T-111 or the tungsten phases.

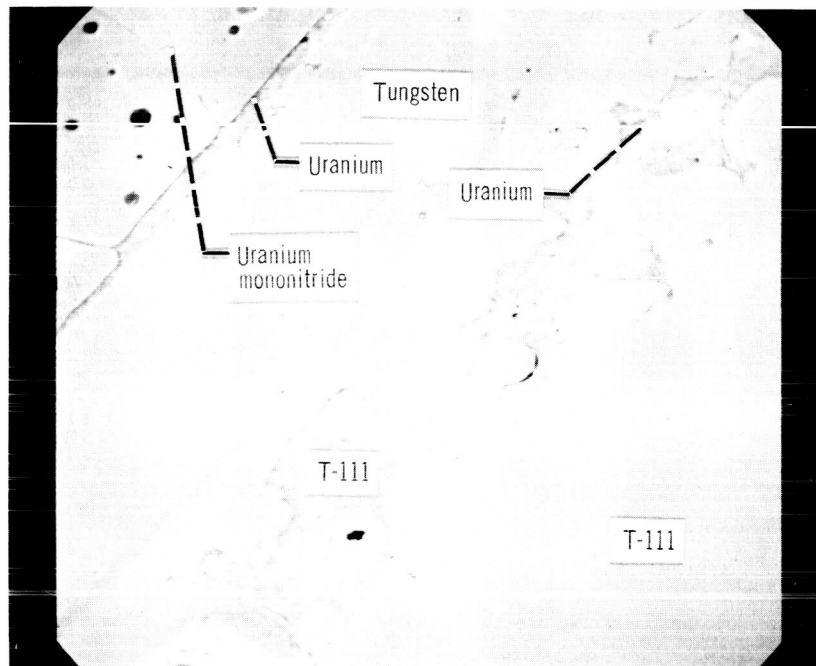
Figure 8. - Reaction area in capsule 5 heated to 2500°C for 10 minutes. Scanning electron micrograph; 20° tilt. X1000.

Figure 8 shows that fuel-liner and fuel-cladding reactions did occur. The most severe attack is at the top and bottom of the fuel pellet where the pellet touched the tungsten capsule wall liner. The fuel, liner, and cladding reacted at these points with the reaction products of tantalum, tungsten, and uranium remaining. Varying degrees of damage occurred to the whole inner surface of the capsule. The surface grains of the fuel pellet densified and doubled in size. The grain boundaries of these surface grains widened, and a second-phase material was observed in these widened boundaries. This second phase was identified as free uranium.

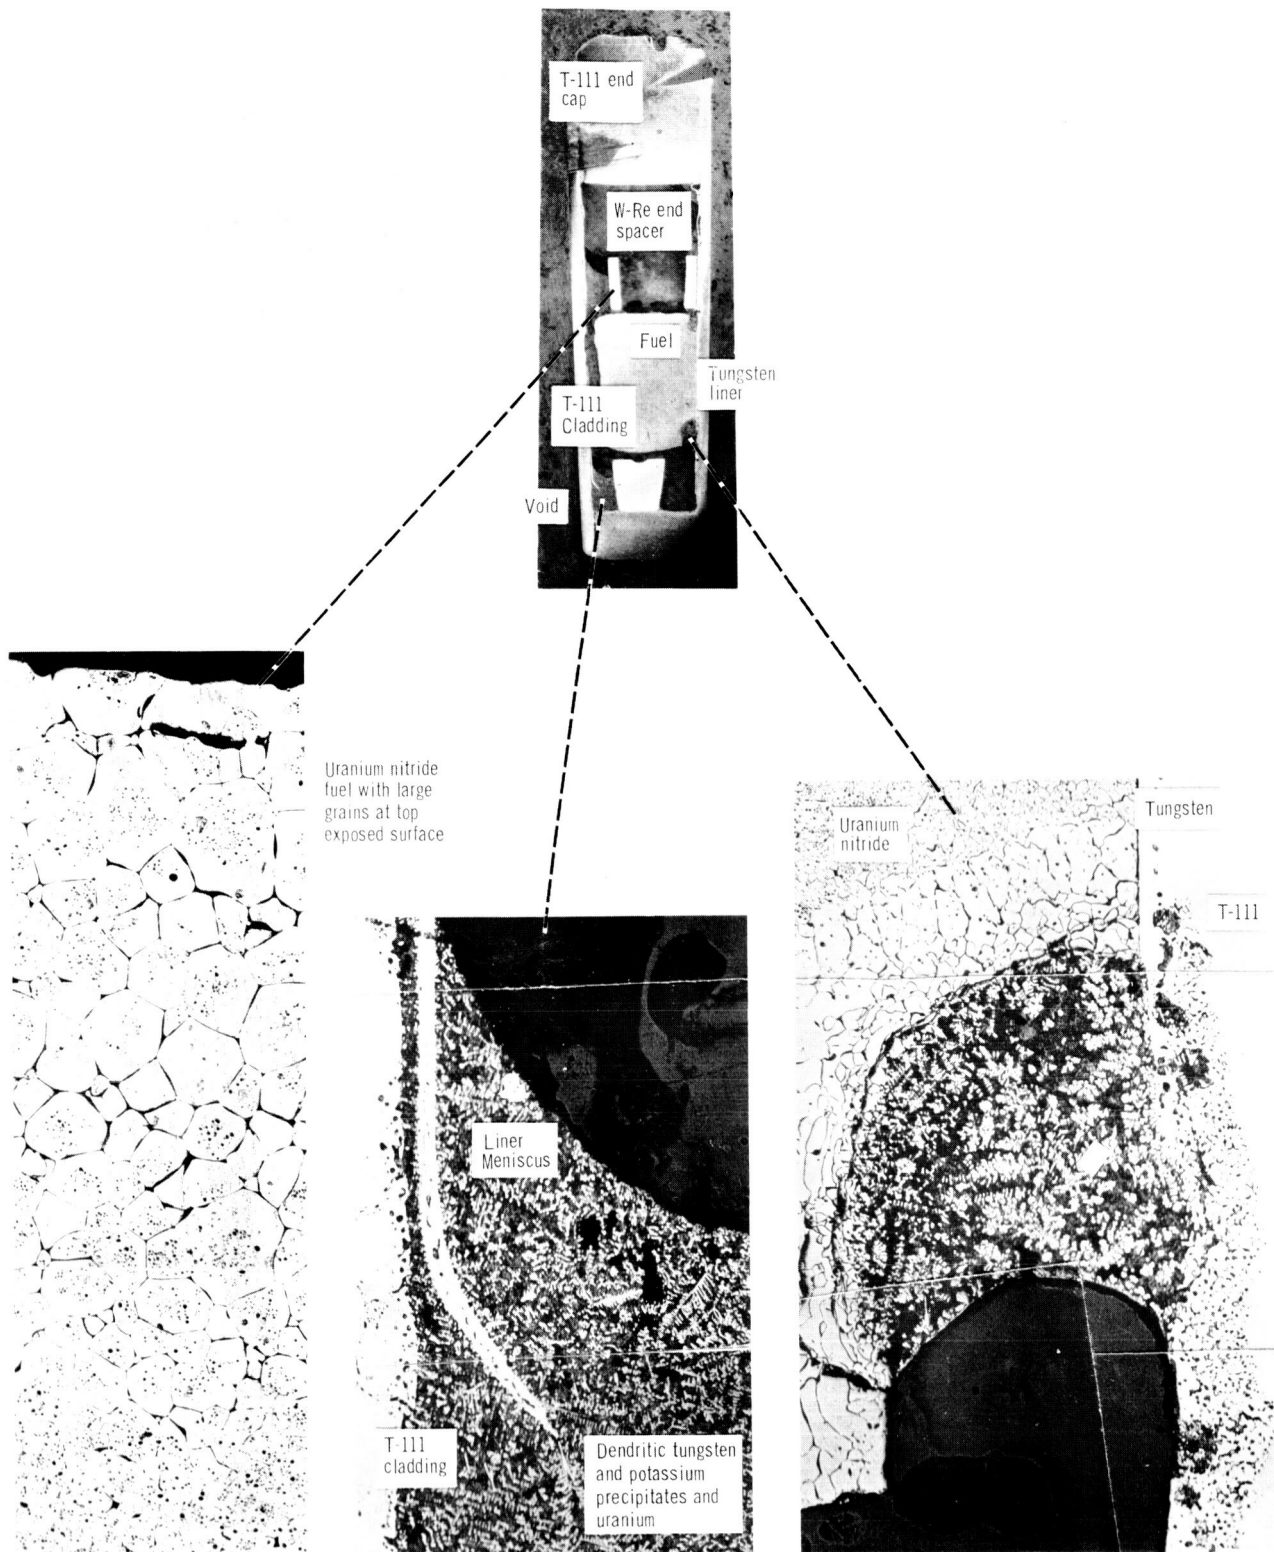
Figure 9. - Longitudinal section of fuel capsule 7 (heated to 2600° C for 10 min.) showing reaction areas and force uranium with precipitated tungsten and tantalum. Photomicrograph magnification, X125.

Capsule 7 (2600^o C for 10 min) showed much more extensive reaction and damage than capsule 5 (2500^o C for 10 min). (See figs. 7 to 9.) Penetration of the grain boundaries of the T-111 can be seen in the figures: Dissolution of both the tungsten liner and the T-111 cladding are evidenced by the uniform thinning of the liner and the capsule wall. Fuel grain growth and a reduction of porosity with grain boundary widening are at and near fuel surfaces not in contact with the capsule walls. The large void area between the fuel and the capsule cladding (fig. 10) was occupied by fuel before the test. The void indicates that fuel has been lost from the fuel pellet. Fine precipitates, identified by scanning electron microscopy (SEM) as tungsten and tantalum, are visible at or near all areas of reaction where solidified free uranium was formed. At temperature, liquid uranium apparently collected either at the bottom of the capsule or where surface tension forces held it. On cooling, the uranium solidified and the meniscus at wetted surfaces was preserved. Figures 7 to 10 are typical of the microstructure of capsule parts in those capsules where temperature-time induced changes occurred. Figure 11 shows an SEM scan of an area of more severe reaction in capsule 7 (2600^o C, 10 min). The SEM spectrometer results indicate the following: Area A is a uranium phase with a trace of tungsten; area B is a phase consisting of tungsten, tantalum, and uranium; and area C is a uranium phase containing a trace of tungsten.

From the nature of the attack (shown in fig. 9), it is deduced that decomposition of the fuel pellet occurred at the pellet surfaces. Nitrogen was released from the fuel pin leaving free uranium on the surfaces of the pellet. (Ref. 10 reports the presence of free uranium at the surface of UN which had been heated under vacuum at 1835°C .) The free uranium then apparently wet the tungsten liner and the tungsten-rhenium end spacers where they contacted the fuel pellet. As the liquid uranium spread, it penetrated all liner cracks, the liner overlap, and the liner-cladding interface. Thus, when the dissociation of the fuel pellet above 1800°C produces sufficient free uranium, the entire interior surface of the capsule can be wetted and damaged by the liquid uranium. In an actual reactor, the fuel also would be redistributed in the fuel pin by this mecha-

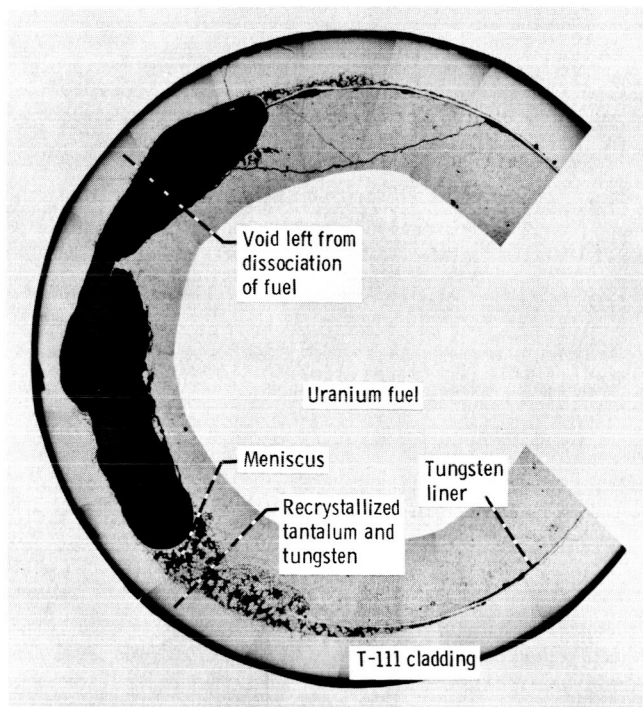
Figure 10. - Fuel-cladding reaction resulting from heating capsule to 2600°C for 10 minutes. The central part of the fuel is not shown. X50.

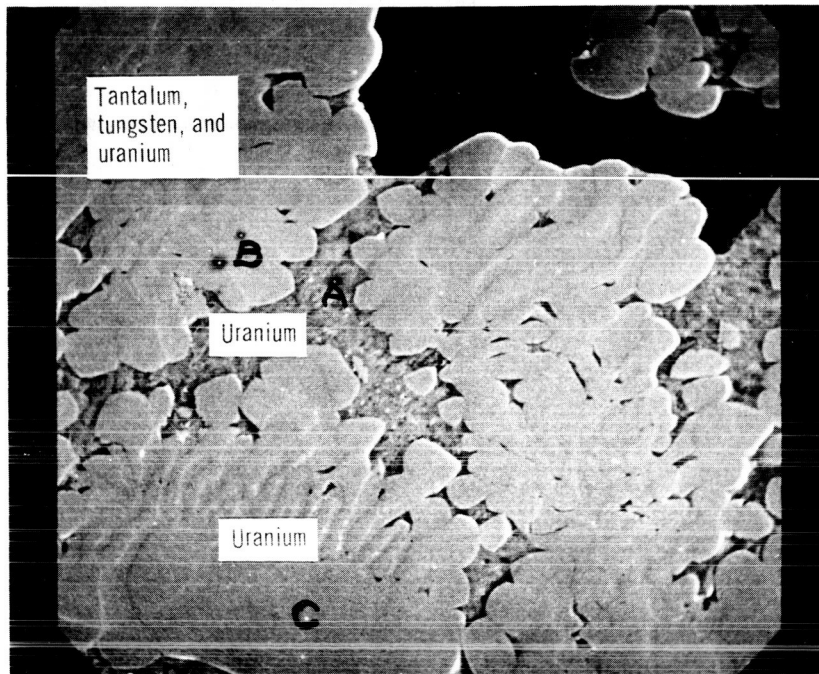
Figure 11. - Reaction area resulting from holding capsule 7 at 2000°C for 10 minutes. Scanning electron micrograph; 20° tilt. X1000.

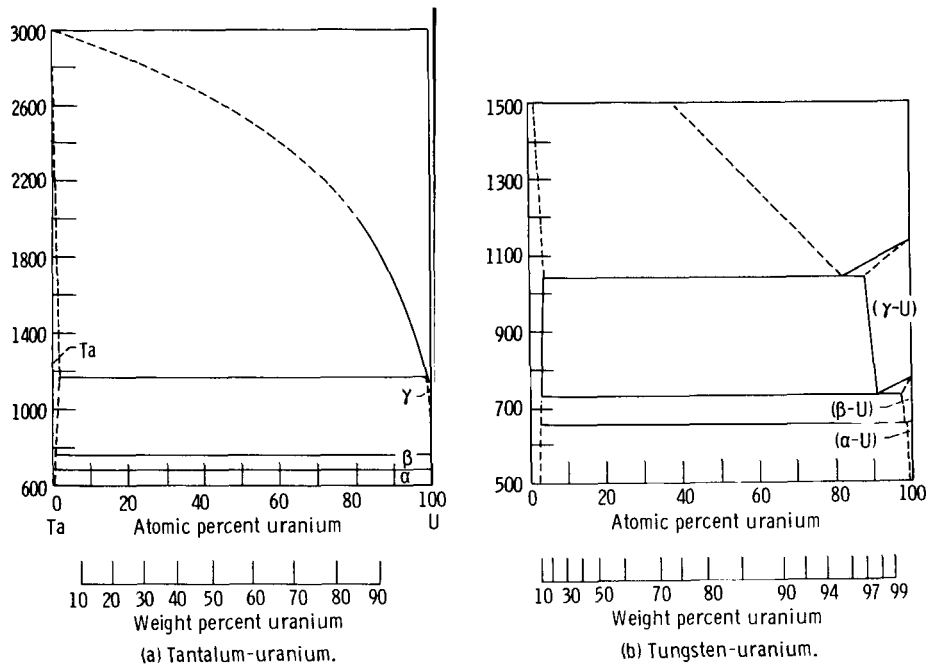
Figure 12. - Phase diagrams (from ref. 12).

The phase diagrams for the uranium-tantalum (fig. 12(a)) system and the uranium-tungsten (fig. 12(b)) system indicate solubility of tantalum and tungsten in liquid uranium (ref. 12). As the capsule cools the tungsten and tantalum precipitate in the uranium.
