NASA TECHNICAL NOTE

NASA TN D-7617

**PERFORMANCE OF COATED COLUMBIUM
AND TANTALUM ALLOYS IN PLASMA
ARC REENTRY SIMULATION TESTS**

by Stanley R. Levine and John P. Merutka

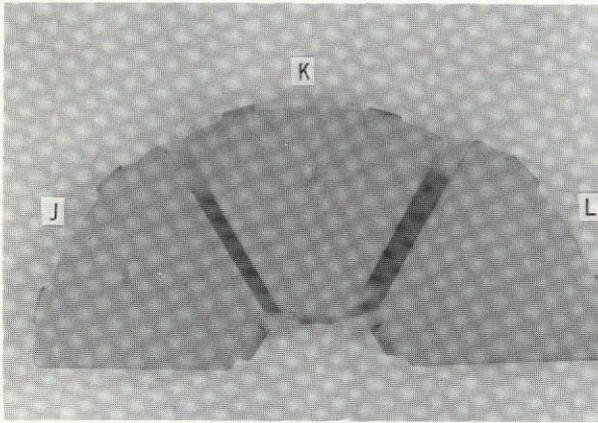
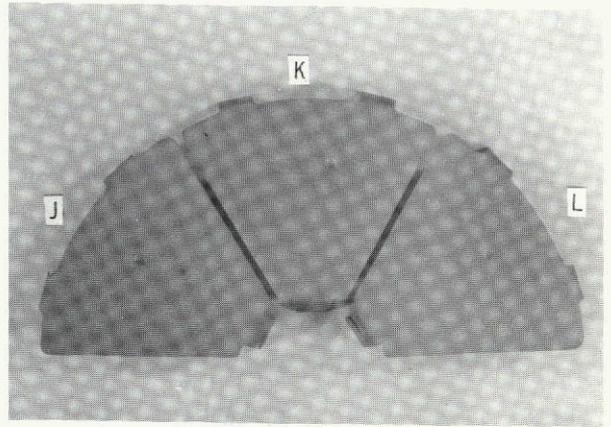
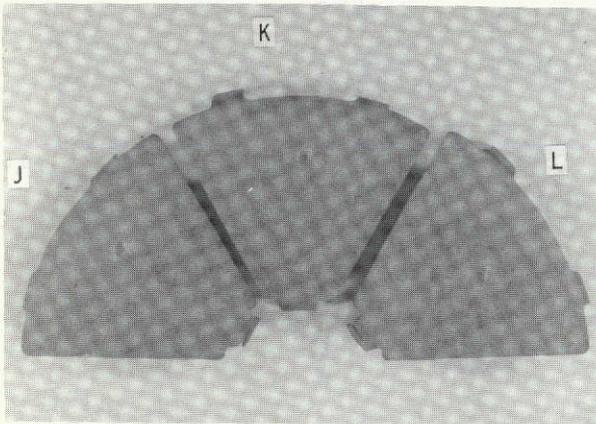
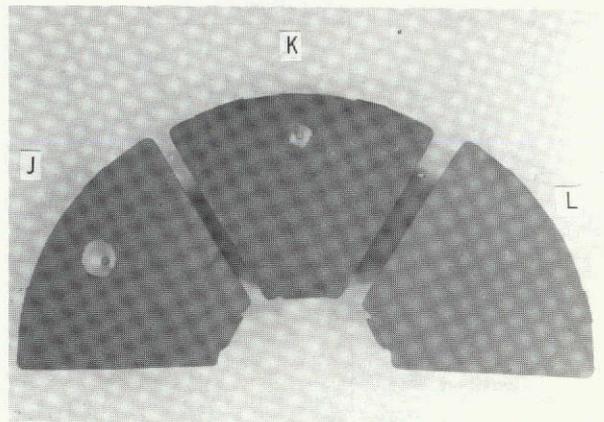
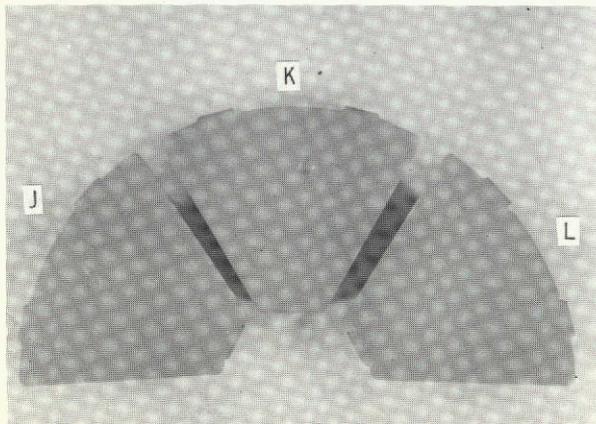
Figure 1. - Intentionally impact damaged specimens prior to test. Specimens J and K by 30 meter per second pellet; specimen L by 15 meter per second pellet.

All twelve coated specimens from each major alloy/coating group were inspected, measured for total thickness, and weighed before nine were intentionally defected. The specimens were defected to simulate possible types of in-service coating damage such as impact by runway debris, meteorites, or handling abuse. Three specimens of each group were defected by a 0.45-centimeter-diameter pellet fired from an air rifle. The pellet struck the coated specimens at either 15 or 30 meters per second causing a 0.20 to 0.30-centimeter-diameter cupped impression in the surface with a depth of 0.30 to 0.50 centimeter. Pellet impact caused coating cracking in all cases, but the 30 meter per second impact also caused visual cracking and some loss of coating on the side opposite the impact. Figure 1 shows typical intentionally impact defected areas before test.

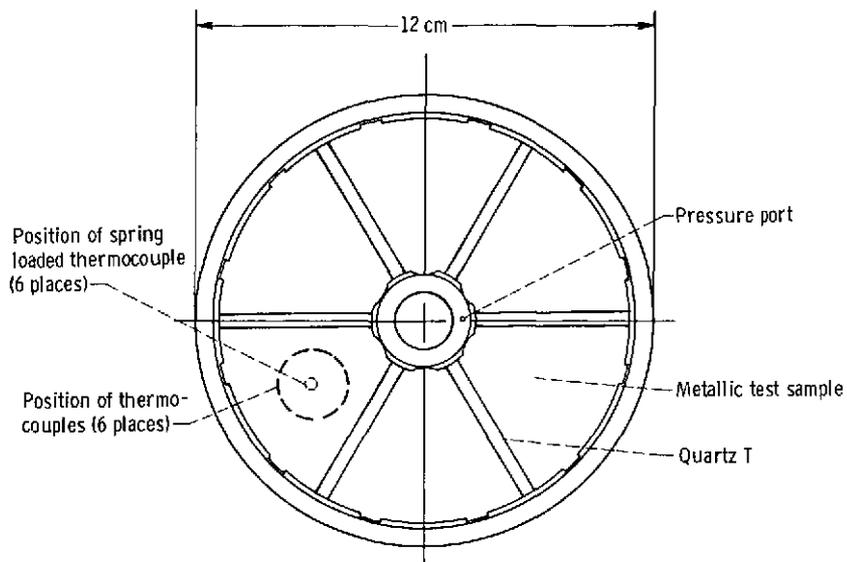
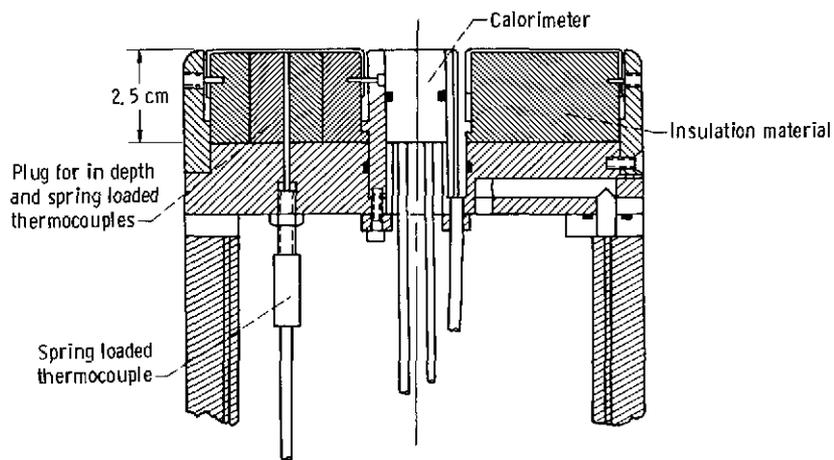
(a) Front view.

(b) Cross section.

Figure 2. - Metallic test model (ref. 6).

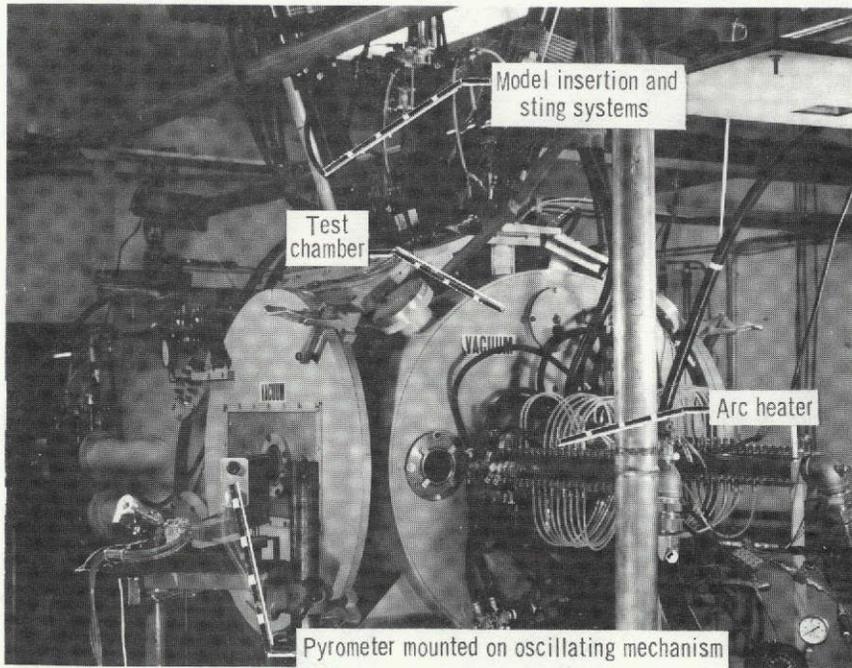
Figure 3. - 1.5-Megawatt plasma arc reentry simulation facility (ref. 6).

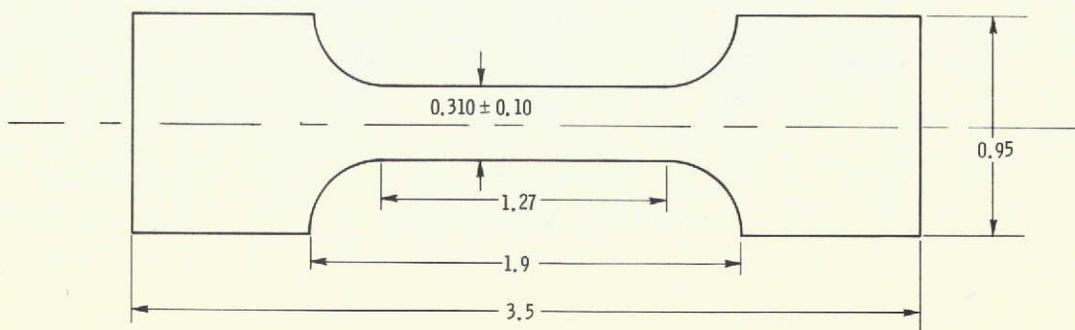
(a) Layout of tensile specimen on 60° plasma arc specimen.

(b) Tensile specimen.

Figure 4. - Tensile specimen configuration. Dimensions in centimeters.

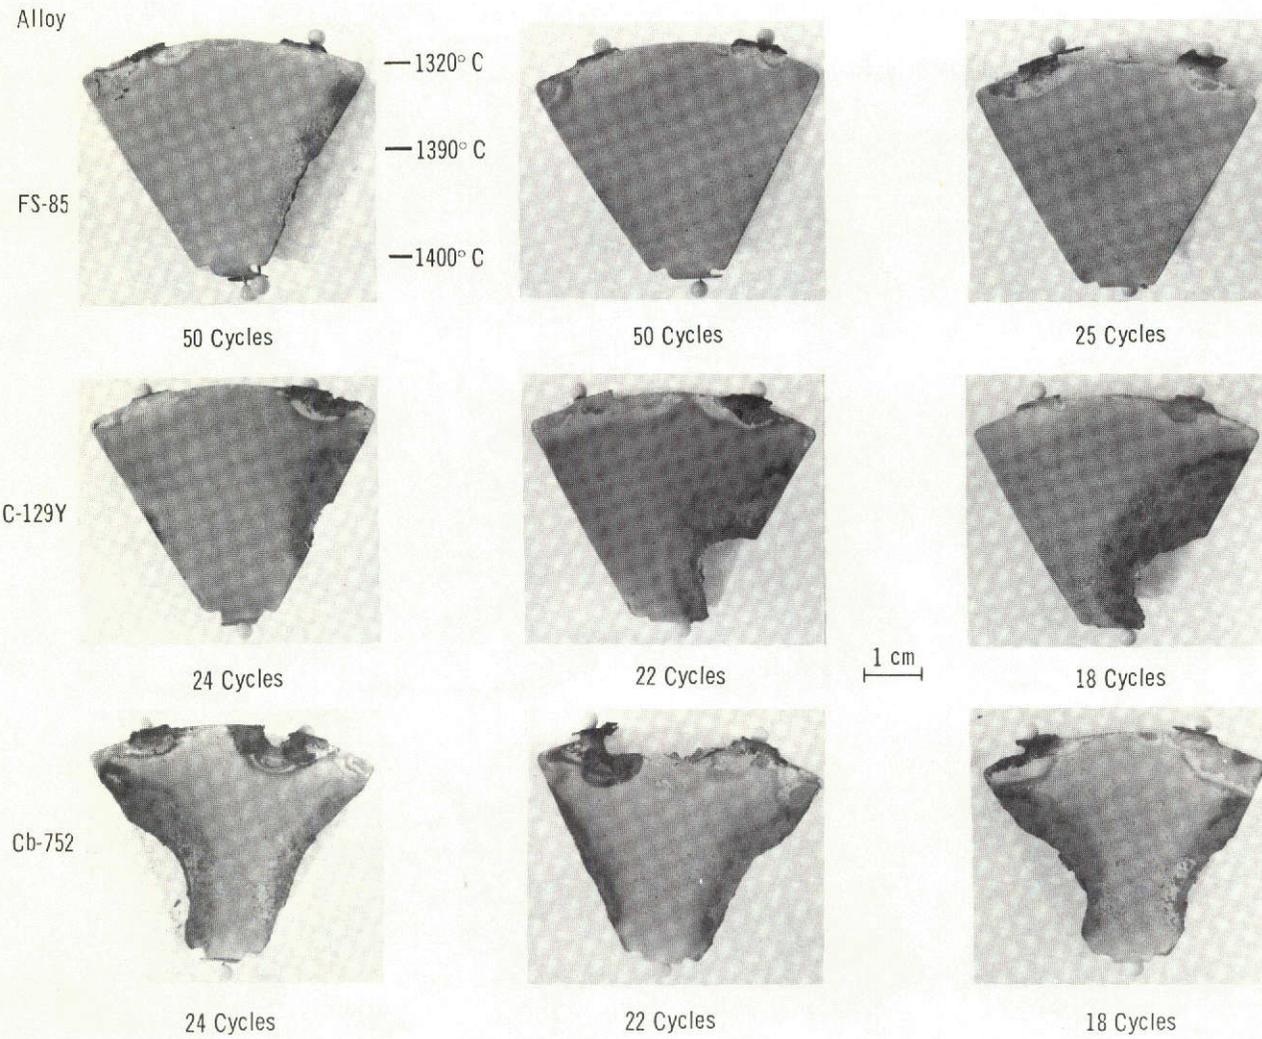
Figure 5. - R512E coated columbium alloys after 1390° C plasma arc exposure.

Visual changes. - Photographs of R512E coated FS-85, C-129Y, and Cb-752 specimens after plasma arc exposure are shown in figures 5 to 7. All FS-85 specimens and the defected C-129Y and Cb-752 specimens were exposed for the scheduled number of cycles. The nondefected Cb-752 and C-129Y specimens (fig. 5) all suffered local coating breakdowns at edges and were removed from the test earlier than the scheduled 25 or 50 cycles. Average temperatures at three radial positions are shown in figure 5.

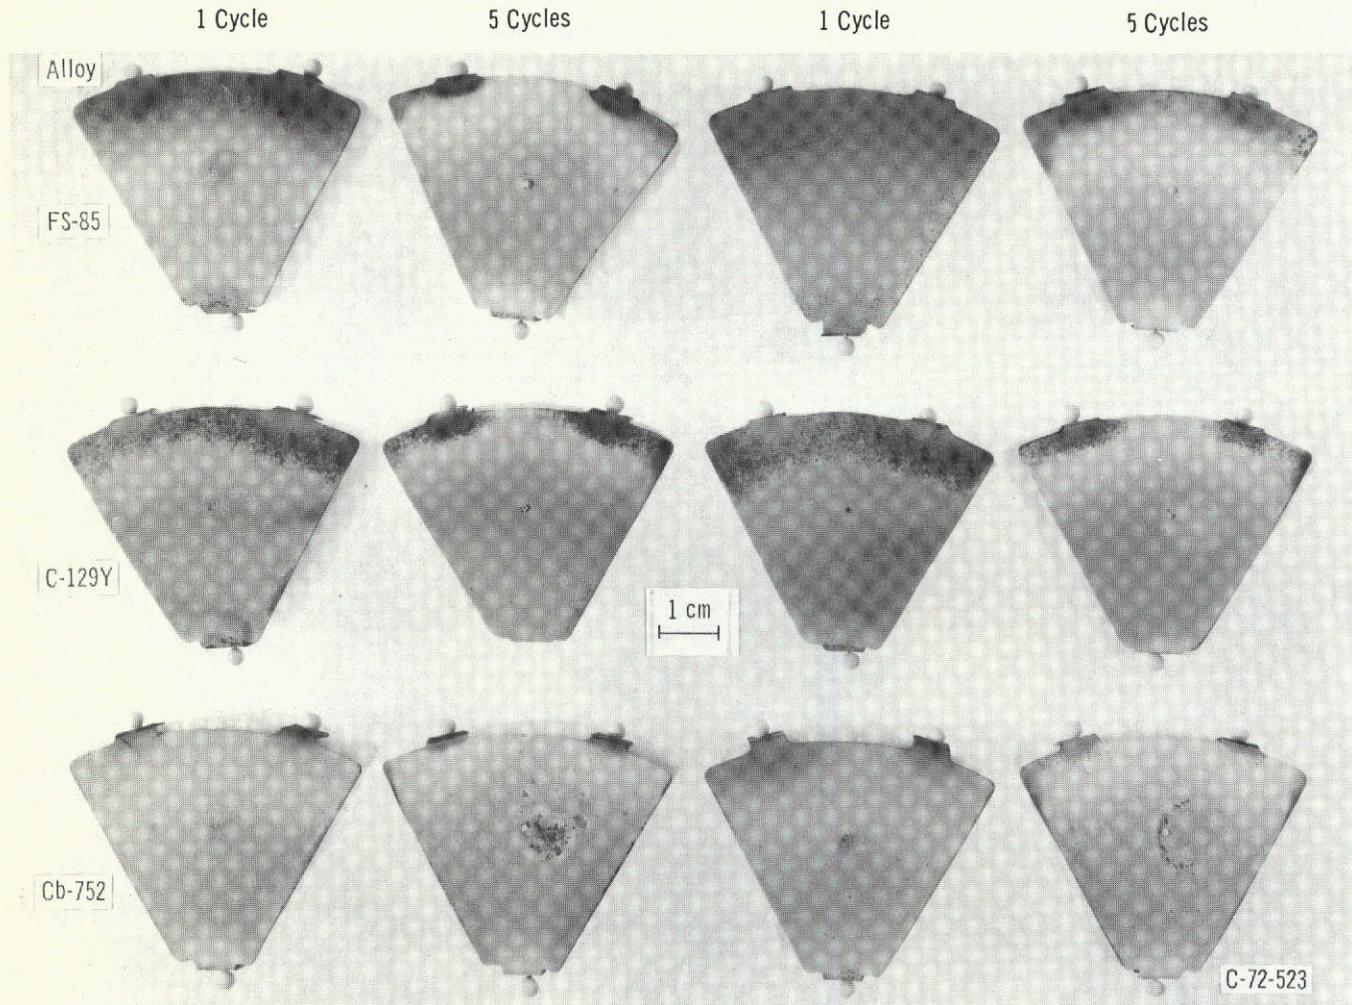
(a) Through-hole defect, 0.092 centimeter.

(b) Coating removal defect, 0.092 centimeter.

Figure 6. - Intentionally defected R512E coated columbium alloys after 1390° C plasma arc exposure.

As is evident from figures 6 and 7, catastrophic growth of the defects in coated columbium does not occur under the temperature and flow conditions of this series of exposures. The impact and coating removal damaged specimens did not develop through holes as a result of oxidation. The through-hole and edge notch defects tended to seal as a result of oxidation of the substrate.

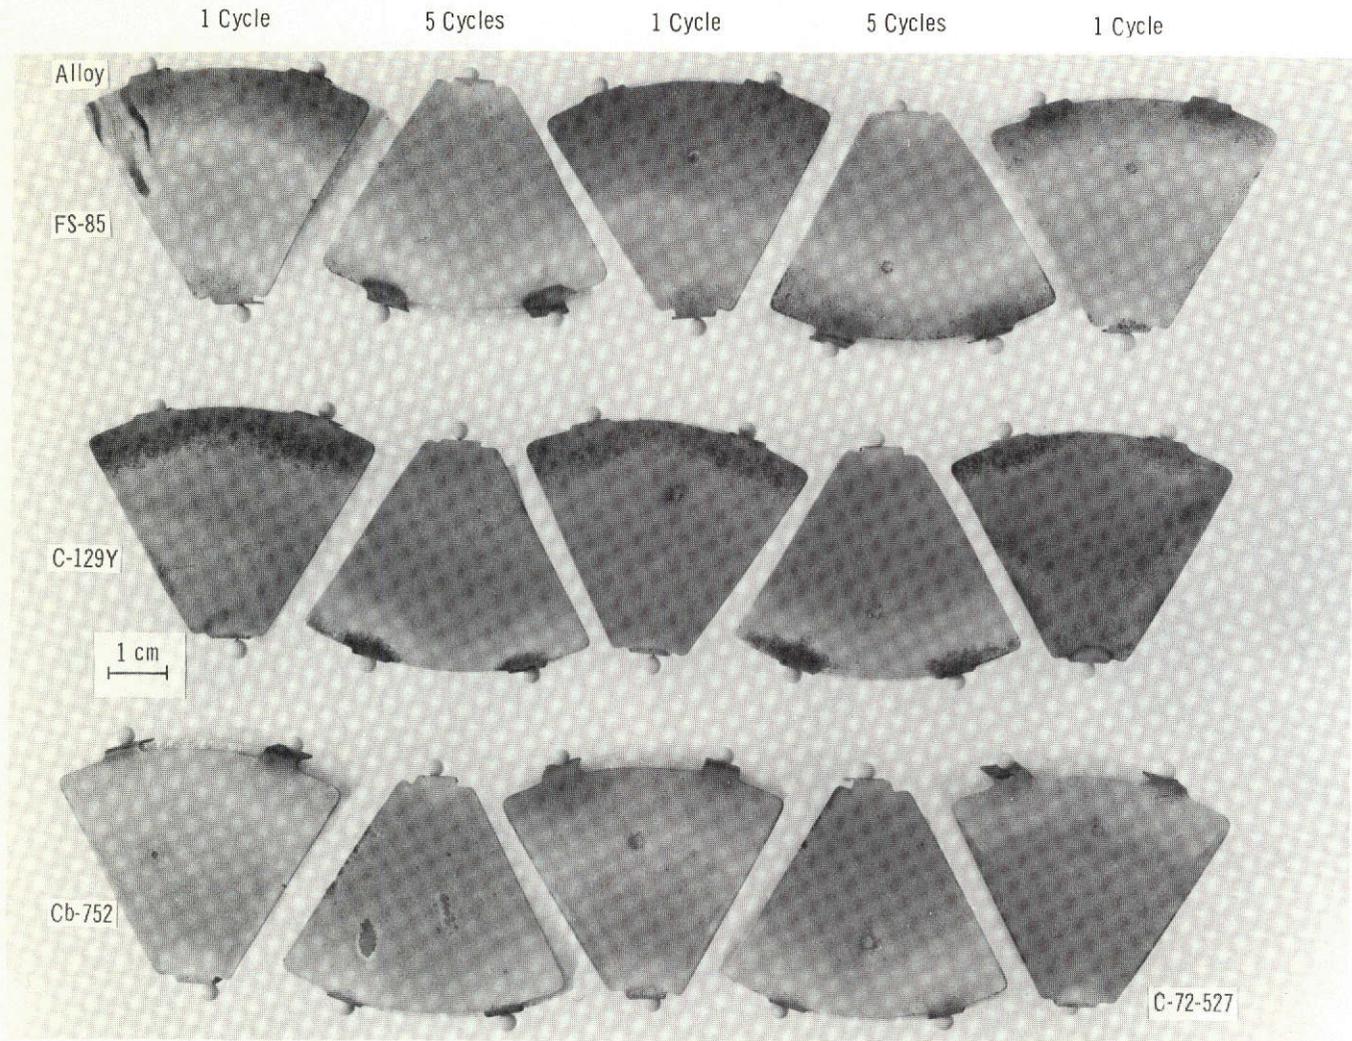
(a) Edge notch defect.

(b) Impact defect, 0.35 gram, 30 meters per second.

(c) Impact defect, 0.35 gram, 15 meters per second.

Figure 7. - Intentionally defected R512E coated columbium alloys after 1390° C plasma arc exposure.

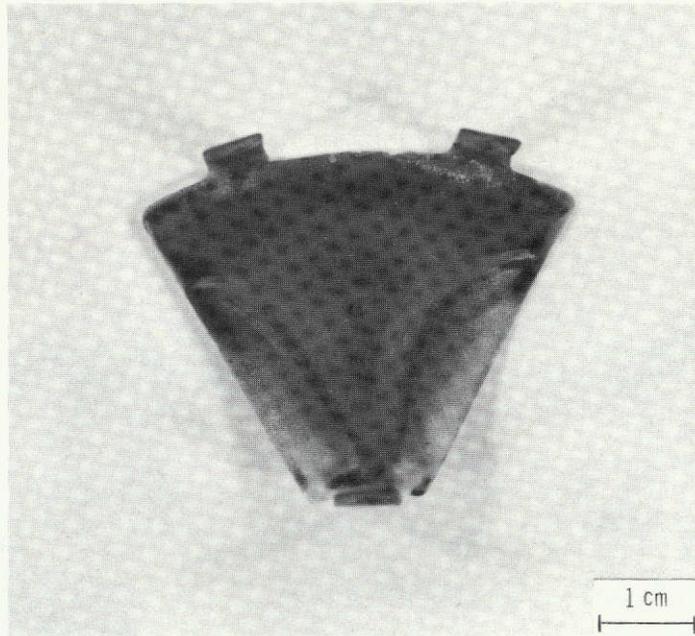
Figure 8. - Oxidation pattern on underside of R512E coated FS-85 after five plasma arc exposure cycles at 1390°C.

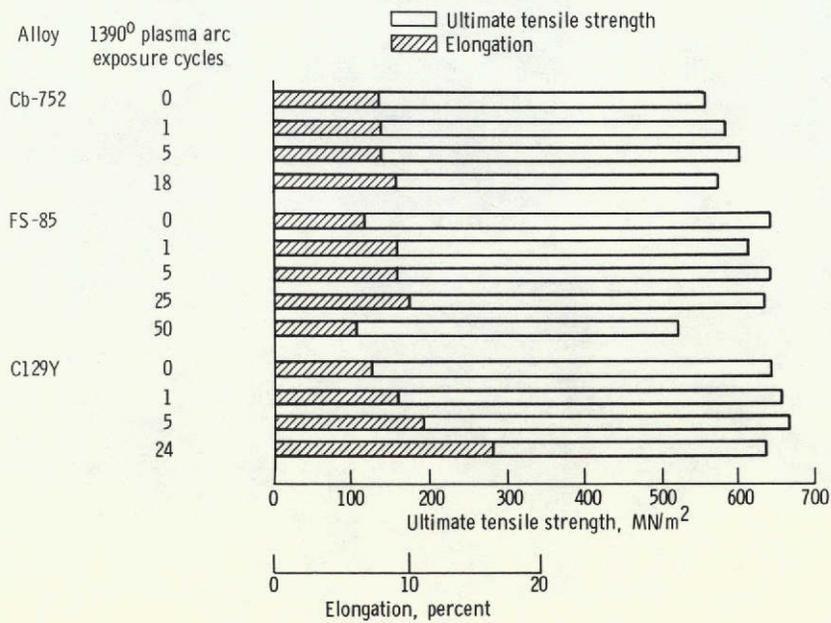
Figure 9. - Room temperature tensile test results for R512E coated columbium alloys. Ultimate tensile strength based on substrate remaining after coating application.

Tensile test results. - Results of tensile tests on as-coated and plasma arc tested coated columbium alloys are presented in figure 9. The short gage length of the tensile specimen and the friction gripping method did not permit instrumentation to determine an accurate yield strength. All exposed tensile specimens were cut so that there was no region of oxygen ingress at the gage sections as a result of coating breakdown or intentional defects.

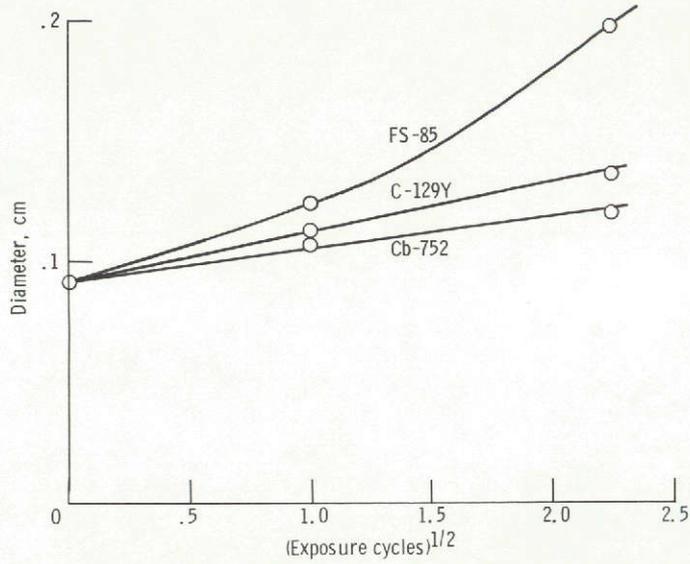
Figure 10. - Metal recession at 0.092-centimeter-diameter through-hole defects in R512E coated columbium alloys after plasma arc exposure at 1390° C.

Defect growth. - The four types of intentional coating damage (through-hole, coating removal from the upper surface, impact damage, and edge notching) did not produce serious columbium substrate degradation in up to five plasma arc exposure cycles. Only the growth of the through-hole defect was followed quantitatively. The increase in diameter of the defect as a result of substrate oxidation is plotted in figure 10 - the defect

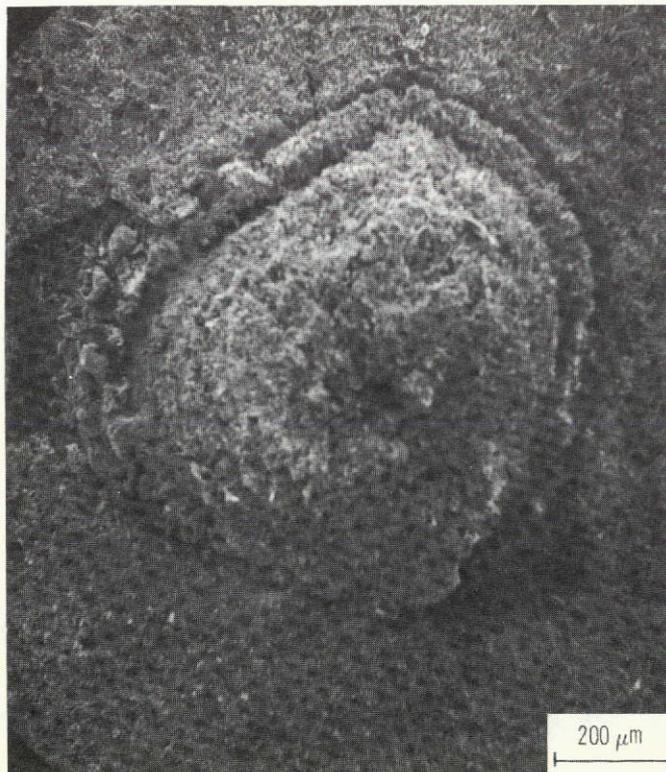
Figure 11. - Scanning electron micrograph showing plugging of 0.092-centimeter through-hole defect in R512E coated FS-85 with substrate oxide after five plasma arc exposure cycles at 1390° C. Scanning electron microscope conditions: 7 picoamperes, 25 kilovolts.

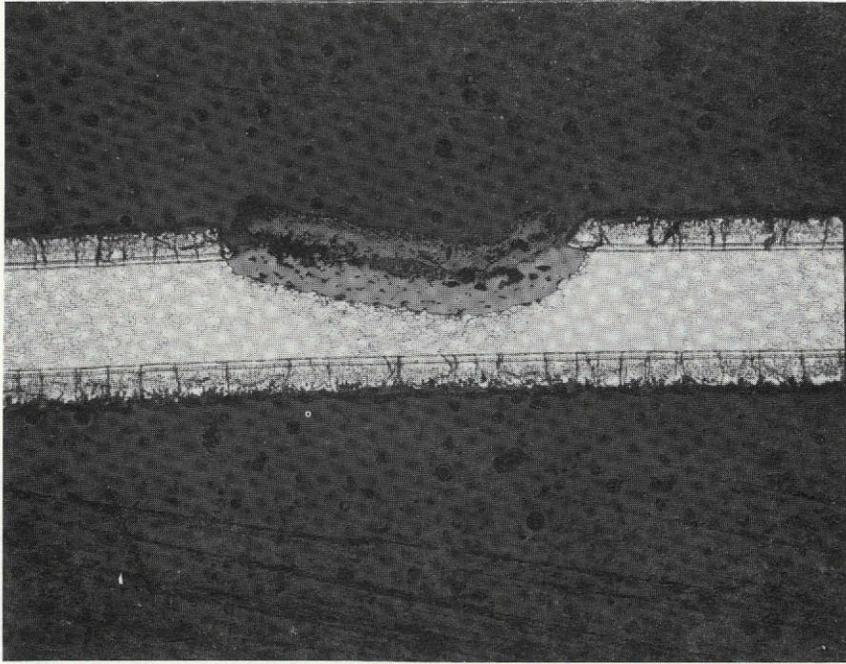
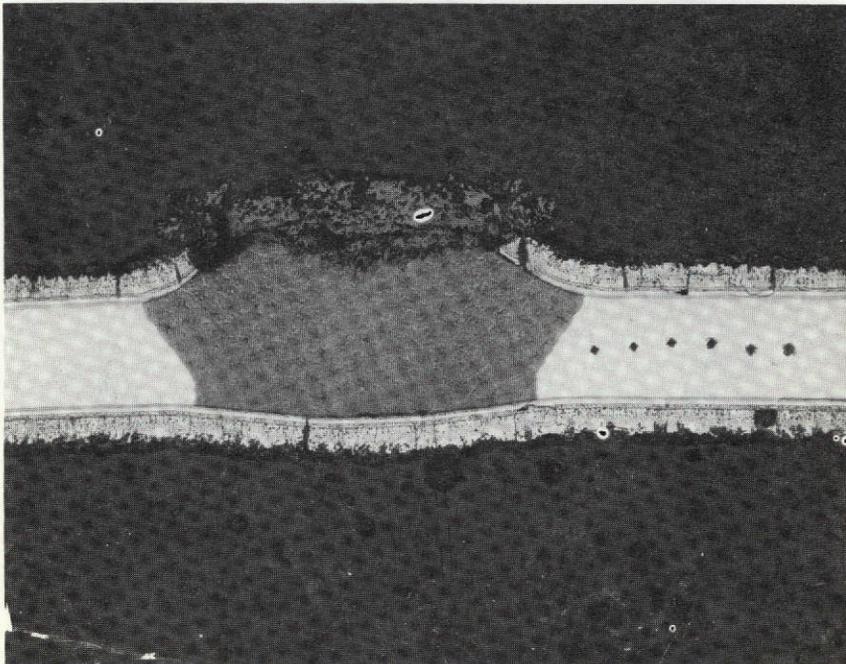
(a) One cycle.

(b) Five cycles.

Figure 12. - Microstructures of R512E coated FS-85 at 0.092-centimeter-diameter intentional coating removal defects after plasma arc exposure at 1390° C.

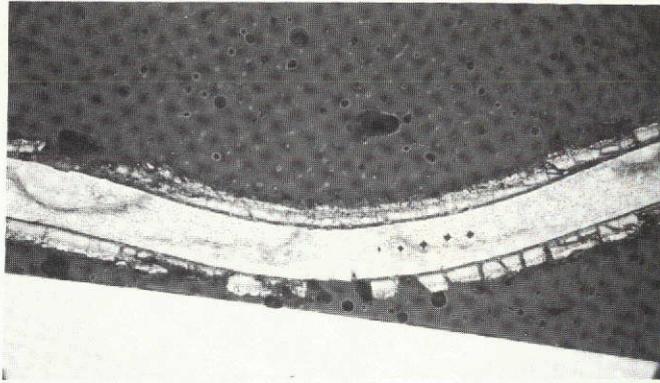
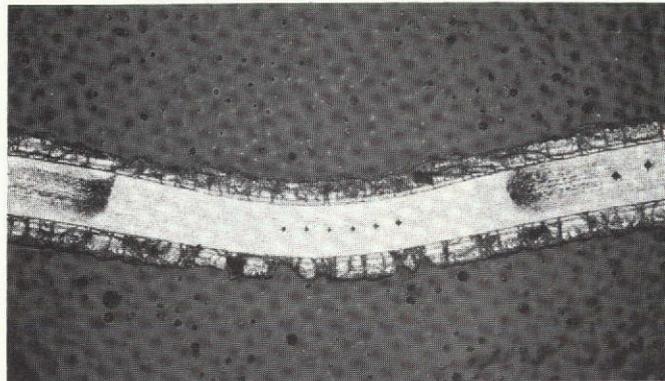
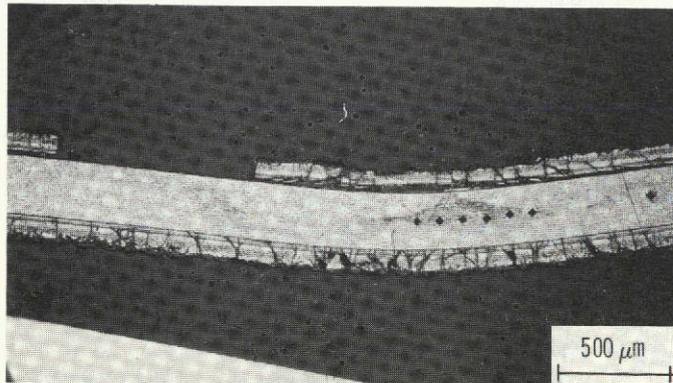
(a) Exposed for one cycle after impact by 30 meter per second, 0.18-gram, 0.45-centimeter-diameter pellet.

(b) Exposed five cycles after impact by 30 meter per second, 0.18-gram, 0.45-centimeter-diameter pellet.

(c) Exposed for one cycle after impact by 15 meter per second, 0.18-gram, 0.45-centimeter pellet.

Figure 13. - Microstructures of R512E coated FS-85 at intentional impact damage sites after plasma arc exposure at 1390° C.

diameter increased only 0.02 to 0.1 centimeter. This is comparable to the metal recession observed at through-hole defects in a static furnace environment (refs. 1 and unpublished information obtained from J. D. Çulp, et al., McDonnell-Douglas Astronautics Co., under NASA contract NASA 3-15546). The through-hole defects tended to plug with substrate oxide. After five cycles, the defect in FS-85 was completely plugged with oxide as shown in the $\times 75$ scanning electron micrograph (fig. 11). For the three alloys, the other three coating defect types underwent slight growth in up to five exposure cycles. Examples of oxidation at surface coating removal defects are illustrated in figure 12. Here, a through-hole was not developed in R512E coated FS-85 after five plasma arc exposures. Extensive cracking of the coating and interstitial oxygen contamination of the substrates occurred at the impact damage sites as illustrated by the microstructures of R512E coated FS-85 in figure 13. However, very little substrate oxidation occurred.

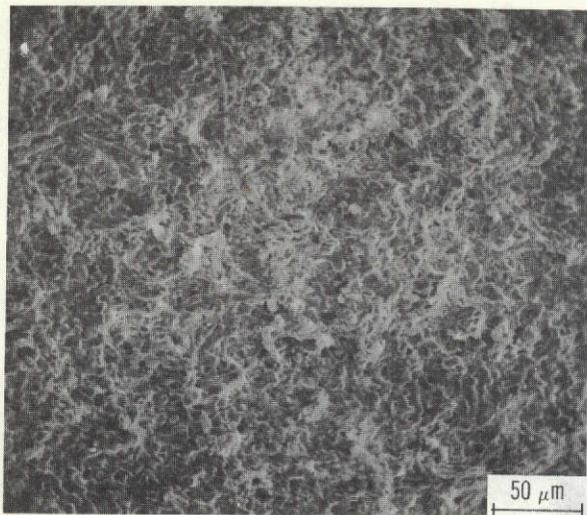
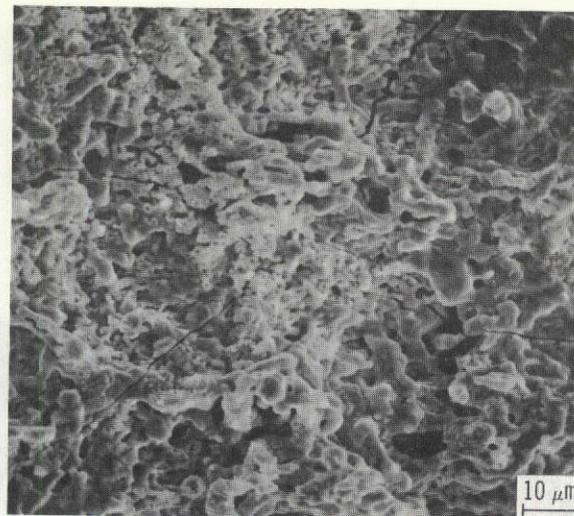
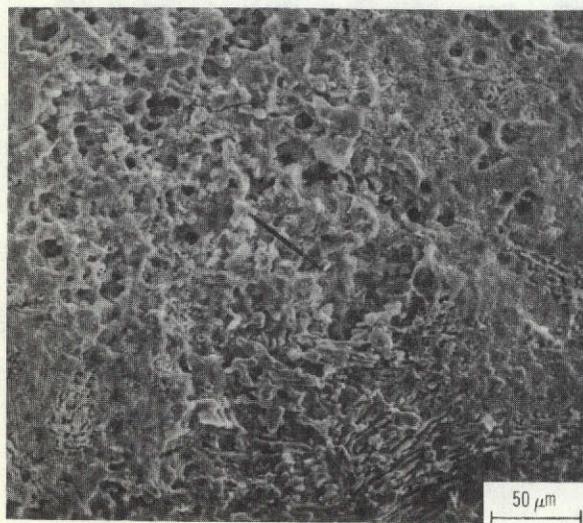
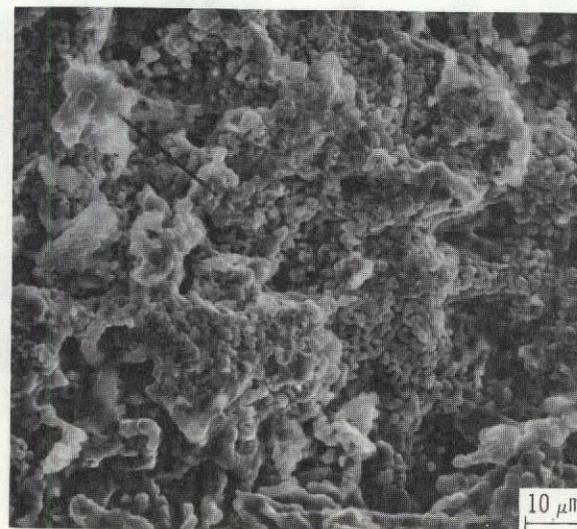
Figure 14. - Scanning electron micrographs of R512E on FS-85 and C-129Y, as-coated. Scanning electron microscope conditions: 20° tilt, 25 kilovolts.

Oxide morphology. - Scanning electron micrographs of R512E coated FS-85 and C-129Y are presented in figure 14. Scanning electron micrographs of R512E coated Cb-752 were similar to R512E coated FS-85. The network of hairline cracks produced during the coating firing cycle is evident on both $\times 300$ photographs. Their presence is not critical to overall coating performance although these cracks may play a significant role in premature failure at the edges of coated thin sheet.

The R512E coated C-129Y has a generally finer texture but less uniformity and more large pits than R512E coated FS-85. The surface structure of coated C-129Y can be broken down into two areas: fine textured areas covering most of the surface, and coarser textured areas as typified by the lower center of the $\times 300$ photograph. The fine texture is attributed to acicular silicide crystals oriented normal to the surface, and the coarser texture is attributed to crystals oriented parallel to the surface. Less evidence of an acicular structure is apparent on R512E coated FS-85 and Cb-752.

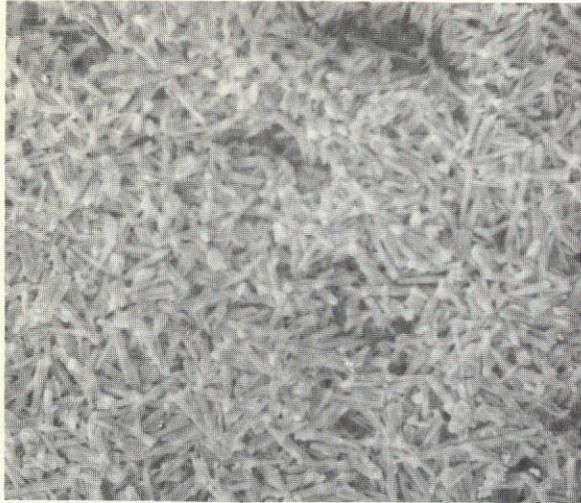
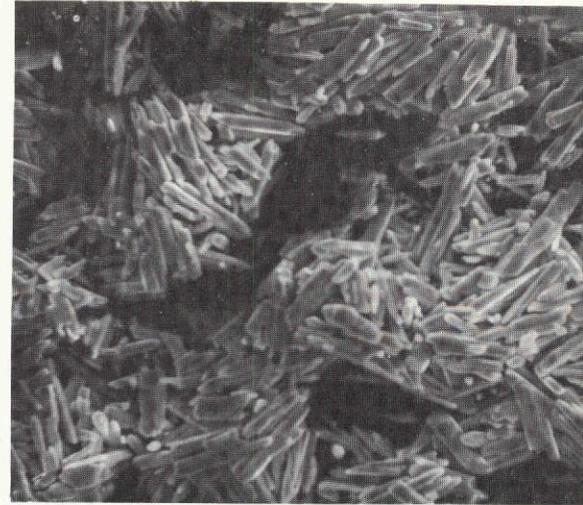
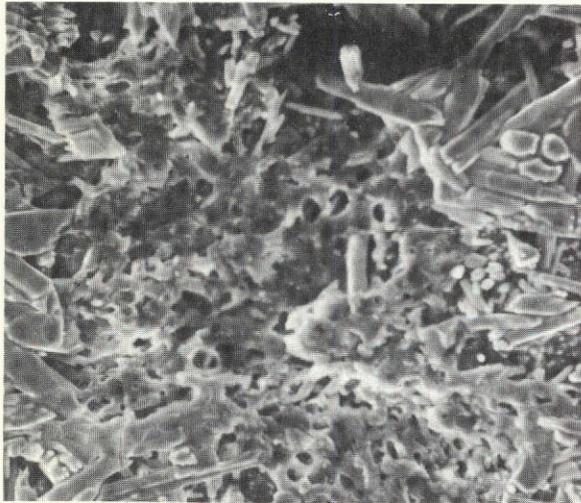
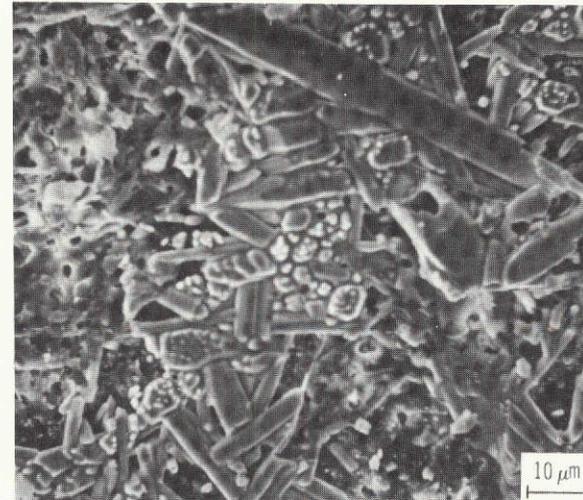
Figure 15. - Scanning electron micrographs of R512E coated FS-85 after plasma arc exposure at 1390° C. Locations, top surface at specimen centerline near forward edge. Scanning electron microscope conditions: 0° tilt, 25 kilovolts.

Figure 15 shows the oxidized surfaces near the forward edge of R512E coated FS-85 after 1, 5, 25, and 50 plasma arc exposure cycles. After one cycle, the surface is 90 percent covered with needle-like oxide particles. After five cycles, the oxide needles agglomerate into bundles covering about 60 percent of the surface. The additional exposure also increases the coarseness of the needles. The 25 and 50 cycles of exposure result in further agglomeration of the needles. A lacy oxide is formed in the gaps between the bundles and over spalled areas.

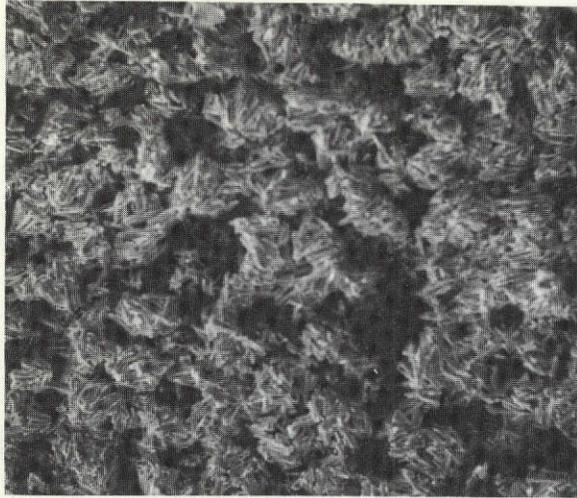
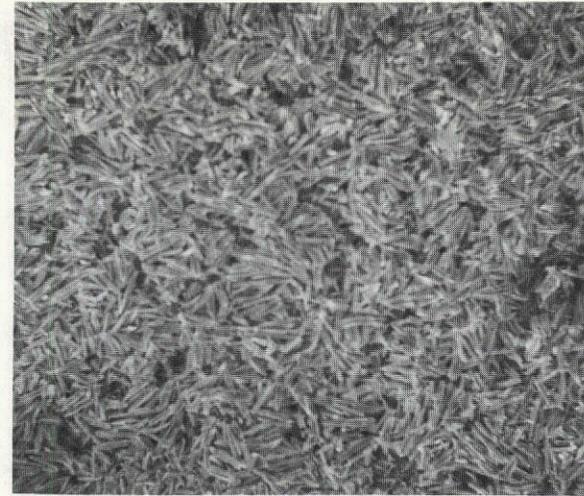
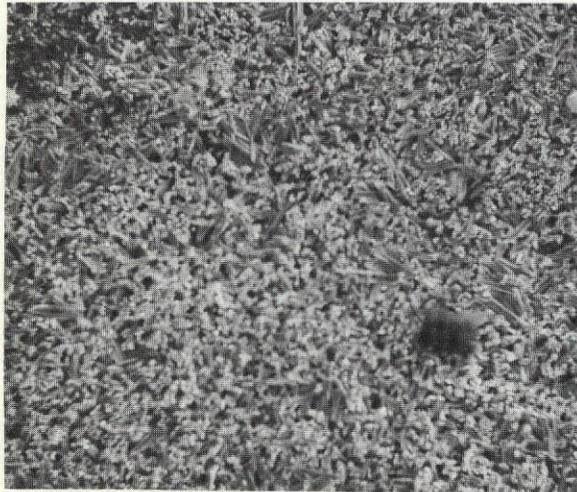
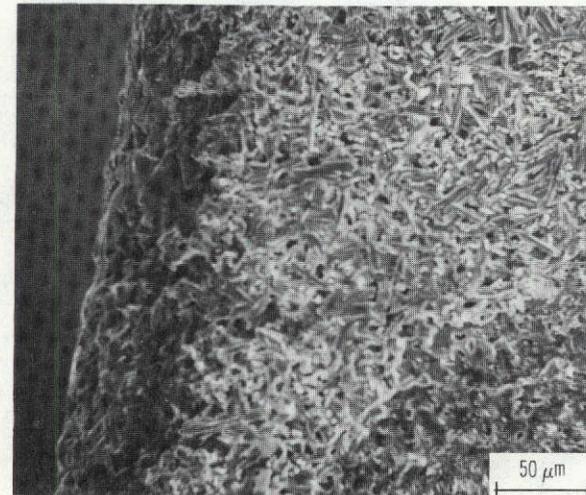
Figure 16. - Scanning electron micrographs of R512E on FS-85, Cb-752, and C-129Y after five cycles of plasma arc exposure at 1390° C. Scanning electron microscope conditions: 0° tilt, 25 kilovolts.

A comparison of oxides formed after five plasma arc exposure cycles on the three coated columbium alloys is shown in figure 16. The oxides on FS-85 and Cb-752 are similar except for the degree of agglomeration of needles, while the oxide on C-129Y (fig. 16) still resembles the original coating structure. Evidence of either spalling or inhomogeneity of the coating is evident in the upper left corner of 16(c).

Figure 16(d) shows an example of spalling at the edge and on the surface of R512E coated C-129Y after five plasma arc exposure cycles. This was also found with the other substrates. Spalling at the edges may be partially responsible for premature coating failures.

A second cause for edge failures, as mentioned earlier, was the tendency for the edges to run hotter than the major surface at the same radial position. This is revealed by the coarser oxide needles found at the edge location (fig. 16(d)) compared to the surface location (fig. 16(c)).

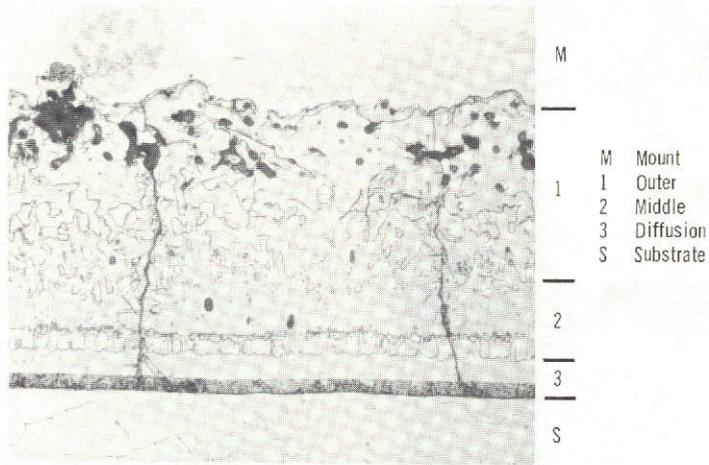
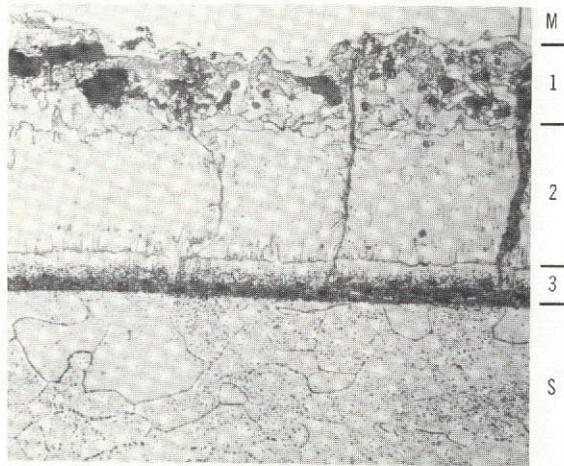
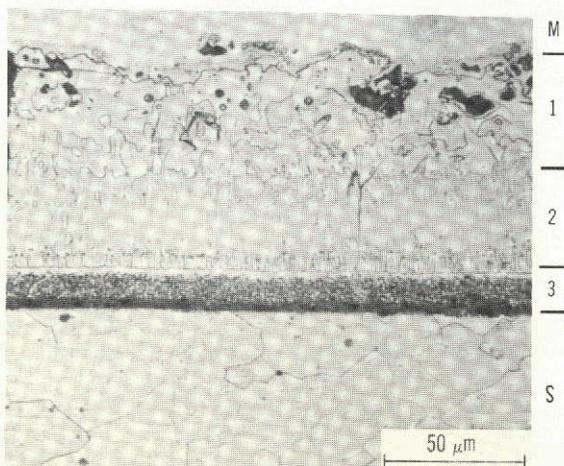
Figure 17. - Photomicrographs of R512E coating as deposited on three columbium alloys.

Zone 1 generally has a thin outer skin caused by depletion of volatile constituents during the 1-hour coating firing cycle at 1415°C . The major part of zone 1 consists of large, generally equiaxed grains of the MSi_2 and M_5Si_3 phases. With the exception of the outer skin, the darker etching material in zone 1 is rich in chromium and iron as revealed by X-ray raster micrography. The lighter etching major phase consists of disilicide rich in elements derived from the respective substrates. Zone 2 has a columnar structure and is rich in chromium and iron. Zone 1 is richer in chromium than iron, the opposite holds true for zone 2.

Zone 3 consists of two sublayers. The thicker outer layer is single phase in FS-85 and heavily loaded with second phase particles in C-129Y and Cb-752. The EMP line scans detected no silicon gradient across the outer band of zone 3 whereas the inner darker etching band exhibited a silicon concentration gradient. The growth of this layer was used to estimate the temperatures of specimens subjected to plasma arc exposure. The growth of this layer was characterized by exposing coated specimens in a furnace for temperatures and times spanning the plasma arc exposure conditions.

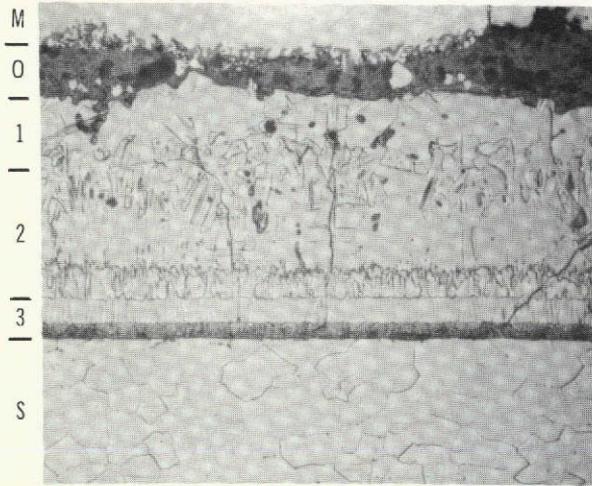
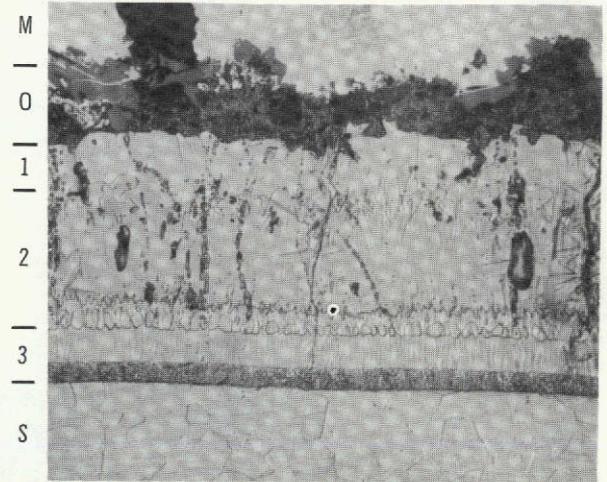
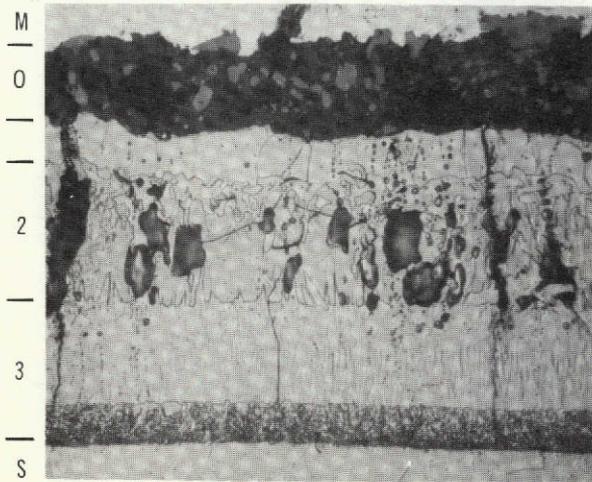
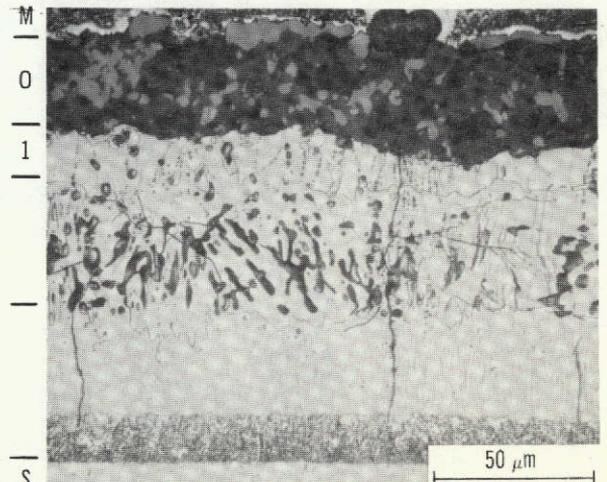
Figure 18. - Photomicrographs of R512E on FS-85 after plasma arc exposure at 1390° C. Locations, top surface near forward edge.

Figure 18 shows the microstructures of coated FS-85 after 1, 5, 25, and 50 cycles of plasma arc exposure. After one cycle, as shown in figure 18(a), the surface oxide consists primarily of small crystals of two oxide phases. An exposure for five cycles, figure 18(b), gives a coarsened oxide structure richer in dark oxide (SiO_2). The agglomerated light colored surface oxide is $\text{Cb}_4\text{Ta}_2\text{O}_{15}$ as revealed by EMP raster micrographs and XRD analysis. Appreciable tungsten and chromium were also present in this oxide. Except for some internal oxidation and a reduction in the thickness of zone 1, no great change in overall coating structure or composition occurs in up to five plasma arc exposure cycles.

After 25 plasma arc exposure cycles, as shown in figure 18(c), zone 1 of the R512E coating on FS-85 is further consumed while zone 3 and the surface oxide thickness increased considerably. The light $\text{Cb}_4\text{Ta}_2\text{O}_{15}$ phase is now present as coarse particles. The dark continuous oxide is now clearly the major oxide phase. This was observed as the lacy oxide between bundles of coarse sintered light oxide needles in the SEM micrographs. The EMP raster micrographs revealed depletion of iron and chromium from zone 1 of the coating. The oxide formed on the under side of the plasma arc exposed specimens was about one-third the thickness of that formed on top. It was essentially SiO_2 with some isolated particles of coarse refractory metal pentoxide still present. Less coating depletion occurred on the bottom surface than on the top surface.

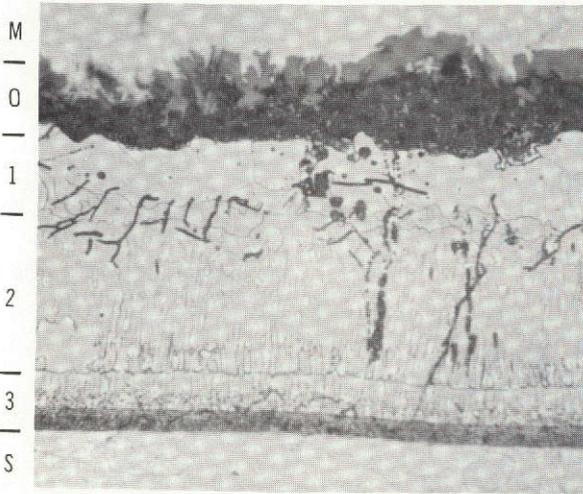
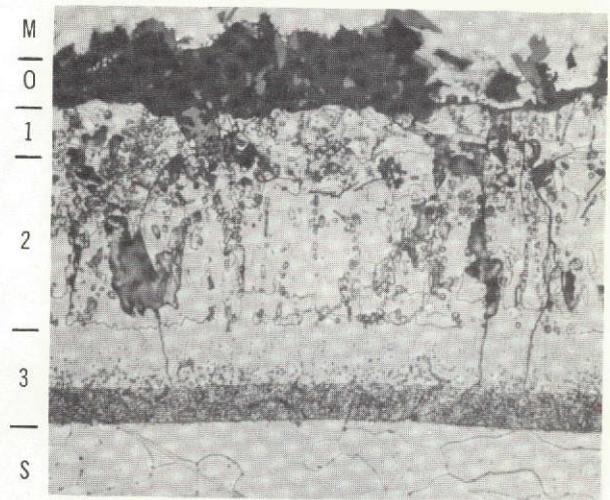
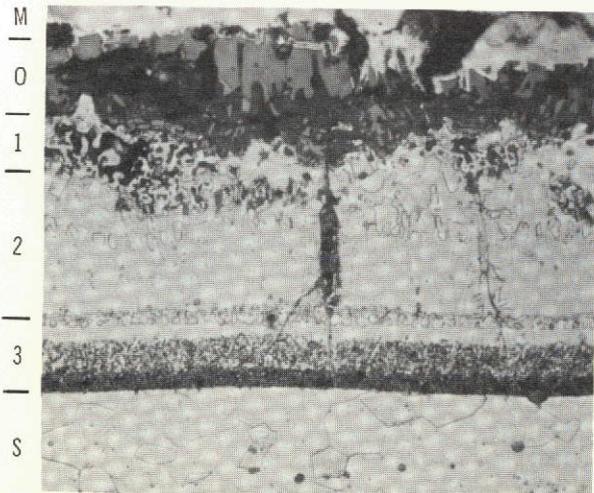
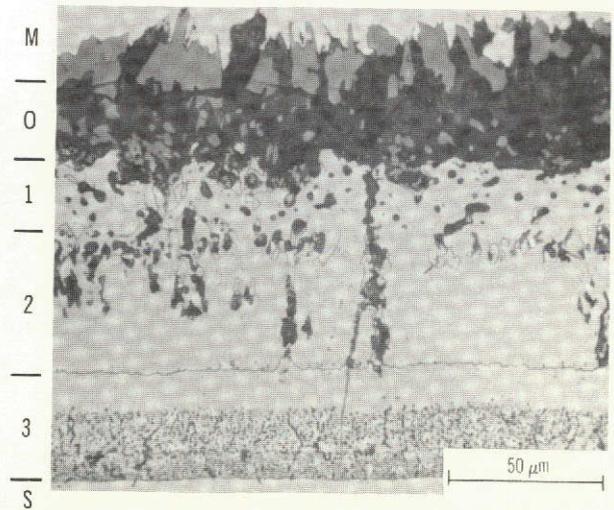
Figure 19. - Photomicrographs of R512E on Cb-752 and C-129Y after plasma arc exposure at 1390° C. Locations, top surface near forward edge.

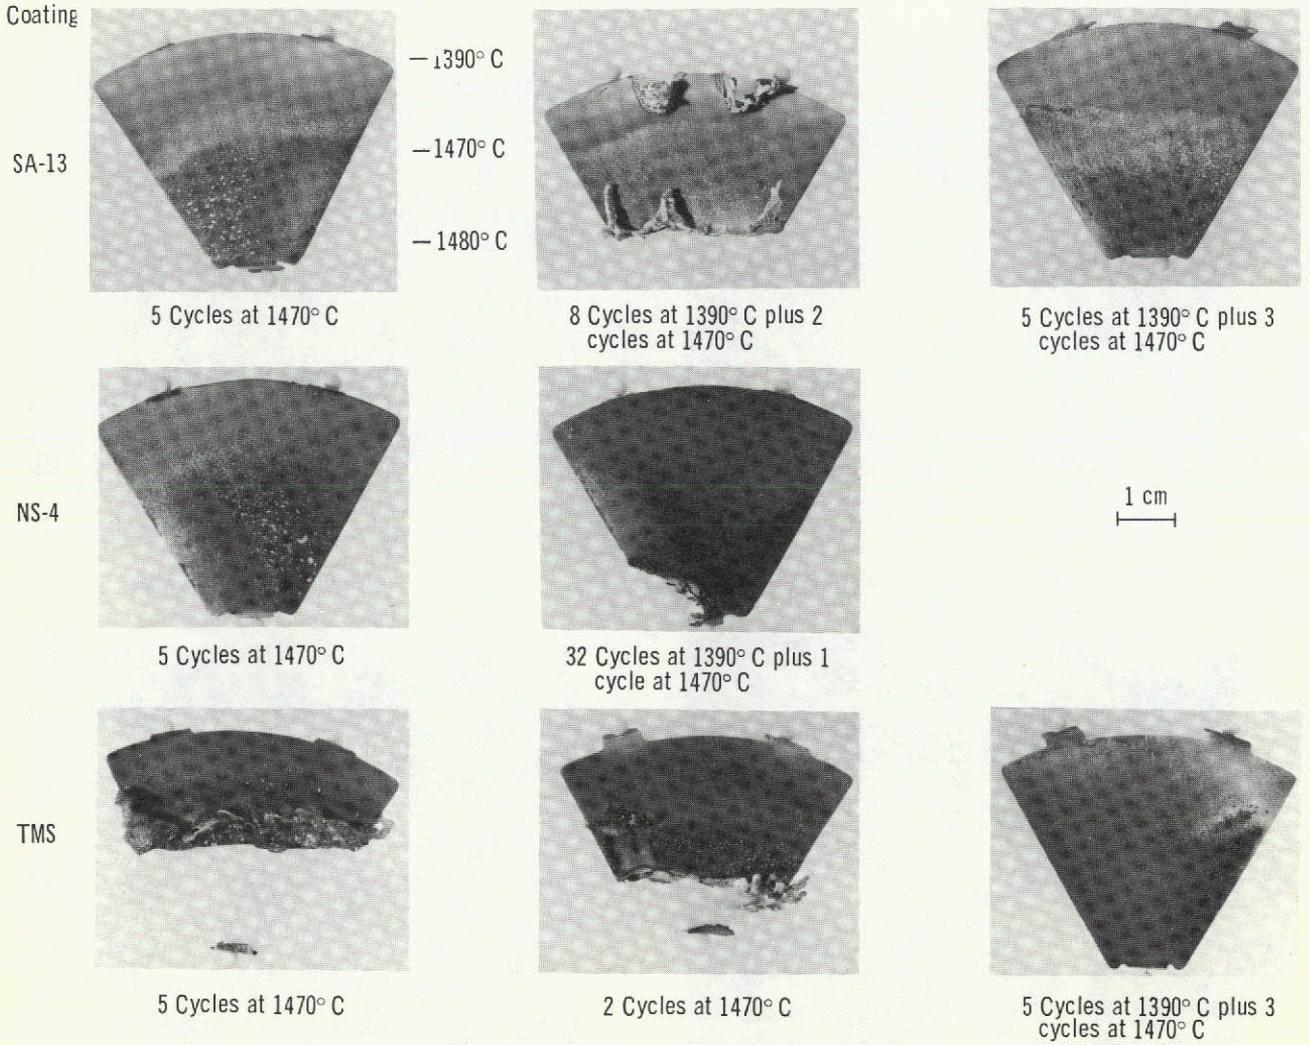
Figure 20. - Silicide coated Ta-10W after plasma arc exposure.

Unlike the coated columbium specimens, there was not a clear trend in coating appearance after exposure. The combination of higher exposure temperatures, less developed coating systems, and the rapid rate of tantalum oxide formation once the coating failed all contributed to the inconsistencies in the visible coating changes that took place in the first few cycles. Figures 20 to 22 show this variability, especially where extensive substrate oxidation and oxide removal by the high mass flow occurred. Four specimens which were exposed at a lower temperature (1390°C) for 5 to 32 cycles prior to exposure at a higher temperature (1470°C) for 1 to 3 cycles are shown in figure 20. They appear different from those specimens exposed only at the higher temperature with the combined exposures producing a glassier surface oxide.
