NASA TECHNICAL NOTE

NASA TN D-7617

**PERFORMANCE OF COATED COLUMBIUM
AND TANTALUM ALLOYS IN PLASMA
ARC REENTRY SIMULATION TESTS**

by Stanley R. Levine and John P. Merutka

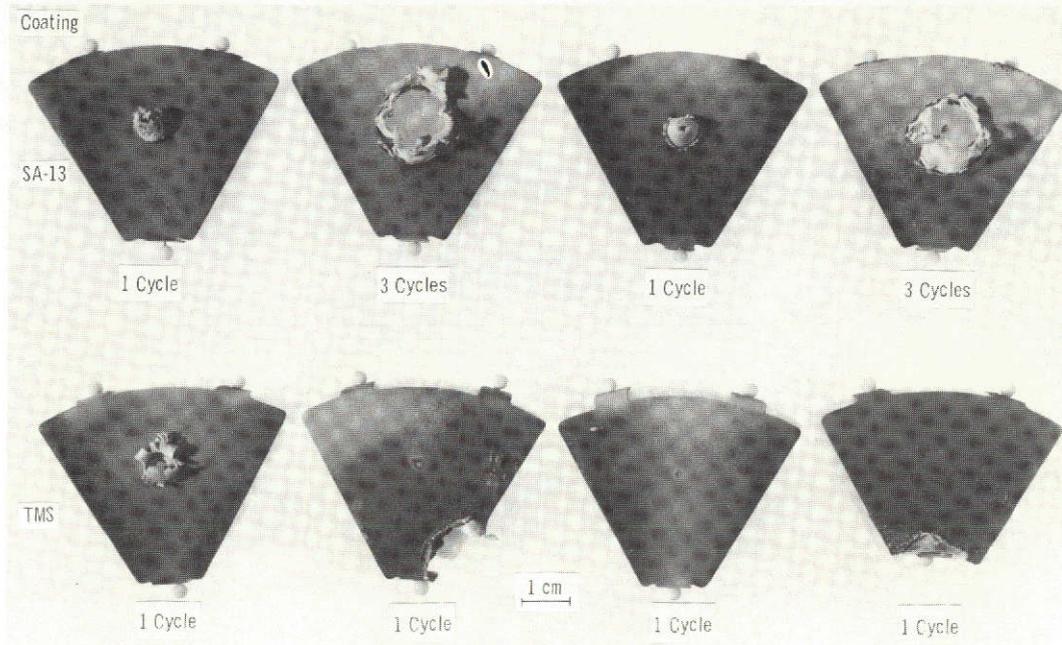
(a) 0.092-Centimeter through-hole defect.

(b) 0.092-Centimeter coating removal defect.

Figure 21. - Intentionally defected silicide coated Ta-10W after 1470° C plasma arc exposure.

Defect growth. - In the plasma arc exposures, most defected tantalum specimens and those specimens which failed prematurely exhibited rapid substrate metal recession and exfoliation of tantalum oxide in a few cycles. This is illustrated by the growth of through-hole defects in SA-13 and TMS coated Ta-10W (fig. 24). In general, the glassy oxide forming TMS coating afforded more protection at coating defects than the SA-13 coating. The difference in behavior was most pronounced in the through-hole coating removal and edge notch damaged specimens and was less pronounced in impact damaged specimens. The growth of through-hole defects in TMS coated Ta-10W is compared with results for SA-13 in figure 24. In one instance the defect healed (as shown in fig. 25); in the other it grew at a rate comparable to defects in SA-13 coated Ta-10W. Comparison of defect growth in SA-13 coated Ta-10W at its test temperature with defect growth in columbium alloys at their test temperature (fig. 24) reveals the severity of the coating defect problem with coated Ta-10W. The intolerance of the substrate to coating defects makes the multimission usefulness of coated Ta-10W questionable.

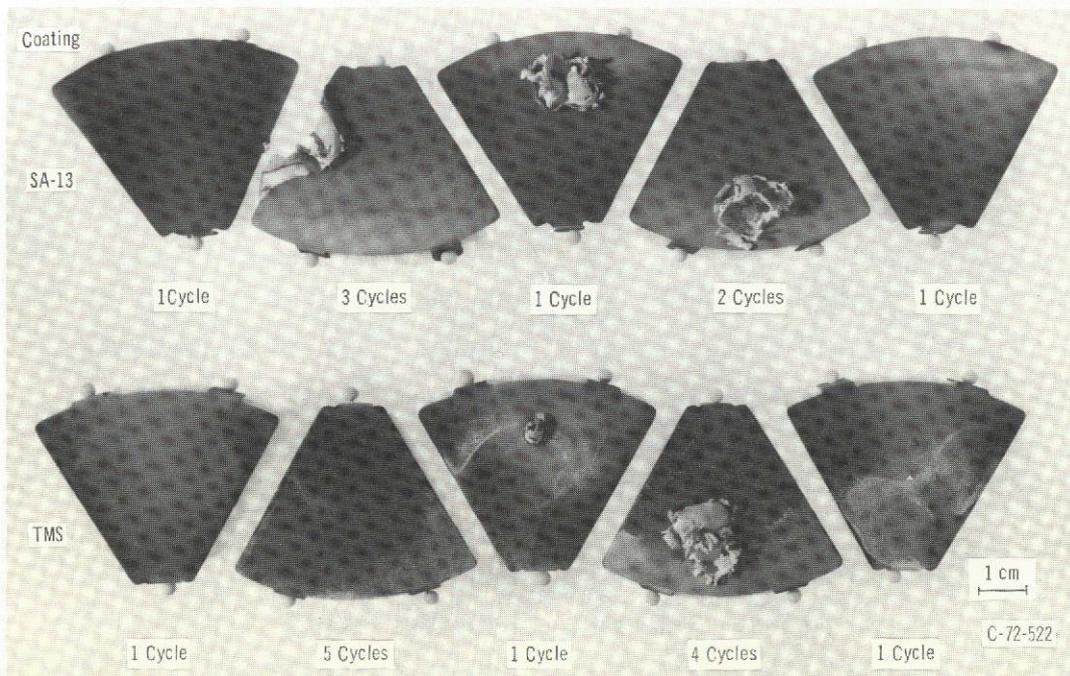
(a) Edge notch defect.

(b) Impact defect, 0.35 gram, 30 meters per second.

(c) Impact defect, 0.35 gram, 30 meters per second.

Figure 22. - Intentionally defected silicide coated Ta-10W after 1470° C plasma arc exposure.

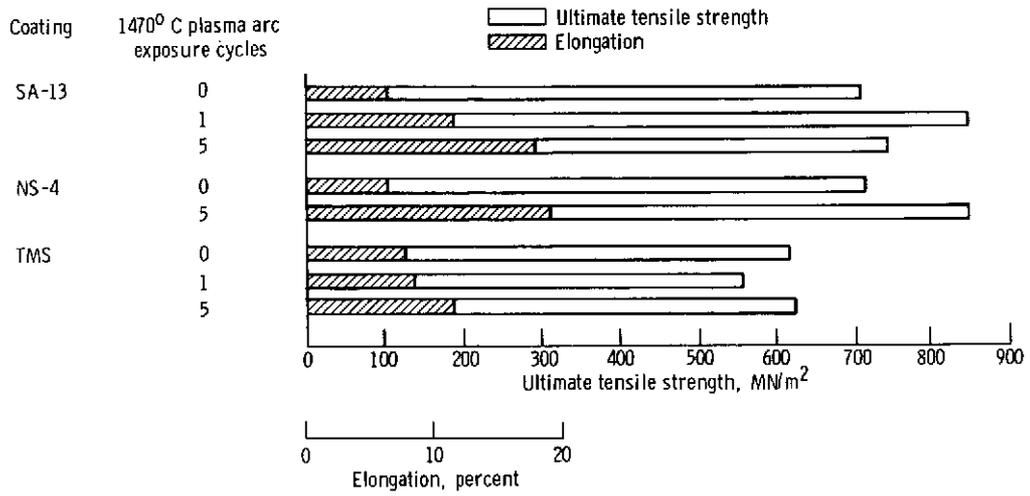
Figure 23. - Room temperature tensile test results for silicide coated Ta-10W. Ultimate tensile strength based on substrate remaining after coating application.

Tensile test results. - The room temperature ultimate tensile strengths and elongations after five plasma arc exposures for the SA-13 and NS-4 coated Ta-10W alloy (fig. 23) are typical of those found in laboratory low air pressure/slow cycle environments for SA-13 coated Ta-10W alloy after 20 cycles (ref. 2). The SA-13 specimens after one cycle at 1425^o and 1540^o C, in the laboratory environment, show an immediate 25-percent loss of ultimate tensile strength with the elongation going to 1 to 2 percent from 12 to 16 percent. However, after 20 cycles at these temperatures, the ultimate tensile strength returns to the as-coated strength of around 6.5×10^2 meganewtons per square meter with an elongation of 7 to 13 percent. The changes in ultimate tensile strength and elongation of TMS coated Ta-10W specimens are not as pronounced as with the other two coatings.

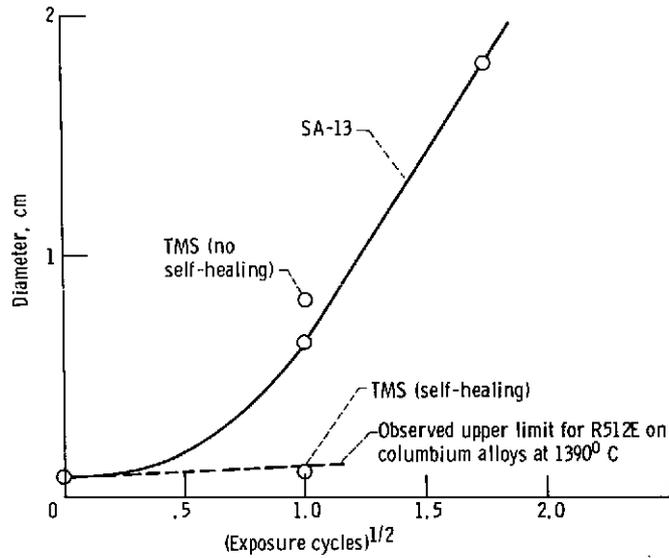
Figure 24. - Metal recession at 0.092-centimeter-diameter through-hole defects in SA-13 and TMS coated Ta-10W after plasma arc-exposure at 1470°C.

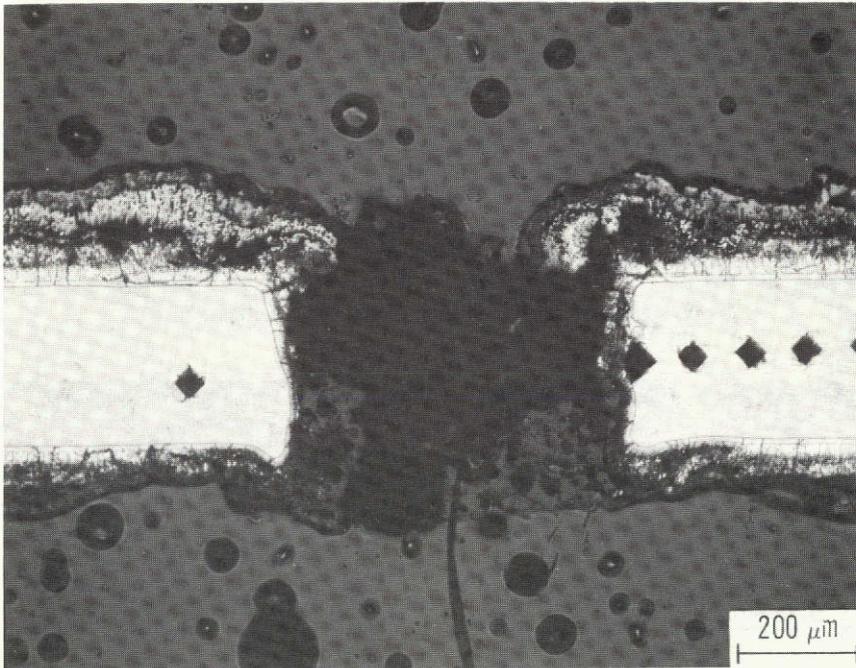
Figure 25. - Healed 0.092-centimeter through-hole defect in TMS coated Ta-10W after one 1470°C plasma arc exposure cycle.

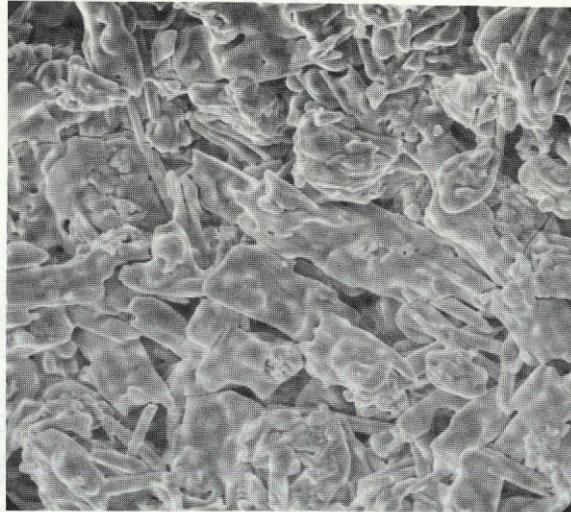
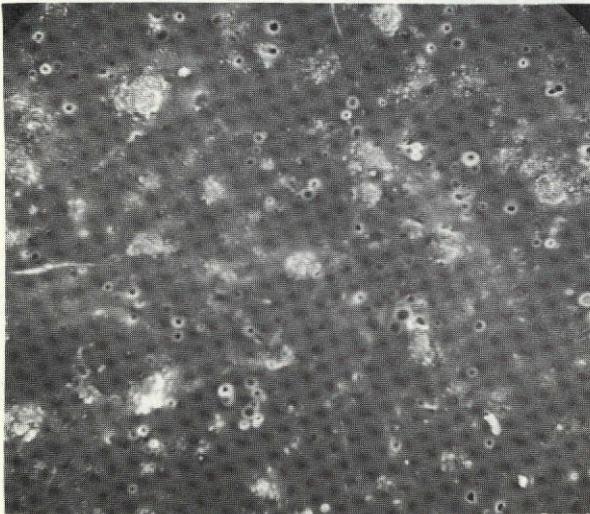
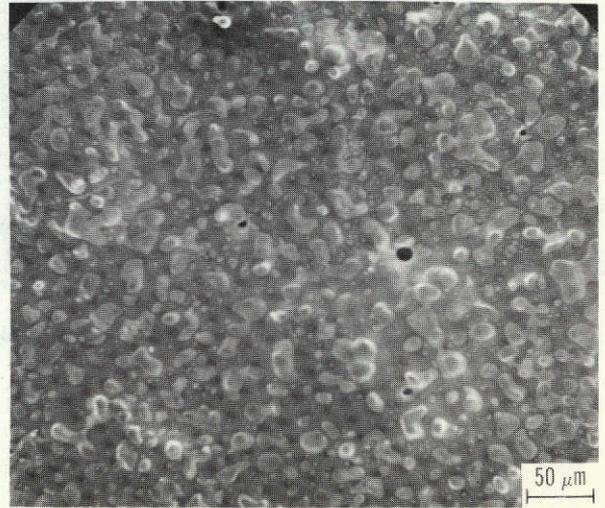
(a) As-coated. Scanning electron microscope conditions: 20° tilt, 11 picoamperes, 25 kilovolts.

(b) After one plasma arc exposure at 1470° C. Location, close to forward edge. Scanning electron microscope conditions: 0° tilt, 13 picoamperes, 25 kilovolts.

(c) After five plasma arc exposures at 1470° C. Location, close to forward edge. Scanning electron microscope conditions: 0° tilt, 13 picoamperes, 25 kilovolts.

Figure 26. - Scanning electron micrographs of TMS coated Ta-10W.

Oxide morphology. - The TMS coating had a rough texture and characteristic coating microcracks in the as-received condition (fig. 26(a)). After one exposure cycle (fig. 26(b)), silica containing pores and TiO_2 inclusions were formed in the hotter forward areas. After five cycles (fig. 26(c)), the relative amount of TiO_2 increased. Fusion of the oxide appears to have occurred. The fact that SiO_2 and TiO_2 form a eutectic liquid at about 1550°C (ref. 9) gives some indication of the actual exposure temperature. In cooler rear areas the oxidized surface bore a closer resemblance to the original coating. After one cycle the predominant silica phase was primarily located in depressions between coating particles. TiO_2 was the predominant phase after five cycles and the silica was extensively crazed.

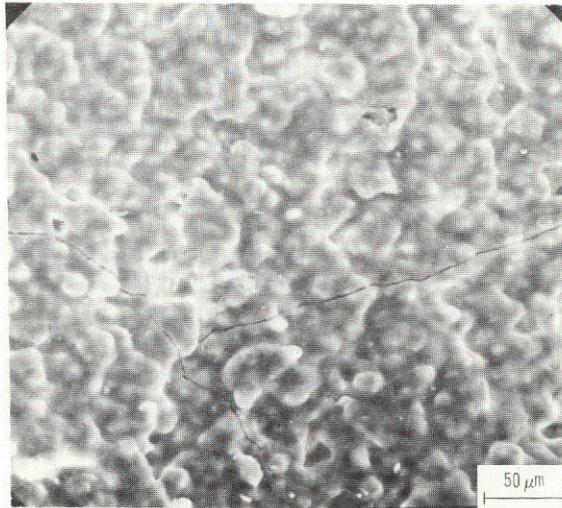
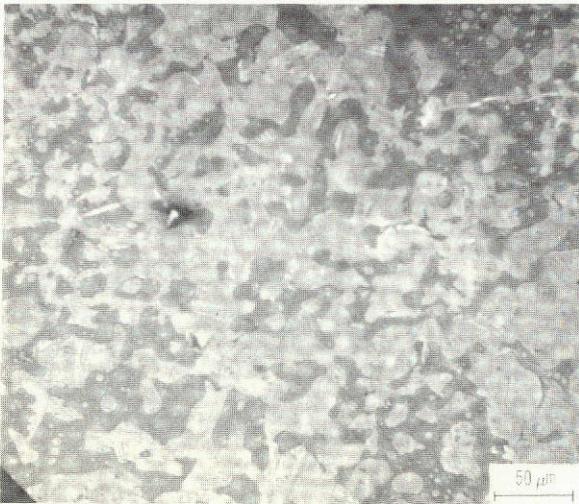
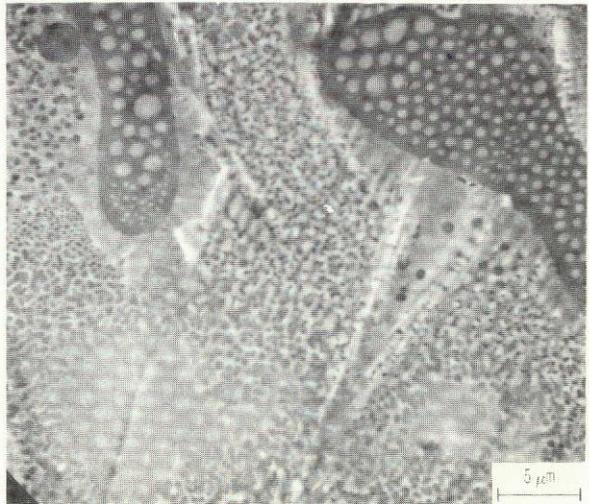
Figure 27. - Scanning electron micrographs of NS-4 on Ta-10W.

The as-received NS-4 coating had a relatively smooth surface texture with characteristic coating microcracks (fig. 27(a)). After five cycles evidence of oxide fluidity is present (fig. 27(b)). The major oxide, TiTa_2O_7 , melts congruently at about 1660°C , and TiO_2 can form a eutectic liquid with SiO_2 at 1550°C (ref. 8). At a higher magnification the light colored areas are revealed to have a coral-like microstructure.

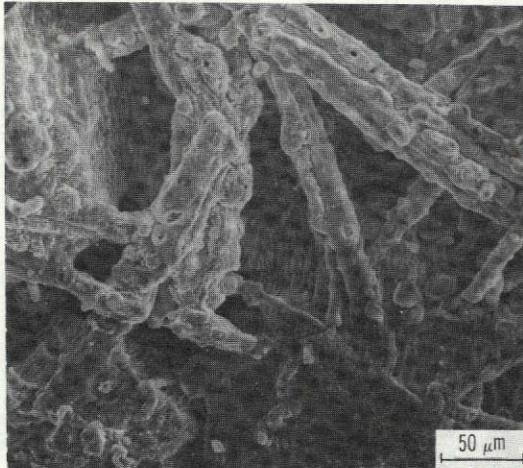
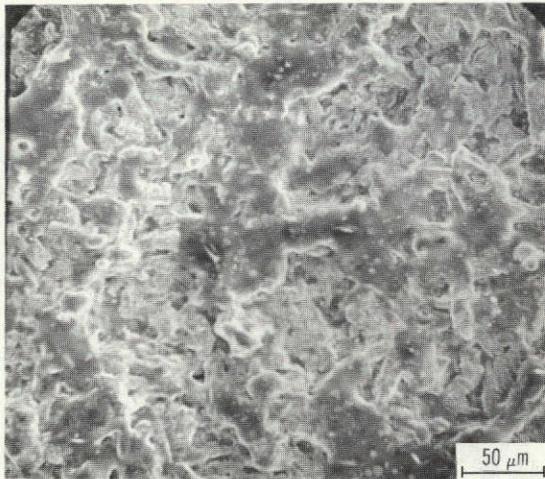
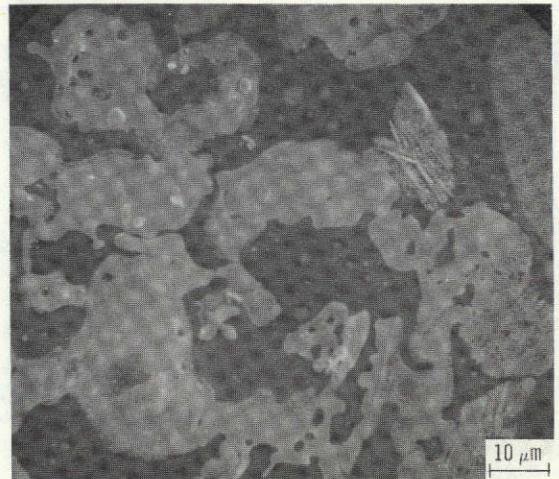
Figure 28. - Scanning electron micrographs of SA-13 on Ta-10W.

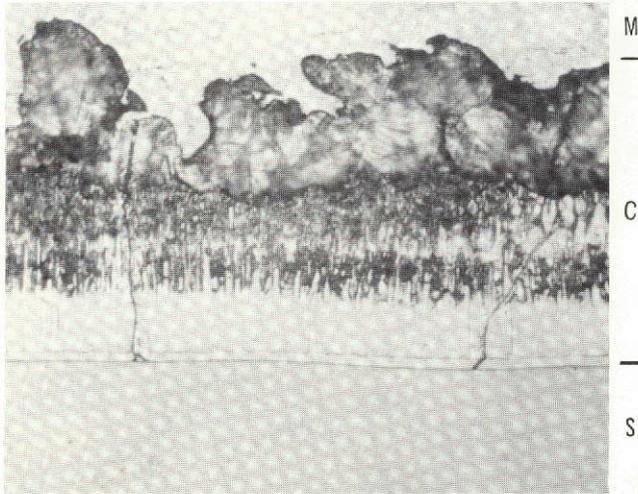
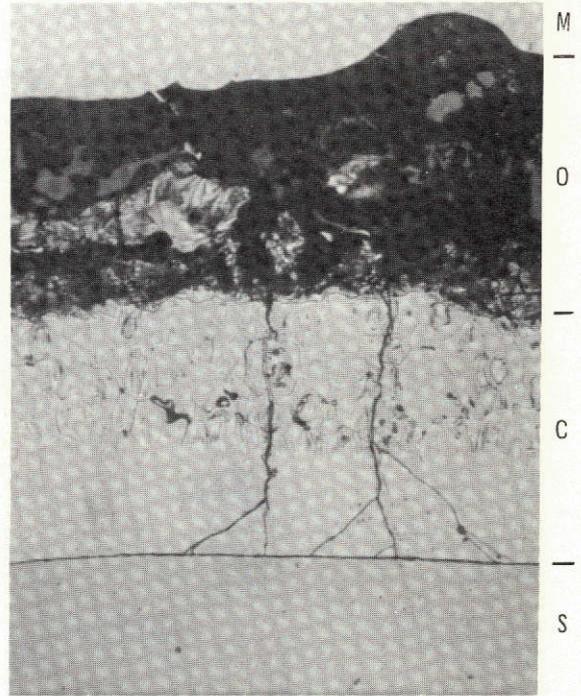
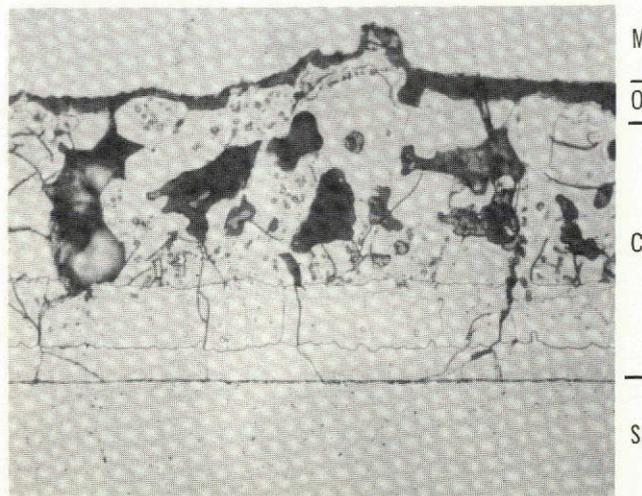
Figure 29. - Photomicrographs of TMS coated Ta-10W. Location on exposed specimens, top surface near forward edge.

Metallography and EMP analysis. - Photomicrographs of the TMS coating on Ta-10W in the as-received condition and after one and five cycle exposures are shown in figure 29. The mount, oxide, coating, and substrate are labeled M, O, C, and S, respectively. The initial nominal coating weight was 29 milligrams per square centimeter, and the initial nominal coating thickness was 0.08 millimeter. The large grained, heavily etched outer stratum of the as-received coating is rich in titanium, manganese, and silicon. The intermediate columnar region, which also etched heavily, is rich in titanium, tantalum, tungsten, and silicon. The inner columnar region is a tantalum and tungsten rich silicide. After one cycle a thick modified silica layer forms. Particles of the outer coating stratum and TiO_2 are included. After five cycles only a thin oxide scale rich in titanium, tantalum, and silicon and containing little manganese is retained. The residual coating also retains little manganese and has a relatively uniform titanium distribution.

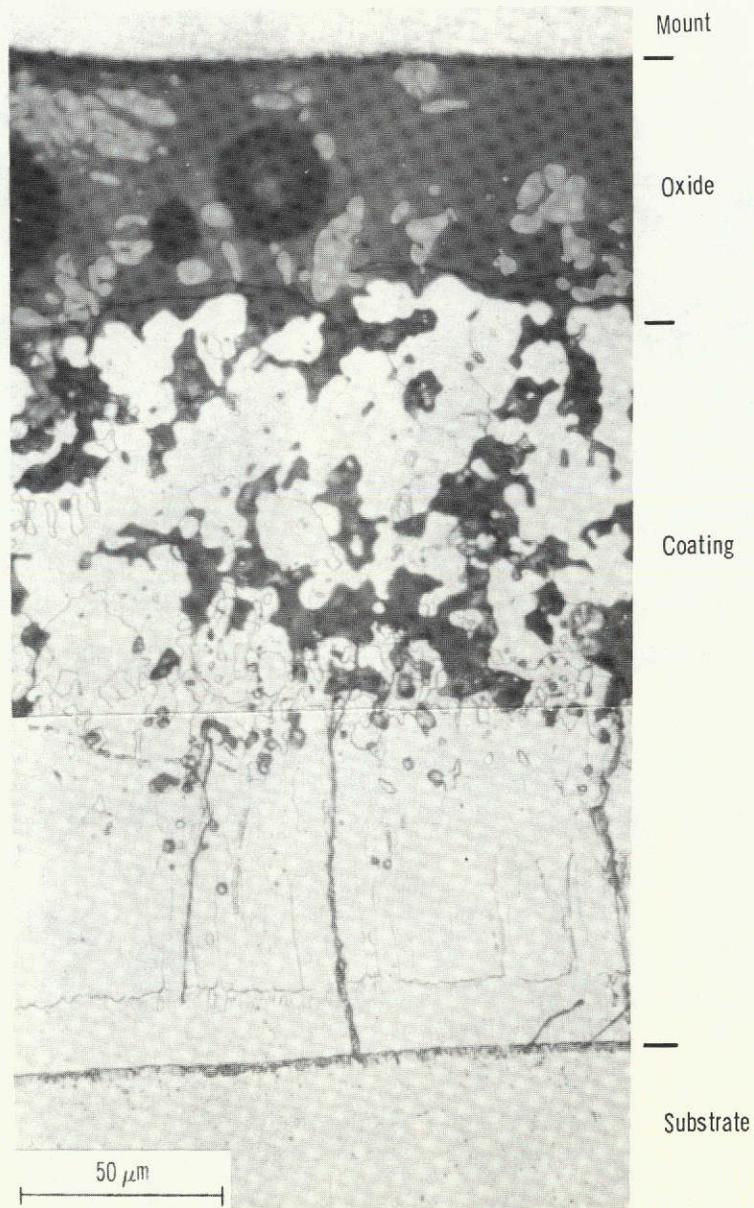
Figure 30. - Photomicrograph of NS-4 coated Ta-10W after five plasma arc exposures at 1470°C. Location, top surface near forward edge.

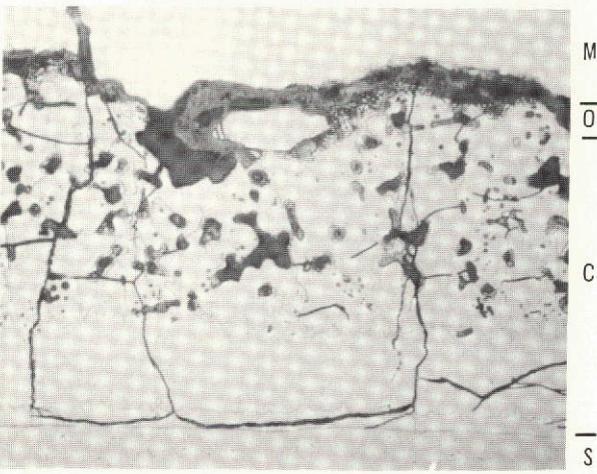
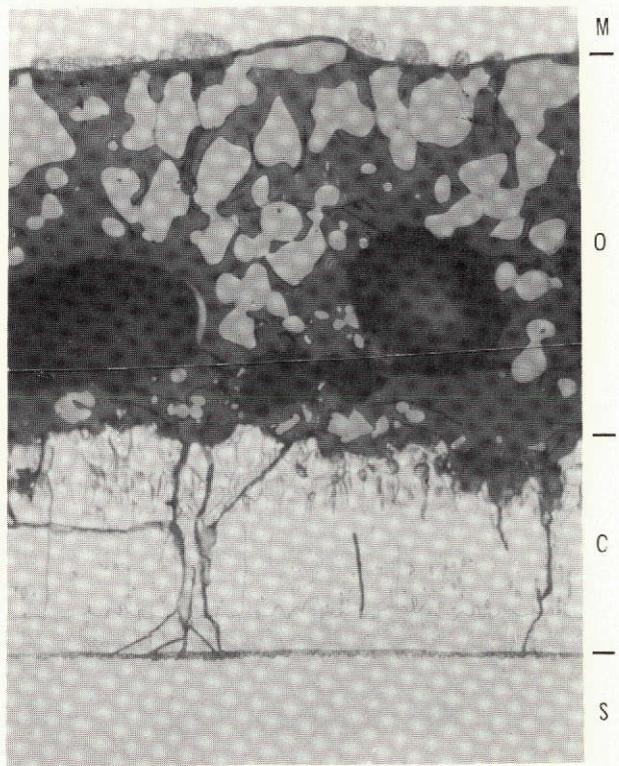
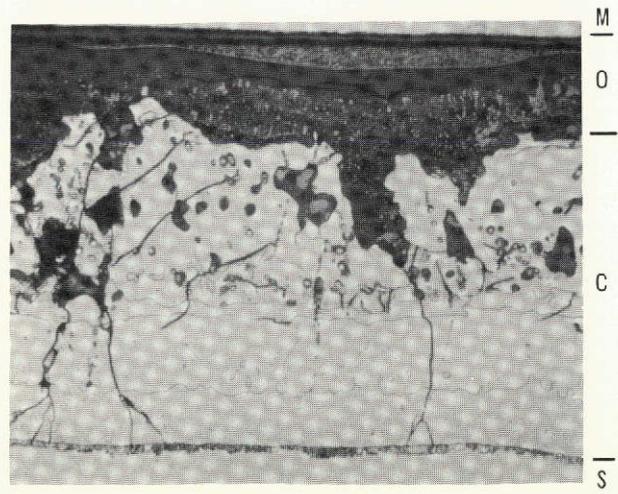
(a) As-received (coated and preoxidized).

(b) After one cycle at 1470° C.

(c) After five cycles at 1470° C.

The 0.1-millimeter-thick preoxidized SA-13 coating, as shown in figure 31(a), already exhibits appreciable internal oxidation. The sample exposed for one cycle (fig. 31(b)) has a very thick oxide consisting of modified silica as the continuous phase. The microstructure of the sample after five cycles of exposure (fig. 31(c)) does not appear to be derived from that of the sample exposed for one cycle. This is probably due to a significant difference in specimen exposure temperatures with the specimen exposed for one cycle seeing a higher average temperature. The thin surface oxide retained on the sample exposed for five cycles contains either Ta_2O_5 or $TiTa_2O_7$. The intermediate dark band is modified silica. The multiphase oxide adjacent to the coating contains all of the constituents initially present in the coating. Extensive internal oxidation of the coating is apparent.
