NASA TECHNICAL MEMORANDUM

NASA TM X-64846

MSFC SKYLAB ATM CALIBRATION
ROCKET PROJECT

Skylab Program Office

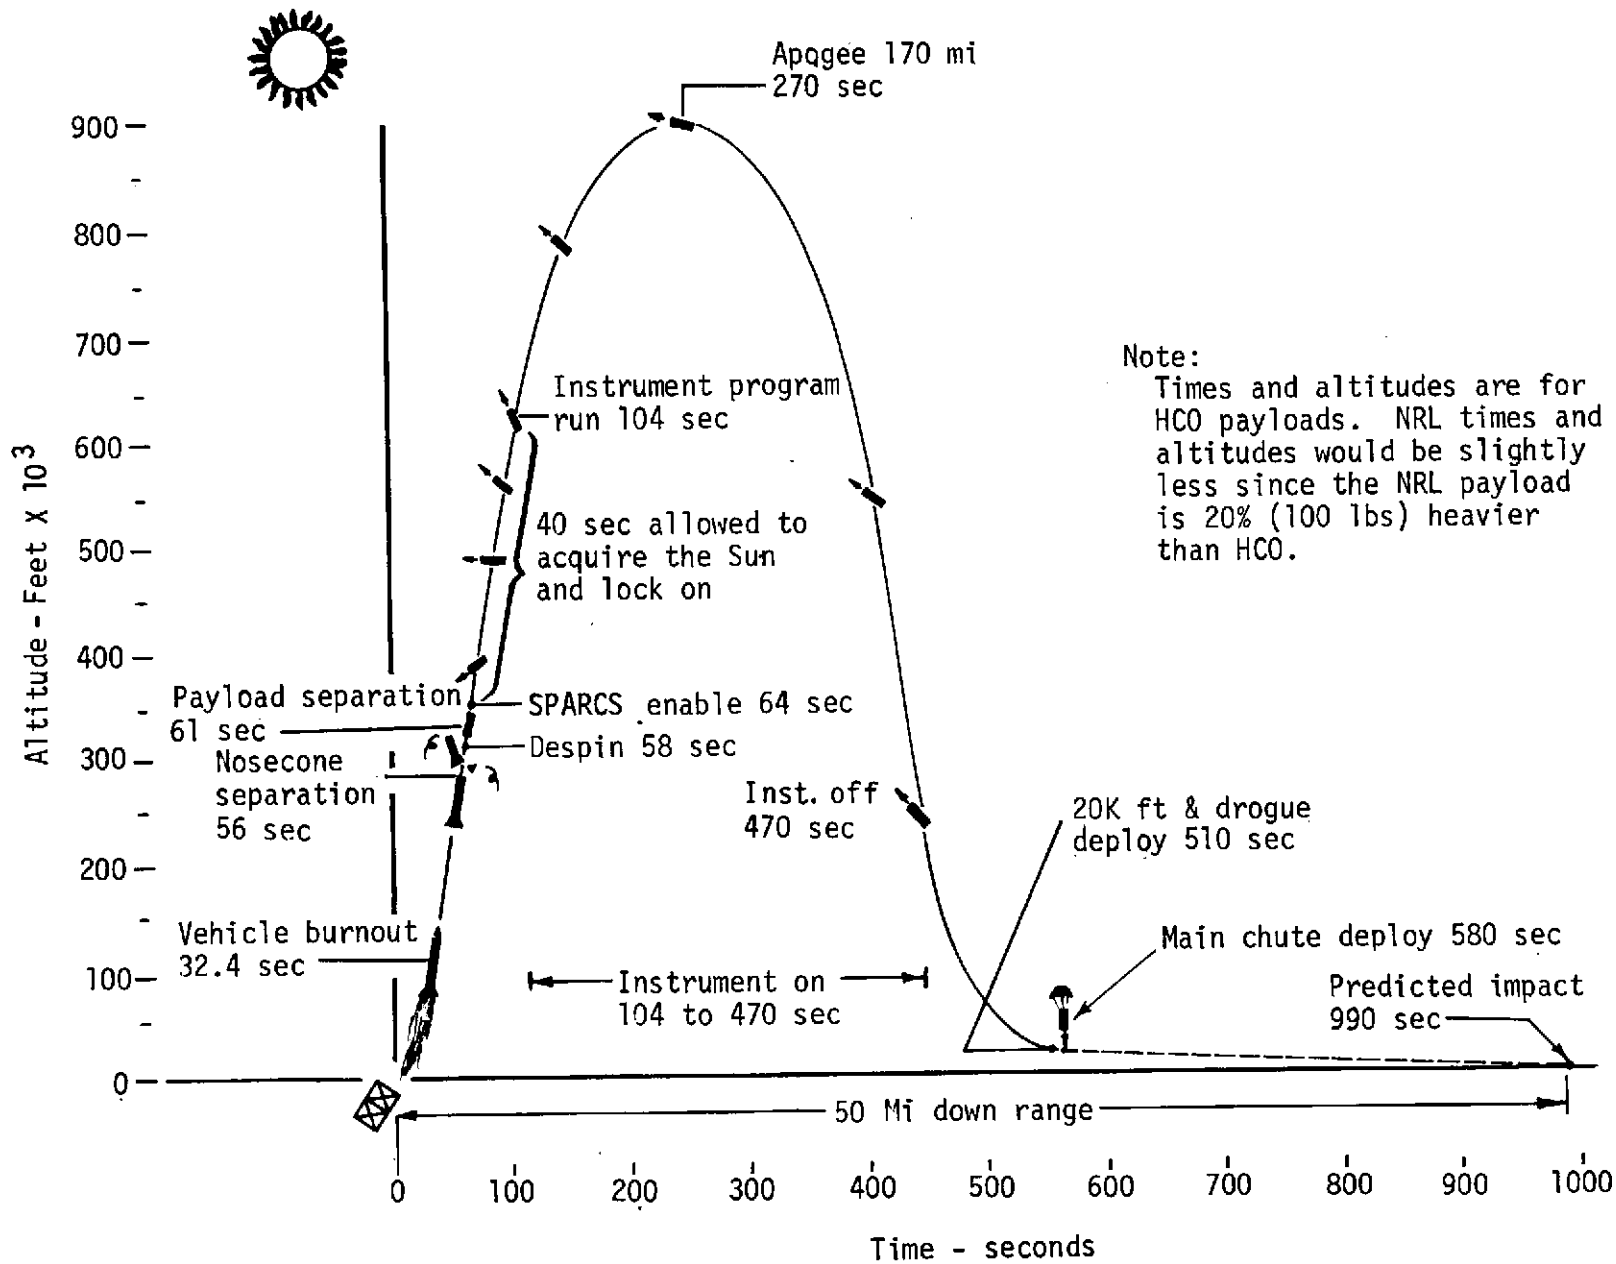
Figure 2-2. Typical Skylab CALROC Flight Profile

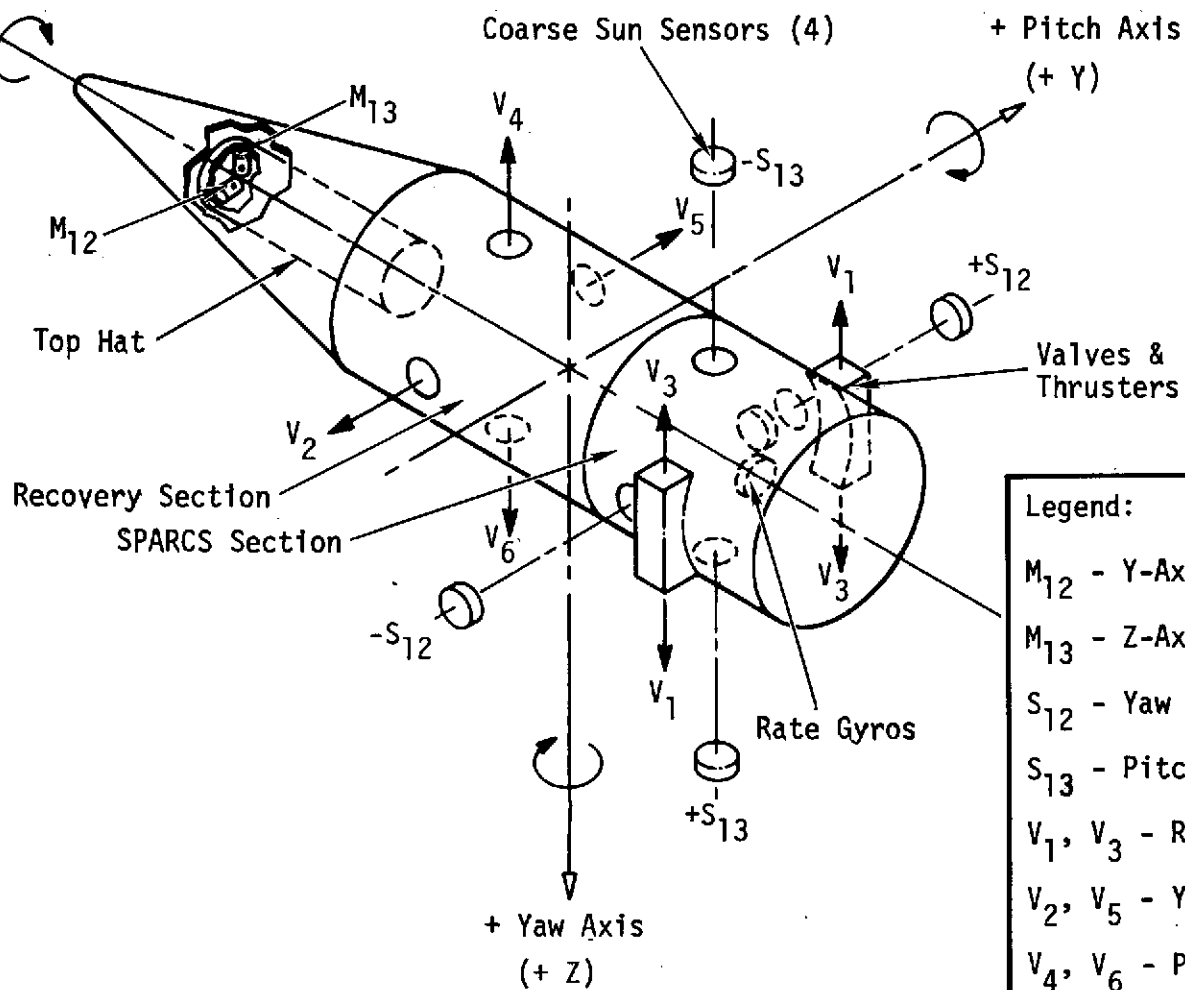
Figure 2-14. CALROC Top Hat and Magnetometer.

M₁₂ - Y-Axis Magnetometer

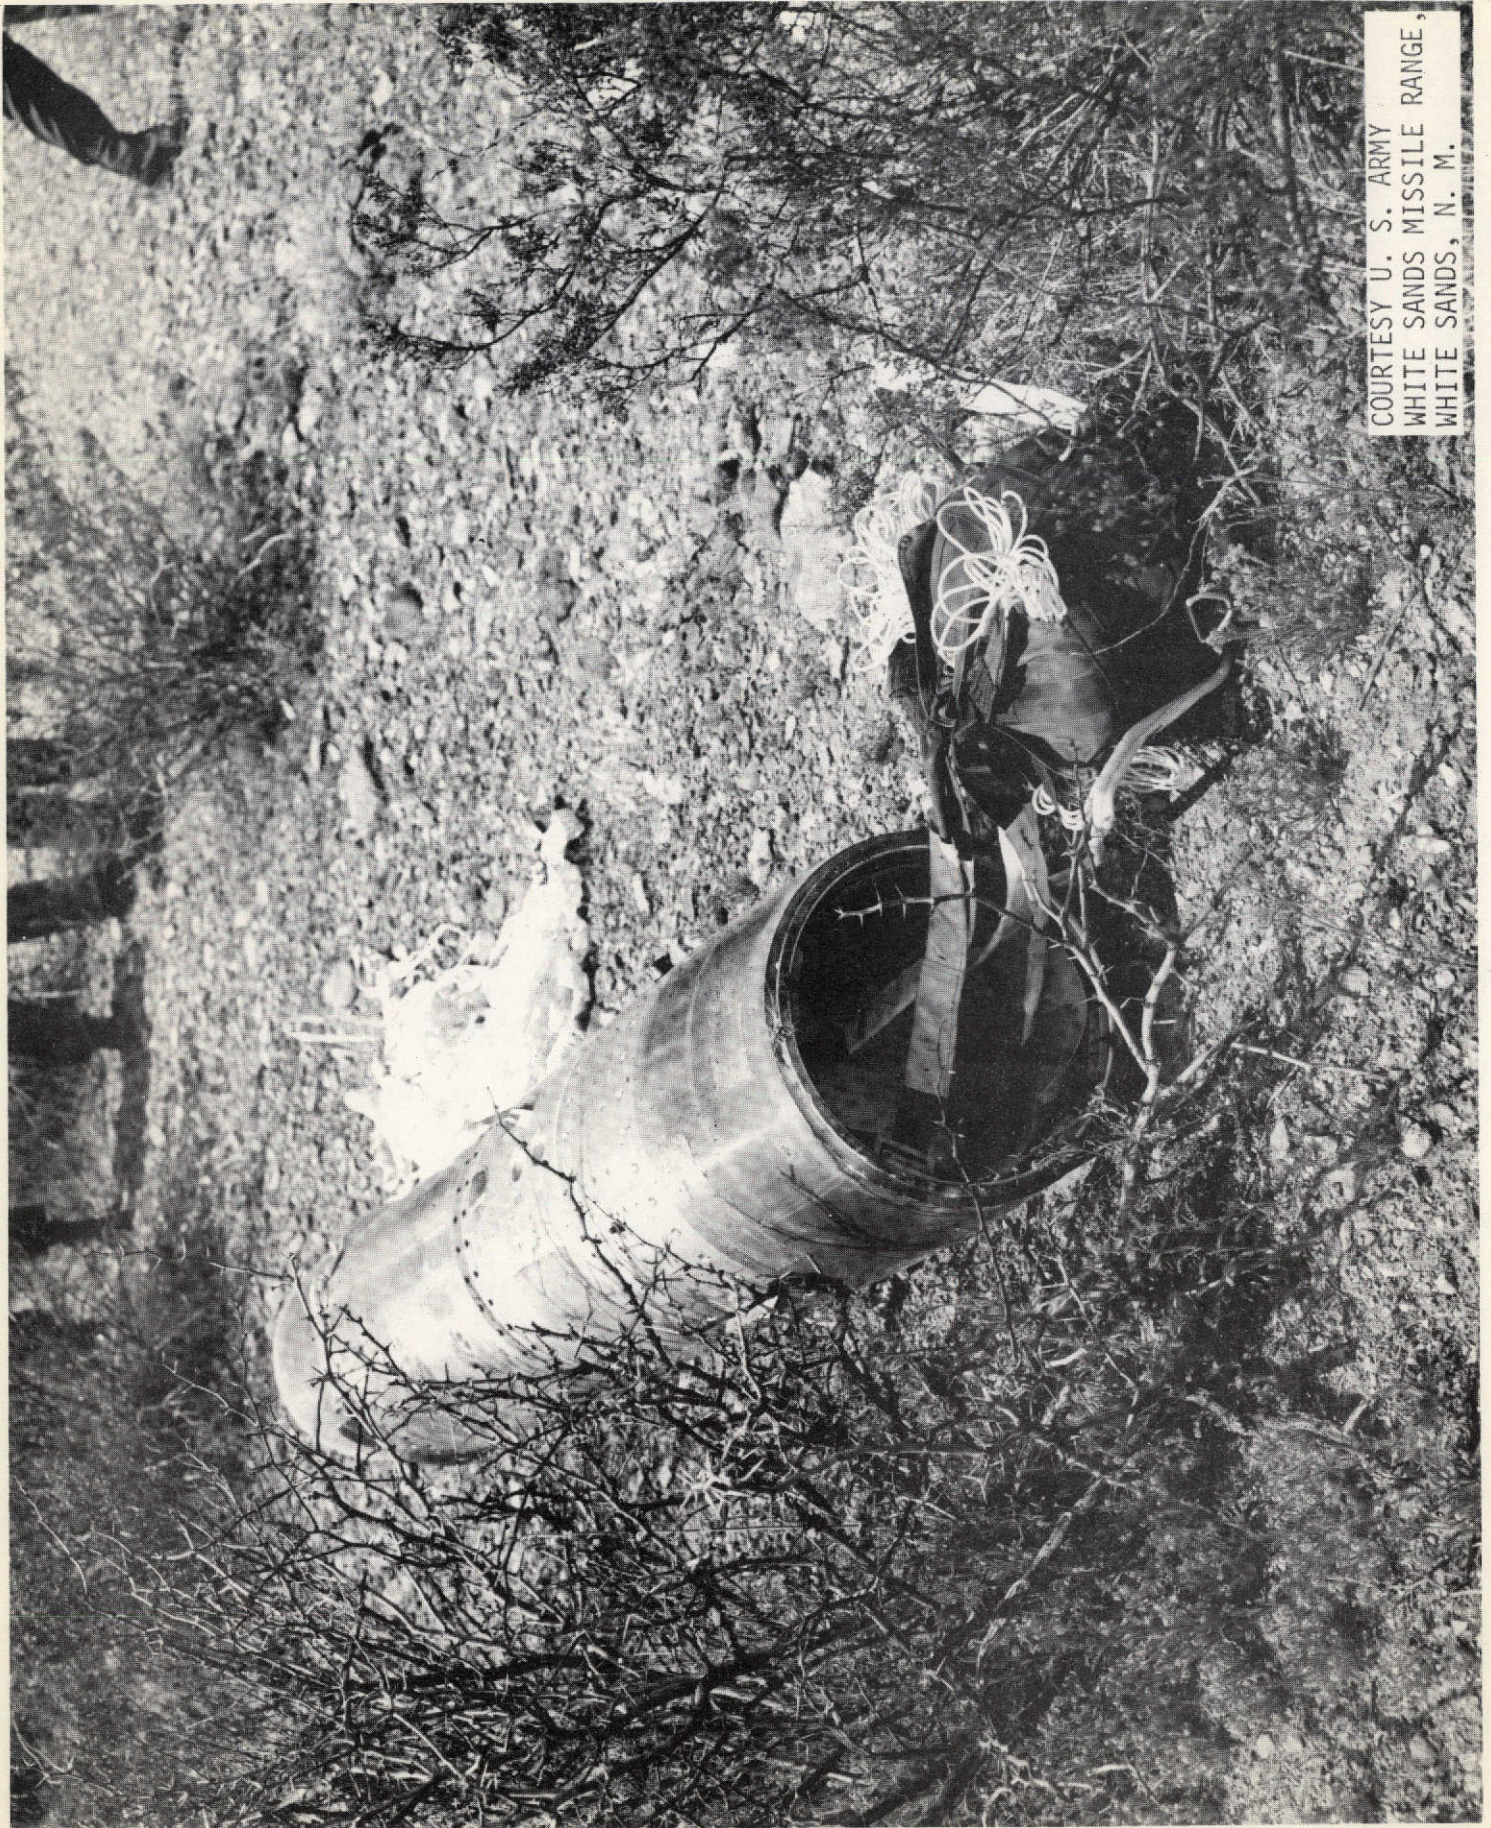
The cause of the Recovery system failure was immediately apparent upon examination of the parachute assembly as it lay on the desert (Figure 4-9). The main parachute was contained in a canvas bag which was closed by four flaps and secured by a bight (loop) of one of the main risers. Excessive friction between the main riser bight and the mouth lock retaining loop pulled the innermost mouth flap through holes in the other three flaps, relocking the mouth lock after the riser line bight had finally pulled free. As a consequence, the main parachute was never deployed, and the only decelerating force, which was too small to be effective, came from the captive drogue chute.

Figure 4-9. Post-Flight NRL CALROC 21.011 Payload.

Because of damage to the four main risers on previous Black Brant flights due to sharp edges of a rapidly rotating canister assembly, protective leather chaffing strips had been sewed to the main risers. This modification had been successfully demonstrated in a drop test, and during the flight of CALROC test flight 21.009. This NRL CALROC flight was the third application of this modification, and proved it to be unreliable. The additional bulk of the leather on the bight, coupled with increased friction, and holes too large in the other three mouth flaps, distorted the mouth lock assembly and caused the bottom flap to be pulled through the other three flaps and relock the main parachute bag. Impact damage throughout the payload was so extensive that refurbishment was not possible. The payload was disassembled and parts used for test purposes.

- a. Change the main parachute mouth locks from four to eight.
- b. Add a mouth lock cord fed through a loop on each flap and tied.
- c. Add two knife cutters stitched to two risers for cutting the tie cord.
- d. Replace leather scuff guards with less bulky aluminized asbestos on both main risers and drogue bridle.
- e. Accordion fold the drogue tow line.

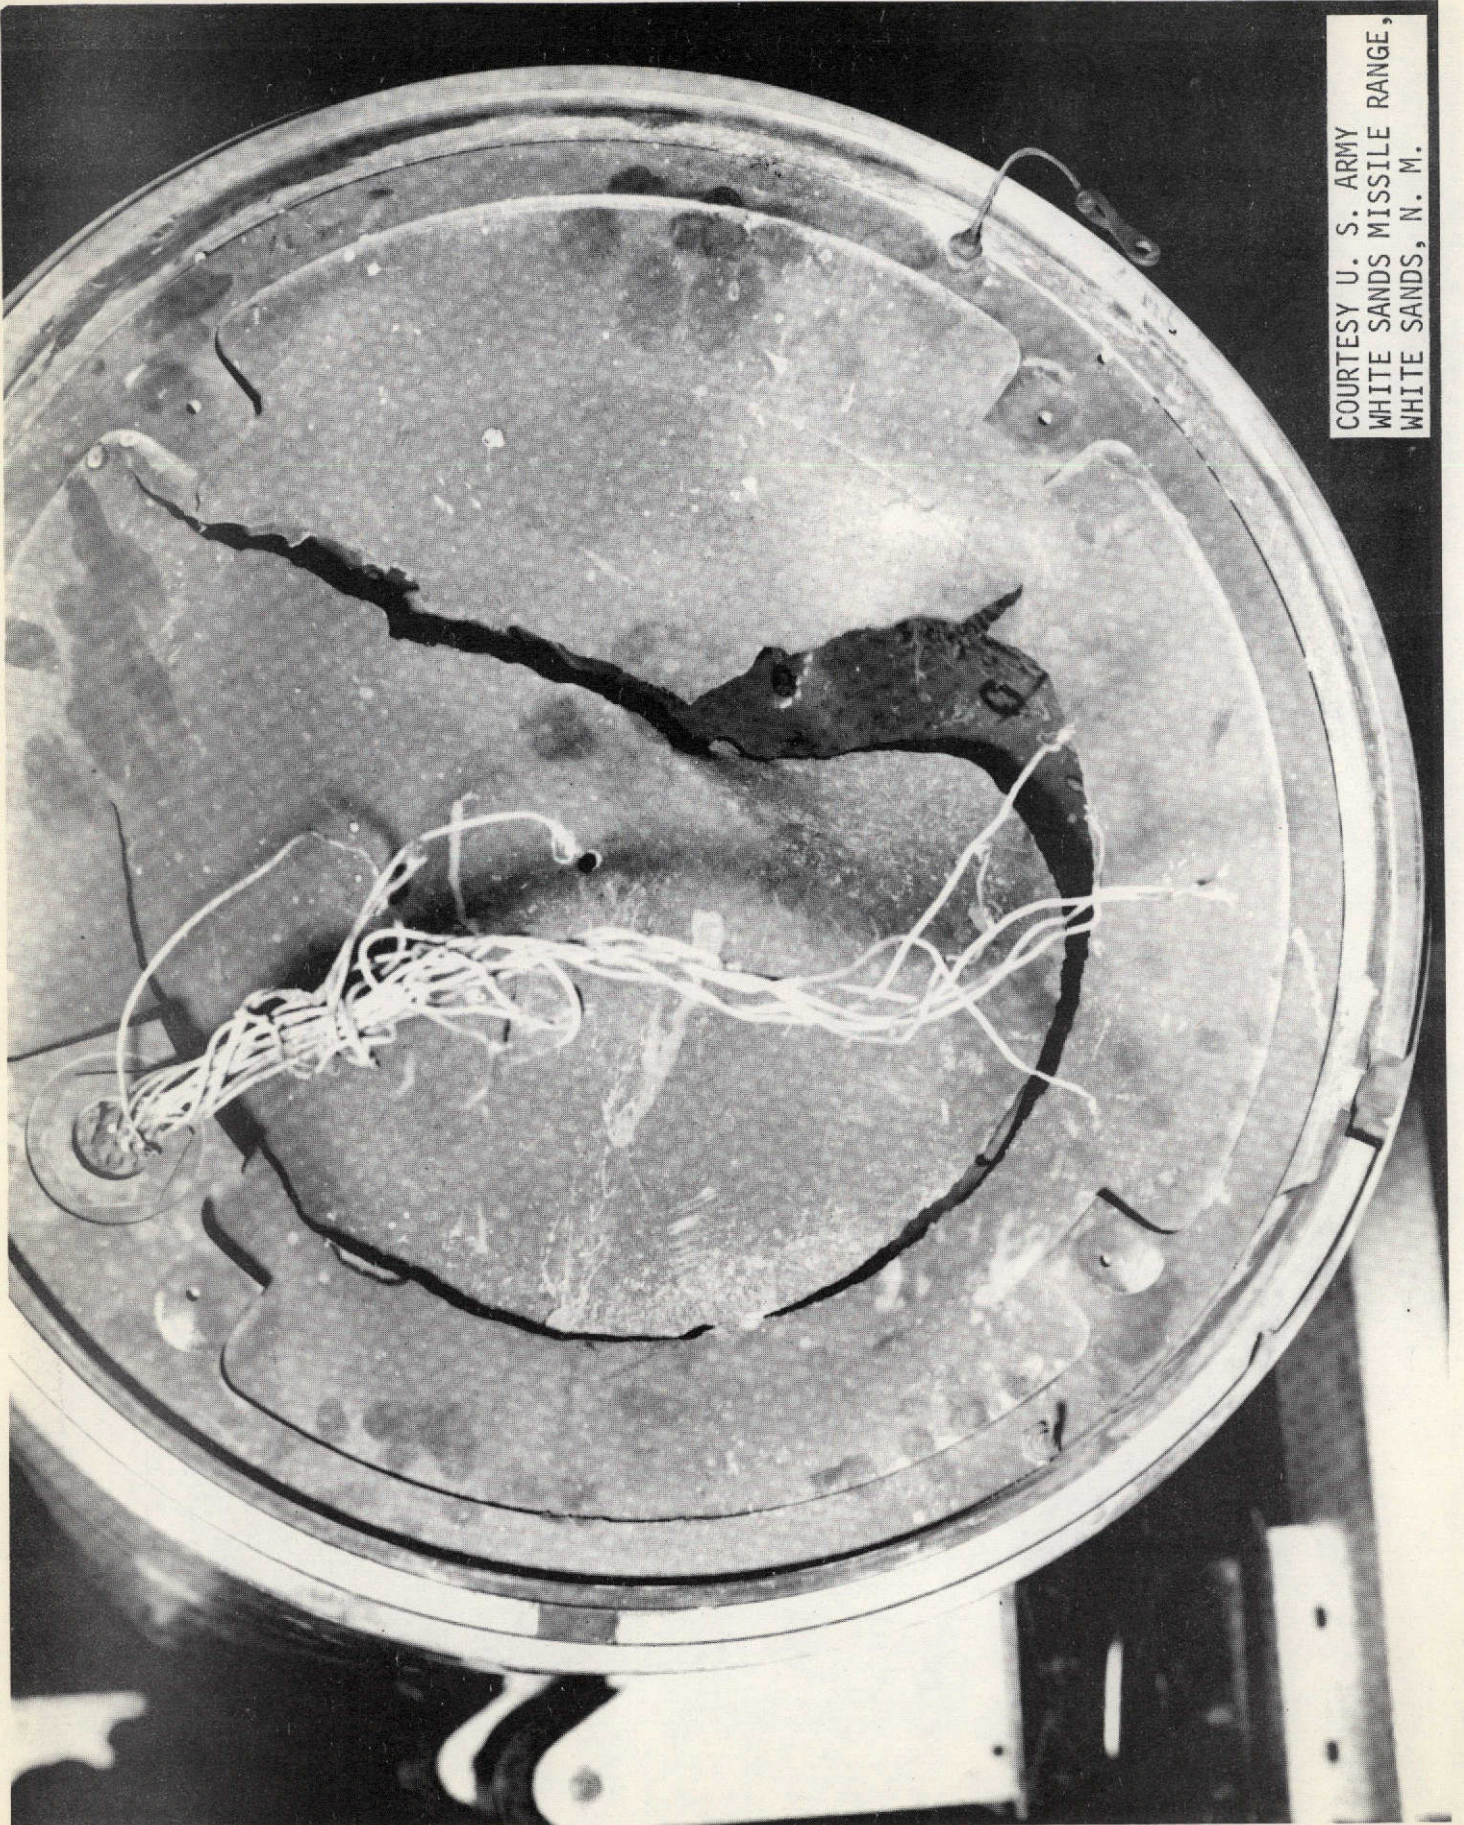
Figure 6-2. Post-Flight HCO CALROC 21.021 Payload, Vacuum Dome Rupture.
