HIGH TEMPERATURE ANTENNA DEVELOPMENT FOR SPACE SHUTTLE

FINAL REPORT

VOLUME II

CONTRACT NUMBER: NAS 9-13004
DRL NUMBER: T-825
DRD NUMBER: MA-129TA
REPORT: MDC E0896

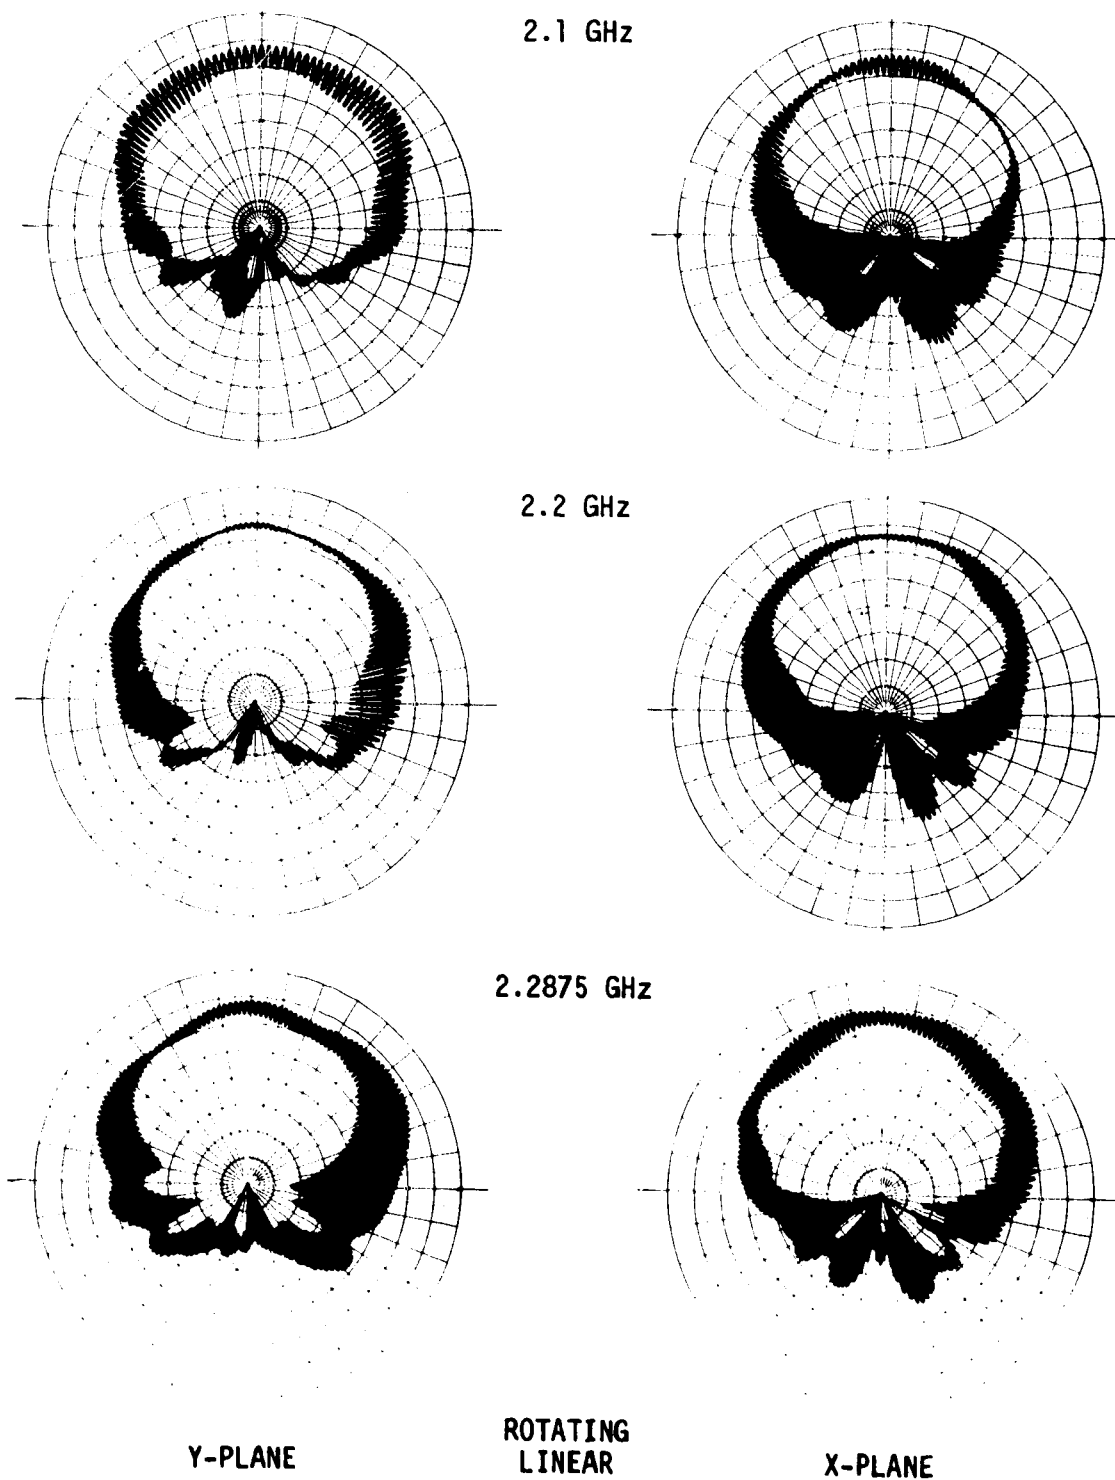
FIGURE 8 PROTOTYPE NO. 2 REFERENCE RADIATION PATTERNS

FIGURE 8 PROTOTYPE NO. 2 REFERENCE RADIATION PATTERNS (Continued)

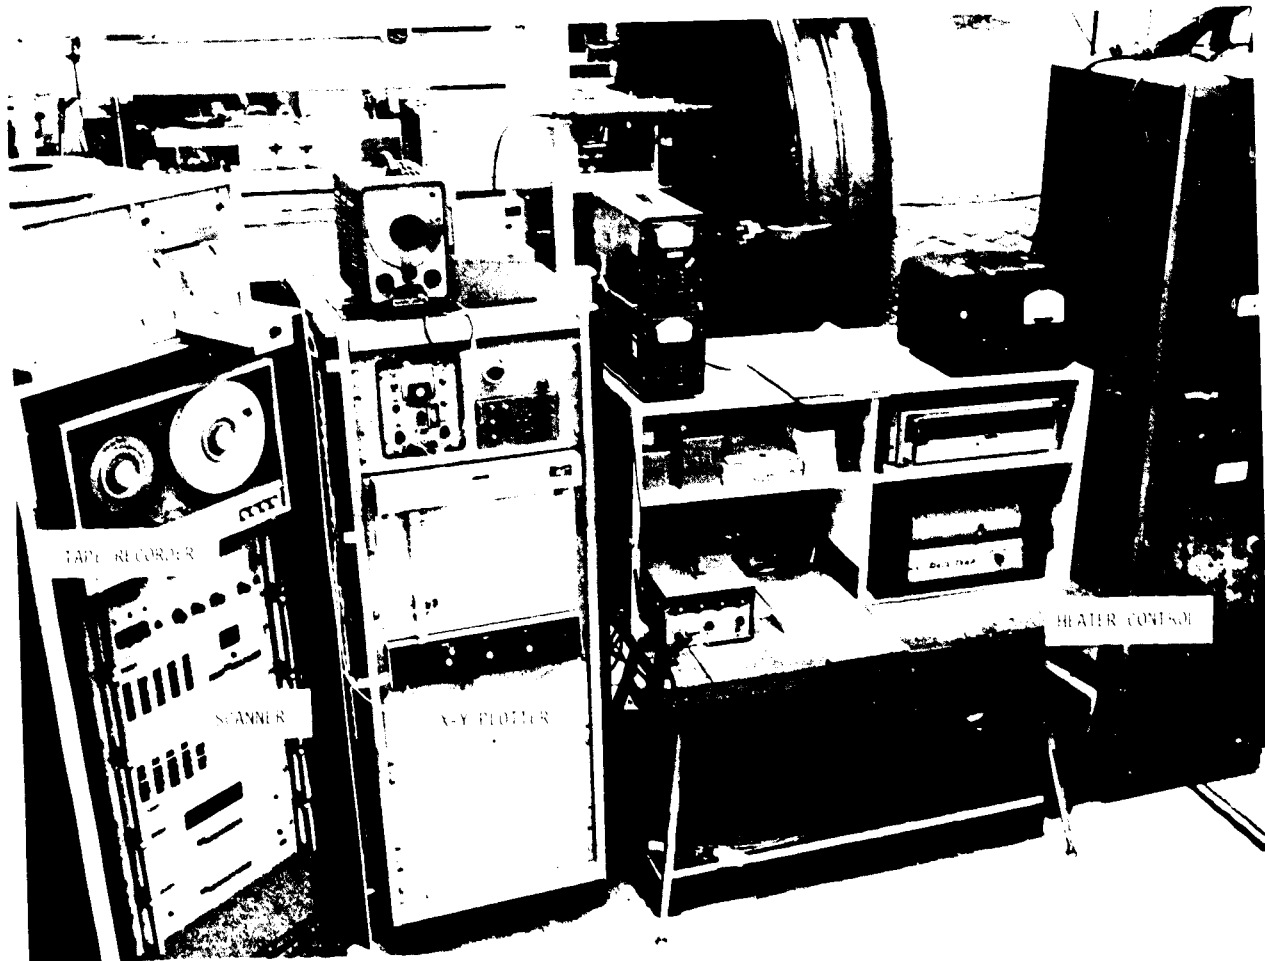
FIGURE 25 MDC MISSION ENVIRONMENT SIMULATOR CONTROL
AND DATA ACQUISITION SYSTEMS

The data acquisition system (figure 25) consisted of a two functional real-time plotter, a Dymec fifty channel scanner and a tape recorder. A print out of the thermocouple outputs is made at selected intervals (e.g., 20 sec). After the tests the data may be tabulated in engineering units (e.g., $^\circ\text{F}$) and plotted as a function of time.

The graphic heater assembly (figure 24) provides a controllable radiant heat source capable of attaining maximum temperatures of 1644 K (2500°F). The heater can be controlled to the desired temperature history manually or automatically through a Data Trak and an ignitron power controller (figure 25). The heater, consisting of 12 two pass (hair pin type) graphite elements, is operated in a nitrogen purged enclosure to prevent oxidation. The susceptor plate forms part of the enclosure and provides a test area of approximately 53 x 53 cm (21 x 21 in.).
