NASA TM X-71782

TECHNICAL PAPER to be presented at the
1975 Aerospace Engineering and Manufacturing Meeting
sponsored by the Society of Automotive Engineers,
Los Angeles, California, November 17-20, 1975

EXPERIENCE WITH INTEGRALLY-CAST COMPRESSOR AND
TURBINE COMPONENTS FOR A SMALL, LOW-COST,
EXPENDABLE-TYPE TURBOJET ENGINE

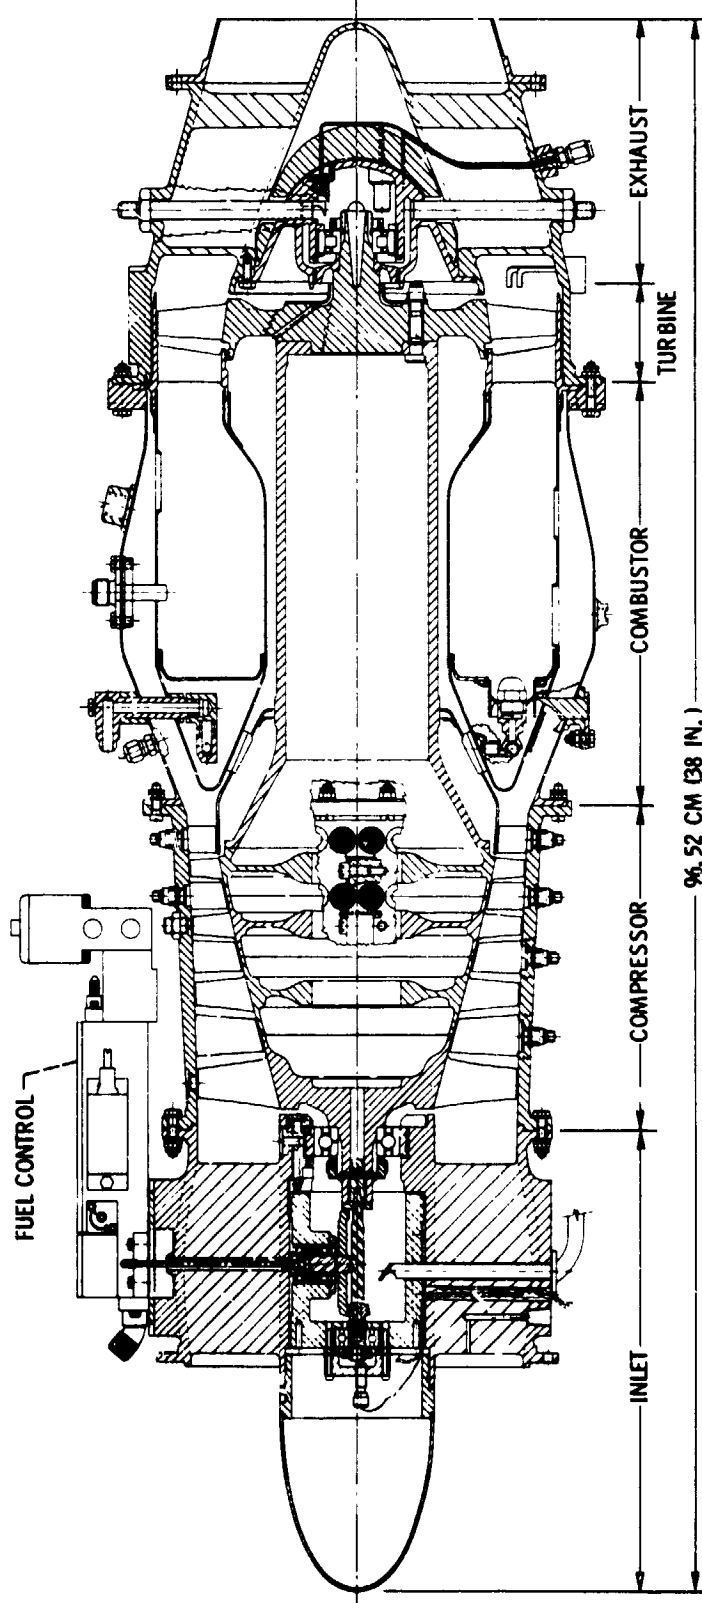
Figure 1. - Cross-sectional view of engine design.

A cross-sectional view of the engine design generated is shown in figure 1.

This axial-flow turbojet engine design consists of a four-stage compressor, an annular combustor, a single-stage turbine and a fixed area exhaust nozzle. Significant features of the design include:

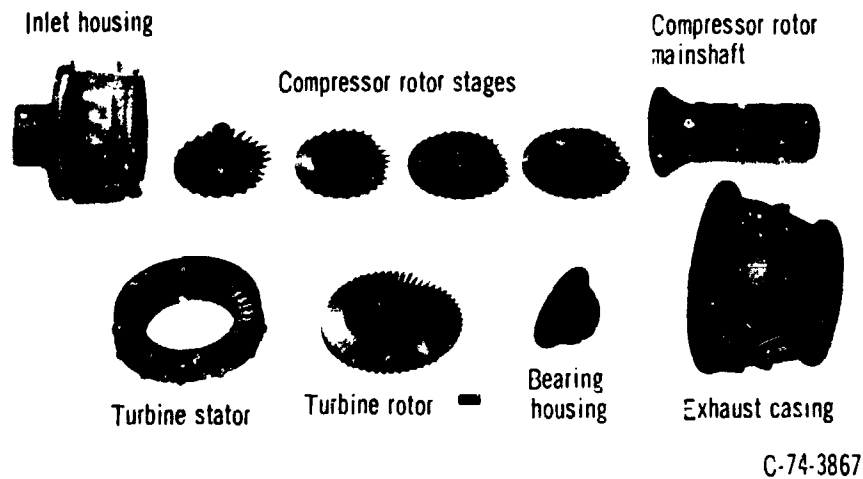
Figure 2. - Castings of major components for small-engine design.

One of the primary low-cost principles found in this engine design is that of utilizing one-piece precision castings to reduce and minimize costly machining operations and to eliminate the need for welded flanges or other parts. The majority of the larger components for this engine were produced through some type of casting process. Included in this category were the most critical of the engine parts, the

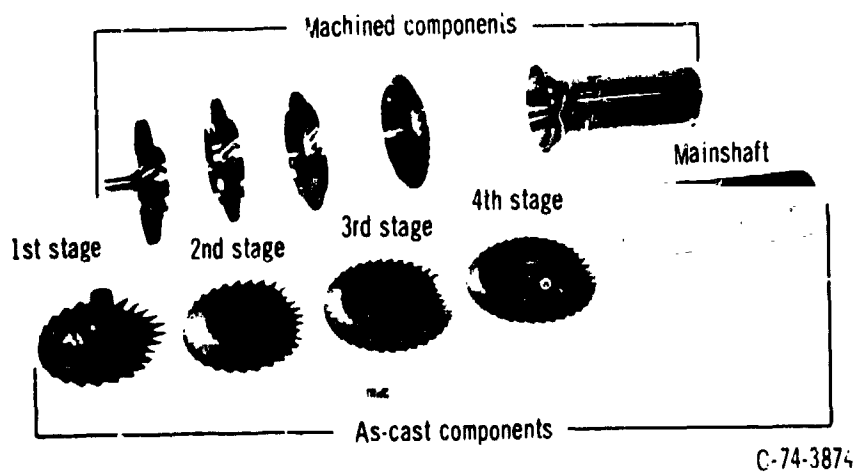
Figure 3. - Comparison of compressor rotor components in "as cast" condition and machined for welding operations.

The compressor rotor mainshaft assembly was of an all-welded design and consisted of a cast hollow rotor shaft and four separate and integrally-cast solid blade/disk rotor stages, all of which were cast from 17-4 PH (AMS 5355), a heat-treatable, high strength, ferrous alloy of relatively low cost and good machinability. (Table I lists the chemical composition for this and other pertinent materials.) Figure 3 compares the compressor rotor components in the "as cast" condition with similar components after "dress-up" machining in preparation for subsequent balancing and welding operations. The mean blade tip diameter for the four rotor stages was about 20 centimeters (8 in.). This and other pertinent dimensions for the hub and tip sections of airfoils for the compressor and turbine components are provided in table II.

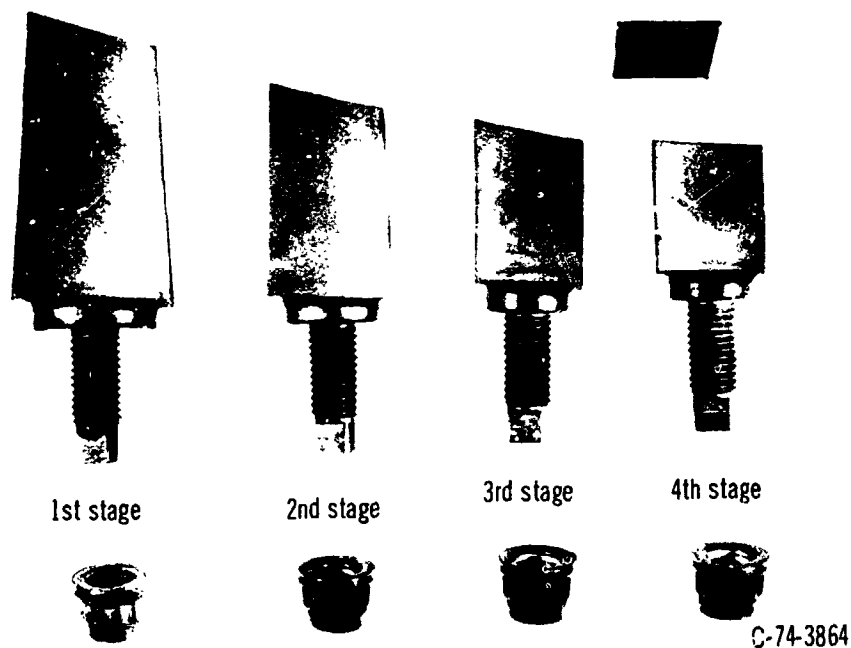
Figure 4. - Individual vanes from each of four compressor stator stages.

Figure 4 shows a cast vane from each of the four stages in the compressor section. The cast stub (stem) at one end of the vane was machined to provide threading for ease of mounting to the compressor casing with the locknut shown on the threaded portion. Flat surfaces were machined on the stem of the stator vanes to allow for orienting and adjusting the vane setting angle.

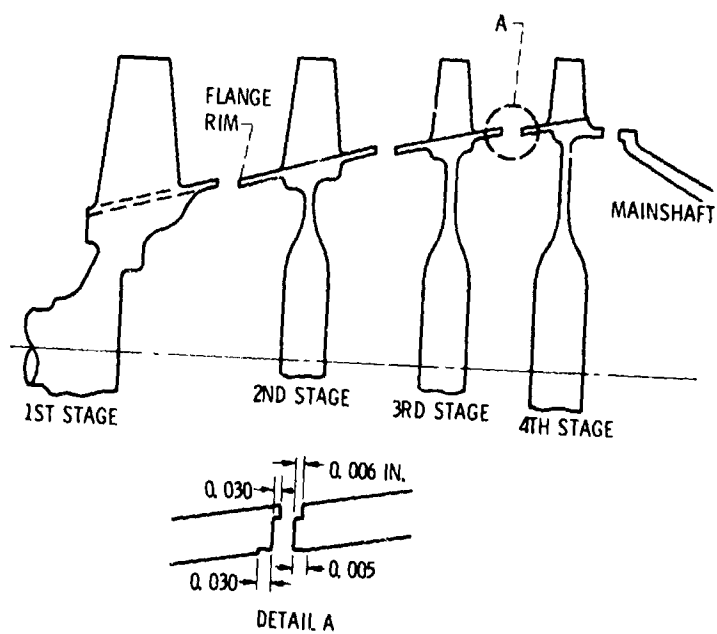
Figure 7. - Cross-sectional view of compressor rotor stages prior to welding.

All-welded compressor rotor-mainshaft assembly. - Figure 7 shows a schematic of the compressor components before welding and also presents a detailed view of the machined geometry of mating flange rims used to obtain dependable welds. The objective was to provide a concentric surface of uniform thickness on the order of 0.229 centimeter (0.090 in.). The "step" design provides an excellent way of aligning the two adjacent rotor stages for the welding operation to assure that the above conditions of concentricity and uniform thickness are obtained where the welded joint is required.

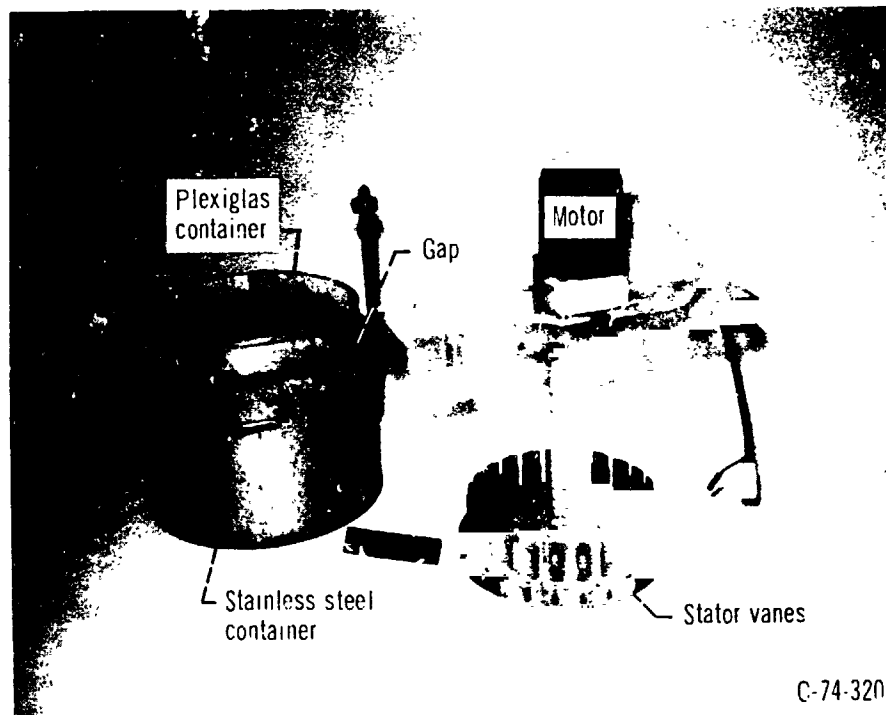
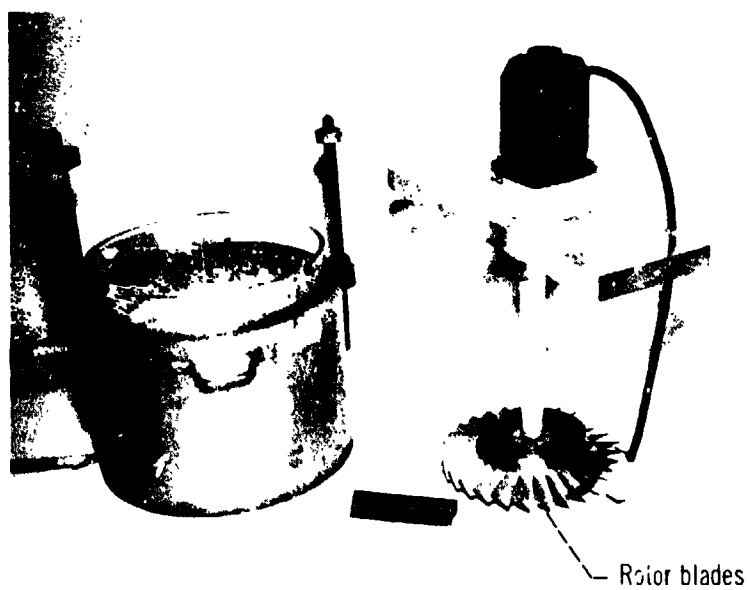
(a) Stator vane milling.

(b) Rotor blade milling.

Figure 10. - Apparatus used for chemical milling compressor airfoils.

Figure 10 shows the apparatus used for chemical milling the rotor blades and stator vanes. Using this apparatus, a single rotor stage or as many as 42 stator

vanes could be machined in one operation. Those surfaces where chemical milling was undesirable, were masked off (not shown in the figures) with a standard commercial maskant or mylar tape. The general procedure was to fill the plexiglas container with about 4 liters of the etchant solution and then to place the plexiglas container inside the stainless steel container. The gap between the containers was then filled with water, and the steel tank placed on a hotplate. The bath solution was heated and controlled to a temperature of 344 K (160° F) and the components to be machined were rotated in the bath solution at a speed of about 35 rpm through the use of the electric motor shown in the figure. Using this technique, the blade or vane profile contour (thickness) was reduced by as much as 0.041 centimeter (0.016 in.) (0.020 cm on a surface). It was found that a 4-liter batch of the solution would "exhaust" itself after about 28 cubic centimeters (1700 sq in. - mils) of metal removal, and the rate of metal removal was about 0.0025 centimeter (0.001 in.) in 4 to 5 minutes. This removal rate is slightly lower than the value of 0.00076 centimeter per minute (0.0003 in./min) listed in reference 8 (Metals Handbook) for stainless steels. The resulting surface finish was as good or better than the original "as cast" surface. Profiles of some blade section contours were obtained with the use of a blade plotting machine. The machine was used to produce 10 x size "eyelash"-type profiles on sheets of Mylar film. Figure 11 presents an overlay of two Mylar plots (before and after chemical milling) for the same blade section to reveal the uniformity of this metal removal method. For the typical case presented, the surface removal was approximately 0.015 centimeter (0.006 in.) in thickness.

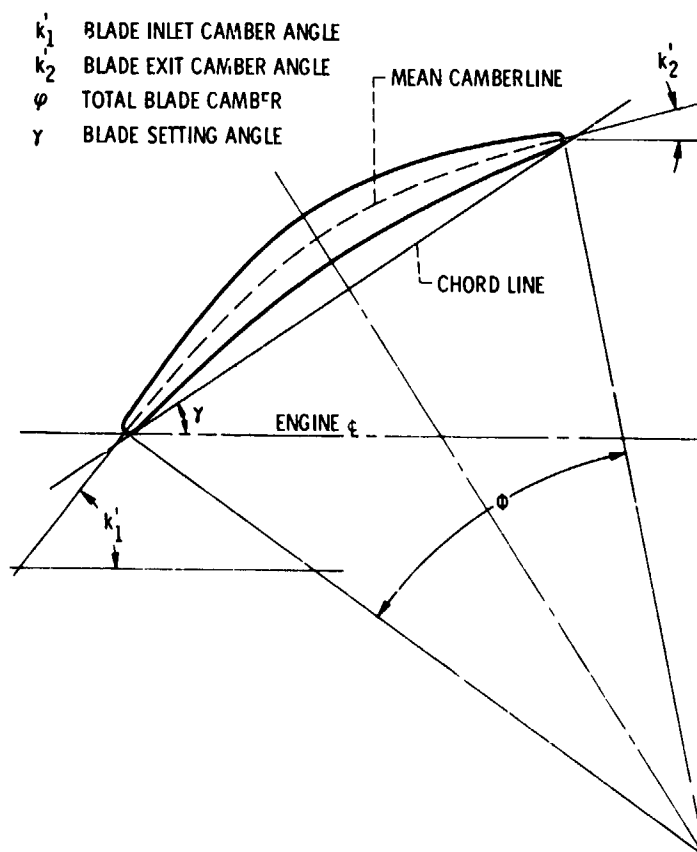
Figure 12. - Typical blade section illustrating blade camber and blade setting angles.

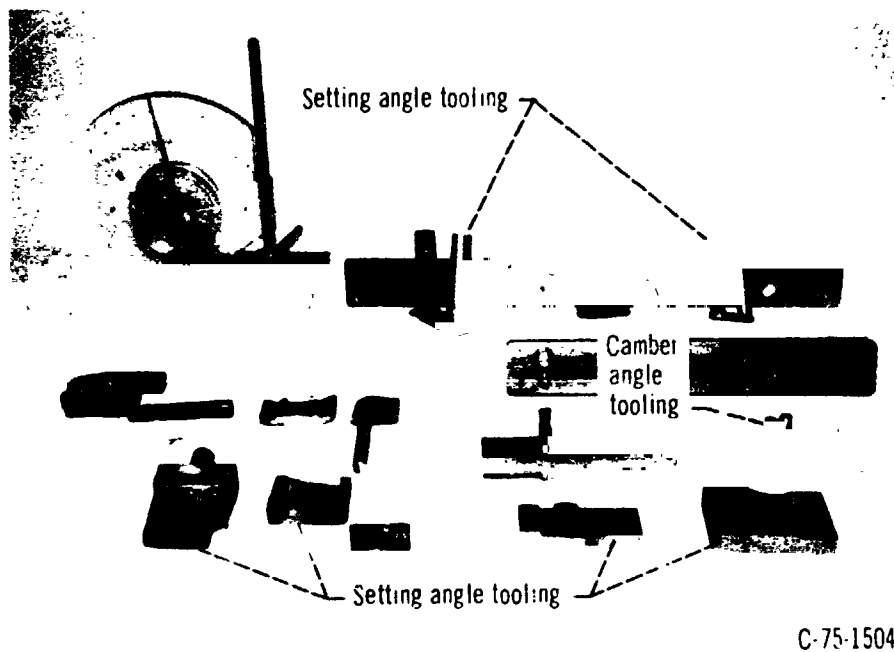
Figure 13. - Tooling developed for affecting compressor rotor blade angle changes.

When blade camber angles were to be changed, the tooling took the form of pins mounted to a flat piece of barstock material $1.3 \times 2.5 \times 25.4$ centimeter ($1/2 \times 1 \times 10$ in.) in length. Figure 14 shows a close-up view of a typical set-up for changing the blade camber angle in the trailing edge region of the blade. A second stage rotor is shown mounted on the table of a milling machine (used as stationary fixture only) and the pins of the forming tool placed over the blade with one pin on each side of the blade ready for the bending operation. One of the pins extends through the barstock and is held in the spindle of the milling machine and becomes the pivoting center for the barstock which is used as a lever arm. A makeshift graduated scale (in degrees) is attached to the "head" which houses the

For altering the setting angle of the blade, the tooling either conformed to the blade surface contour or was constructed to slide over the blade to firmly grip the blade along almost the entire span of the leading and trailing edge as well as at a section near the blade base. Figure 16 presents profile overlays (before and after twist) for the hub and tip sections of a first-stage rotor blade showing the amount of twist affected. If blade setting angles were determined to be within $\pm 0.5^{\circ}$ of the desired setting angle, the twist operation was considered successful. Otherwise, those blades not within this tolerance would be re-twisted until acceptable. Blade setting angles at the tip section were changed by as much as 5° using this technique.

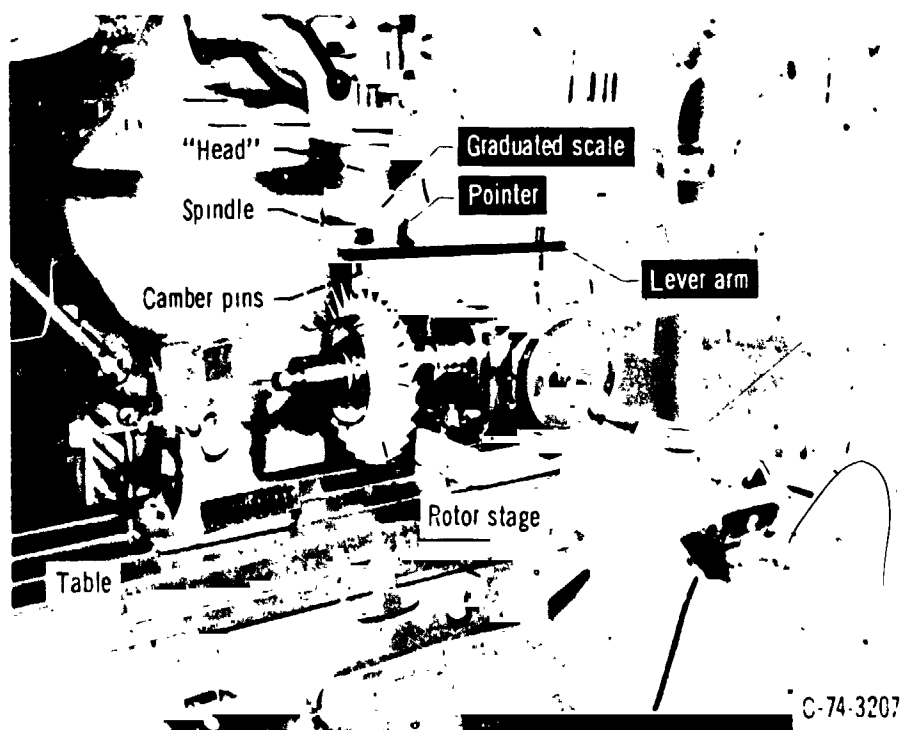
Figure 14. - Typical set-up for affecting angular change in blade camber in compressor rotor stages.

spindle and a pointer is "attached" to the lever arm to provide an indication of angle change that occurs. For the bending operation set-up as shown in figure 14, the bending occurs from the approximate midchord region of the airfoil back to the trailing edge. If a camber angle change was required in the leading edge region, a similar bending operation was performed. Although it was obvious that angle changes would have to be limited when approaching a section near the blade-to-disk joint of the integral casting, angle changes on the order of 5° were still possible at a region of only 0.38 centimeter (0.15 in.) above the blade-disk joint for the third and fourth stage blading. At the same blade span for the first and second stage blading, practically no angle change (about $1/2^{\circ}$) was possible with this tooling. (The first and second stage blading was somewhat thicker than that of the third and fourth stages.) Figure 15 presents some overlays of "eye lash" profiles (from blade plotter) for the hub, midspan, and tip sections of a fourth stage rotor blade (before and after) to indicate the camber angle change after a dual bending operation. The table accompanying the profiles lists the camber angles before and after bending. Total blade camber angles were changed by as much as 7° in the blade tip region. The average time required to affect blade camber angle changes for a complete rotor stage was about one working day (8 man-hr). If, upon subsequent full-scale engine testing it was found that additional re-cambering or even de-cambering was required, these new changes were accomplished with the same tooling.

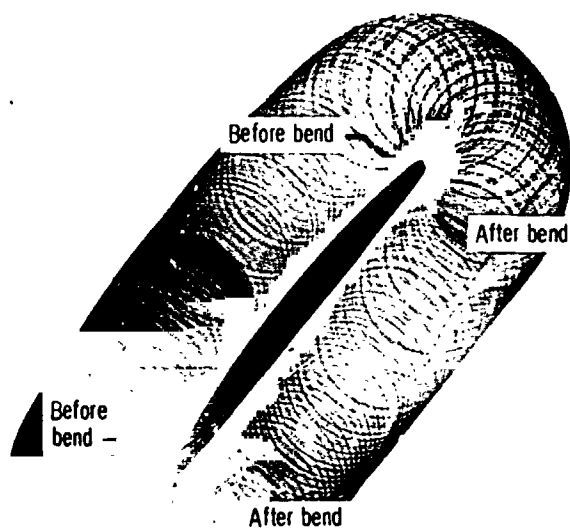
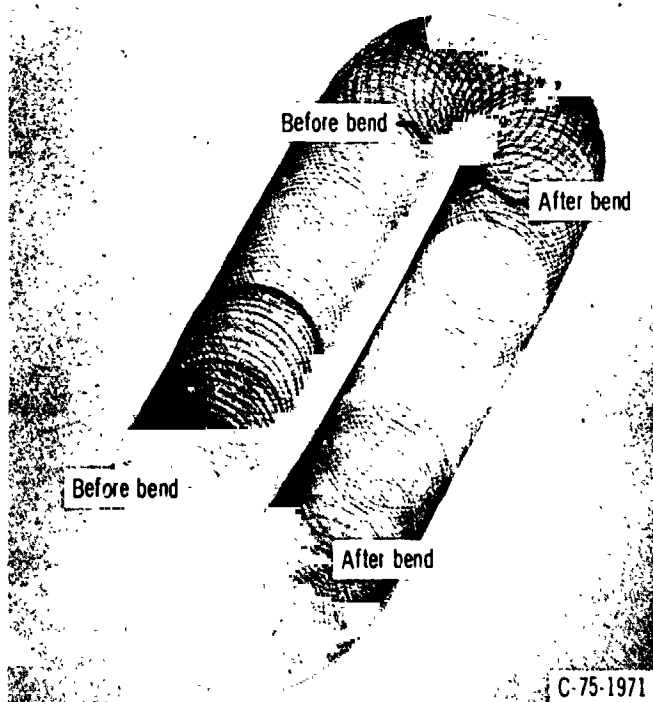
Figure 15. - Overlays of "eyelash" profiles at selected sections of a fourth stage rotor blade before and after blade camber angle change.

Section	Setting angle, λ	
	Before bend	After bend
C-C	31.5°	30.9°
F-F	56.3°	51.9°

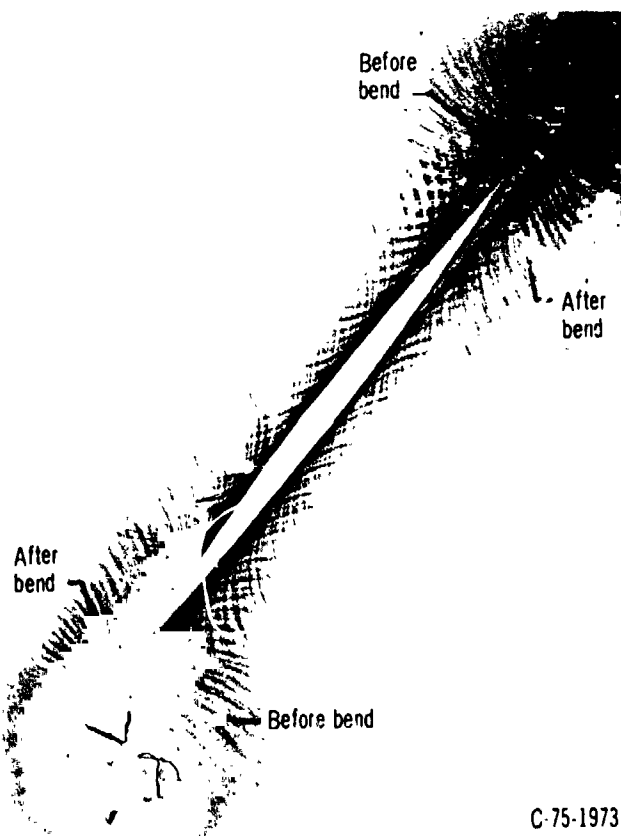
Figure 16. - Overlays of "eyelash" profiles at selected sections of a first stage rotor blade before and after blade setting angle change.

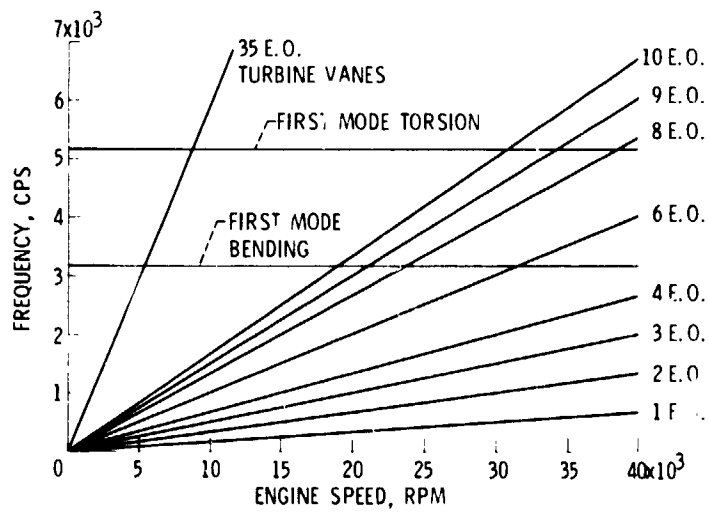
Figure 18. - Turbine rotor blade interference diagram.

In addition to the 1 and 2 per rev excitation frequencies normally generated by the engine, the other engine orders of significant interest would be 3 and 35 since there were three struts downstream, and 35 stator vanes upstream of the rotor. According to the diagram, none of these engine orders should present any critical resonance problems with respect to the first mode bending over the range of speeds from 7000 rpm (windmilling speeds for engine starts at sea level static) to the maximum operating speed of 38,000 rpm. The 35 engine order does intercept the first mode torsion critical frequency at about 9000 rpm, but upon engine start the speed is quickly accelerated through this speed regime to an idle speed of at least 25,000 rpm.

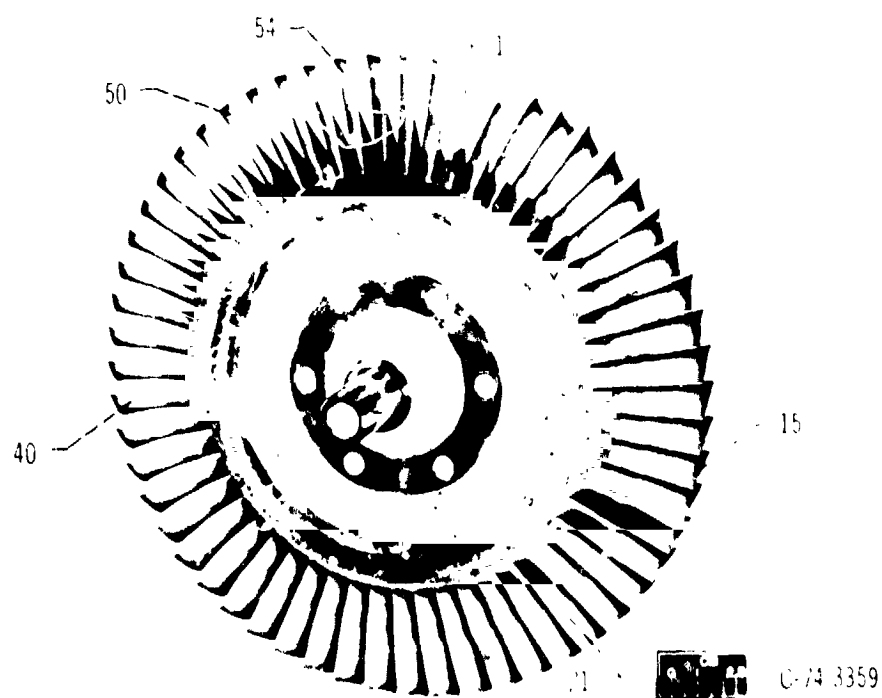
Figure 20 - Turbine rotor showing location of failed blade and those with cracks in the trailing edge

inspection of the turbine rotor revealed that five other blades had chordwise cracks in the trailing edges at approximately the same span distance. Figure 20 shows the downstream side of the turbine rotor with blades having cracked trailing edges. Figure 21 shows a closeup view of the trailing edge of blade 21 clearly revealing the crack which had already propagated for a distance of about 0.95 centimeter (3/8 in.).

Although probably coincidental, it was observed that the general pattern or location of cracked blades (including the fractured one) on the rotor (see fig. 20) resembled the pattern of the 3-diameter modes for the excitation frequencies of 2737 and 4266 hertz (figs. 26(b) and (e), respectively). Furthermore, it was noticed that the cracked blades of the rotor and the "nodal" blades of the hologram for 4266 hertz appear to be very nearly in line with the six bolt holes for attaching the rotor to the compressor rotor mainshaft assembly.

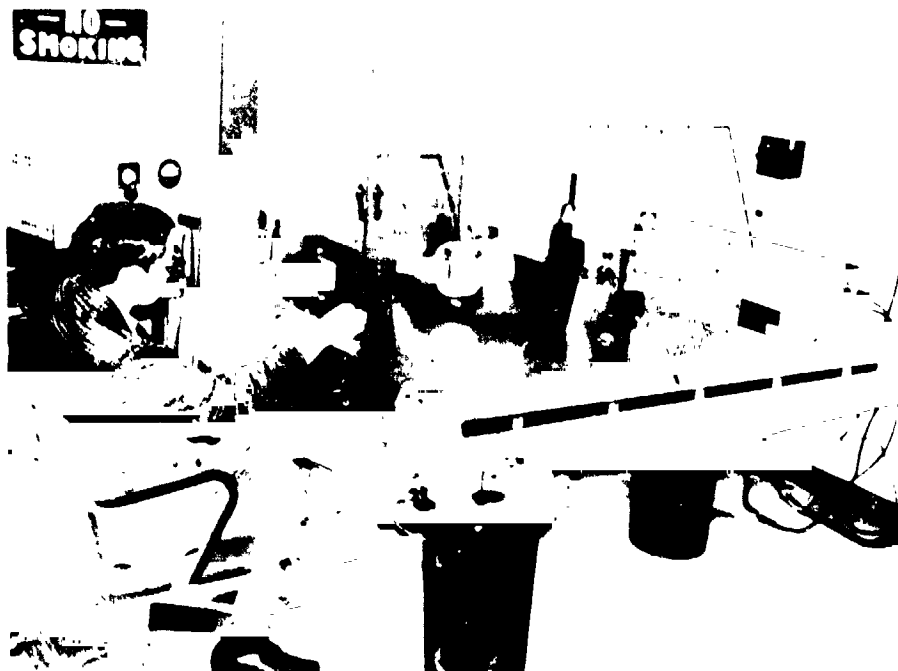
Figure 22 - Apparatus used for ultrasonic inspections of turbine blade and turbine rotor

In an attempt to resolve the cause of failure, vibration tests were conducted on an individual blade and an entire turbine rotor. One general purpose of these tests was to verify the calculated values for the fundamental natural frequencies of the blading for the bending and torsional modes. Another purpose was to take advantage of this technique for determining highly stressed regions of the blade for strategic placement of strain gages for rotative tests, if so desired.

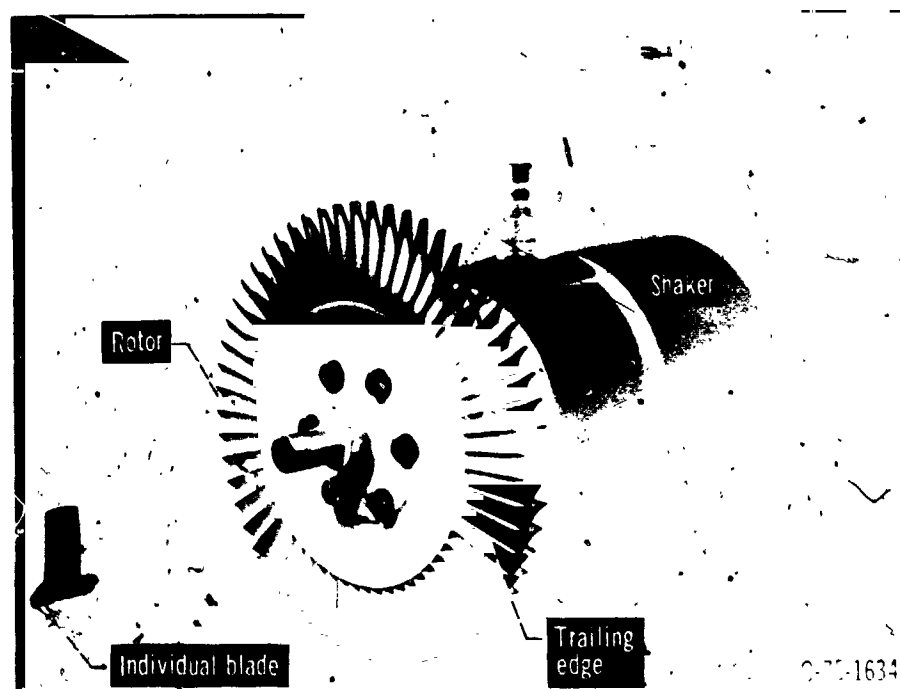
Figure 24. - Turbine wheel mounted on vibration exciter

An entire turbine rotor assembly was subsequently mounted to the shaker (see fig. 24) and excited to resonant frequencies to produce the series of hologram-photographs shown in figures 25(a) through (f). The resonant frequencies are listed with each hologram. The rotor was centrally supported, and mounted similar to the manner in which it would be for an engine assembly (six through-bolts), and vibrated along its horizontal axis. According to reference 10 the vibration modes can be classified by the number of diametral mode lines, and the holograms presented are so classified.
