EVALUATION OF HIGH PRESSURE WATER BLAST WITH ROTATING SPRAY BAR  
FOR REMOVING PAINT AND RUBBER DEPOSITS FROM AIRPORT RUNWAYS,  
AND REVIEW OF RUNWAY SLIPPERINESS PROBLEMS CREATED BY RUBBER  
CONTAMINATION

Walter B. Horne, Langley Research Center and  
Captain Guy D. Griswold, Base Civil Engineers  
Langley Air Force Base

**NATIONAL AERONAUTICS AND SPACE ADMINISTRATION  
LANGLEY RESEARCH CENTER, HAMPTON, VIRGINIA 23665**

1. Report No. TMX-72797	2. Government Accession No.	3. Recipient's Catalog No.
4. Title and Subtitle EVALUATION OF HIGH PRESSURE WATER BLAST WITH ROTATING SPRAY BAR FOR REMOVING PAINT AND RUBBER DEPOSITS FROM AIRPORT RUNWAYS, AND REVIEW OF RUNWAY SLIPPERINESS PROBLEMS CREATED BY RUBBER CONTAMINATION		5. Report Date November 1975

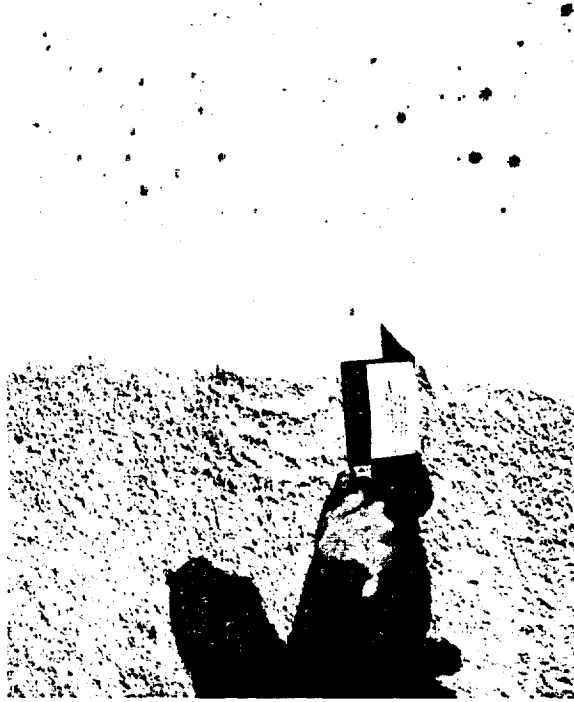
a) TYPICAL RUNWAY PAINT STRIPE SURFACE BEFORE PAINT REMOVAL. A. T. D. = 0.01 IN.

b) LOOSE PAINT PARTICLES ON RUNWAY SURFACE AFTER PASS BY HIGH PRESSURE WATER BLAST

FIGURE 4. - PHOTOGRAPHS OF PAINT STRIPE SURFACE ON LAFB RUNWAY 7/25 BEFORE AND AFTER PASS BY HIGH PRESSURE WATER BLAST USING A ROTATING SPRAY BAR

Paint removal.- Visual observations and photographs taken during and after paint removal on runways 7/25 and 17/35 (see figure 1, 4, and 5), indicated that the high pressure water blast with rotating spray bar did an excellent job of removing bulk paint from the runway marking areas. The bulk paint was broken up into small particle sizes (see figure 4) which were easily removed from the runway by runway vacuum sweepers, especially when the pavement surface dried out.

In most runway marking areas, a faint residual paint stain remained after two passes of the cleaning equipment. Close visual inspection of the stains showed that the stains appeared to be below the top of the pavement surface texture, and impregnated vertical or nearly vertical slopes of pavement surface granules. These surfaces were probably not exposed to direct impingement by the high velocity water jets of the rotating spray bar. Figure 5 shows a photograph taken of the approach end of runway 17 during re-painting of the threshold bar markings after paint removal. This photograph shows some slight discoloration of the pavement surface in the paint removed areas produced by the residual paint stains. Base civil engineering judged the stain problem to be insignificant and felt that paint removal achieved on the runways satisfied its paint removal specifications. No pavement surface damage attributable to the paint removal equipment could be found on either runway 7/25 or runway 17/35 after the paint removal program was completed.

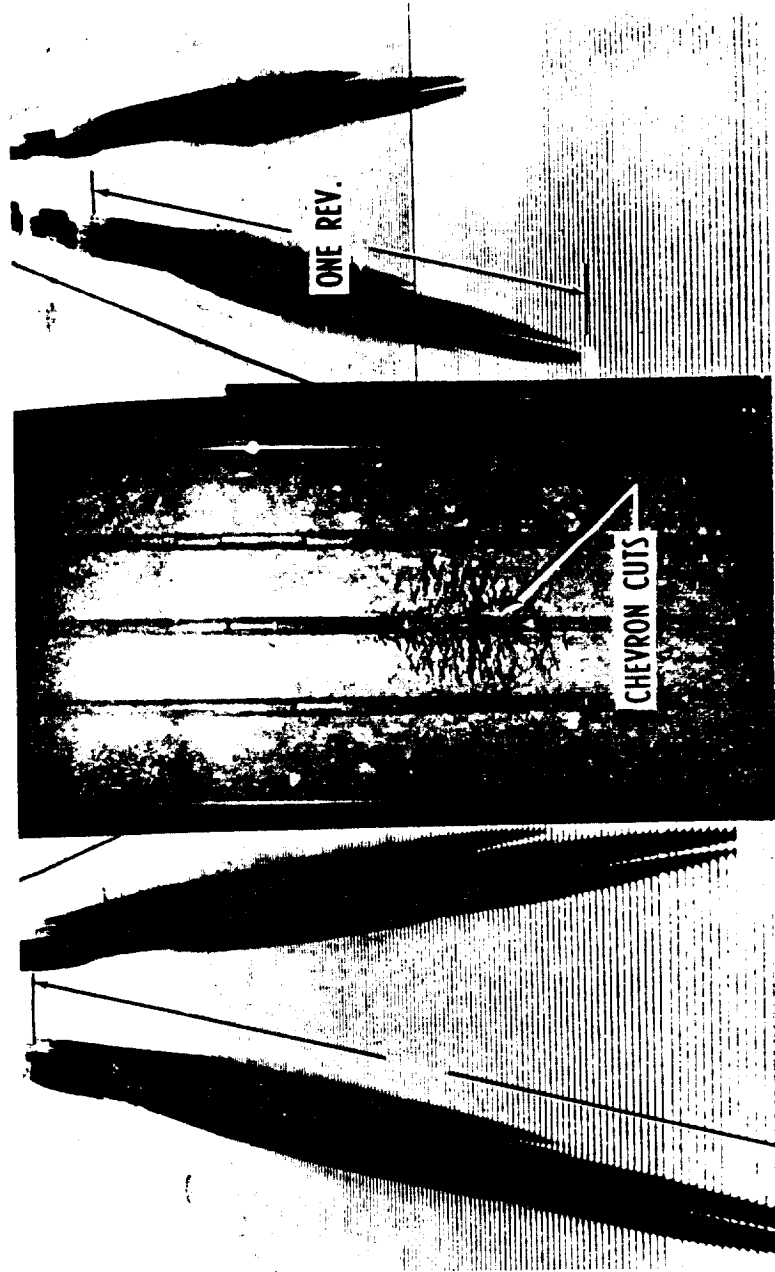
**FIGURE 20. - TIRE DAMAGE FROM WHEEL SPINUP AT TOUCH DOWN  
ON DRY GROOVED RUNWAY**

**WALLOPS GROOVED CONCRETE,  $1 \times \frac{1}{4} \times \frac{1}{4}$  in. GROOVE PATTERN;  
CV-990 JET TRANSPORT MLG TIRE; SIZE 41 X 15.0 - 18;  $p = 160 \text{ lb/in.}^2$ ;  
 $V_G = 125 \text{ knots}$ ;  $V_v = 4 - 5 \text{ ft/sec}$**

Visual observation of the tires of aircraft parked at airports having grooved runways suggest that only the larger diameter aircraft tires, and of these, only those employing high inflation pressures, develop chevron cuts on grooved runways. Reference 16 points out that the degree of chevron cutting of tire treads is also affected by the magnitude of the aircraft touchdown speed. Reference 16 states that for each combination of tire and grooved pavement surface, there is a ground speed below which no chevron cutting occurs, and above which the extent of the chevron cut damage increases with increased speed.
