SATELLITE & MESOMETEOROLOGY RESEARCH PROJECT

*Department of the Geophysical Sciences
The University of Chicago*

SPEARHEAD ECHO AND DOWNBURST NEAR THE APPROACH END OF
A JOHN F. KENNEDY AIRPORT RUNWAY, NEW YORK CITY

T. Theodore Fujita

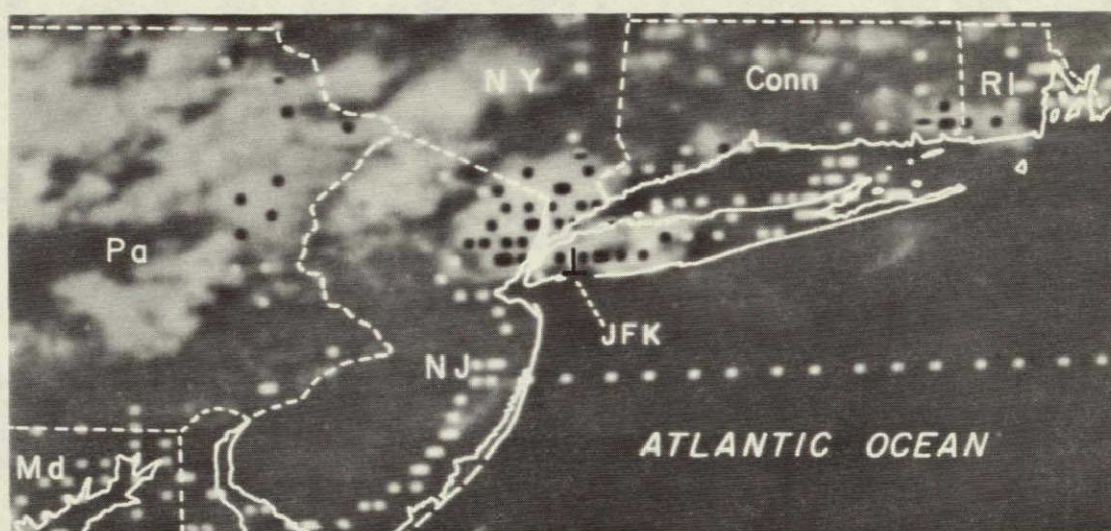
Figure 1. Visible picture of the JFK Thunderstorm at 2003 GMT, about 2 minutes before the aircraft accident. An inverted T symbol is the projected length of a 45,000-ft high, imaginary pole at JFK as seen from the satellite. The image of a cloud at 45,000 ft will shift northward as much as the length of the pole in this figure.

The satellite imagery closest to 2005 GMT, the accident time, was obtained at about 2003 GMT. Unfortunately, the image had been transmitted with coastlines and state boundaries in dots which cannot be removed from the image. An attempt was made to superimpose the precise coastlines so as to determine the three-dimensional features of the JFK Thunderstorm at the time of the accident (see Figure 1).

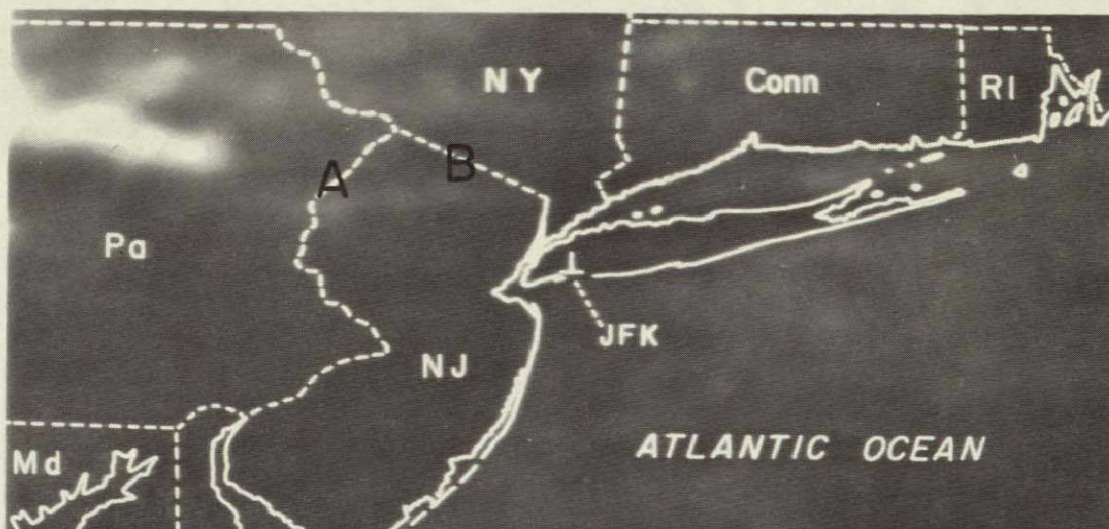
Figure 3. A cumulus line A - B in northern New Jersey. The line was a precursor of the JFK Thunderstorm. Infrared picture at 1703 GMT.

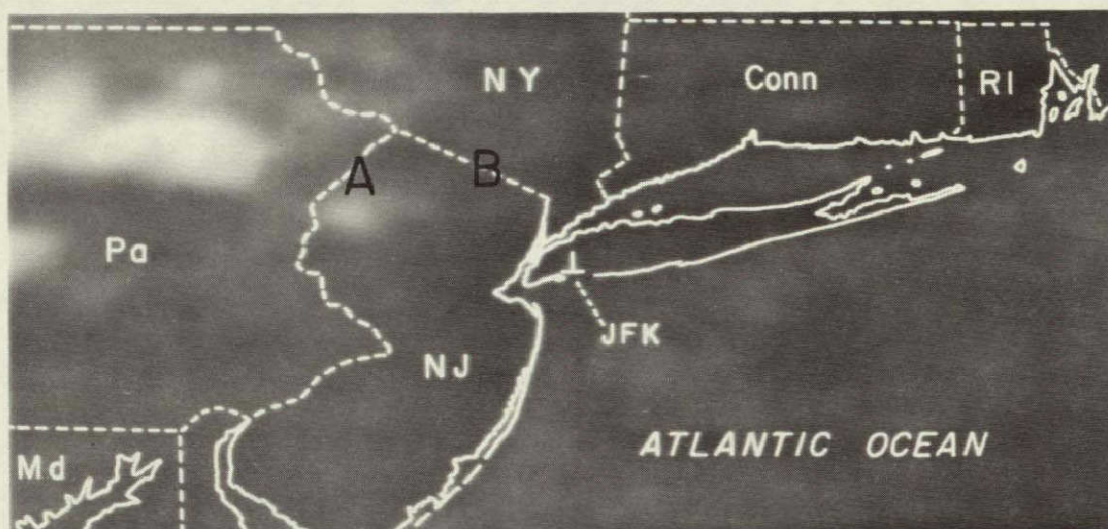
Figure 4. IR picture at 1733 GMT showing an explosive growth of the west end of the cumulus line A - B.

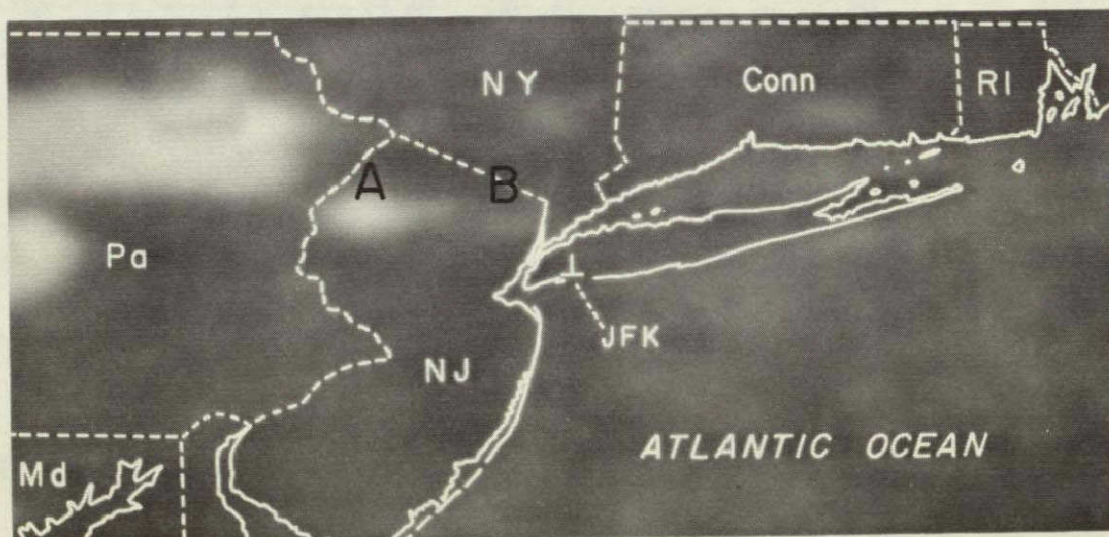
Figure 5. IR picture at 1803 GMT. The west and east ends were separated into clouds A and B.

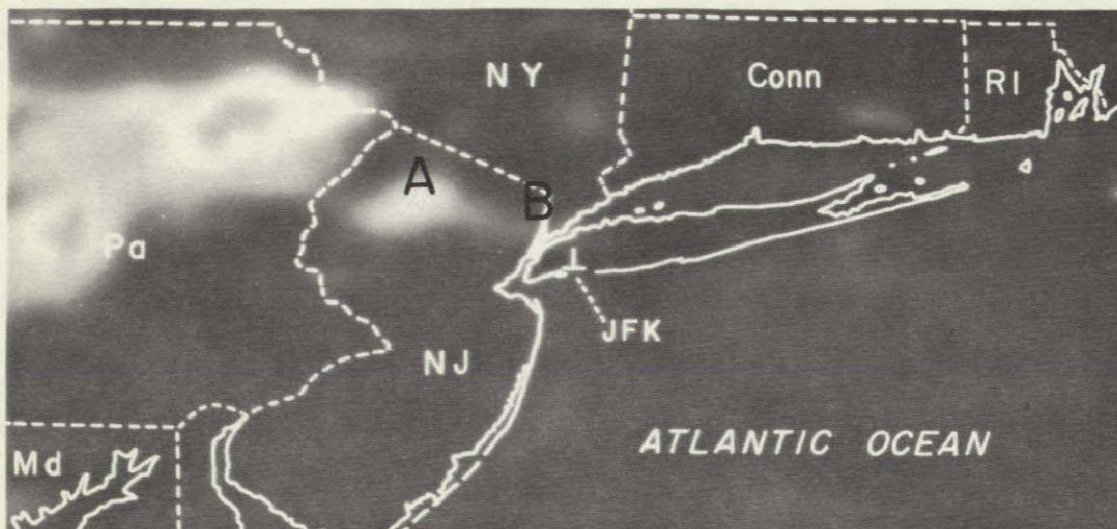
Figure 6. IR picture at 1833 GMT. Cloud B was moving eastward just to the north of JFK. Cloud A started forming an anvil cloud.

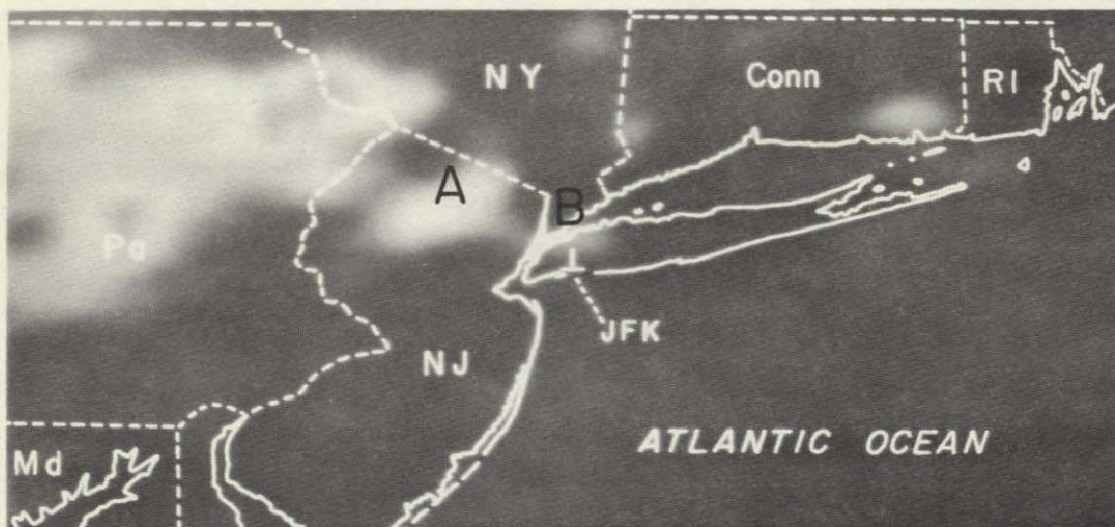
Figure 7. IR picture at 1903 GMT. An anvil is spreading east-northeastward from cloud A. Cloud B is passing just to the north of JFK.

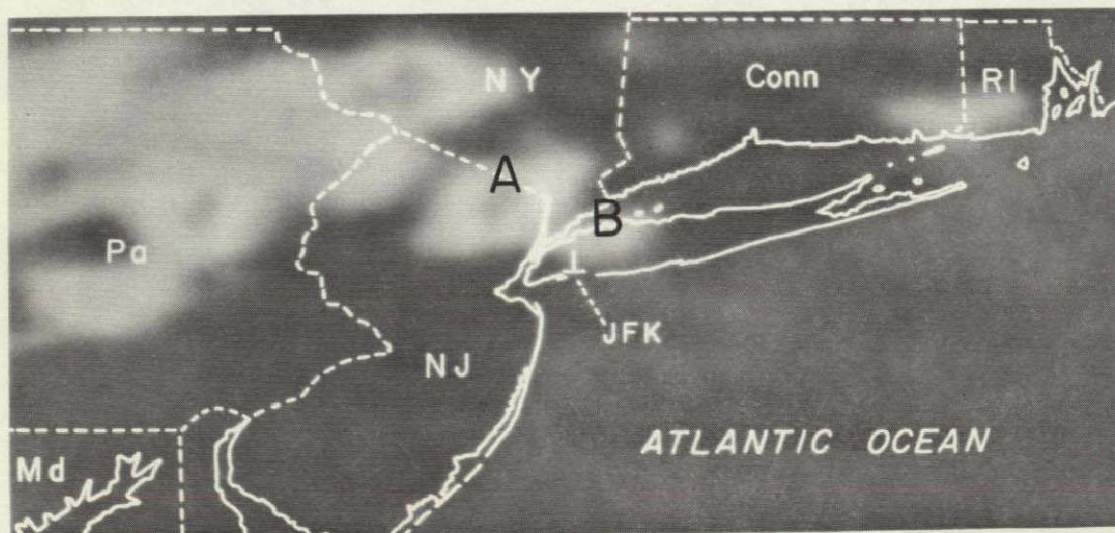
Figure 8. IR picture at 1933 GMT. The first appearance of a dark grey area inside cloud A. The area is characterized by -44°C or colder temperature; correctly, equivalent blackbody temperature.

At 1933 GMT, just about 30 minutes before the accident, a light-grey area appeared inside cloud A. the equivalent blackbody temperature at the boundary of this area was -44°C (Figure 8). The simultaneous visible picture reveals the formation of an arc cloud along the south edge of cloud A.

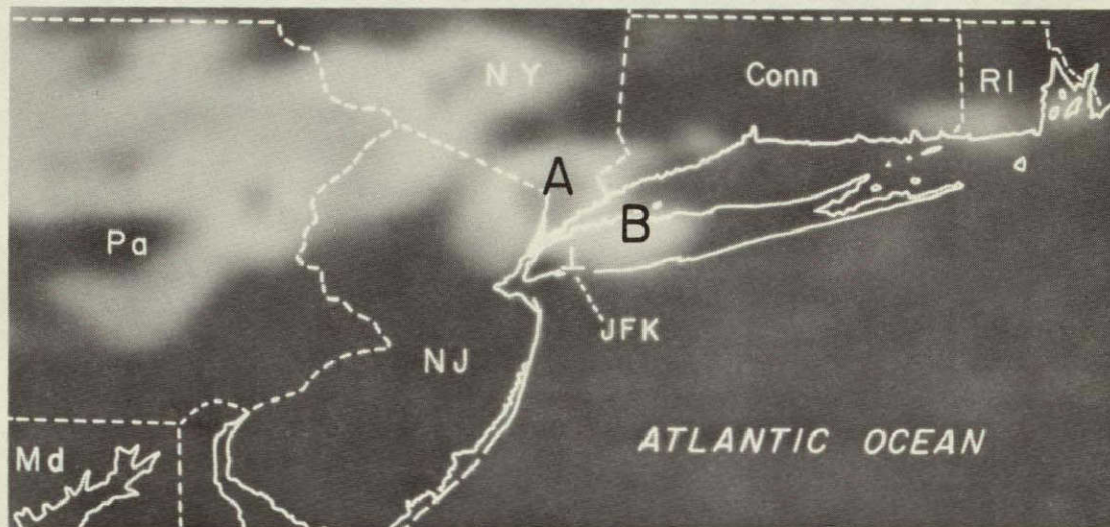
Figure 9. IR picture at 2003 GMT, two minutes before the aircraft accident at JFK. An inverted T denotes the projection of an imaginary, 45,000-ft tower at JFK.

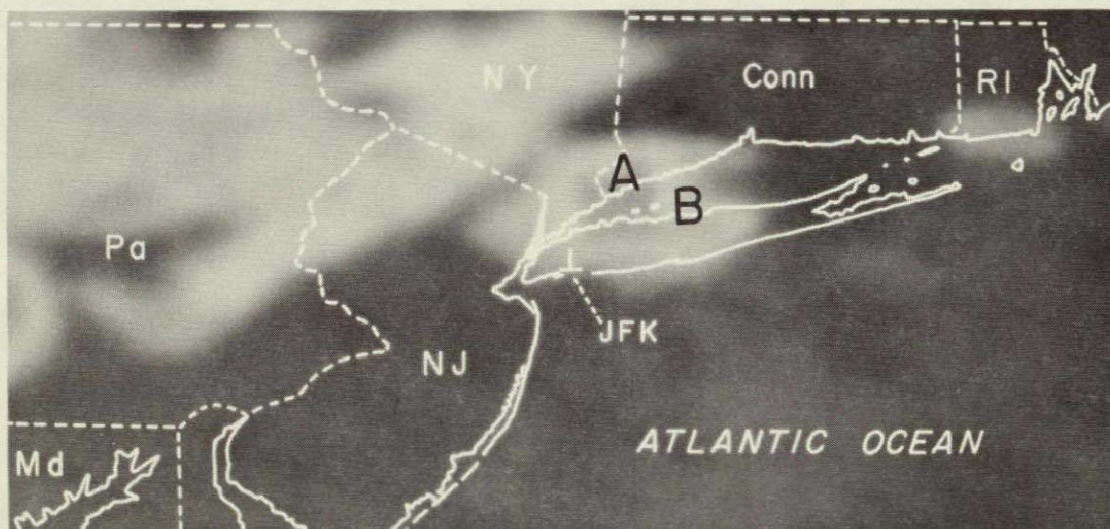
Figure 10. At 2033 GMT, the JFK Thunderstorm became an isolated storm situated ahead of an active squall line.

A sequence of three pictures taken at 2033 GMT (Figure 10), 2103 GMT (Figure 11), and 2133 GMT (Figure 12) reveals that the areas of overall cloud as well as the areas of cold cloud tops kept increasing.

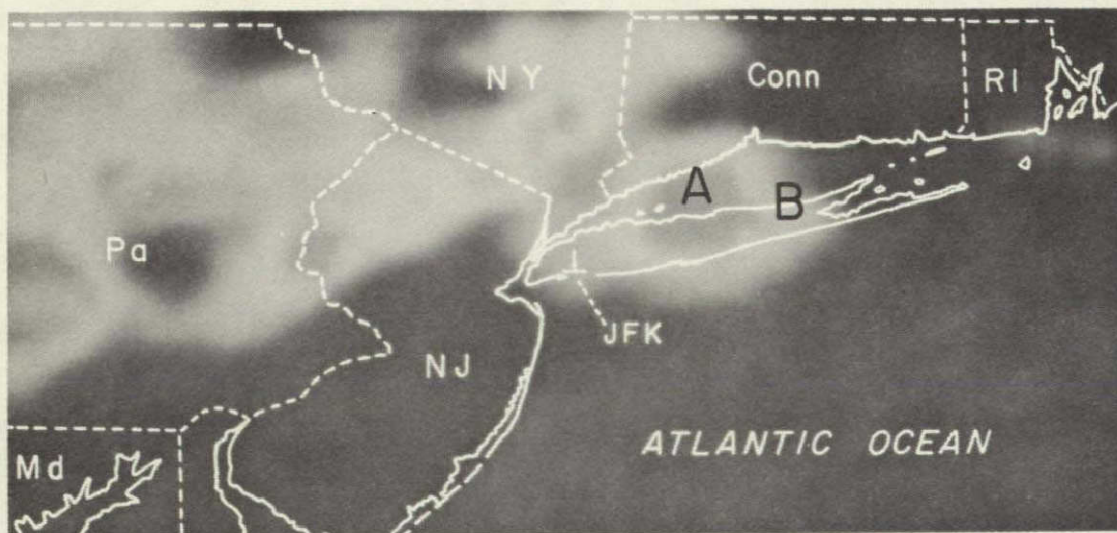
Figure 11. IR picture at 2103 GMT when the growth rate of the JFK Thunderstorm was decreasing.

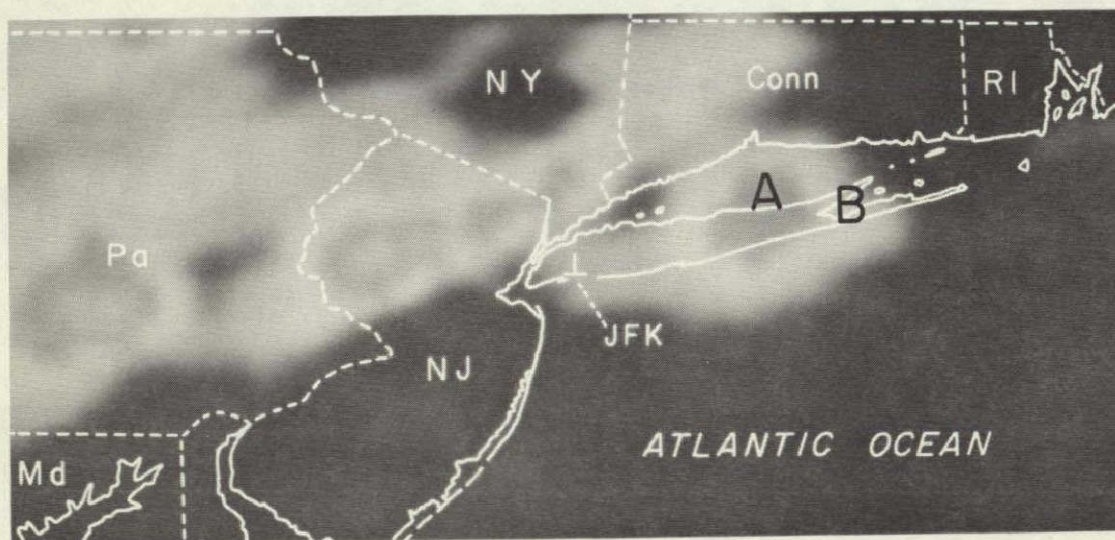
Figure 12. IR picture at 2133 GMT. The cloud area was 3200 sq. nautical miles, while the radar echo covered an area as small as 100 sq. nautical miles. The JFK Thunderstorm is decaying rapidly.

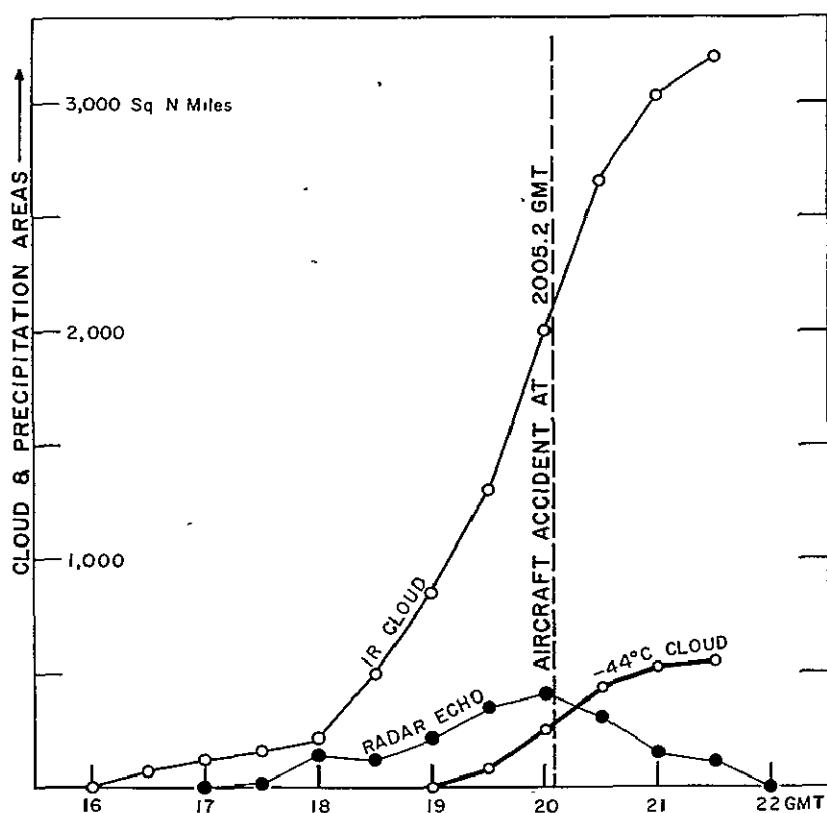
Figure 13. Variation of the cloud imagery and radar-echo areas during a 6-hour period on June 24, 1975. The rates of increase in the cloud and -44°C isotherm areas reached their maxima at about 2005 GMT. At the same time, the radar-echo area hit its peak, suggesting that the accident occurred during the height of the JFK Thunderstorm.

It should be noted, however, that the rate of increase in the cloud area reached its maximum at about 2000 GMT (Figure 13). Likewise, the growth rate of the -44°C area hit the maximum at about the same time. Furthermore, the area of radar echo also reached the peak. Evidently the accident occurred when the JFK Thunderstorm was in its most active stage.

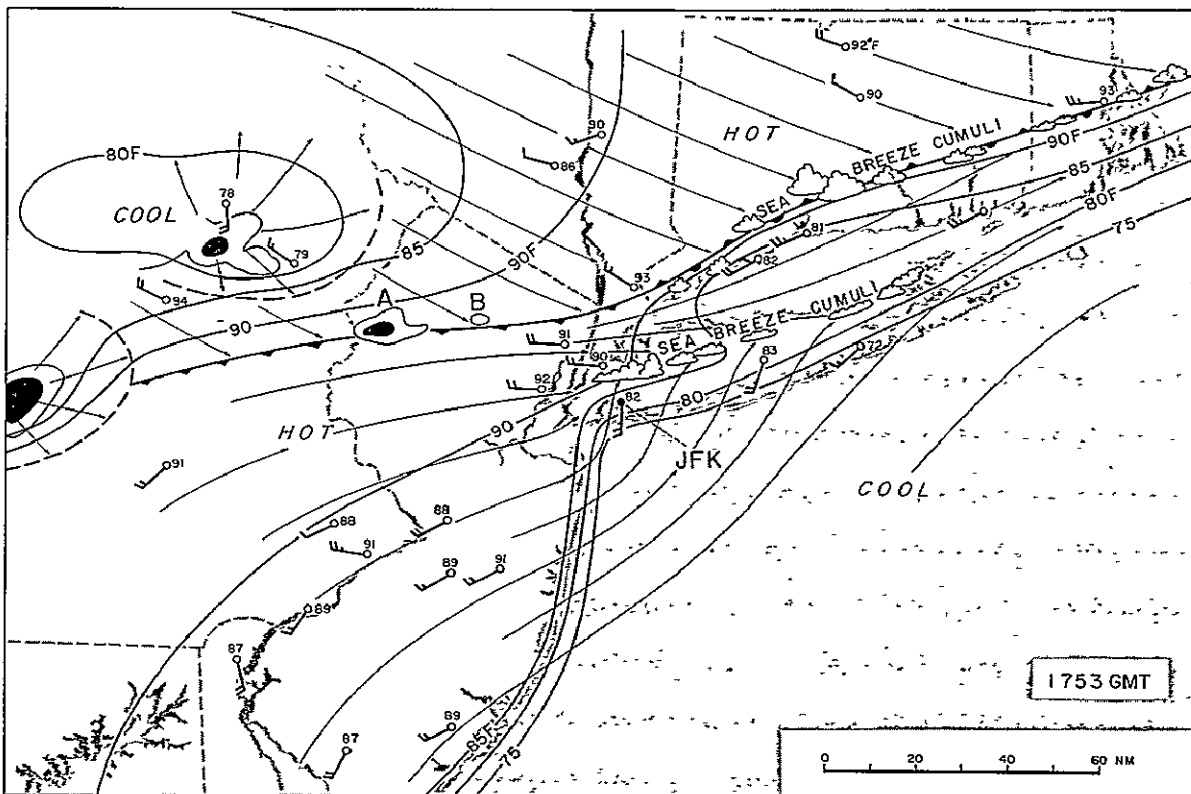
Figure 15. The mesoscale weather situation at 1753 GMT. The numbers by the stations indicate the air temperatures in Fahrenheit. Winds are plotted by doubling the barbs. One full barb denotes 5-kt wind.

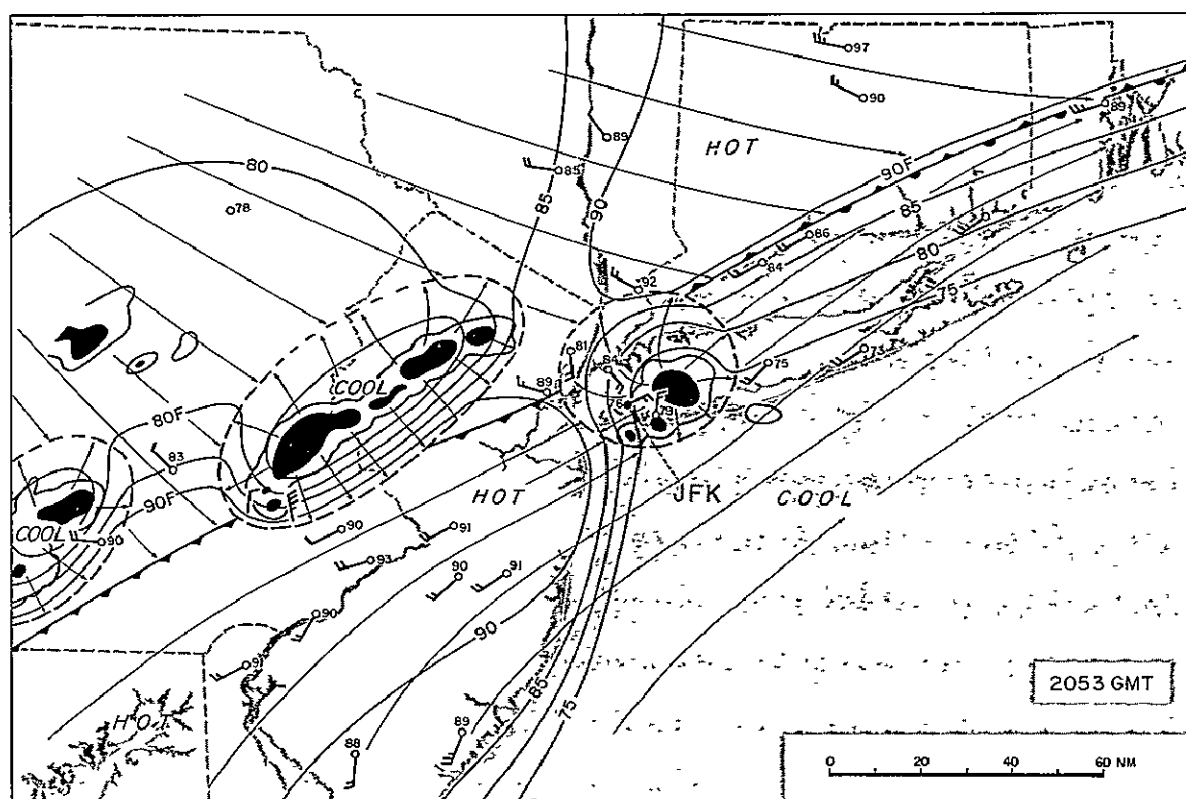
Figure 18. The mesoscale weather situation at 2053 GMT. Runway 13R-31L open for landing at 2053 GMT. One full barb denotes 5-kt wind.

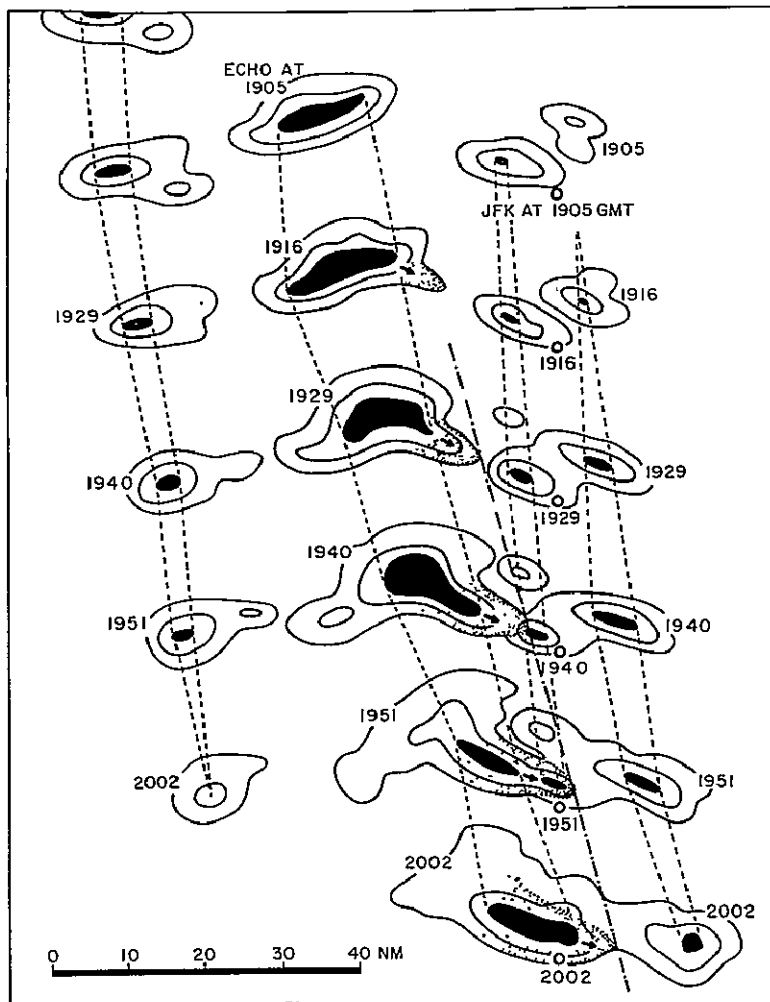
Figure 21. Formation and advance of a spearhead echo. This time sequence shows how a small appendage grew into a spearhead echo, resulting in the decay of the parent echo.

The 1951 GMT radar picture shows that the parent echo was drawn entirely into the appendage, which was moving rapidly toward JFK Airport. The appendage

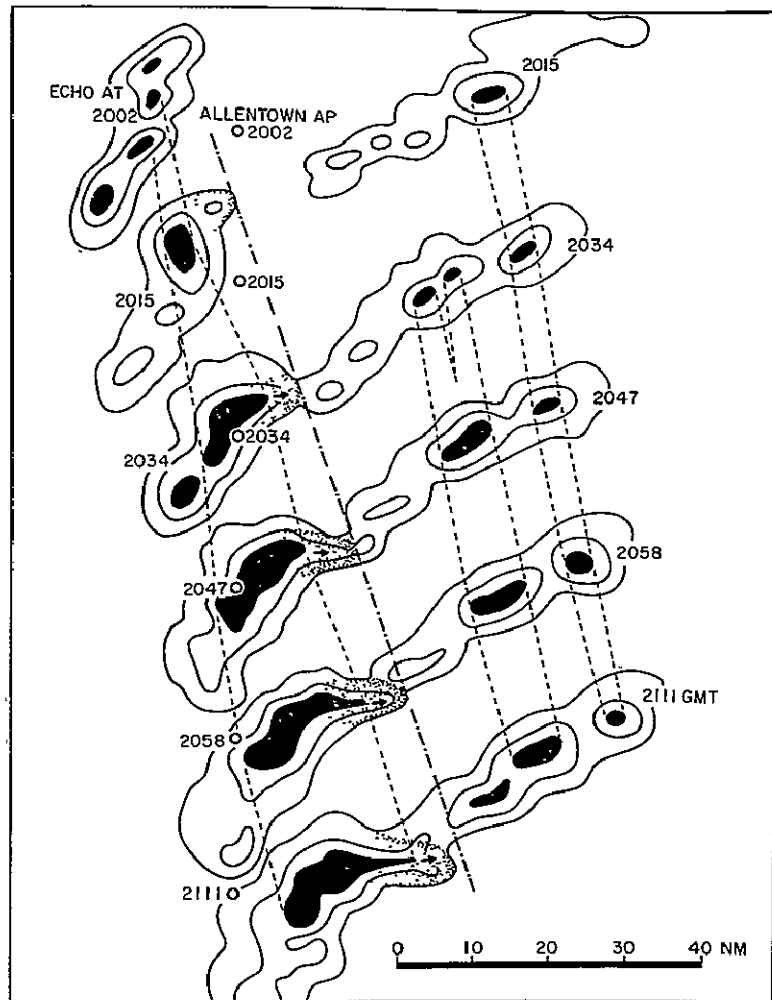
Figure 22. Another spearhead echo of June 24, 1975, which developed to the north of Allentown Airport, Pa.

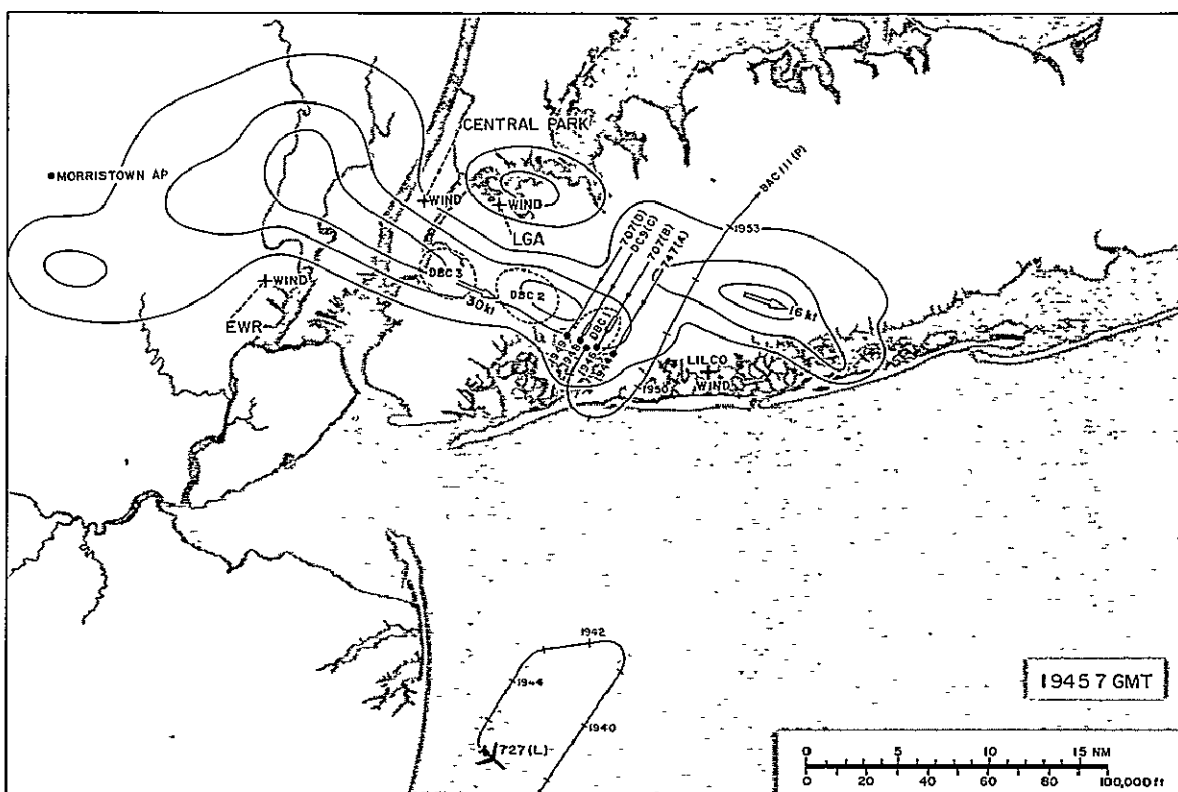
Figure 26. Radar echoes at 1945.7 GMT and the aircraft paths converted into time-space domain.

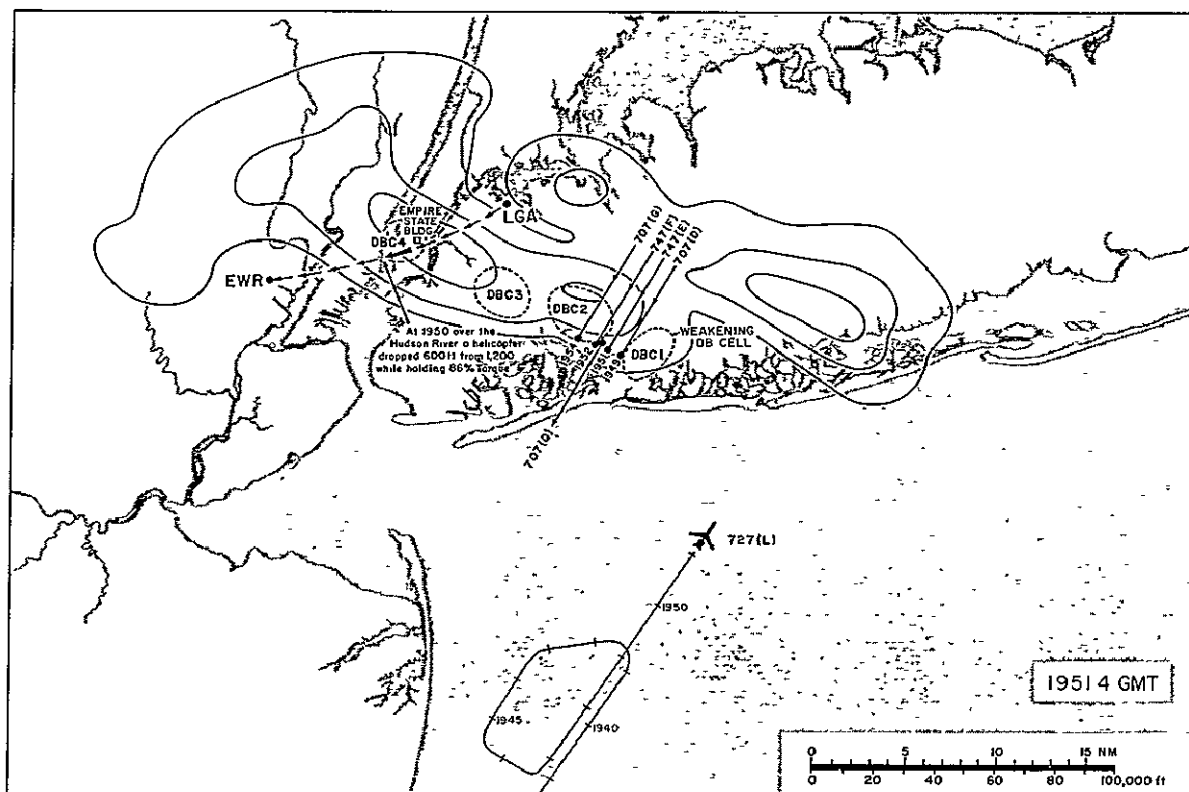
Figure 28. Four downburst cells in relation to the spearhead echo at 1951.4 GMT.

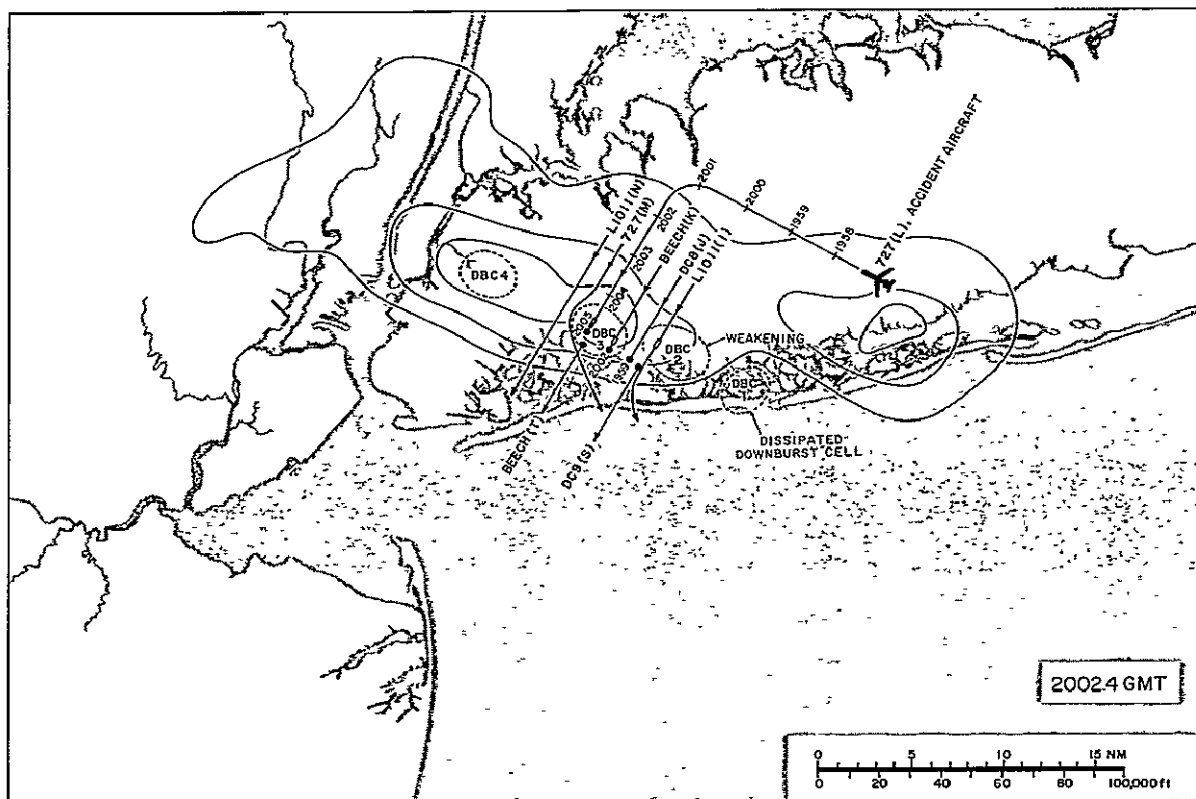
Figure 30. Radar echoes at 2002.4 GMT, just about 3 minutes before the accident.

At 2002.4 GMT, the next radar time, Aircraft "L" was approaching the outer marker with the landing gear down. A few minutes later, at 2006, Aircraft "N" observed on airborne radar a circular cell about 3 miles in diameter located over the threshold of runway 22-L. Aircraft "L" had hit the ground short of the runway (Figure 30).

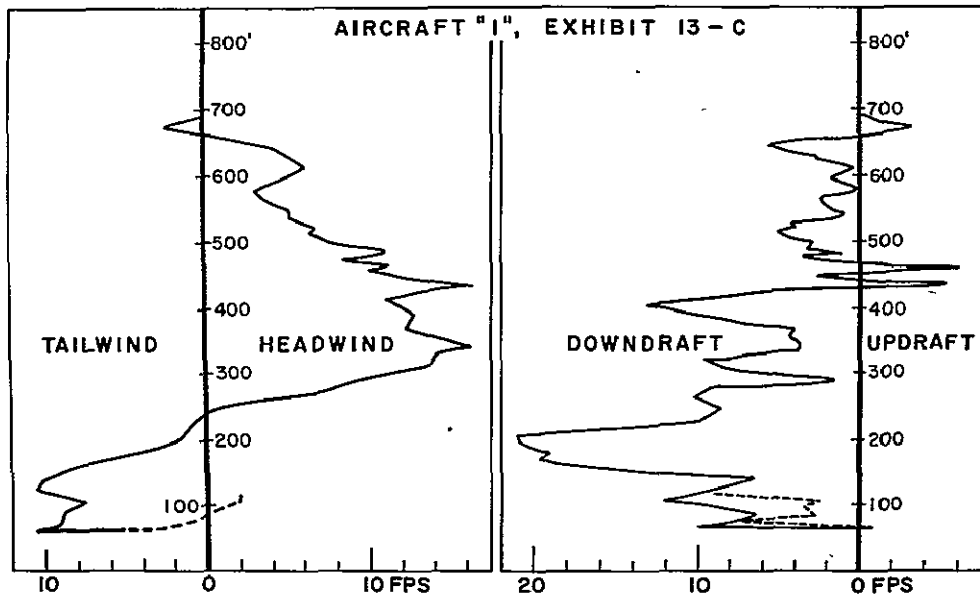
Figure 31. The wind profiles of Aircraft "I" from Exhibit 13-C. Winds are plotted as the function of height above runway.

The headwind component in Exhibit 13-C shows that Aircraft "I" was experiencing about 15 fps (9 kts) headwind when it flew into heavy rain at about 400 ft. At 250 ft, the headwind changed into tailwind. Downward current then intensified reaching 21 fps at 210 ft (Figure 31).

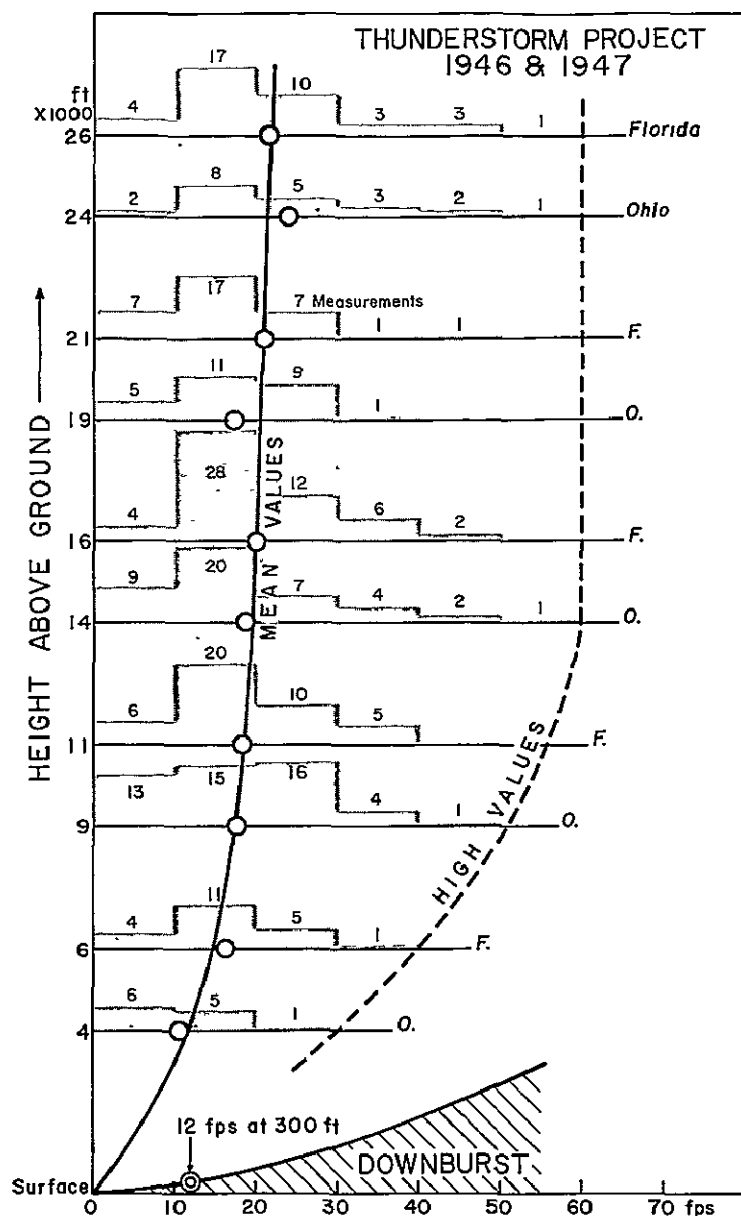
Figure 32. Frequencies of down-draft speeds measured by the Thunderstorm Project, 1946 and '47. Frequencies were plotted from Table 10 of the Thunderstorm (1949).

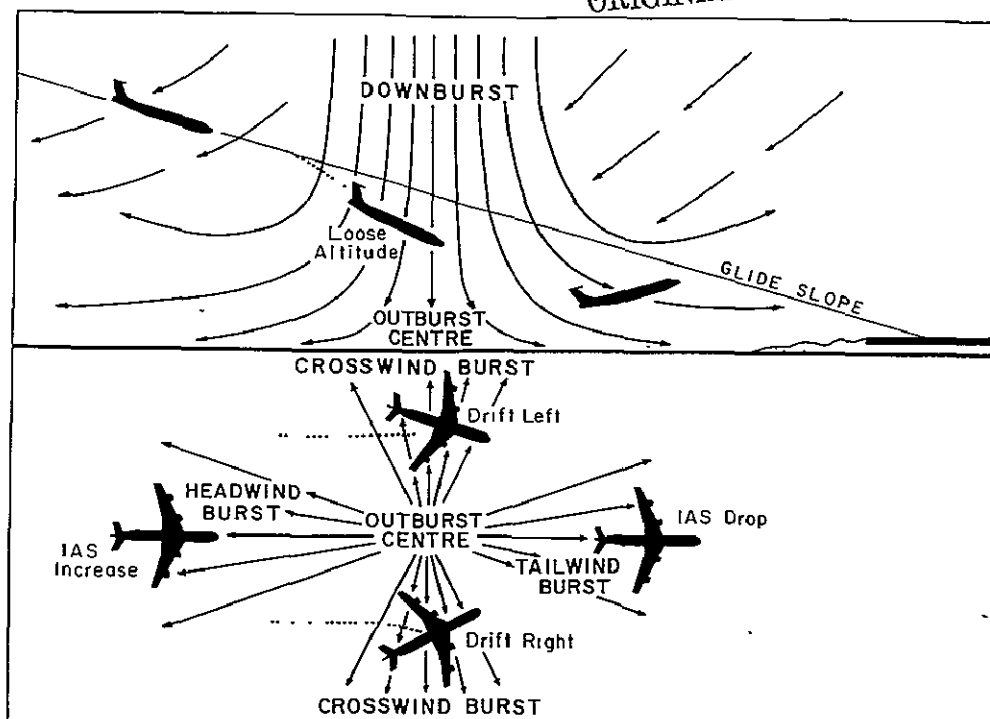
Figure 34. Effects of downburst and outburst upon aircraft during a final approach. Of these the most dangerous one is the downburst, crosswind burst, and tailwind burst encountered near the ground. Outburst is defined as being the strong outflow created when a downburst hits the ground and spreads out.

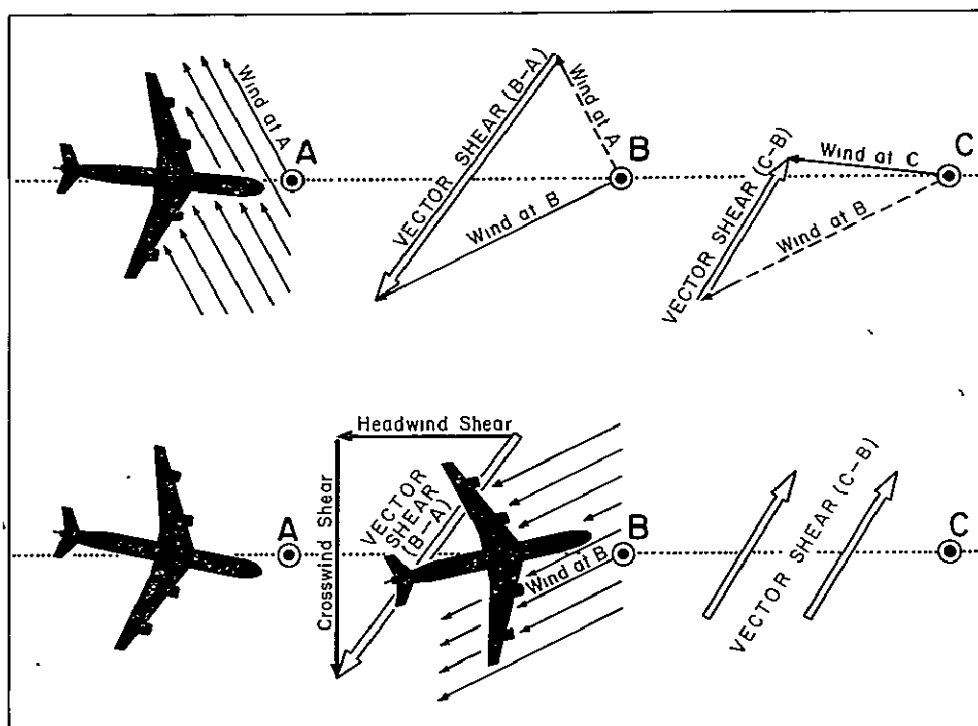
Figure 35. Pictorial expression of vector shear, headwind shear, and crosswind shear likely to be encountered by an aircraft flying in or near a downburst cell.

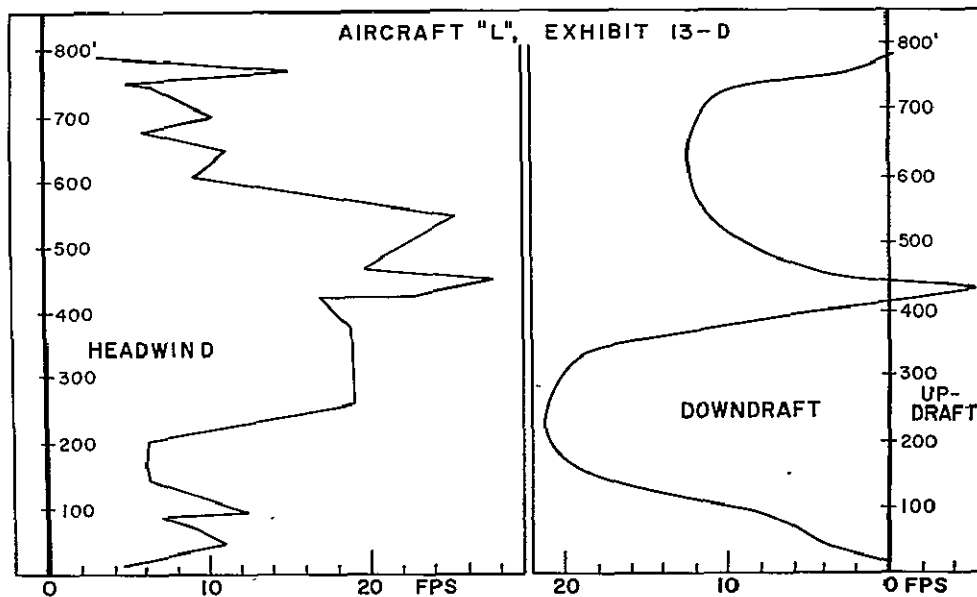
Figure 36. The wind profiles of Aircraft "L" from Exhibit 13-D. Winds are plotted as the function of height above the JFK runway level.

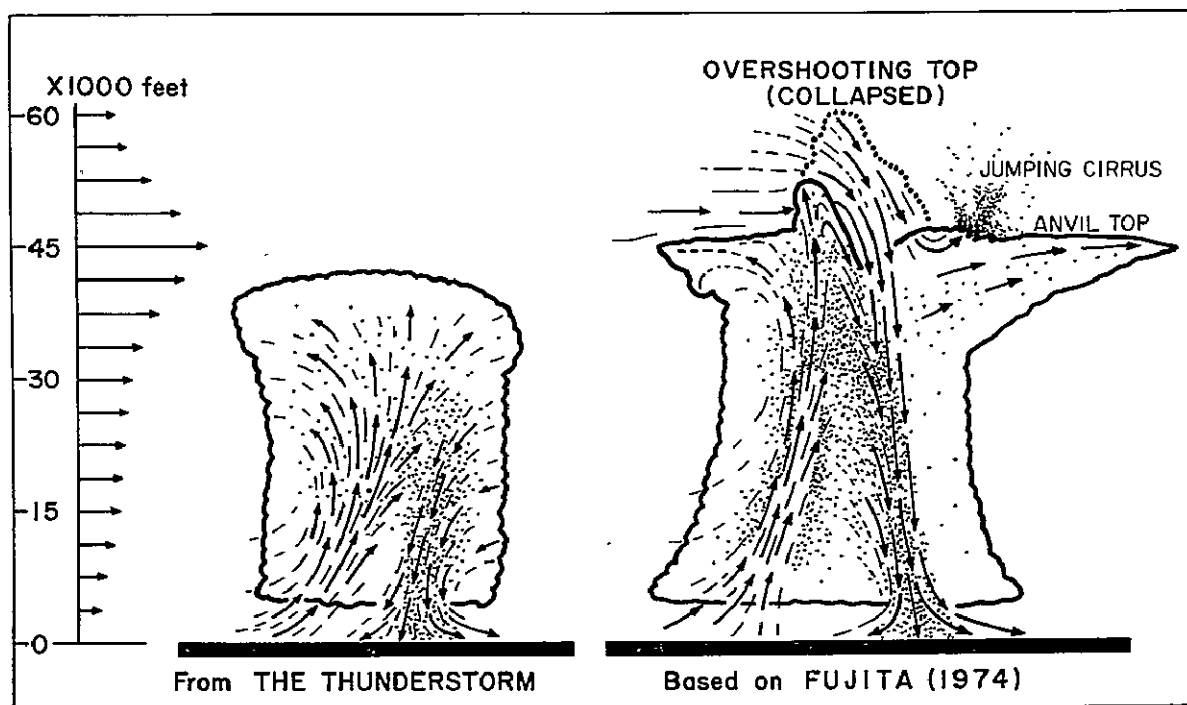
Figure 39. Models of thunderstorm circulation. Downdrafts in most thunderstorms originate in mid-troposphere (left). The stratospheric air above the anvil level plunges into the downburst.

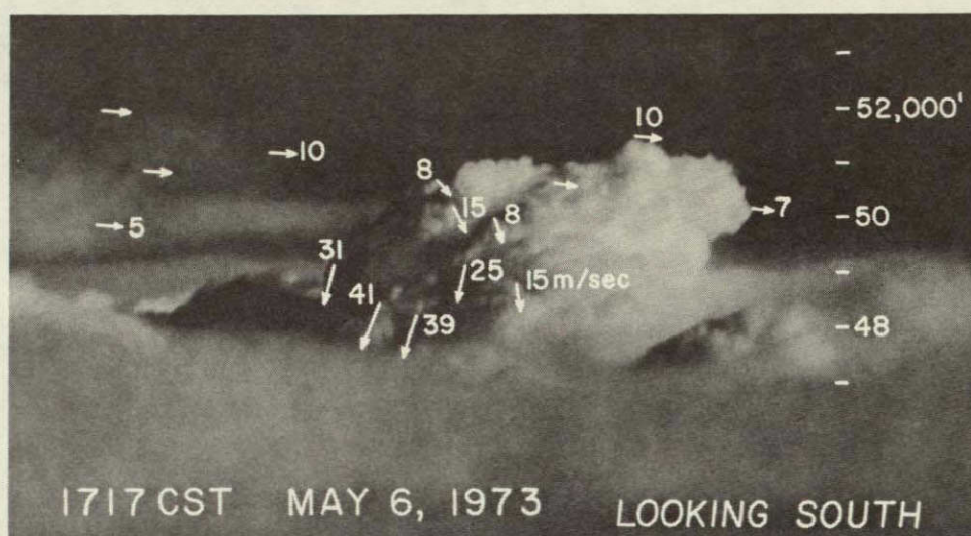
Figure 40. An extremely fast, descending motion atop a Texas thunderstorm of May 6, 1973. A downward velocity of 41 m/sec or 92 mph at 48,000 ft was measured by use of a picture sequence taken every second while flying at 45,000 ft in a research Learjet. By Fujita (1974).

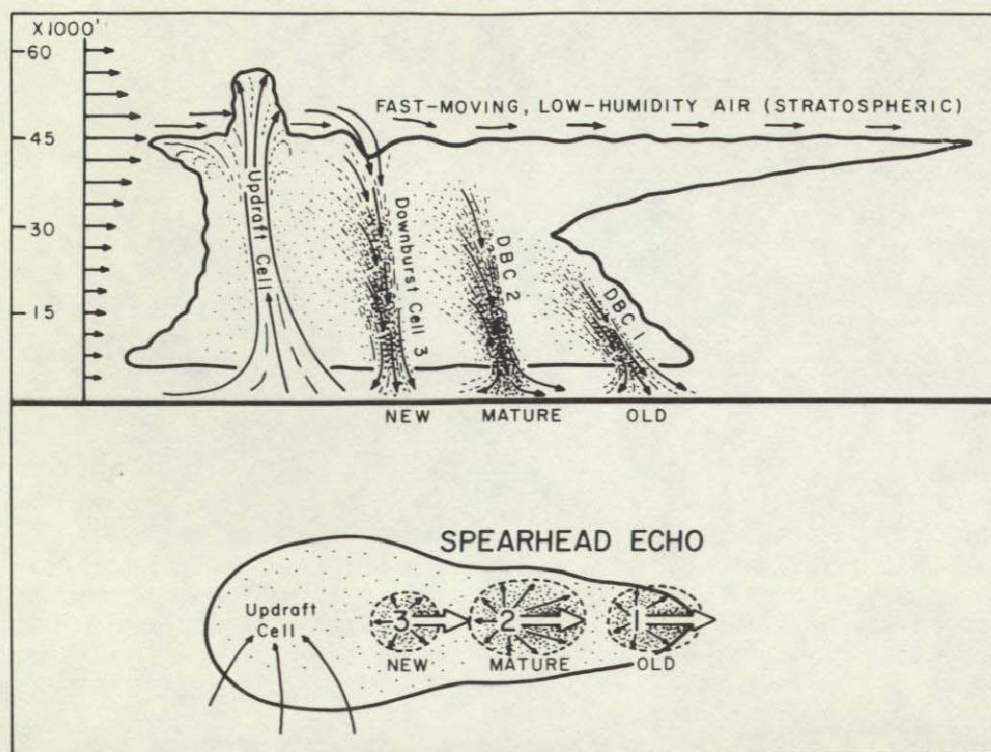
Figure 41. A model of spearhead echo. Being fed by the fast-moving, jet-stream air from above, downburst cells move faster than the parent cloud. A family of downburst cells in their various stages appears on radarscope as a spearhead-shaped echo. Low-humidity air is injected from the stratosphere, not from the side of the cloud.

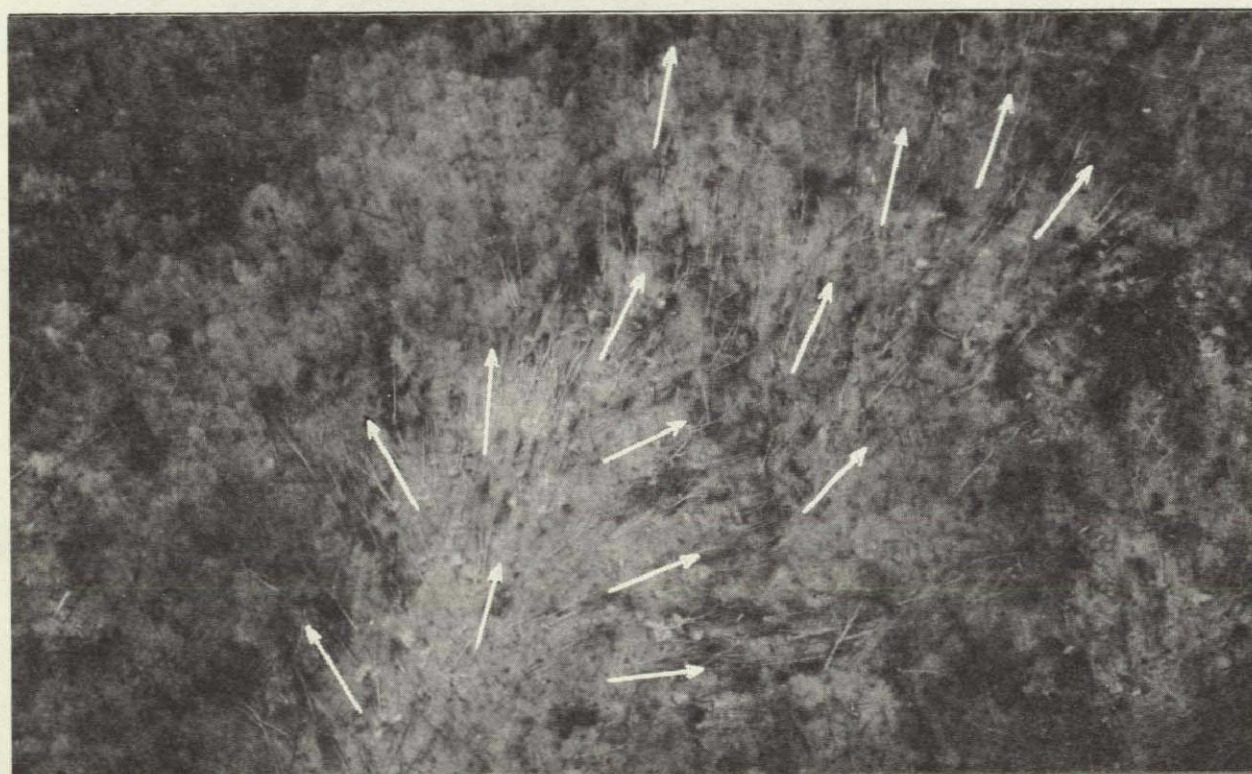
Figure 42. Over 300 trees blown over by an intense outburst near Beckley, West Virginia. Similar patterns of trees were photographed by the author at numerous locations along the paths of tornadic thunderstorms of April 3, 1974, the day of the super-outbreak tornadoes.

During the damage survey of the April 3, 1974 tornado super-outbreak, the author witnessed from a low-flying Cessna airplane various patterns of tree damage. Some distance away from the tornado paths, trees in the forests were blown over in radial directions, as if they had been blown outward. It is suspected that these trees were pushed over or felled by strong winds which blew outward from the outburst center (Figure 42).

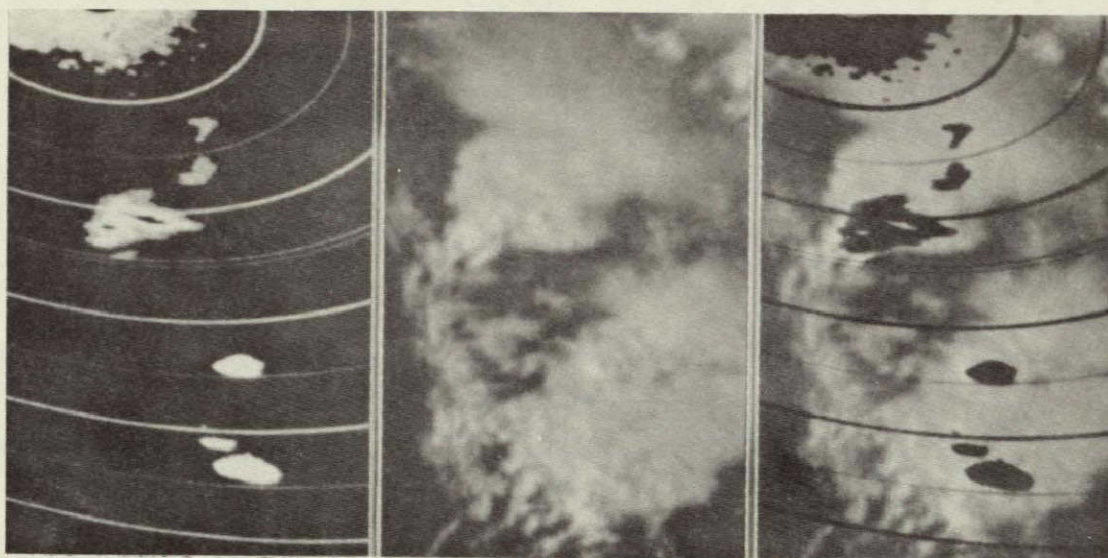
Figure 43. Features of a spearhead echo 100 nm to the south of Kansas City, Mo. on May 6, 1975. Radar echoes at 2222 GMT (left), SMS picture at 2222 GMT (center), and their combination.
