DYNAMICS OF SOLID LUBRICATION AS
OBSERVED BY OPTICAL MICROSCOPY

by Harold E. Sliney
Lewis Research Center
Cleveland, Ohio 44135

TECHNICAL PAPER to be presented at Joint Lubrication Conference
cosponsored by the American Society of Mechanical Engineers
and the American Society of Lubrication Engineers
Boston, Massachusetts, October 5-7, 1976

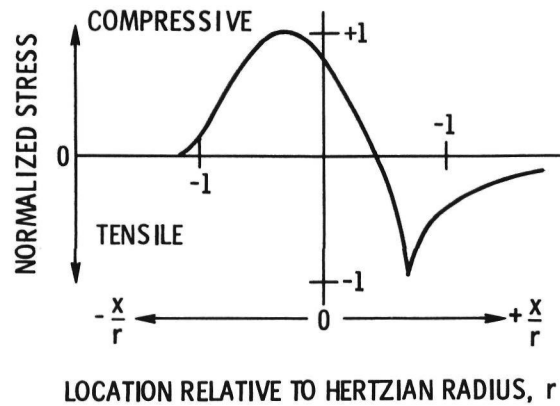
(a) CRACK IN COMPRESSION.

(b) CRACK IN TENSION.

(c) SURFACE STRESS COMPONENT IN SLIDING DIRECTION.

Figure 5. - Crack formation and propagation in unlubricated contact. Load, 13.2 N (3 lb); original magnification, X150.

Figure 5 shows a series of nearly identical cracks in the glass passing through the concentrated contact. In figure 5(a), a crack is barely visible at the center of the contact, where the surface is under compression. In figure 5(b), the same crack has moved near the exit where the surface is under tension and the crack has widened and has propagated laterally.

Figure 5(c) is a plot derived from reference 6 of surface stress components within the contacts and in the sliding direction. Although friction was not measured in our experiments, it is clear that crack closing under compression and widening under tension qualitatively agree with the analysis.

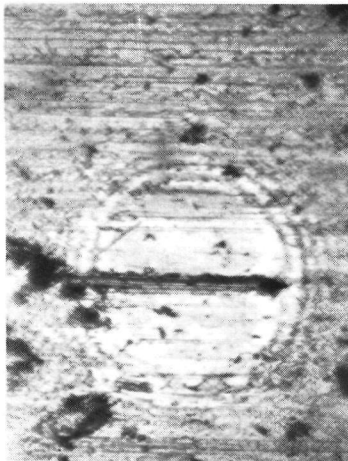
(a) SiC PARTICLE ENTERING CONTACT.

(b) PARTICLE PART WAY THROUGH CONTACT.

(c) PARTICLE AT CONTACT EXIT.

(d) CONTACT AFTER 10 DISK REVOLUTIONS.

Figure 7. - Abrasive action of silicon carbide particles. Load, 13.2 N (3 lb); original magnification, X150.

A small amount of 400 grit (-37 micron) abrasive silicon carbide (SiC) powder was then intentionally sprinkled ahead of the contact. Figure 7(a) shows several abrasive scratches and a SiC particle which is about to enter the contact. Distortion of the interference fringes by the scratches and by the particle are apparent. Figure 7(b) shows the SiC particle, which has become embedded in the glass and has entered the contact causing a wide scratch in the tool steel and leaving a trail of very fine SiC fragments which fractured from the parent particle. Figure 7(c) shows the same particle about to leave the contact area. Figure 7(d) was recorded after only ten disc revolutions and shows the severely abraded wear scar on the ball and the pile-up of abrasive particles at the inlet region of the contact.

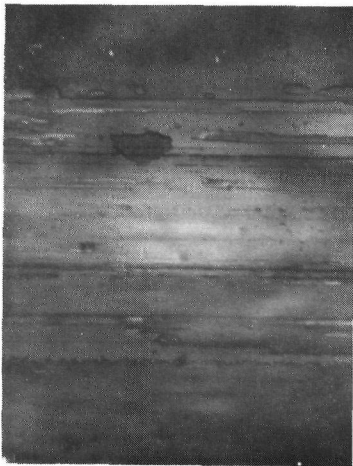
(a) LUBRICANT PARTICLES APPROACHING CONTACT.

(b) PARTICLES ENTERING CONTACT.

(c) EXTENSIVE PLASTIC FLOW OF MoS₂ IN CONTACT.

Figure 8. - Behavior of MoS₂ powder in an initially unlubricated contact, 13.2 N (3 lb) load. Original magnification, X150.

(d) BALL/DISK CONTACT.

(e) BALL CONTACT (NOTE COMPLETE MoS₂ FILM).

(f) UNDERSIDE OF DISK WEAR TRACK.

(g) BALL WEAR SCAR WITH FILM REMOVED BUT WITH COMPACTED MoS₂ STILL AT INLET.

Figure 8. - Concluded. Contact after 420 disk revolutions.

Figure 8(a) shows the first MoS₂ particles arriving at the contact inlet; the particles have penetrated the interference fringes but have not yet entered the contact. The next photograph is after 5 mm more of sliding. The MoS₂ has penetrated about 0.07 mm or one-third of the contact diameter. After an additional 10 mm of sliding, a discontinuous film of MoS₂ has extended across the entire contact diameter with some MoS₂ adhering to the glass and some to the steel ball. MoS₂ begins to pile up at the inlet to form a lubricant reservoir. In a short time, a film of MoS₂ formed over the entire length of the circular wear track on the glass disk. The film was in the form of discrete parallel streaks of lubricant alternating with some apparently unlubricated areas. No observable wear occurred during the first 200 disk revolutions. However, figure 8(d) shows that after 420 revolutions, some wear has occurred.

The ball and disk were then separated in order to more clearly observe the condition of each surface. The ball surface (fig. 8(e)) is coated with MoS₂. The underside of the wear track as viewed through the glass disk (fig. 8(f)) reveals patches of adherent MoS₂ film and little damage to the glass. The MoS₂ film was then removed from the ball contact and a flat worn area of 0.25 mm diameter can be seen in figure 8(g).

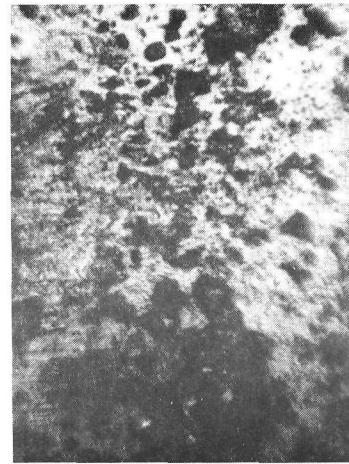
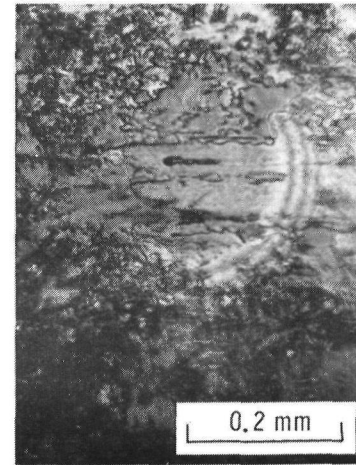
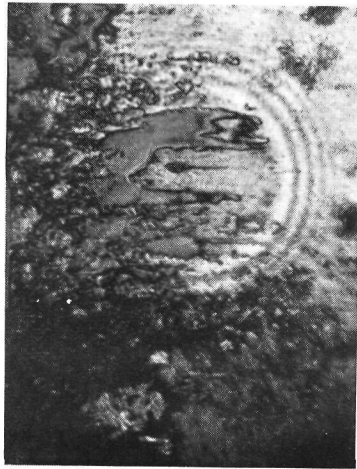
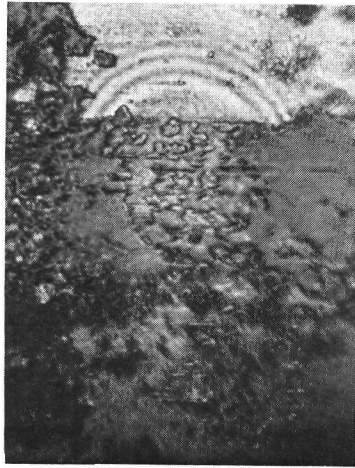
(a) LOOSE MoS₂ POWDER ON GLASS DISK.

(b) MoS₂ IN STATIC CONTACT (13.2 N).

SLIDING DIRECTION OF GLASS →
(c) CONTACT AT INITIATION OF SLIDING.

Figure 9. - Behavior of MoS₂ in an initial static contact followed by sliding contact, 13.2 N (3 lb) load; original magnification, X200.

Figure 9. - Concluded. Changing pattern of MoS₂ distribution during sliding.

Contact initially lubricated. - Figure 9(a) shows MoS₂ powder lightly sprinkled on the disk. The next photograph shows the compaction which occurs upon contact with the ball under a static normal load of 13.5 N (3 lbs). The remaining photographs are a sequence which illustrates the ever-changing distribution of MoS₂ in the contact. The Hertzian diameter decreases

intermittently indicating that solid lubricant accumulation of the inlet can form a wedge which partially supports the load. However, after 130 disk revolutions a large increase in contact diameter indicated ball wear. Also, many scratches were evident on the glass surface.

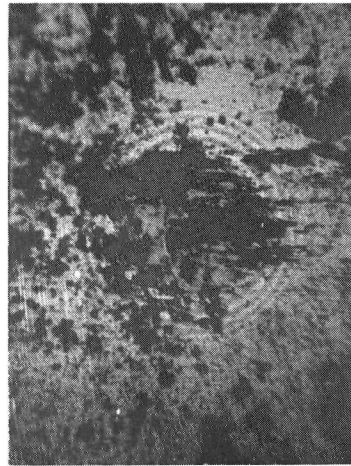
(a) GRAPHITE IN STATIC CONTACT (13.2 N LOAD).

(b) CONTACT AS SLIDING BEGINS.

(c) CONTACT AFTER 1/4 DISK REVOLUTION.

(d) CONTACT AFTER 2 DISK REVOLUTIONS.

Figure 11. - Behavior of natural (Mexican) graphite in an initial static contact followed by sliding contact; original magnification, X150.

Contact initially lubricated. - Figure 11(a) shows a static Hertzian zone with graphite particles trapped within the contact. The photographs that follow show that additional graphite readily enters and passes through the Hertzian contact. However, wear, especially of the glass surface, occurs rapidly.

Considerable graphite adhered to the steel ball, but much less adhered to the glass. The behavior in general was no different than in the case of graphite lubrication of the initially-unlubricated contact.

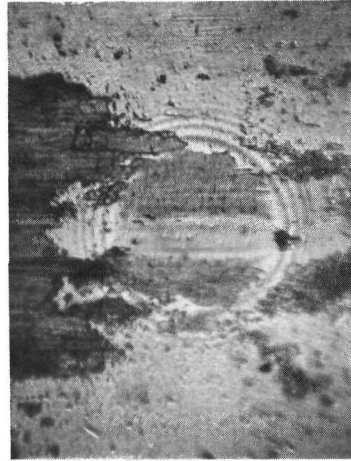
(a) FIRST PARTICLES ENTERING CONTACT.

(b) PROGRESSIVE FILM FORMATION.

(c) PROGRESSIVE FILM FORMATION.

(d) COMPLETE FILM FORMATION AFTER ONLY 10 mm OF SLIDING.

Figure 12. - Behavior of graphite fluoride in initially unlubricated contact. Load, 13.2 N (3 lb); original magnification, X150.

(e) CONTACT AFTER 1/4 REVOLUTION (40 mm OF SLIDING).

(f) CONTACT AFTER 20 REVOLUTIONS.

(g) CONTACT AFTER 40 REVOLUTIONS.

(h) CONTACT AFTER 300 REVOLUTIONS.

Figure 12 indicates the first particles of $(CF_x)_n$ entering the sliding contact, the progressive filling of the contact, and the formation of an adherent $(CF_x)_n$ film on the wear track.

The film is transparent; microscopic features on the ball surface can be observed through the film. Also the interference fringes are clearly visible on the exit side of the contact, but have slightly shifted radii caused by the finite film thickness. Track width is observable because of slight shadowing at the edges of the track; the track width is approximately equal to the contact diameter. The $(CF_x)_n$ formed a complete lubricating film in the Hertzian contact after only one-quarter revolution of the glass disk (fig. 12(d)). No measurable wear occurred until after about 100 disk rotations when the small, initial supply of lubricant was no longer adequate to maintain a complete lubricating film and a slow wear process began. The last photograph show wear on the ball and scratches on the glass after 300 disk revolutions. Abrasive wear became predominant as wear particles from the glass and the steel ball accumulated at the contact inlet.
