CERAMIC THERMAL-BARRIER COATINGS FOR COOLED TURBINES

by Curt H. Liebert and Francis S. Stepka
Lewis Research Center
Cleveland, Ohio 44135

TECHNICAL PAPER to be presented at Twelfth Propulsion Conference
cosponsored by the American Institute of Aeronautics and
Astronautics and the Society of Automotive Engineers
Palo Alto, California. July 26-29, 1976

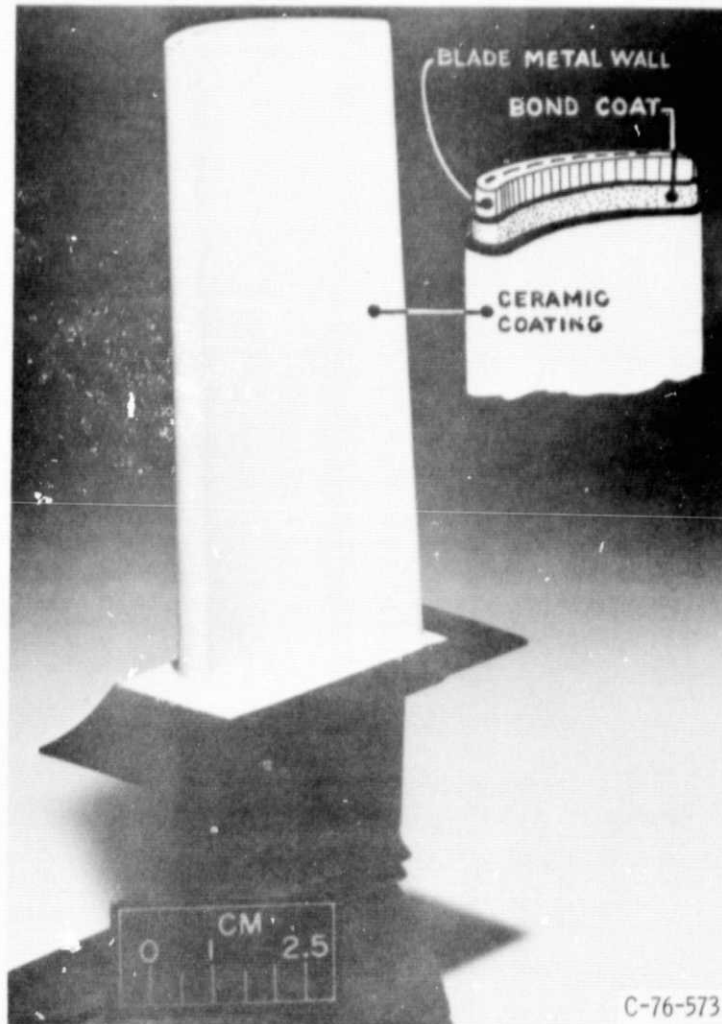
Figure 1. - Ceramic coated turbine blade.

An air-cooled turbine blade covered with a ceramic thermal barrier coating is shown in figure 1. The procedure used for depositing the ceramic coating onto the blade metal substrate was to prepare the substrate surface, plasma-spray on a bond coat and then plasma-spray on the ceramic coating. The most current application process is described herein.

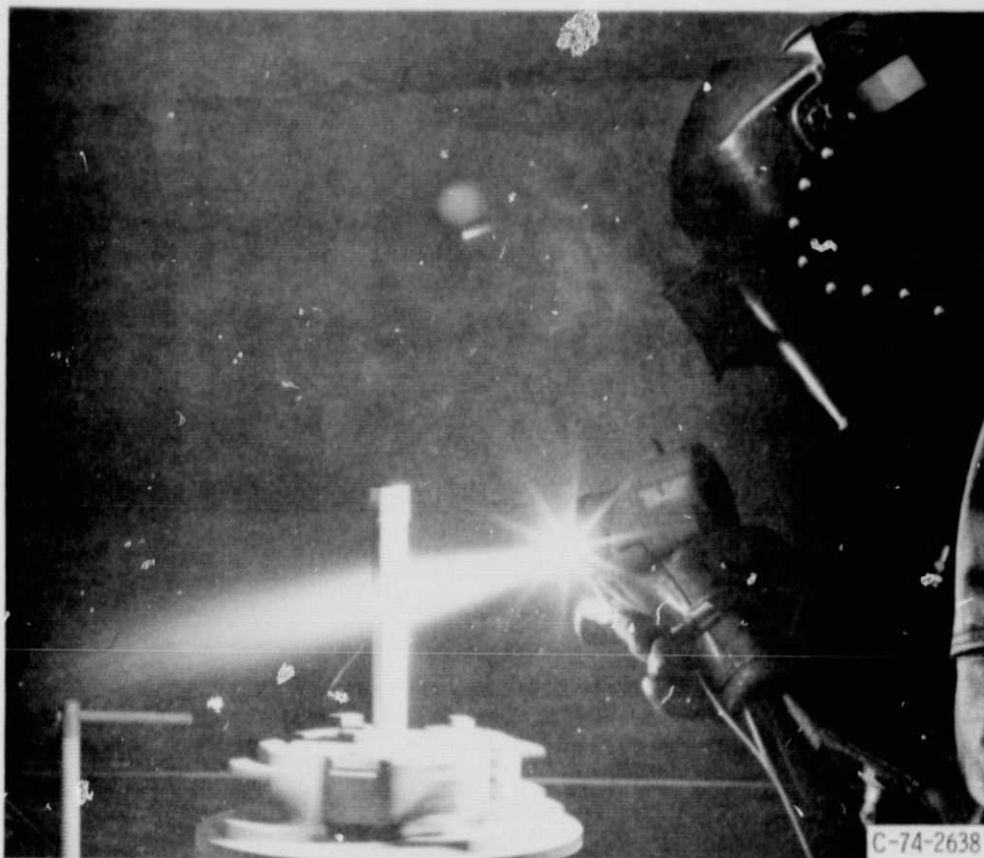
Figure 2. - Plasma spray application.

Commercial grit-blasting equipment was used to clean and roughen the vane and blade surfaces. In figure 2, a hand-held plasma-spray gun is used to apply powders of bond and ceramic materials. In the gun⁽⁴⁾ an electric arc is contained within a water-cooled nozzle. Argon gas passes through the arc and is excited to temperatures of about 17 000 K. The bond and ceramic powders were mechanically fed into the nozzle and were almost instantaneously melted.

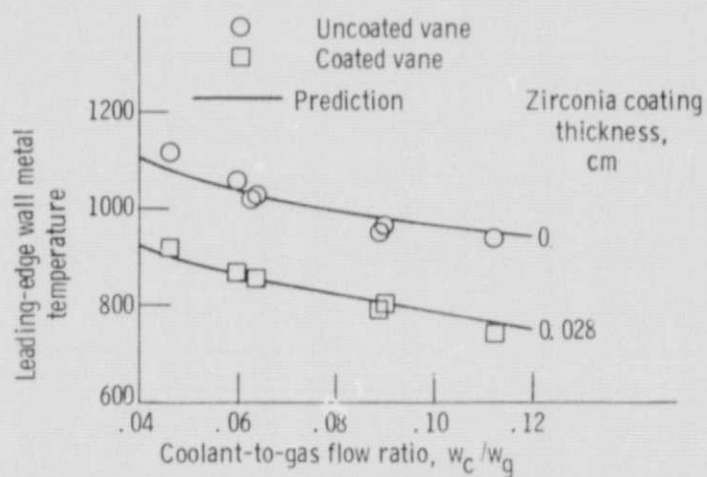
Figure 3. - Comparison of calculated and measured midspan leading-edge wall metal temperatures of uncoated and zirconia-coated turbine vanes operating in a research engine. Inlet gas temperature, 1644 K, inlet gas pressure, 3 atm; coolant temperature, 319 K.

Figure 3 compares measured and predicted wall metal temperatures at the midspan of the leading-edge of an uncoated and coated turbine vane operating in the research engine. The comparison is shown over a range of calculated coolant-to-gas flow ratios from 0.04 to 0.12 and includes measurements at ratios of about 0.045, 0.06, 0.09, and 0.11. The results show good agreement between prediction and measurement. The predicted and measured reductions in leading-edge metal temperature for the coated vane agreed within 25 K. The results showed large reductions in leading-edge metal temperature with the 0.028-centimeter thick zirconia coating. At a coolant-to-gas flow ratio of 0.06 the metal temperature was reduced by 190 K - from 1055 K for the uncoated vane to 865 K for the coated vane.

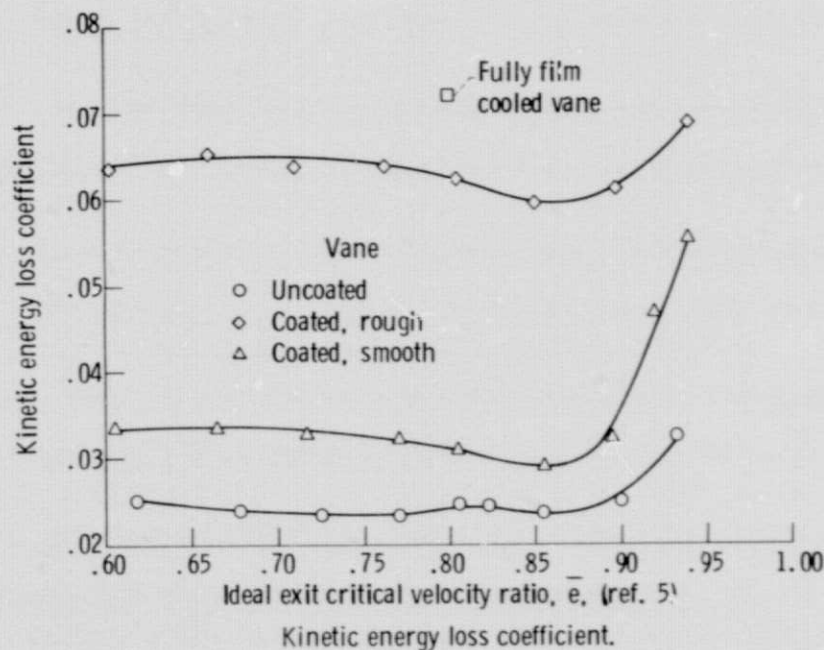
Figure 4. - Overall aerodynamic performance of a core turbine vane.

The kinetic energy loss coefficient⁽⁵⁾ for the three test vanes is shown in figure 4. The loss for the rough-coated vane was much larger than the loss for either the smooth-coated or uncoated vane. In the as-sprayed condition the ceramic coating had a surface roughness averaging about 8 to 10 micrometers. Polishing with solid aluminum oxide smoothed the ceramic coating to a surface roughness averaging 1.6 to 3.0 micrometers. This smoothing reduced the loss to about one-half of that obtained with the rough coating. The loss for the smooth-coated vane was higher than the loss for the uncoated vane. At an ideal exit critical velocity of 0.8, which is near design, the kinetic energy loss coefficients were 0.062, 0.031, and 0.023 for the rough-coated, smooth-coated, and uncoated vanes, respectively.

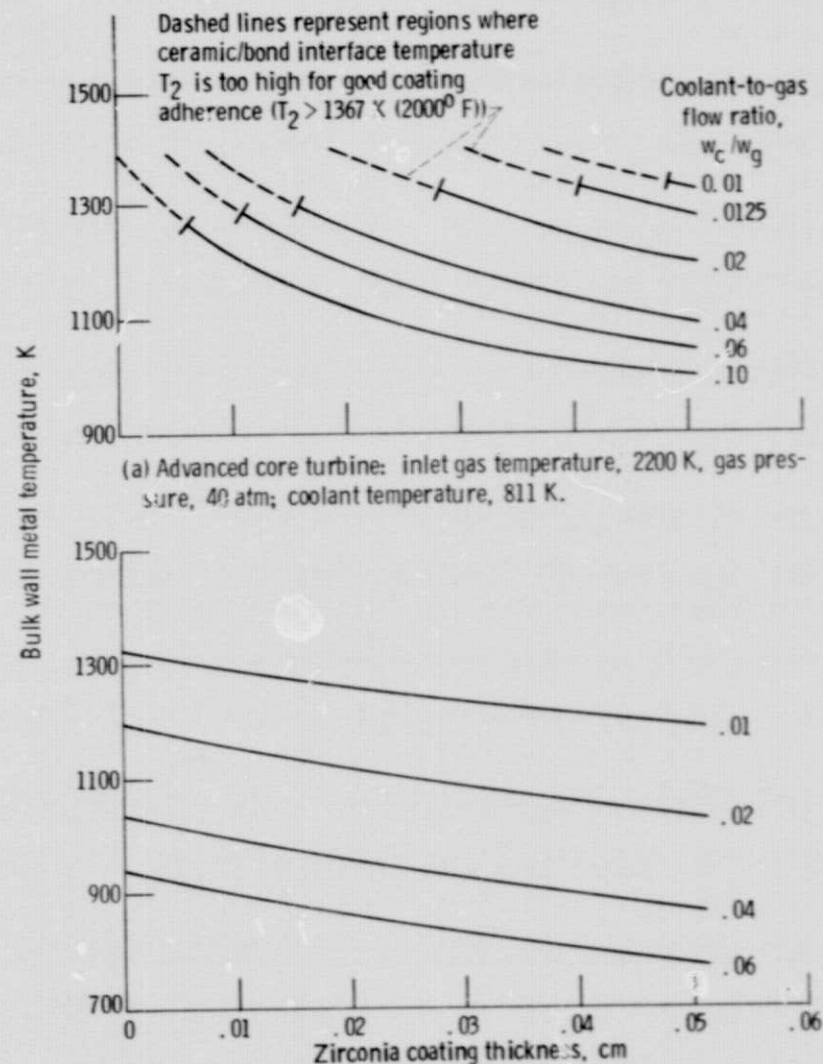
Figure 5. - Reductions in metal temperatures and coolant flows for vanes coated with various thicknesses of zirconia.

Predicted reductions in bulk turbine-vane metal temperatures and coolant-to-gas flow ratios with increases in ceramic coating thickness on vanes in the advanced core engine turbine and in the research engine turbine are shown in figures 5(a) and (b), respectively. Bulk wall metal temperature (integrated average temperature over entire vane) was substantially reduced as ceramic coating thickness was increased. The reductions in metal temperature with increasing coating thickness were greater for the core engine than for the research engine. The reason is the higher heat fluxes associated with the conditions of the core engine.

The dashed portions of the curves in figure 5(a) illustrate a limitation associated with using the current ceramic composite coatings in applications such as the core engine with high gas temperature and pressure. The limitation is the ability of the ceramic coating to adhere to the bond coating when the temperature at the interface between these two layers exceeds 1367 K. This limiting temperature was determined with furnace tests described in reference 9.

As shown in figure 5(a) at the tick marks, thicker layers of the coating were required to give acceptable interface temperatures (1367 K) as coolant-to-gas flow ratio was decreased. This is because the heat flux will decrease as flow ratio is reduced. Reducing the heat flux will also reduce the thermal gradient through the metal wall. This together with the constant limiting interface temperature resulted in slightly increased average vane metal wall temperatures (fig. 5(a)).

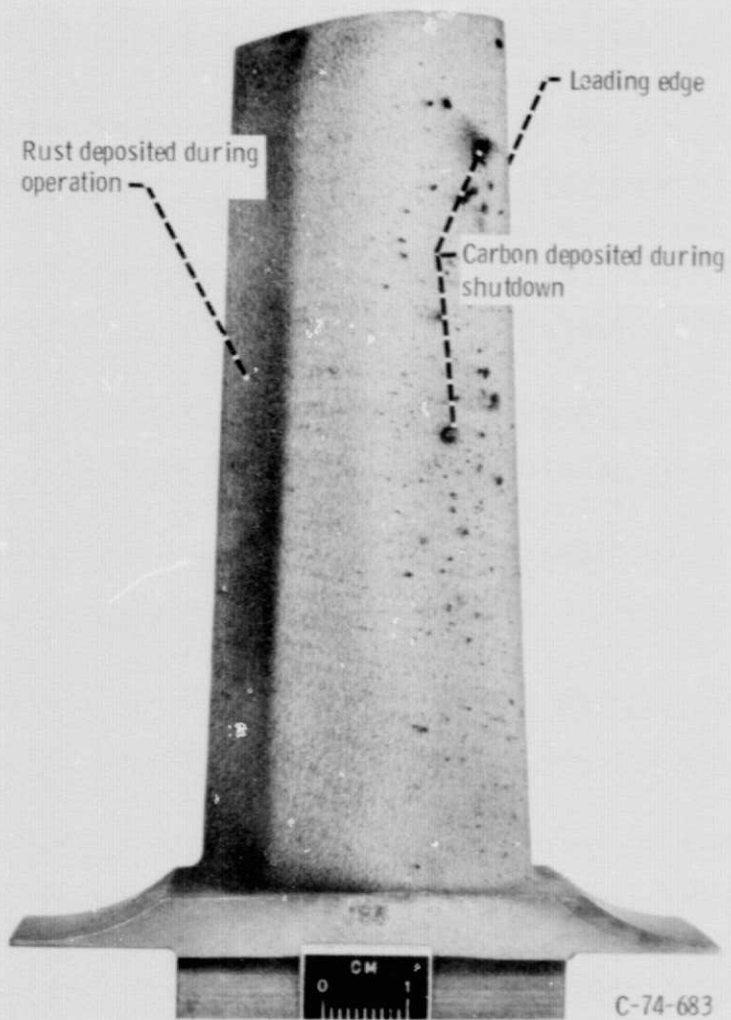
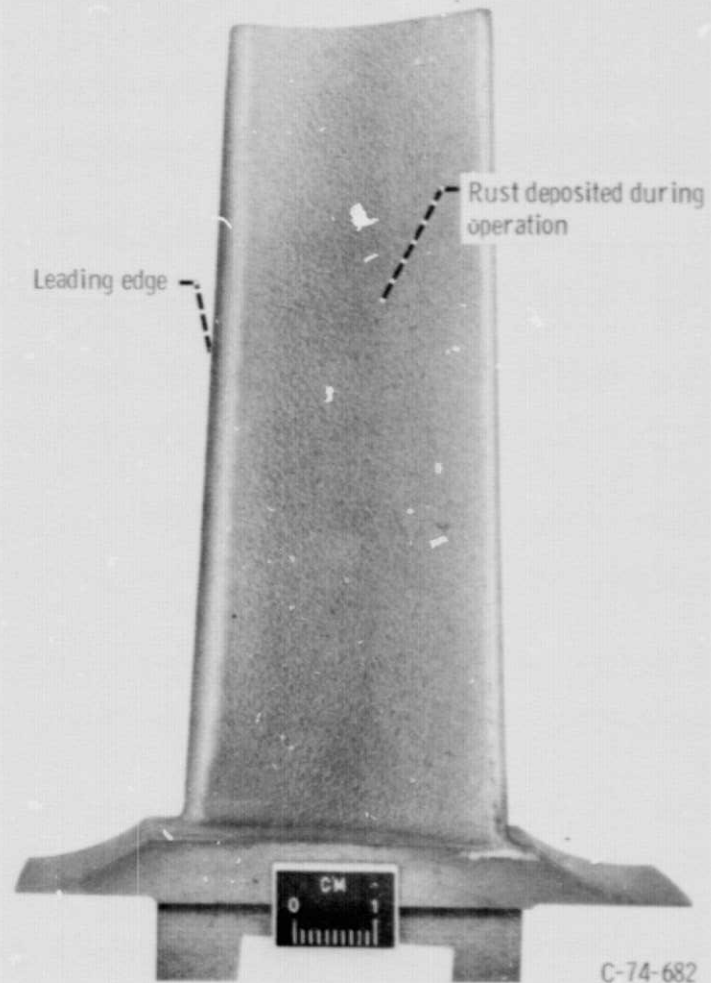
(a) Suction surface.

(b) Pressure surface.

Figure 6. - Ceramic-coated blade after steady-state testing in research engine.

metal wall temperatures were generally 920 K and the transient values were momentarily as high as 1200 K. Figure 6 shows one of the blades after completion of the tests. No deterioration was evident.

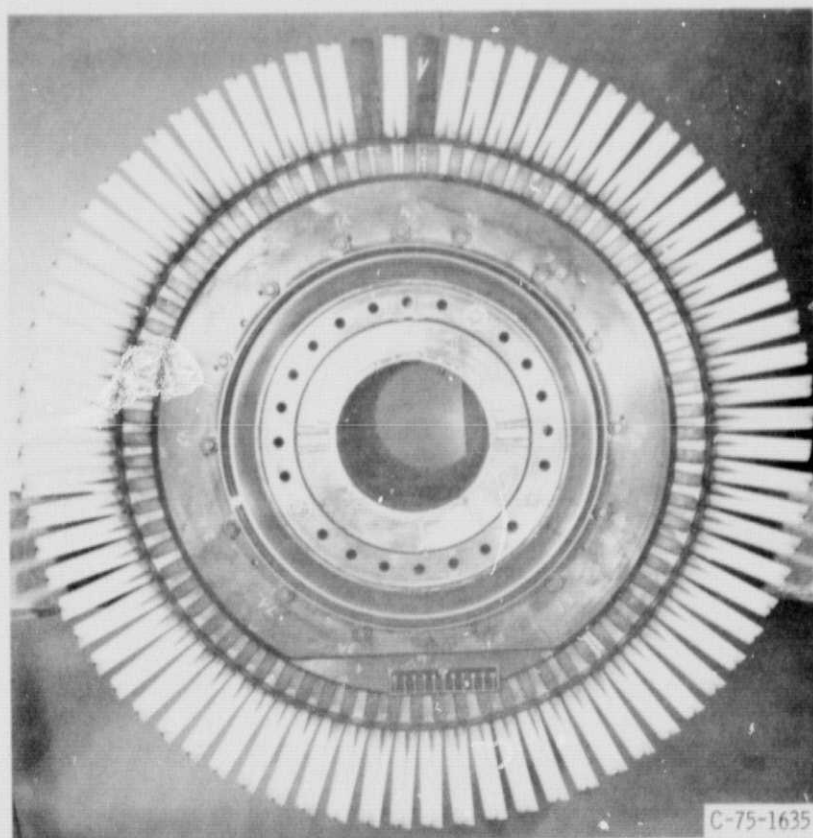
Figure 7. - Ceramic coated blades after 500 cycles of testing.

A trailing edge view of the rotor assembly of the coated blades after conclusion of the cyclic tests⁽¹²⁾ is shown in figure 7. (The two uncoated

blades shown in the figure were used as reference blades for other tests. The black spots on the blade tips in figure 7 are soot deposits that occurred during engine shutdown. The black lines along the span near the root on the suction surface were also caused by soot deposition.

Despite foreign object damage which caused minor chipping at the blade leading edges, the coatings were in very good condition. The chipped areas did not further deteriorate and the exposed bond coat in the chipped regions remained intact for at least 400 cycles of testing. Ceramic coating roughness measurements showed no roughness change over the duration of the tests. In actual usage the roughness should be reduced to improve the durability and aerodynamic performance.

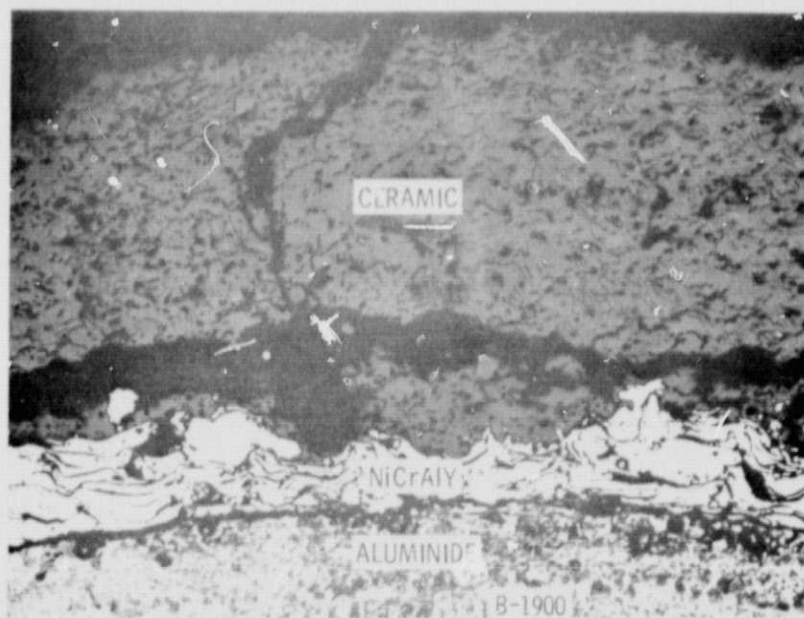
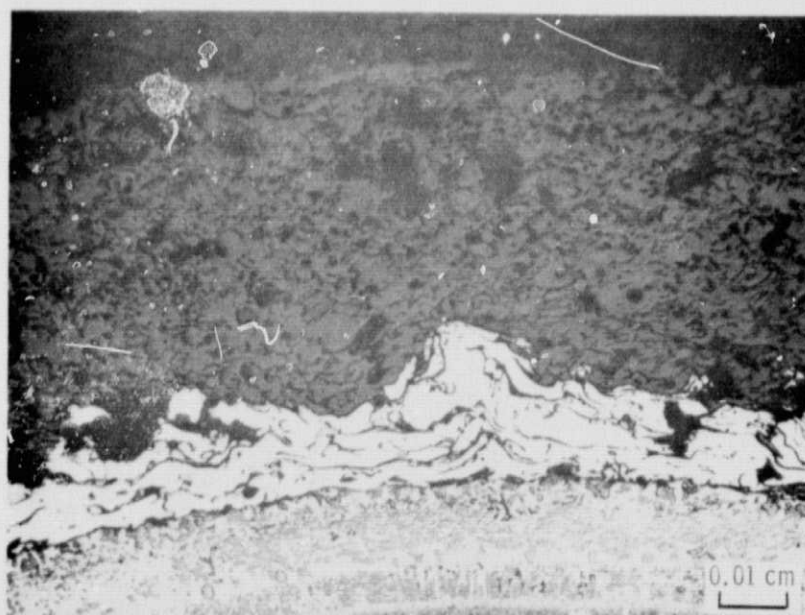
(a) CALCIA - STABILIZED ZIRCONIA COMPOSITE.

(b) YTTRIA - STABILIZED ZIRCONIA COMPOSITE.

Figure 8. - Microstructure of zirconia composites on turbine blade leading edge at midspan after cyclic engine tests. X150. (Ref. 12.)

The microstructure (fig. 8)⁽¹²⁾ of the bond coat and the ceramic coatings was metallographically examined on several blades at the leading edge region where durability problems are most likely to occur. The ceramic microstructure consisted of solid material connected with a network of fine voids interspersed with larger voids. The photomicrographs (fig. 8) also showed that the aluminate that was originally present on all of the blades tested in the engine was not completely removed by grit-blasting. Also, the NiCrAlY bond adhered well to this aluminate coating. Cracks in the calcia-stabilized zirconia coating tested for 500 cycles were observed on some of the photomicrographs (fig. 8(a)). These cracks generally were located parallel and adjacent to the bond coat. In some cases these cracks penetrated to the outer surface of the coating. The formation of such cracks can weaken the coating adherence. These cracks, however, did not cause spalling of the coating.
