**A 15,000-HOUR CYCLIC ENDURANCE TEST  
OF AN 8-CENTIMETER-DIAMETER ELECTRON  
BOMBARDMENT MERCURY ION THRUSTER**

**TECHNICAL PAPER** to be presented at the  
Twelfth International Electric Propulsion Conference sponsored by  
the American Institute of Aeronautics and Astronautics  
Key Biscayne, Florida, November 15-17, 1976

A 15,000-HOUR CYCLIC ENDURANCE TEST OF AN 8-CENTIMETER-DIAMETER  
ELECTRON BOMBARDMENT MERCURY ION THRUSTER

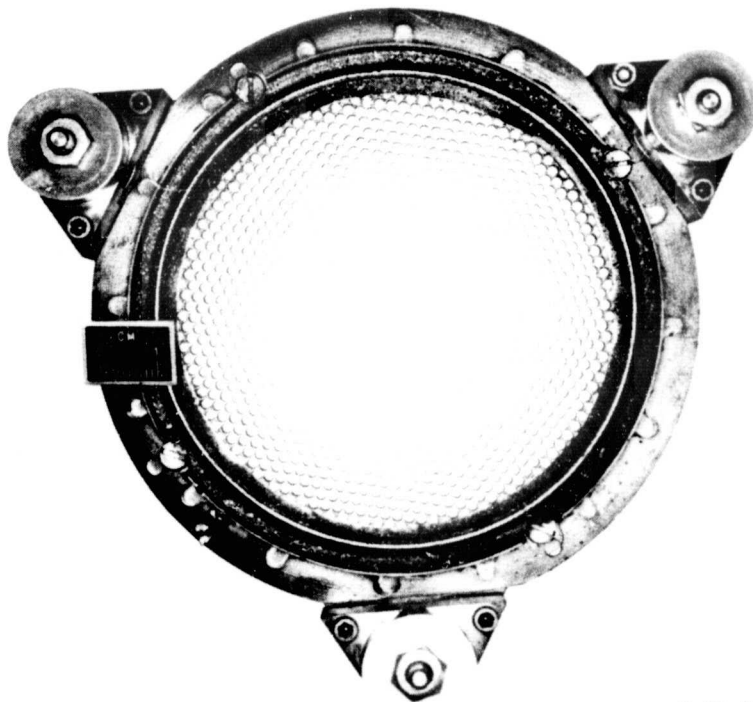
Figure 17. - Upstream side of screen grid after 15 000 hour test.

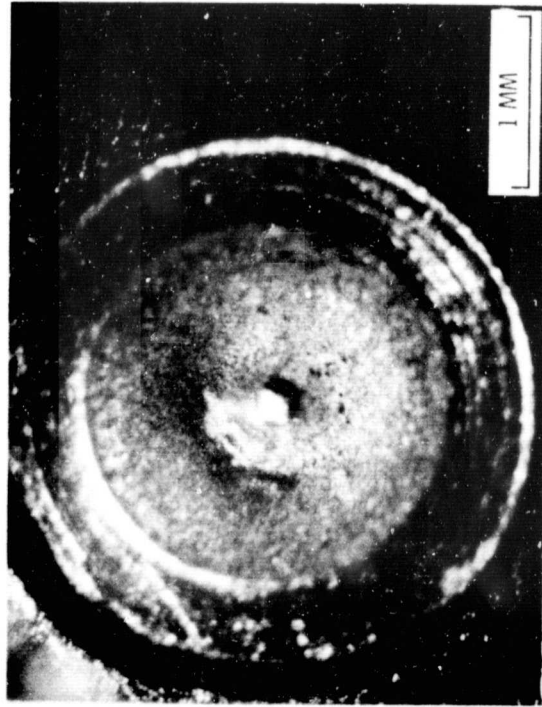
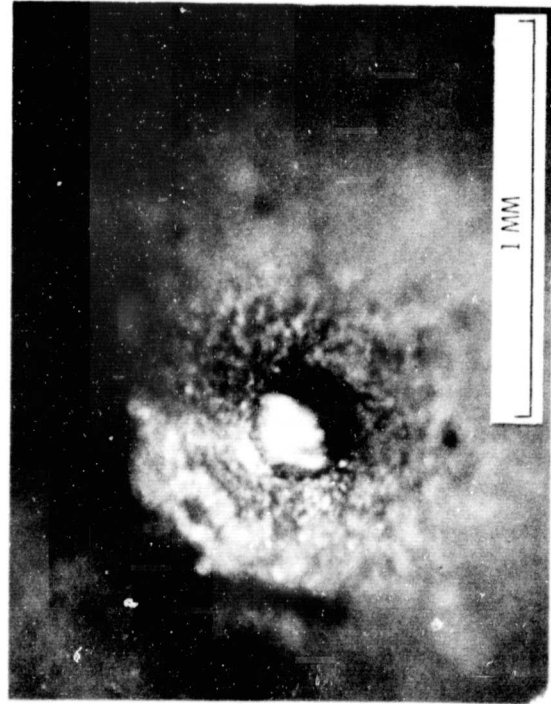
Figure 23. - Photomicrographs of cathode tip after 1156 hours.
