NASA TM X-73457

INFLUENCE OF DEBRIS DENT ON EHD LUBRICATION

by Lavern D. Wedeven
Lewis Research Center
Cleveland, Ohio 44135

TECHNICAL PAPER to be presented at
Joint Lubrication Conference cosponsored by the
American Society of Lubrication Engineers and
the American Society of Mechanical Engineers
Boston, Massachusetts, October 5-7, 1976

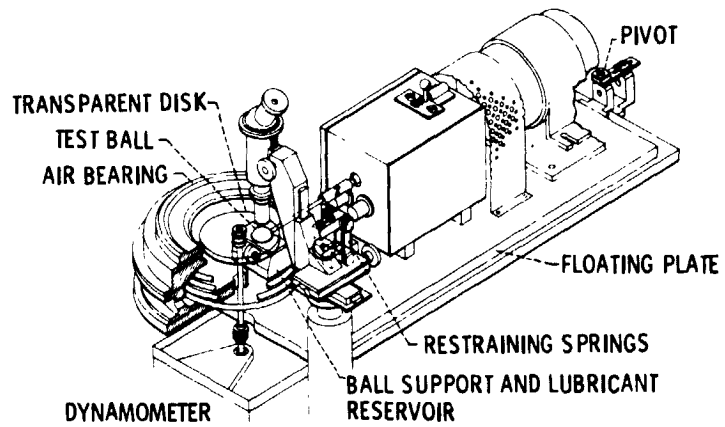
Figure 1. - Optical EHD rig.

Film thicknesses were made using optical interferometry. The optical elastohydrodynamic apparatus is shown in figure 1 and described in detail elsewhere (15, 16). The basic components of the apparatus consist of a ball which rides against a transparent disk.

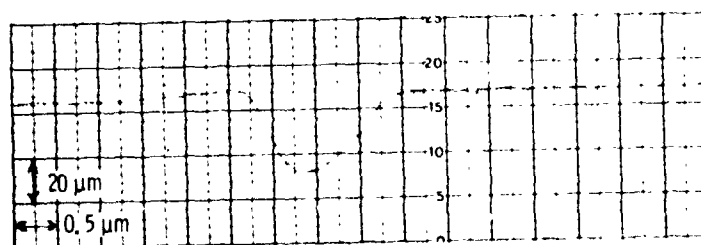
Figure 4. - Stylus trace across dent center.

A stylus trace across the dent center is shown in figure 4. The stylus was rotated about an axis concentric with the ball center so that the ball curvature could be eliminated. The dent is very shallow, being approximately $80\text{ }\mu\text{m}$ wide and $0.8\text{ }\mu\text{m}$ deep. One side of the dent is more sharply sloped than the other. The maximum slope is less than 3° . A very slight built-up edge appears at the shoulder of the more steeply sloped side of the dent.

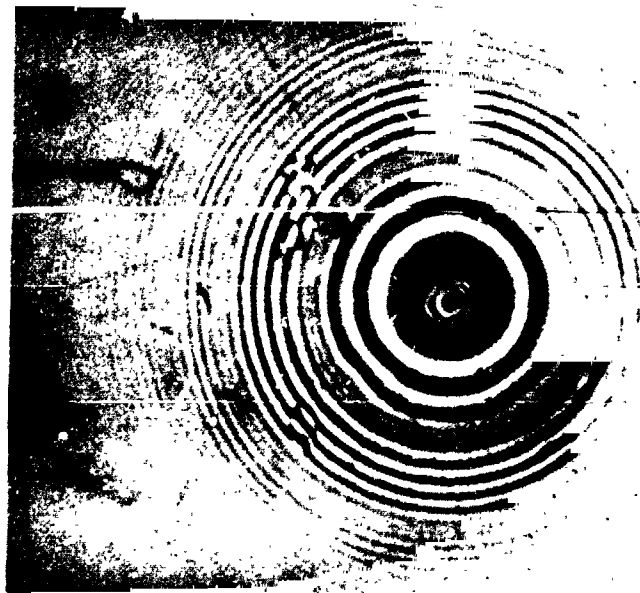
Figure 5. - Photomicrograph of dent in dry static contact under low load.

Figures 5 and 6 show the dent under dry contact conditions for two loads. The maximum Hertzian pressures, assuming smooth surfaces, are respectively $0.34 \times 10^9\text{ N/m}^2$ (50 000 psi) and $1.2 \times 10^9\text{ N/m}^2$ (175 000 psi). The actual maximum pressure which will be located at the dent shoulders will be much greater than this (19).

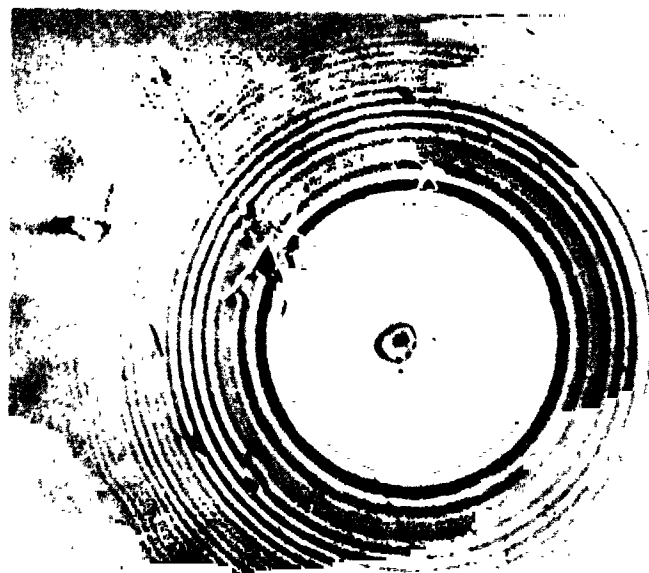
Figure 6. - Photomicrograph of dent in dry static contact under high load, 37.8 N.
 $P_{max} = 1.2 \times 10^9 \text{ N/m}^2$ (175 000 psi).

When the central film thickness is very small, approaching that of the dry contact case of figure 6, the local pressure around the dent shoulders may be substantially above that of the Hertzian pressure for smooth surfaces while the pressure within the dent cavity may be substantially below the Hertzian pressure for smooth surfaces. The pressure peak at the dent shoulders will create a local stress concentration slightly below the surface which may

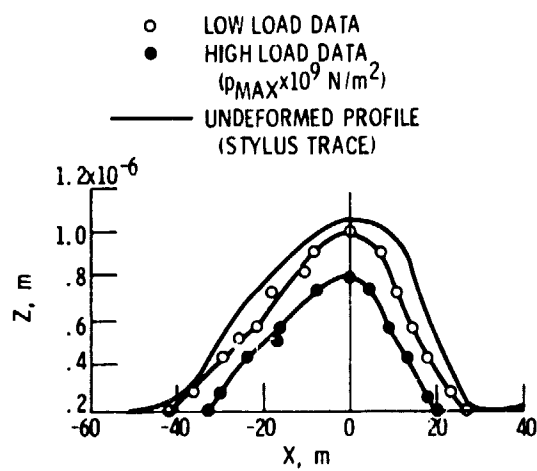
Figure 7. - Comparison of dent cross-sectional profiles for two loads under dry static contact conditions with undeformed profile.

The cross-sectional shape of the dent for the two loads of figures 5 and 6 are plotted in figure 7. Because the dent is very much wider than it is deep the vertical scale has been expanded. The high load is seen to deform the dent so that the maximum surface separation is 30 percent smaller than the depth of the undeformed dent. In addition, the deformation at the dent shoulder, under the higher load, causes the surfaces to meet at a much sharper angle.

The static measurements of the heavily loaded dry contact shown in figure 7 can, for comparison purposes, be considered as a severe stress condition. The heavily loaded condition corresponds to the same load used in the dynamic experiments where the maximum Hertzian pressure, assuming smooth surfaces, is $1.2 \times 10^9 \text{ N/m}^2$ (175 000 psi).

If there were no EHD effect on the pressure distribution around the dent under lubricated conditions we would expect the dent shape to look like that of the heavily loaded profile of figure 7 with an additional feature of the presence of a uniform film thickness (h_0) separating the surfaces. The pressure distribution around the dent would be identical to that of the dry contact case. That is, the pressure within the cavity created by the dent will be zero and there will be a pressure rise of two or three times the Hertzian pressure around the shoulder of the dent.

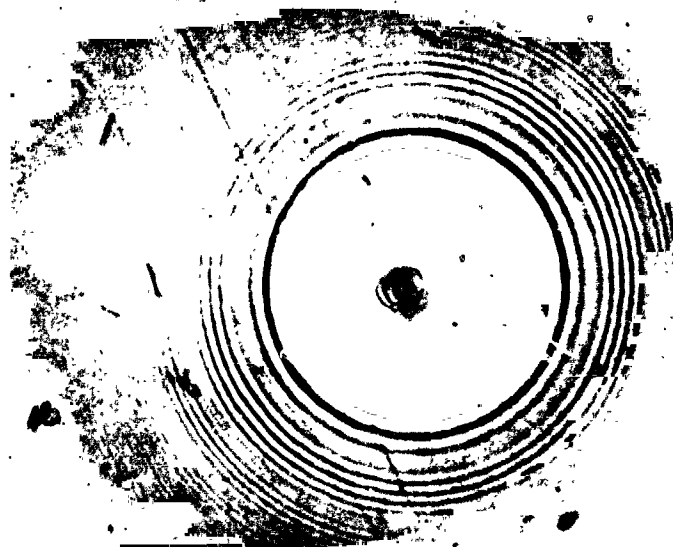
Figure 8. - Photomicrograph of dent in lubricated static contact; load, 37.8 N;
 $p_{max} = 1.2 \times 10^9 \text{ N/m}^2$.

Figure 8 shows a photomicrograph of the dent in the presence of the synthetic paraffinic lubricant. More fringes are formed within the dent because the fluid has a higher refractive index than air. The load (37.8 N) is the same as in figure 6. A comparison of the cross-sectional profiles between the dry and lubricated case are shown in figure 9. The pressure, and therefore, the refractive index within the dent under lubricated conditions are not known. The solid curve corresponds to a refractive index at atmospheric pressure and the dashed curve corresponds to a refractive index at a pressure equal to the maximum Hertzian pressure for smooth surfaces.

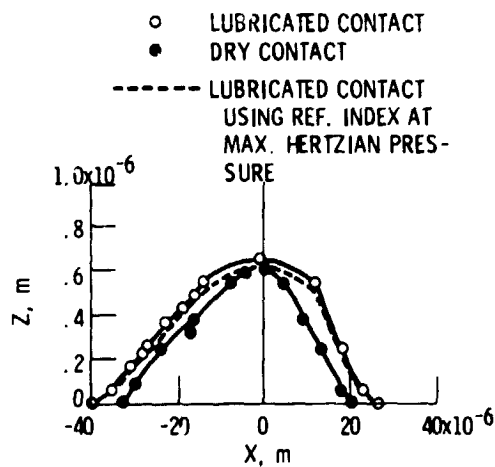
Figure 9. - Dent cross-sectional profiles for dry and lubricated contact conditions; load, 37.8 N, $p_{\max} = 1.2 \times 10^9 \text{ N/m}^2$.

Comparing the dry and lubricated dent cross-sections in static contact it is apparent that with no lubricant present the deformation around the dent is greater than is realized in the presence of a lubricant. The lubricant appears to become entrapped and compressed within the dent and thereby reduces the deformation.

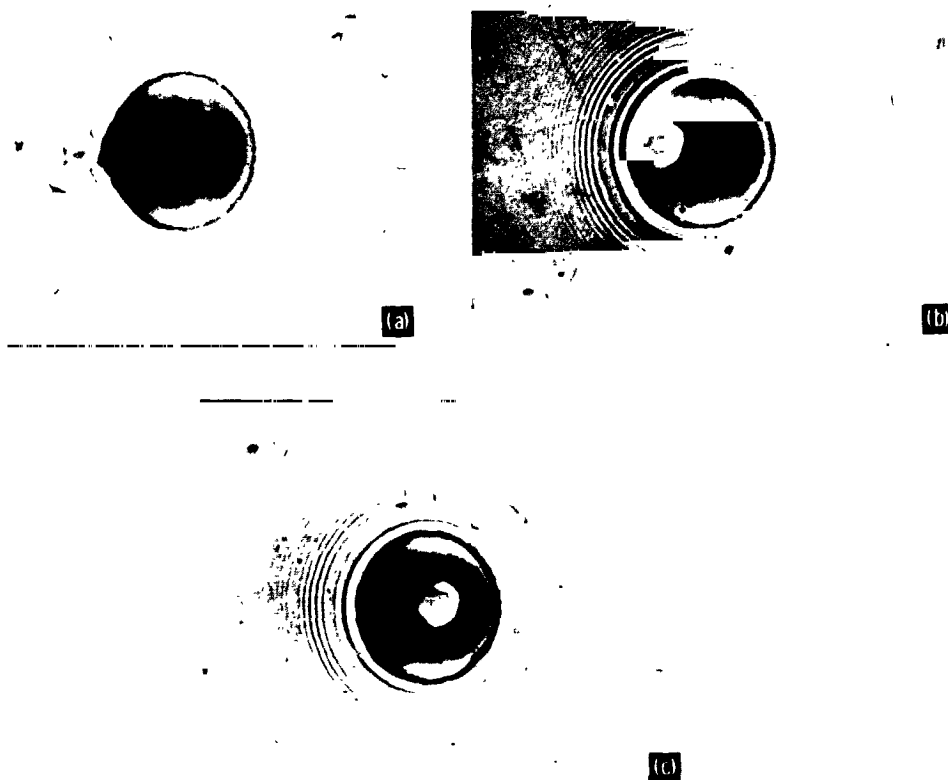
Figure 10. - Photomicrographs of dent in three different positions: $h_0 = 0.14 \mu\text{m}$, $p_{\max} = 1.2 \times 10^9 \text{ N/m}^2$, $u = 0.0134 \text{ m/s}$.

Figure 10(a), (b), and (c) show photomicrographs of the dent in three different positions. The central film thickness (h_0) is approximately $0.14 \mu\text{m}$ which is on the order of six times smaller than the depth of the dent. The maximum Hertzian pressure, assuming smooth surfaces, is $1.2 \times 10^9 \text{ N/m}^2$ (175 000 psi) and the surfaces are in pure rolling ($u = 0.0134 \text{ m/s}$). The cross-sectional shapes of the dent at the various positions are shown in figure 11(a), (b), and (c).

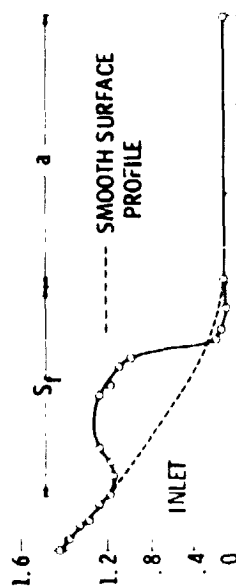
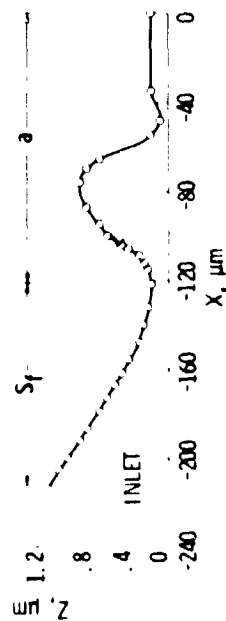
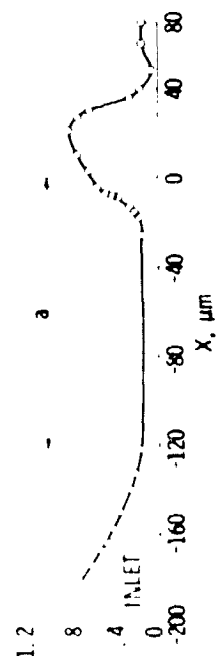
(a) DENT PROFILE OF FIG. 10(a).

(b) DENT PROFILE OF FIG. 10(b).

(c) DENT PROFILE OF FIG. 10(c).

Figure 11. - Dent profiles of figs. 10(a), (b), and (c);
 $h_0 = 0.14 \mu\text{m}$, $u = 0.0134 \text{ m/s}$.

When the dent is in the inlet region as shown in figure 11(a) it completely alters the converging geometry associated with the inlet. The dashed line in

figure 11(a) gives the smooth surface geometry which is characterized by a continuously decreasing slope as the Hertzian region is approached. The presence of the dent locally increases the slope at the leading edge of the dent while at the trailing edge the slope has changed to the opposite direction. These local modifications of the shape of the inlet region must surely affect the hydrodynamic pressure generation in the inlet region. The greater slope at the leading edge of the dent should be less favorable for pressure generation than the trailing edge where the slope is in the opposite direction. Evidence of this can be seen by the local reduction in film thickness at the leading edge of the dent. This local reduction in film thickness continues to appear as the dent passes through the Hertzian region as shown in figure 11(b) and (c). The entire film thickness associated with the dent appears to be "frozen in" as it passes through the Hertzian region.

While a film thickness reduction is again observed at the leading edge of the dent it does not appear to be as great in magnitude as the film thickness reduction measured under the smaller film thickness conditions of figure 11.

An intermediate central film thickness as shown in figure 11 results in a condition where the EHD film thickness modifications are slightly different for the leading and trailing edges of the dent. The local reduction in film thickness at the leading edge must be accompanied by a reduction in pressure and stress concentration. The trailing edge, however, does not receive the same benefit. These film thickness measurements may be a contributing factor in connection with the frequent observations of surface initiated fatigue spalls originating at the trailing edge of debris dents (1, 2). Figure 22(a) and (b) shows typical fatigue spalls which have originated at the trailing edges of debris dents. These fatigue spalls are from the inner races of 207-size deep groove ball bearing tests reported by Parker (9). Figure 22(b) and (c) show debris dents from the same bearing test program. Microcracks can clearly be seen at the trailing edge of the dents. An additional feature shown in figure 22(d) is the surface glazing at the leading edge and sides of the dent. Such glazing, which does not appear at the trailing edge, must correspond to the lower film thickness which occurs at the leading edge and sides of the dent as shown in figure 10. This type of glazing or peeling is very frequently observed at the edges of dents, furrows, and scratches. If the λ ratio (h_0/σ) is small the glazing would be expected to appear on all sides of the indented defect. A larger λ ratio is expected to show surface glazing only at the leading edge like that of figure 22(d). This type of information may be helpful during post-test evaluations.

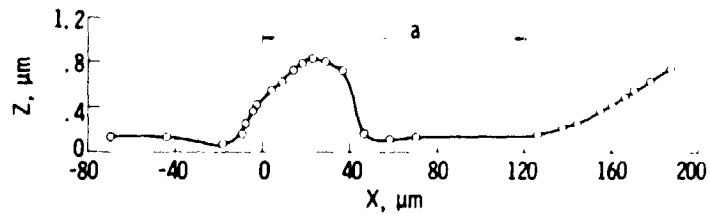
Figure 13. - Dent profile of Fig. 12 where rolling direction has been reversed, $h_0 = 0.14 \mu\text{m}$, $u = 0.0134 \text{ m/s}$.

Further evidence of the local film thickness reduction at the leading edge of the dent is shown in figure 12. Here the rolling direction has been reversed so that the dent passes through the conjunction in the opposite direction. The black fringe corresponding to the film thickness reduction in figure 11 is now seen on the opposite side of the dent in figure 12. The cross-sectional profile through the center of the dent is shown in figure 13. The reduction in film thickness at the leading edge of the dent appears to be more pronounced in figure 11 than in figure 13 where the direction has been reversed. This may be accounted for by the fact that one side of the dent is more sharply curved than the other and has a slight build-up of material along its edge. This may also be the reason for the slight reduction in film thickness observed at the trailing edge of the dent seen in figure 12 and figure 13.

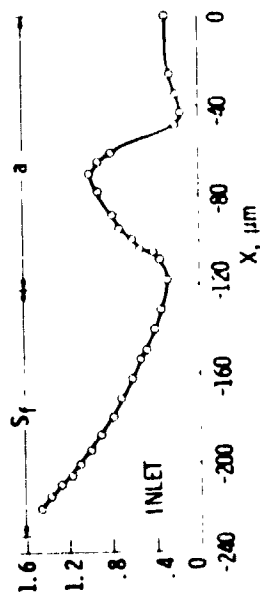
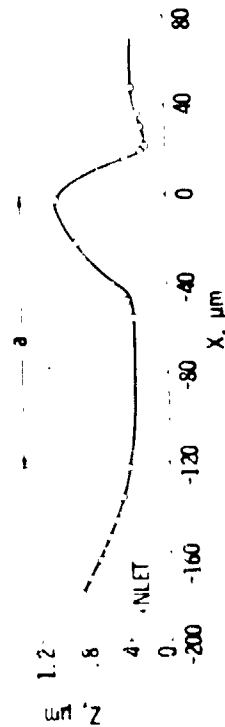
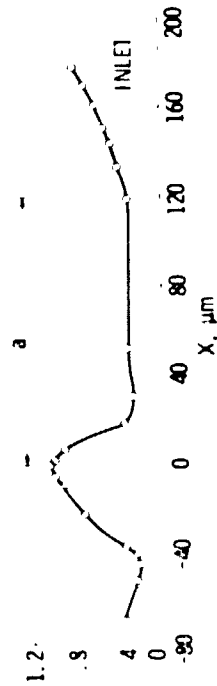
(a) DENT PROFILE OF FIG. 14(a).

(b) DENT PROFILE OF FIG. 14(b).

(c) DENT PROFILE OF FIG. 14(c).

Figure 15 - Dent profiles of figs. 14(a), (b), and (c);
 $h_0 = 0.30 \mu\text{m}$, $u = 0.0432 \text{ m/s}$.

(b), and (c). The same general features again appear. That is, a film thickness reduction is observed at the leading edge as shown in figure 14(a) and (b) and figure 15(a) and (b). When the rolling direction is reversed, as shown in figures 14(c) and 15(c) a reduction in film thickness at the leading edge is again observed but is less pronounced due to the reasons stated above.

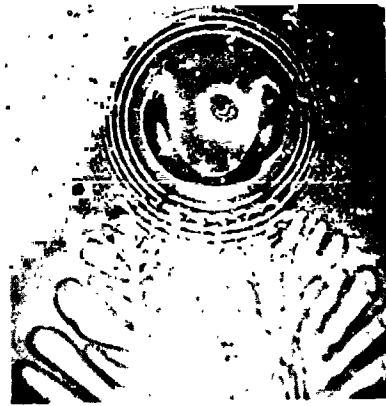
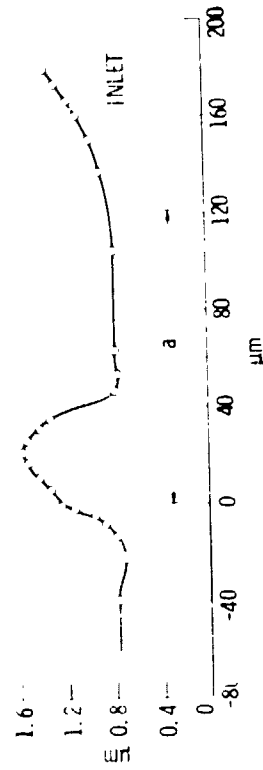
Figure 16 - Photomicrograph and profile of dent for large film thickness, $h_0 = 0.79 \mu\text{m}$.

Figure 16 shows the dent under conditions where the central film thickness (h_0) is $0.78 \mu\text{m}$ which is approximately equal to the depth of the dent. A high viscosity traction fluid, described in table II, was used in this case so that the dent could be photographed under speed conditions which were compatible with the flash duration of the light source.

When the central film thickness is relatively large as shown in figure 16 there is considerably less local elastic deformation around the dent shoulders as shown in figure 19. That is, the dent approaches the undeformed shape. This implies that the pressure around the dent will approach that of the case for smooth surfaces and that local stress concentration at the dent shoulders will be substantially reduced from the dry contact case.

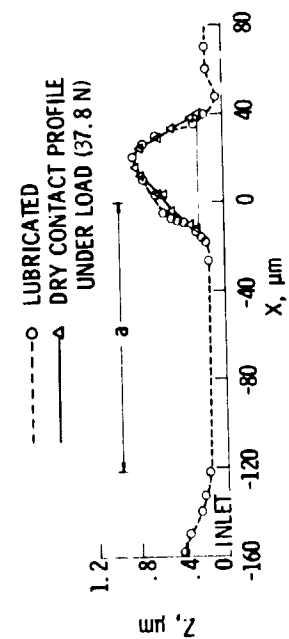
Figure 17. - Comparison of dry contact dent profile with profile under dynamic conditions of Fig. 10(c); $h_0 = 0.14 \mu\text{m}$.

This heavily loaded dry contact profile is compared with the lubricated profile in figure 17 where the central film thickness is $0.14 \mu\text{m}$. The two profiles have been superimposed so that the deepest point of the dent on each profile coincides. Comparison of the two profiles shows that the dent is not as severely deformed under lubricated conditions as it is under dry contact conditions. In addition, there is less deformation at the leading edge of the dent than the trailing edge.

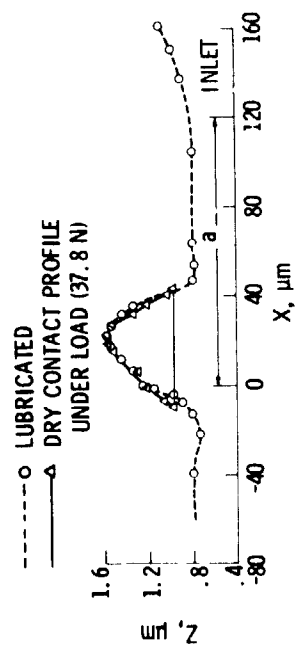
Figure 19. - Comparison of heavily loaded dry contact dent profile with profile under dynamic conditions of Fig. 15; $h_0 = 0.78 \mu\text{m}$.

Figures 19 and 20 compare respectively the dry contact and undeformed dent profiles with the dent profile under much larger film thickness conditions ($h_0 = 0.78 \mu\text{m}$). Under these larger film thickness conditions the deformation around the dent is far less than the dry contact case shown in figure 19 and approaches very closely the undeformed profile as shown in figure 20.

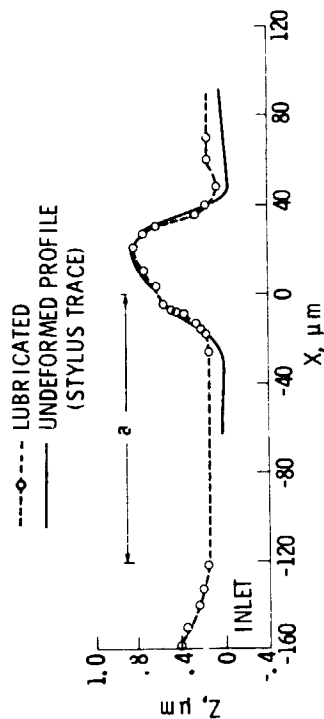
Figure 18. - Comparison of undeformed dent profile with profile under dynamic conditions of Fig. 10(c); $h_0 = 0.14 \mu\text{m}$.

In figure 18 the undeformed dent profile obtained from the stylus trace is compared with dent profile under the dynamic conditions of figure 17. In contrast with the dry contact profile, the undeformed profile can be thought of as representing the dent shape where the influence of EHD has created a pressure environment around the dent which allows the dent to pass through the Hertzian region in an "undeformed" state; i.e., the pressure around the dent is everywhere equal to the Hertzian pressure for smooth surfaces. Comparing the profiles of figure 18 shows that under dynamic conditions where the film thickness is $0.14 \mu\text{m}$ the local deformation around the dent is significantly greater than its undeformed condition.

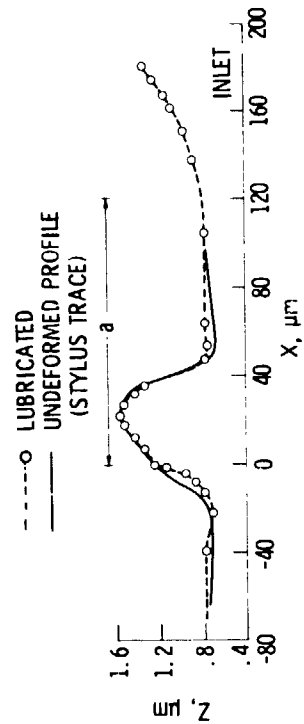
Figure 20. - Comparison of undeformed dent profile with profile under dynamic conditions of Fig. 16; $h_0 = 0.78 \mu\text{m}$.

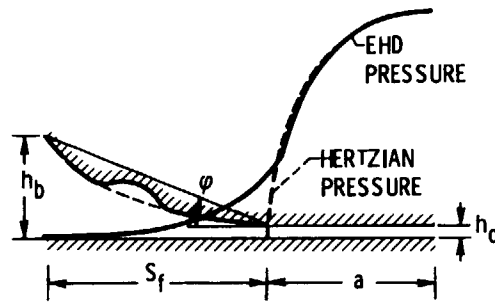
Figure 21. - Schematic drawing showing characteristic inlet dimensions.

If a characteristic inlet convergence angle ϕ is defined as illustrated in figure 21 it can be shown that

$$\varphi = \arctan 2.27 \frac{(ah_0)^{1/3}}{R^{2/3}} \quad (3)$$

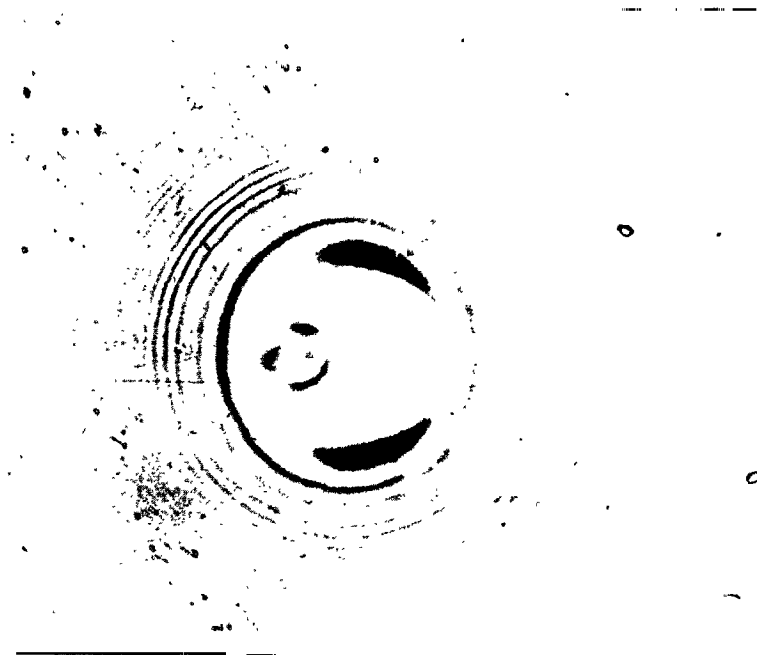
Figure 23. - Photomicrograph of dent under combined rolling and sliding conditions;
 $h_0 = 0.26 \mu\text{m}$.

The present study has concentrated on pure rolling conditions. If sliding as well as rolling is present additional EHD effects appear. Figure 23 and figure 24 show the film thickness distribution around the dent under conditions where the ball surface, which contains the dent, is moving faster than the sapphire disk. Local film thickness modifications occur at the converging and diverging sides of the dent as a result of the EHD effects associated with the relative surface velocity while passing through the Hertzian region. When the dent profile is compared with the undeformed profile as shown in figure 24 there appears to be a substantial increase in film thickness on the trailing side of the dent. This local increase in deformation due to sliding is in line with the results reported by Jackson (21) and Cheng (22). The presence of sliding may increase the stress concentration at the trailing edge. The leading edge, according to Chiu (3) may benefit from a reduction in local pressure under sliding conditions. These EHD effects associated with sliding will be located on the opposite sides of the dent for the case where the indented ball surface is moving slower than the sapphire disk. The implication that the presence of sliding creates additional pressure and stress concentration is in line with the detrimental effect sliding has on surface initiated fatigue (1) and the existence of pressure rippling (23).

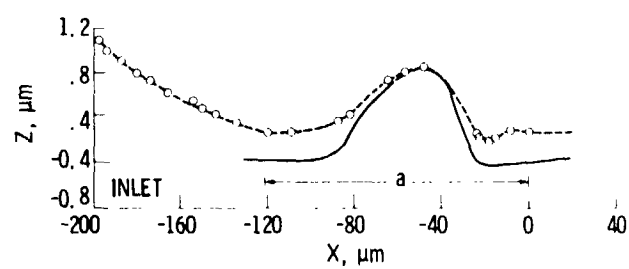
Figure 24. - Comparison of undeformed dent profile
 with rolling/sliding profile of Fig. 23; $h_0 = 0.26 \mu\text{m}$.
