NASA TM X-73465

EFFECT OF A CHROMIUM-CONTAINING FUEL ADDITIVE ON HOT CORROSION

by Carl E. Lowell and Daniel L. Deadmore
Lewis Research Center
Cleveland, Ohio 44135
July 1976

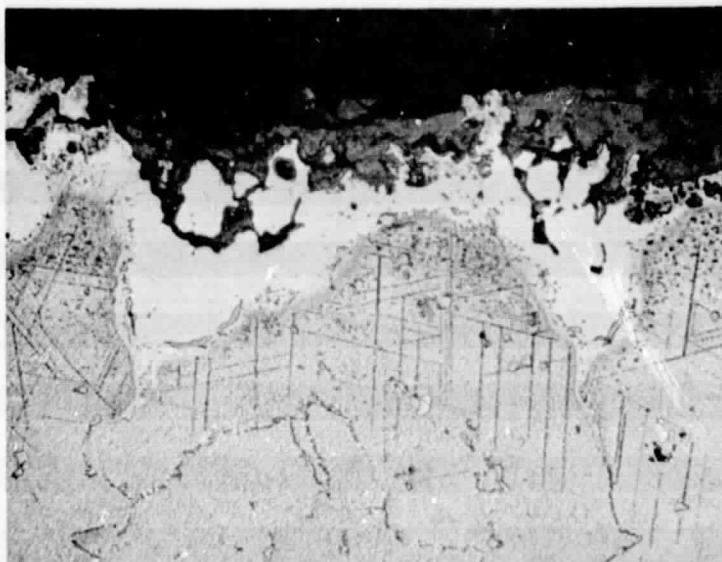
The mode of microstructural attack is shown in Figs. 5 to 8. Typical of the three nickel base alloys is IN-738 which is shown in Fig. 5. It is a γ/γ' alloy. These phases can be seen in the unaffected metal beneath the depletion zone. The results of hot corrosion are the same for all salt conditions with a heavy external scale layer over a zone, depleted in γ' , which is filled with voids. The nature of the corrosive attack can easily be seen by comparison with the oxidative-only attack shown in Fig. 5(d).

Figure 5. - Effect of MO.3 hot corrosion at 900°C on the microstructure of IN-738. Salt-5PPM, additive-300PPM; etched. X250.

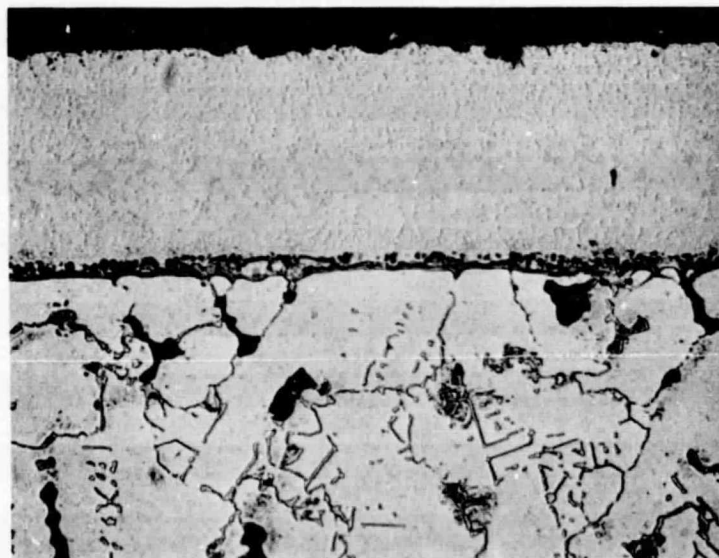
The microstructure of coated MM 509 (Fig. 8) showed no attack at all. Not even the spalled areas of the coating which were evident by surface examination (Fig. 4) could be seen in any part of the microstructure. It appears that the overlay coating is very resistant to corrosive attack.

Figure 8. - Effect of MO.3 hot corrosion at 900° C on the microstructure of coated MM 509. Salt-5PPM, additive-300PPM, 100-one hour cycles, washed every 10 cycles; etched. X250.
