**INTERIOR AND EXTERIOR FUSELAGE NOISE MEASURED ON  
NASA'S C-8A AUGMENTOR WING JET-STOL RESEARCH AIRCRAFT**

**Michael D. Shovlin**

**Ames Research Center  
Moffett Field, California 94035**

**April 1977**

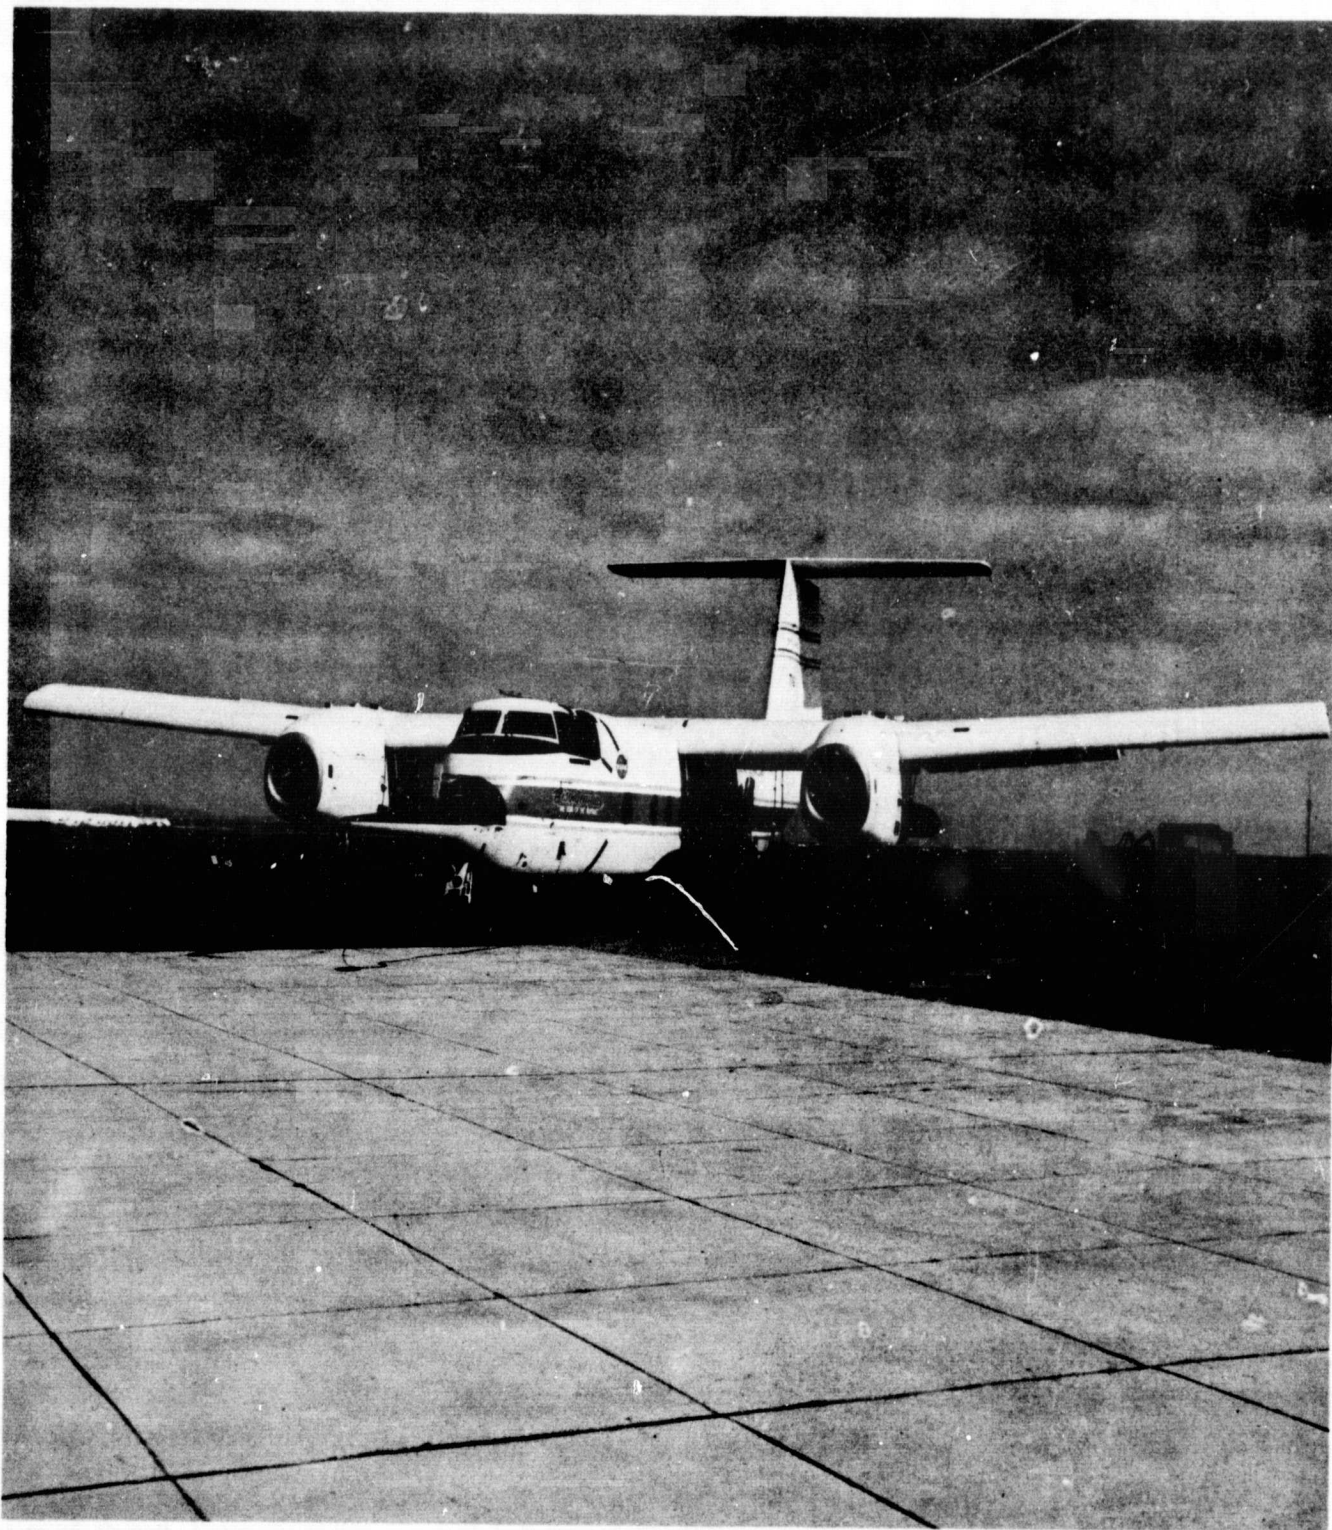
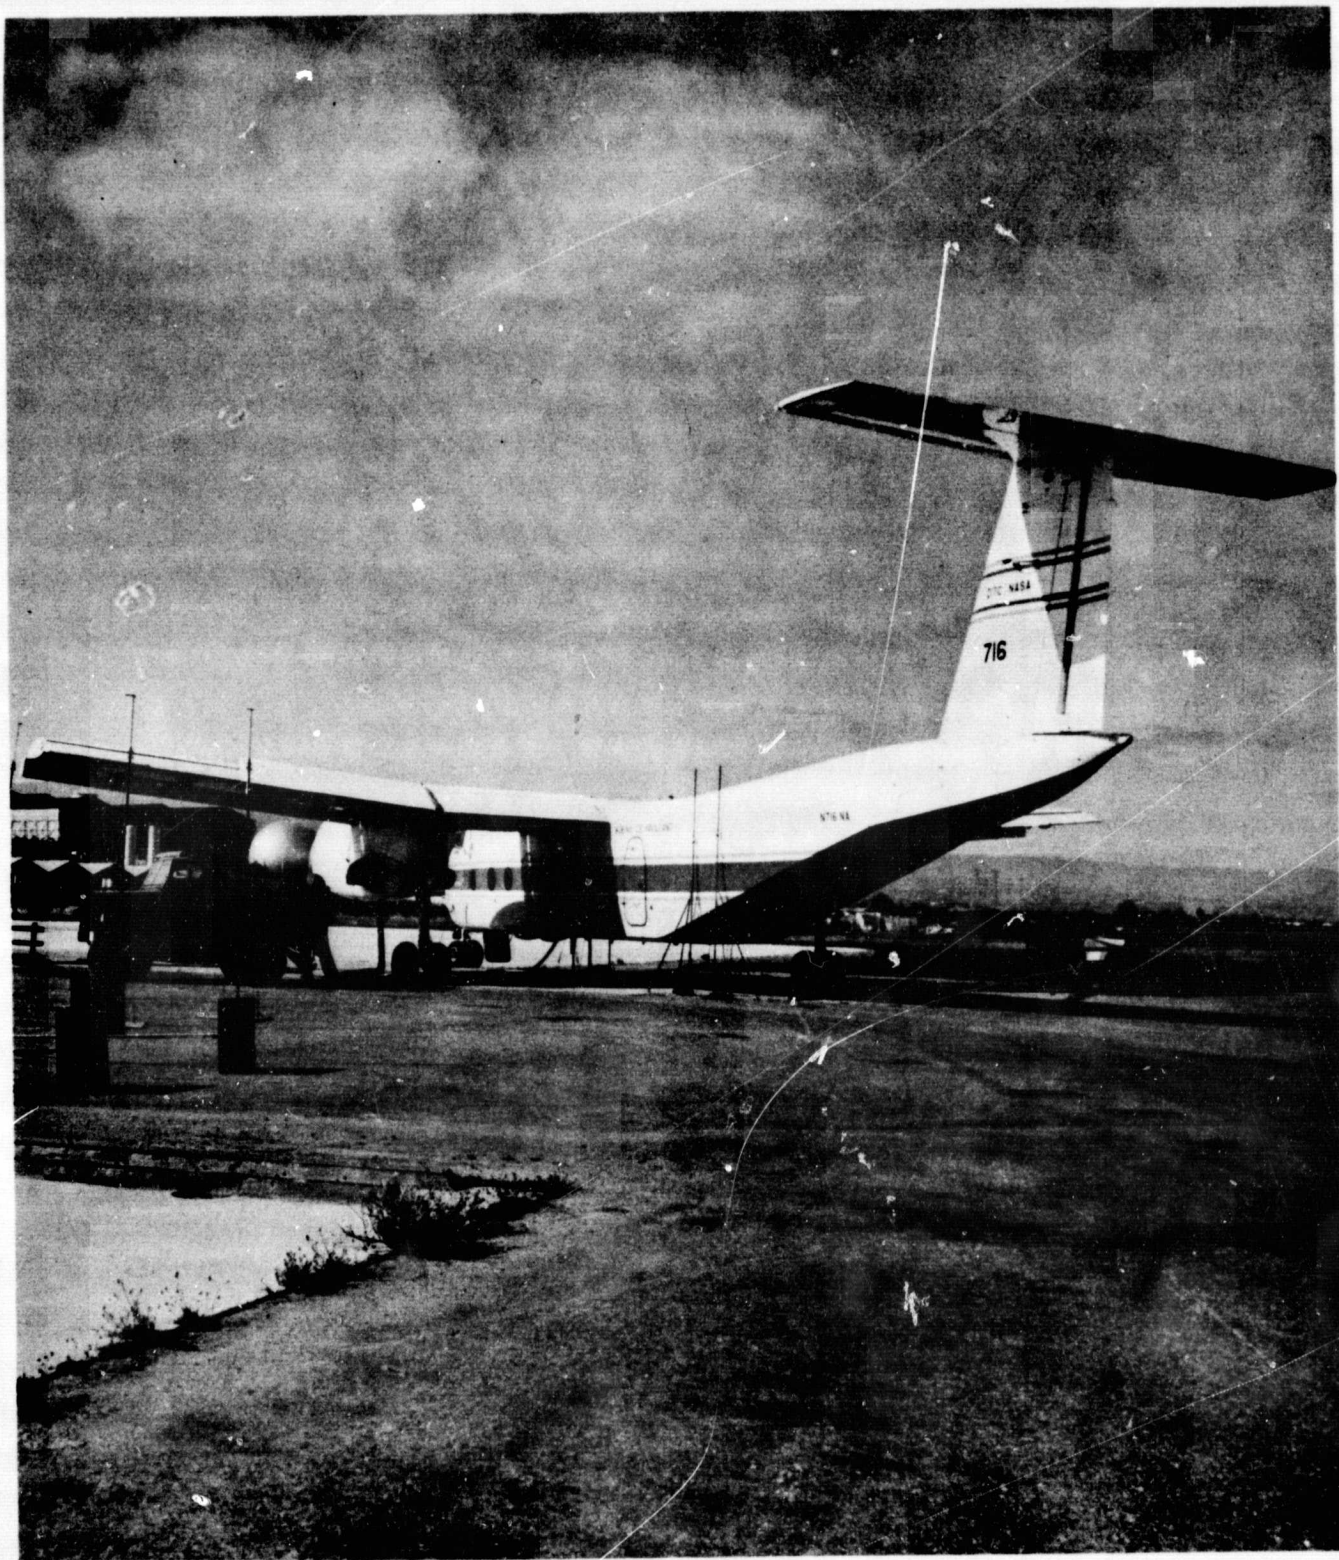
Figure 7.— AWJSRA at Ames Research Center's X-14 test site.

The aircraft near field noise levels were measured at the Ames Research Center's X-14 static test site which is located away from the Center's main buildings. Figure 7 shows the C-8A parked on one of the heavy thrust pads of the site, where the nearest building, a trailer, was approximately 35 m away and in a line slightly forward of the instrumented quadrant.

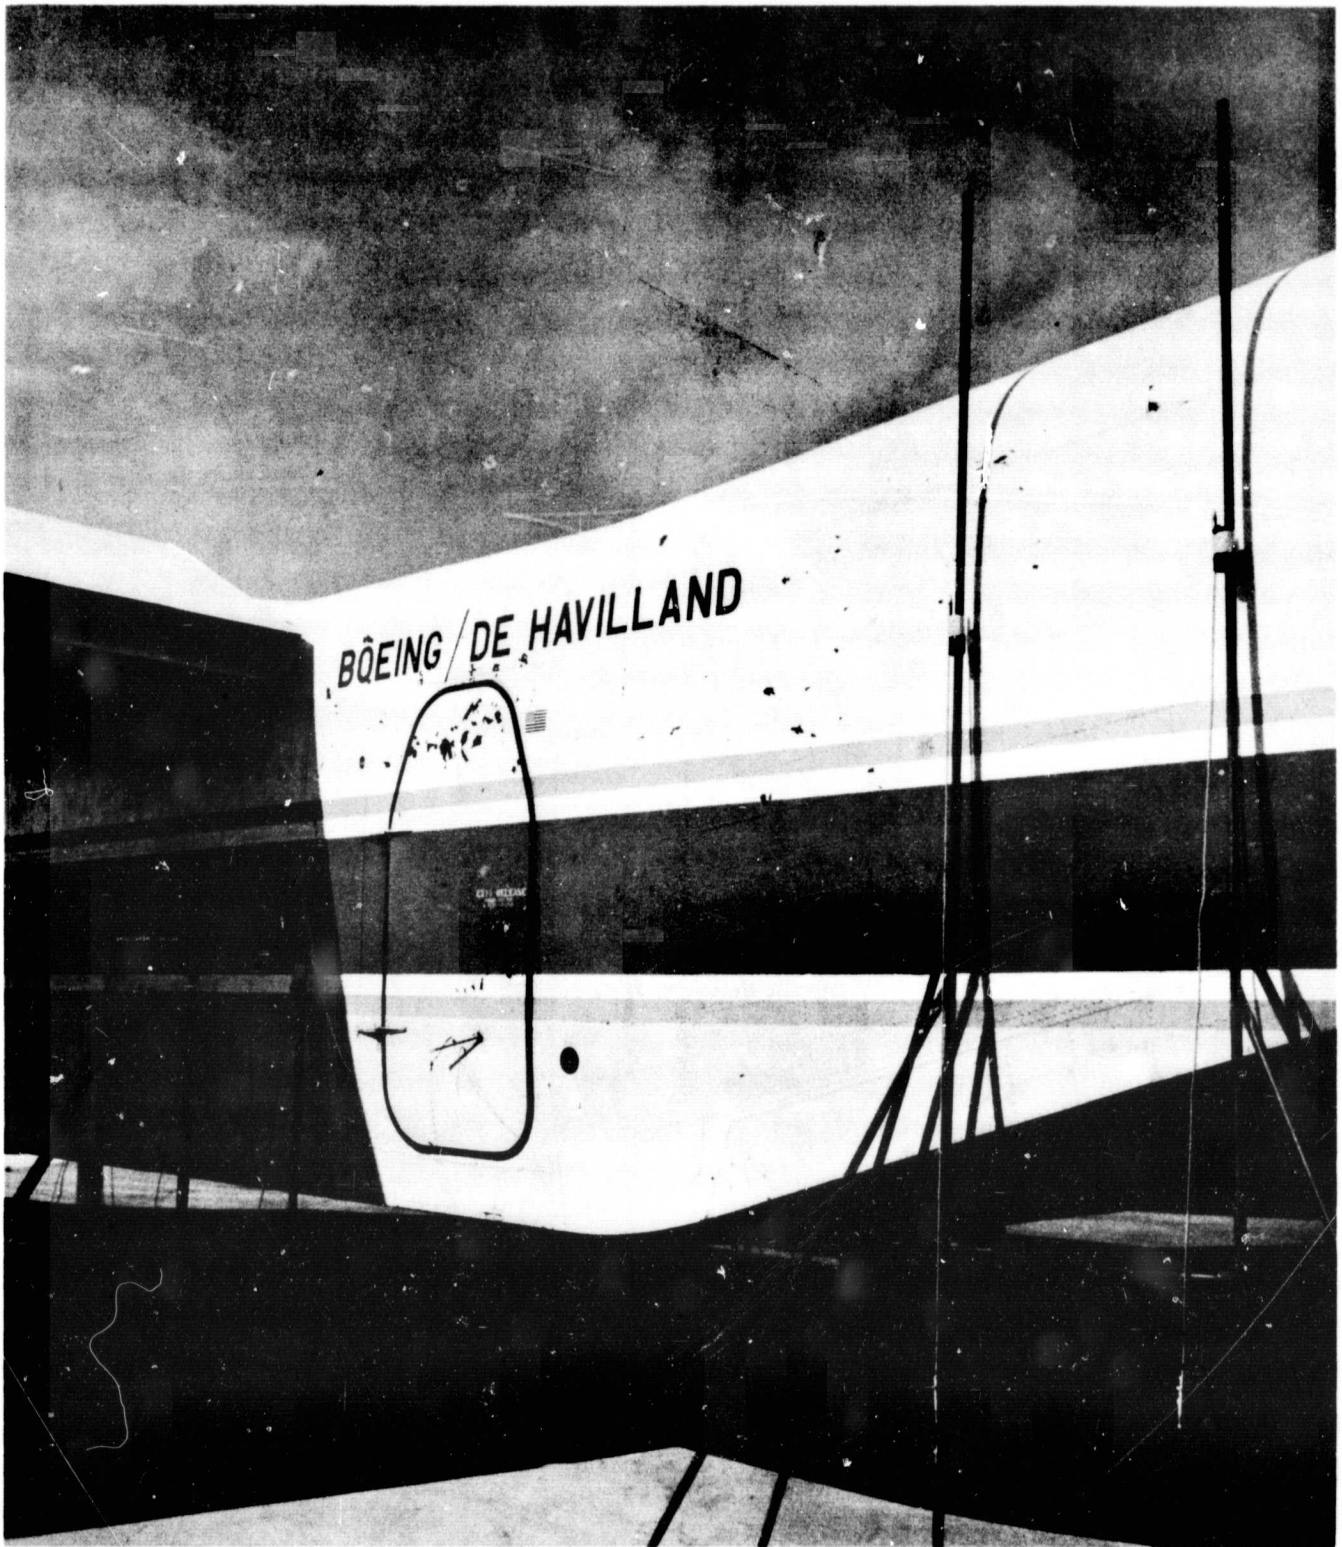
(a) Interior microphones 5 and 6.

Figure 11.- Aft fuselage microphone installation.

(b) Exterior microphones 10 and 11.

The locations of the aft fuselage microphones (4, 5, 10, and 11) are shown in figures 11 and 12. The left side of the fuselage is somewhat cluttered aft of the door, with safety equipment and a main electrical panel, requiring these microphones to be placed rearward of this area. The microphones were located half way from the floor to the fuselage shoulder and on both sides of the main support frame at the end of the cargo ramp. The external microphones (10-11) were placed outside directly opposite the interior microphones (5-6) and positioned approximately 5 cm from the fuselage skin with the diaphragm parallel to the ground and pointing upwards.
