DEVELOPMENT OF A PLASMA SPRAYED CERAMIC GAS PATH
SEAL FOR HIGH PRESSURE TURBINE APPLICATIONS

FINAL REPORT

by
L. T. Shiembob

PRATT & WHITNEY AIRCRAFT GROUP
COMMERCIAL PRODUCTS DIVISION
UNITED TECHNOLOGIES CORPORATION

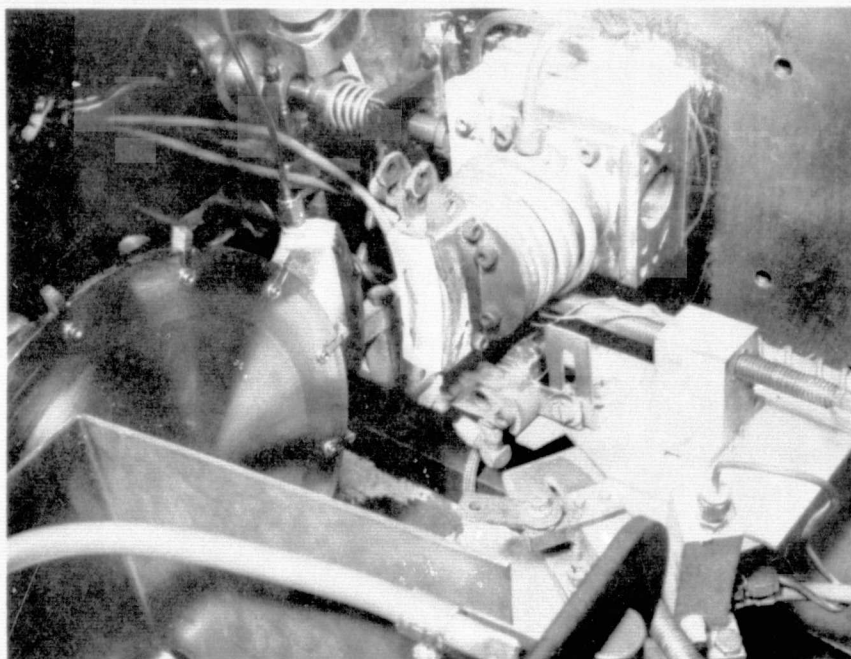
Figure 2 High Temperature Abradability Test Rig

Note: Near side heating torch not shown.

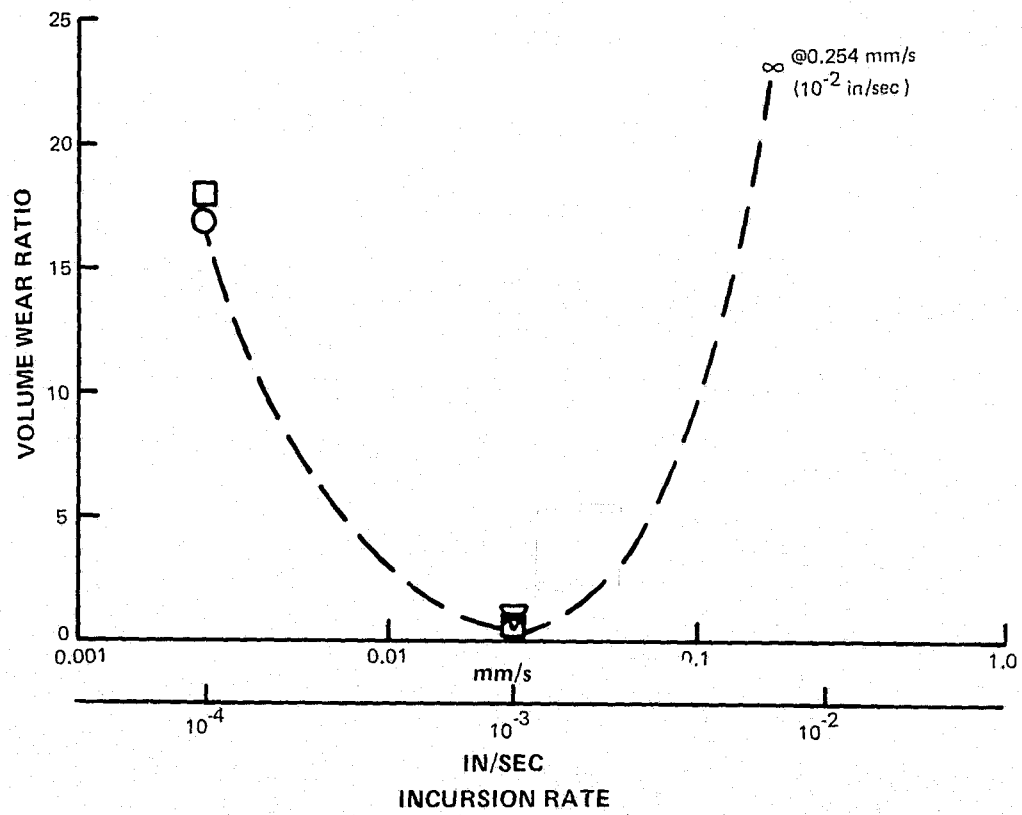
Figure 3 Abradability Sensitivity to Incursion Rate

SEAL TEMP. — 1589K (2400F)
NO. BLADES — 12
BLADE MAT'L. — PWA 1455
BLADE TIP TKNS. — 0.3175 CM (0.125 IN.)

Use of a 12-bladed rotor for the abradability tests resulted in better than an order of magnitude improvement in blade tip to seal volume wear ratio (VWR) over the performance with a single bladed rotor demonstrated under NAS3-18565. A strong sensitivity to the incursion rate between the seal and the rotor was demonstrated, with an optimum rate of approximately 0.0254 mm/sec (0.001 in/sec).

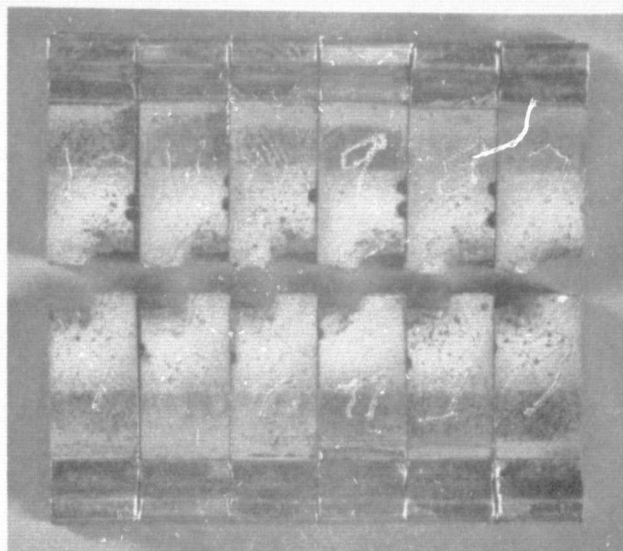
Figure 4 Abnormal Blade Tip Wear (Abradability Test No. 1)

Note: Leading face of blades shown.

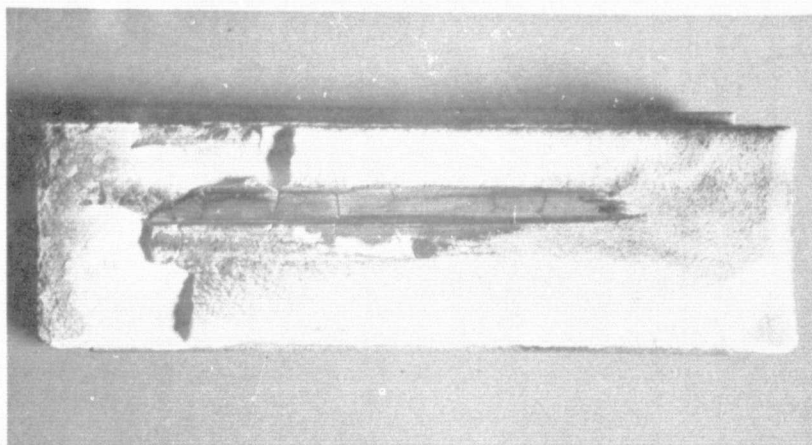
Figure 5 Test Specimen (Abradability Test No. 1)

Rub Direction

Note: Spallation at lower end and upper corner due to thermal shocking while setting test conditions. Excessive windage necessitated approx. 8 heating and cooling cycles before achieving test conditions.

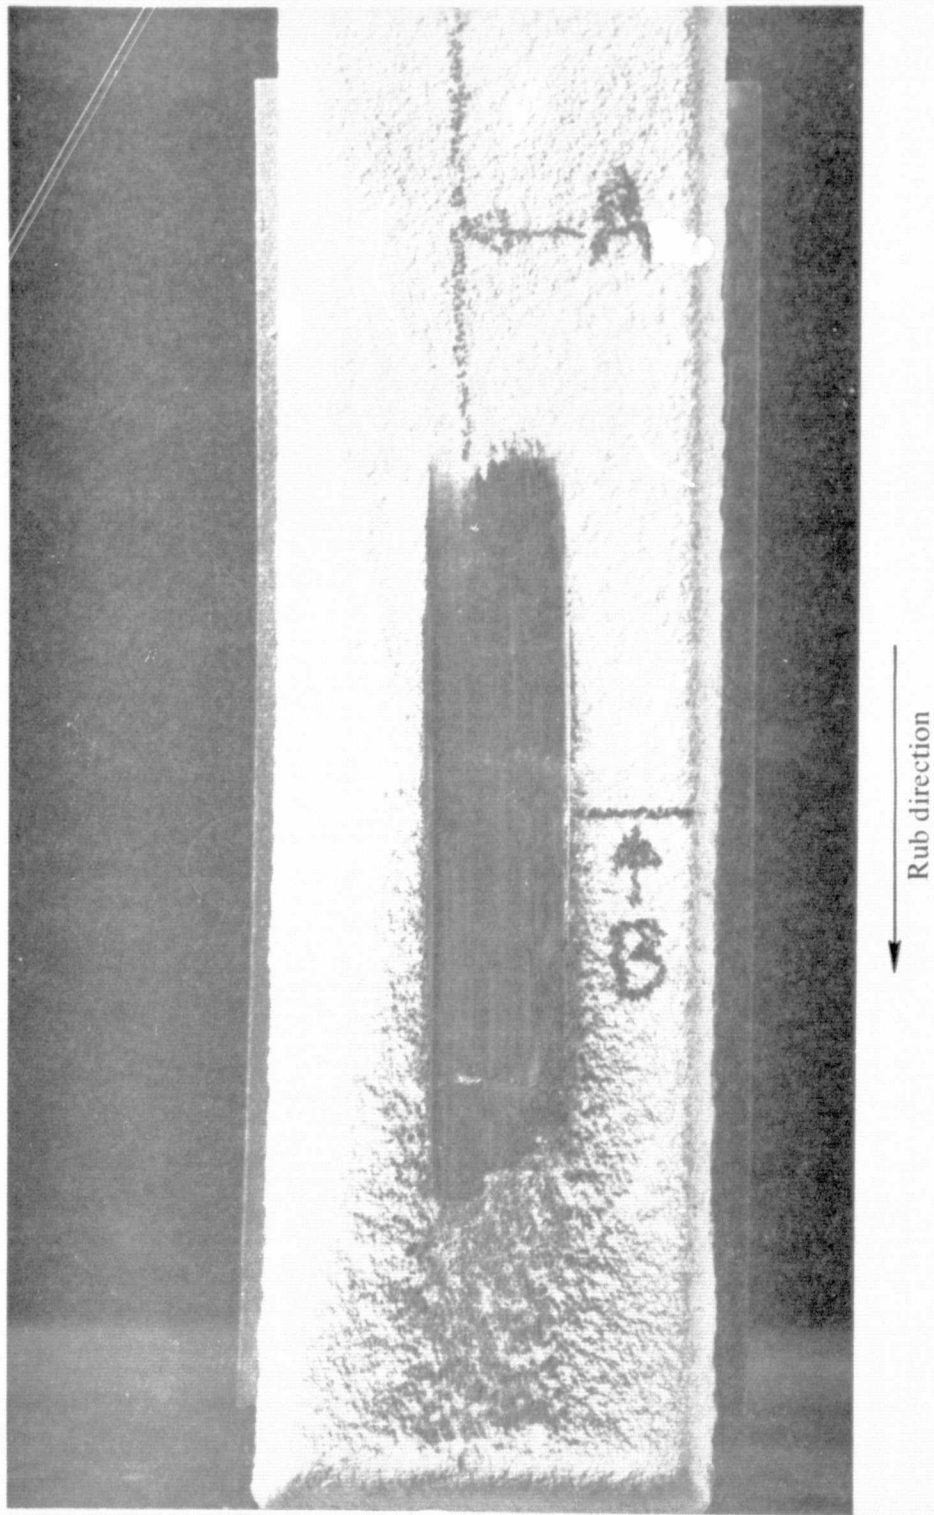
Figure 6 Axial Cracks in Rub Path, (Abradability Test No. 3)

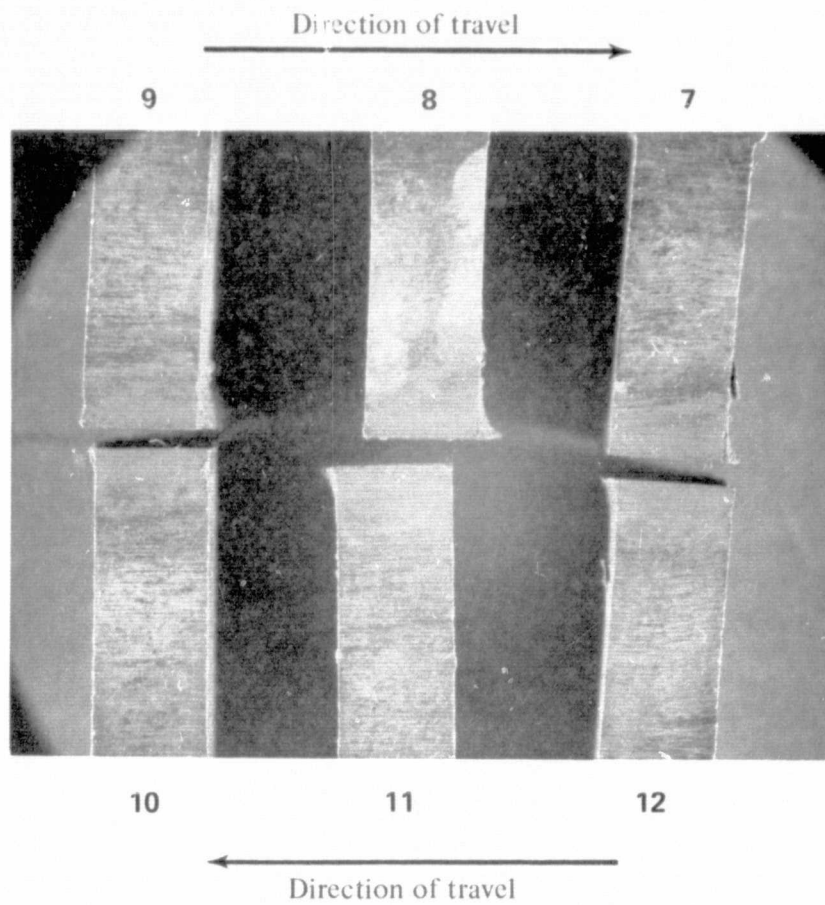
Figure 7 *Metal Pickup on Leading Side of Blades, (Abradability Test No. 6)*

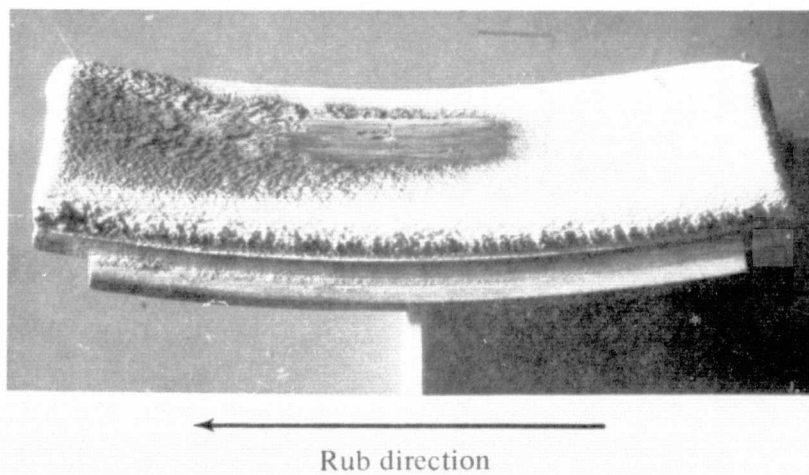
Figure 8 *Metal Deposits on Seal Specimen Downstream of Rubbed Area, (Abradability Test No. 6)*

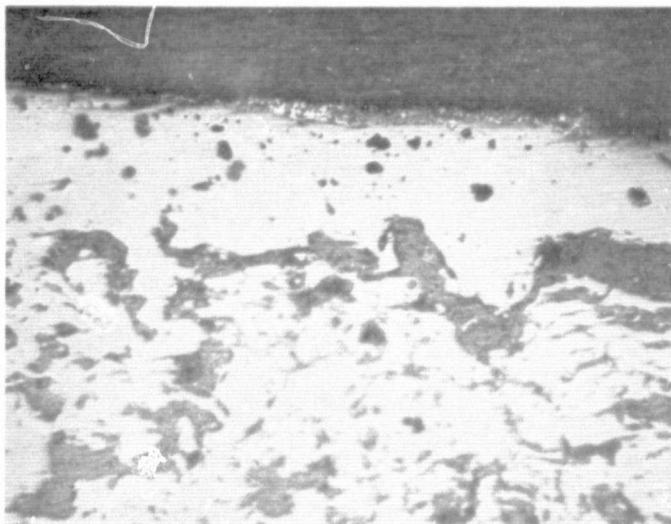
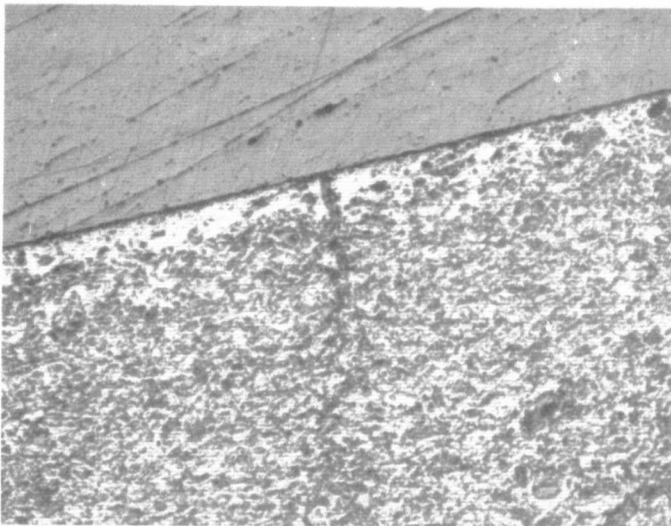
Figure 9 Metal Transfer and Seal Densification in Rub Path, (Abradability Specimen No. 3)

1. Small amounts of blade tip residue were seen on the sections of the rub path which were examined. Deposit thicknesses up to approximately 0.0051 mm (0.0002 in.) were found as shown in Figure 9 (a).

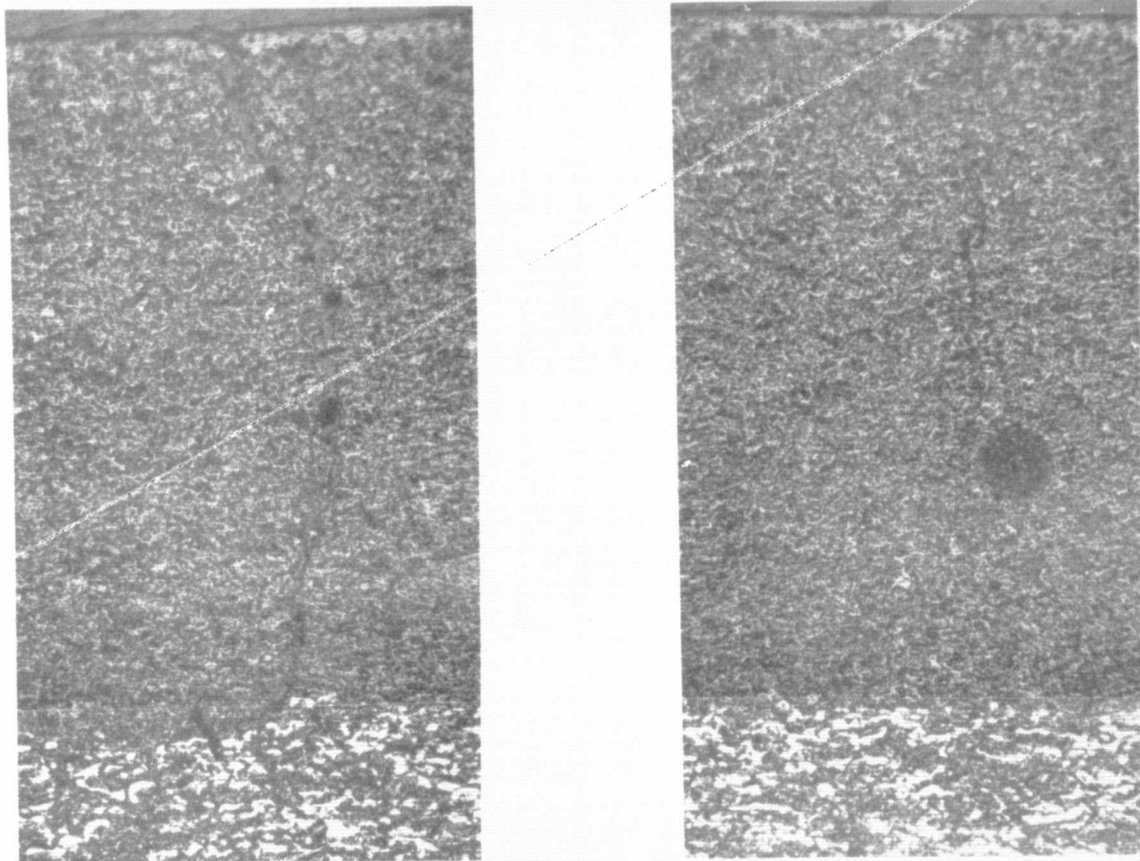
Figure 10 Typical Cracks in Circumferential Section, (Abradability Test No. 3)

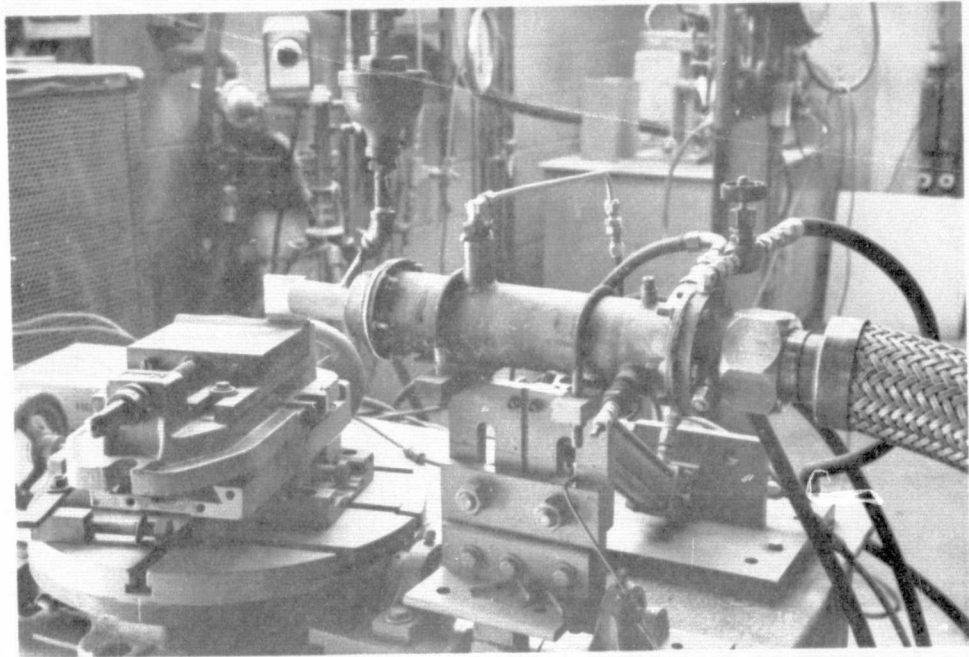
Figure 11 Hot Particulate Erosion Rig

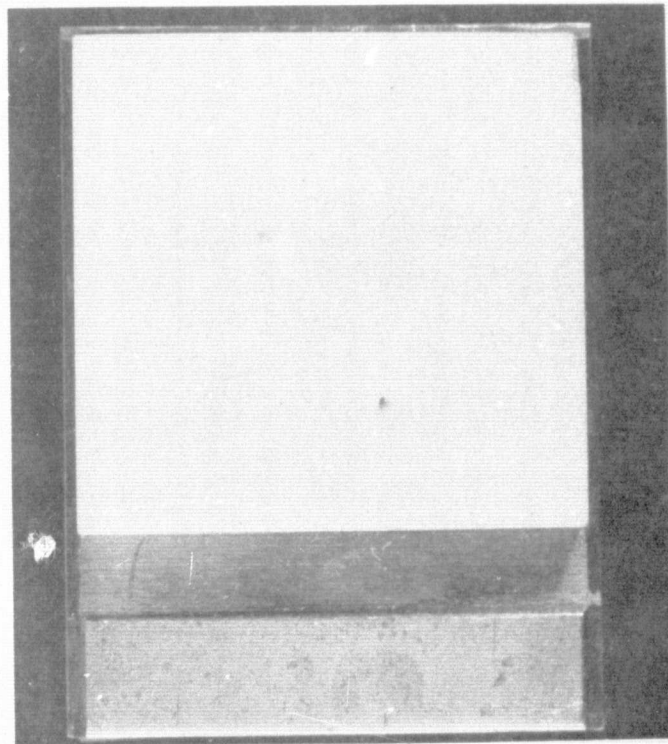
Figure 12 Erosion Test Specimen

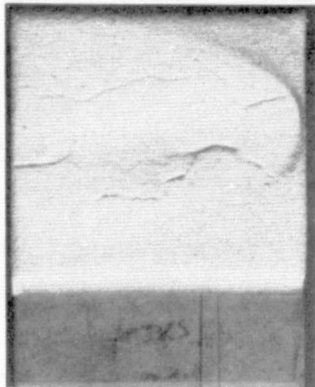
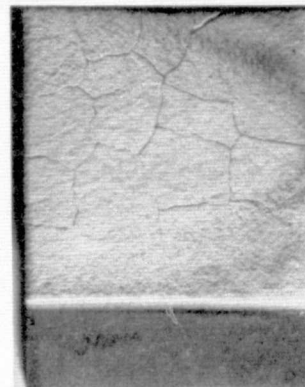
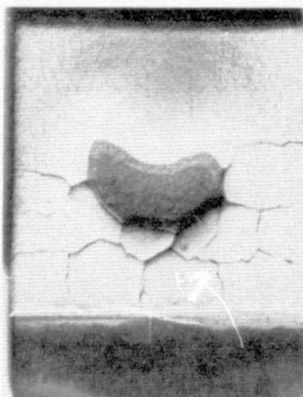
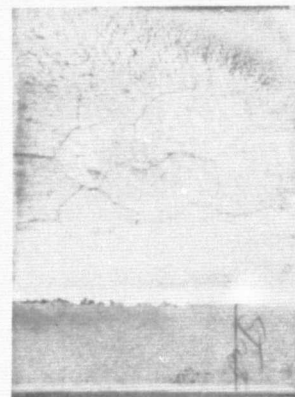
Figure 13 Tested Erosion Specimens

SURFACE TEMP. — AS NOTED
 IMPINGEMENT ANGLE — AS NOTED
 PARTICULATE — NO. 80 GRIT Al_2O_3
 PARTICULATE FLOW — 6.0 LB/HR.

TEST DURATION — 20 MIN.
 GAS VELOCITY — 0.35 MACH.
 NOZZLE DIAMETER — 0.75 IN.
 STANDOFF DISTANCE — 1.5 IN. @ Q

TOP HALF OF CERAMIC LAYER
 DELAMINATED AND SPALLED AT
 INTERMEDIATE LAYER INTERFACE
 AFTER 15 MINUTES.

BOTTOM HALF OF CERAMIC LAYER
 FRACTURED AT INTERMEDIATE LAYER
 INTERFACE WHEN ACCIDENTALLY
 DROPPED POST TEST.

INCREASED POROSITY SURFACE
 LAYER.

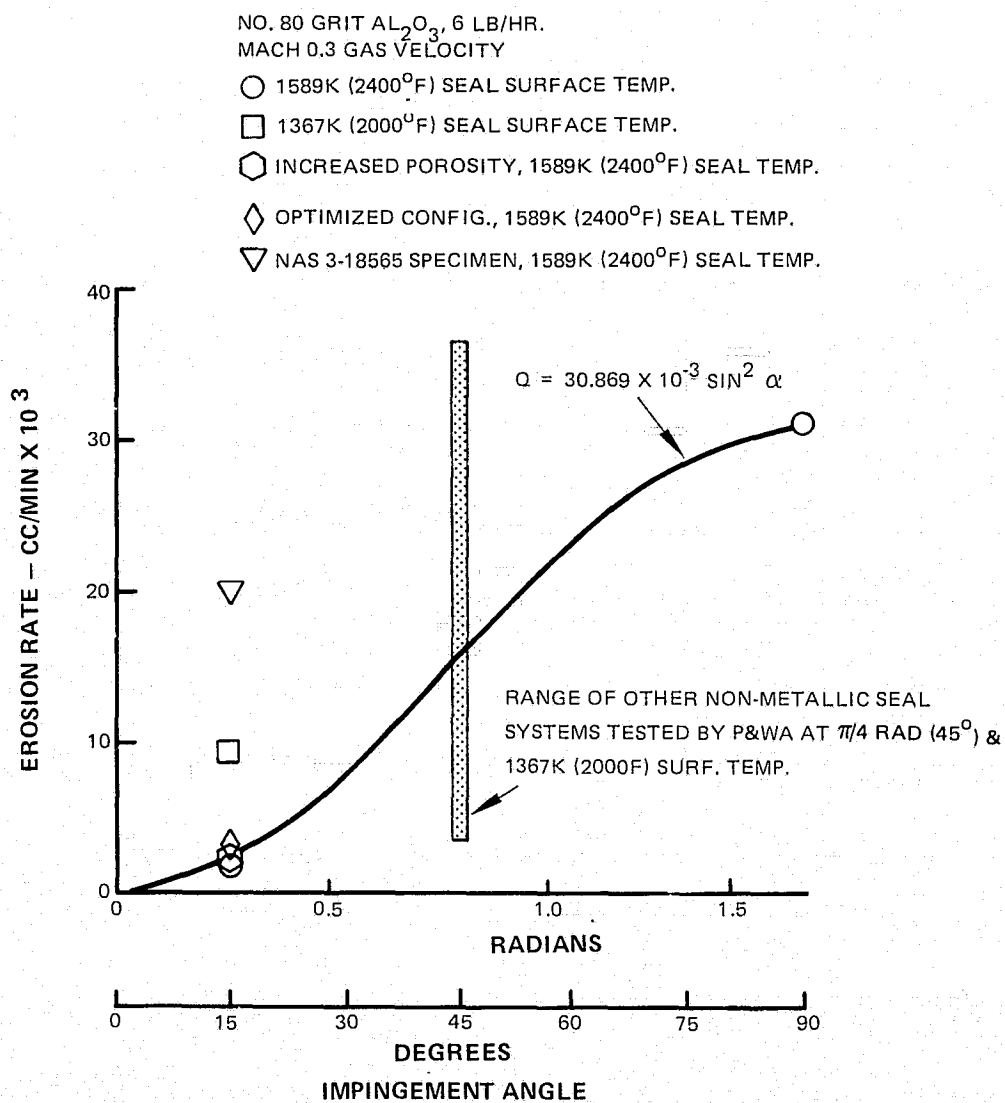
Figure 14 Erosion Test Data Correlation

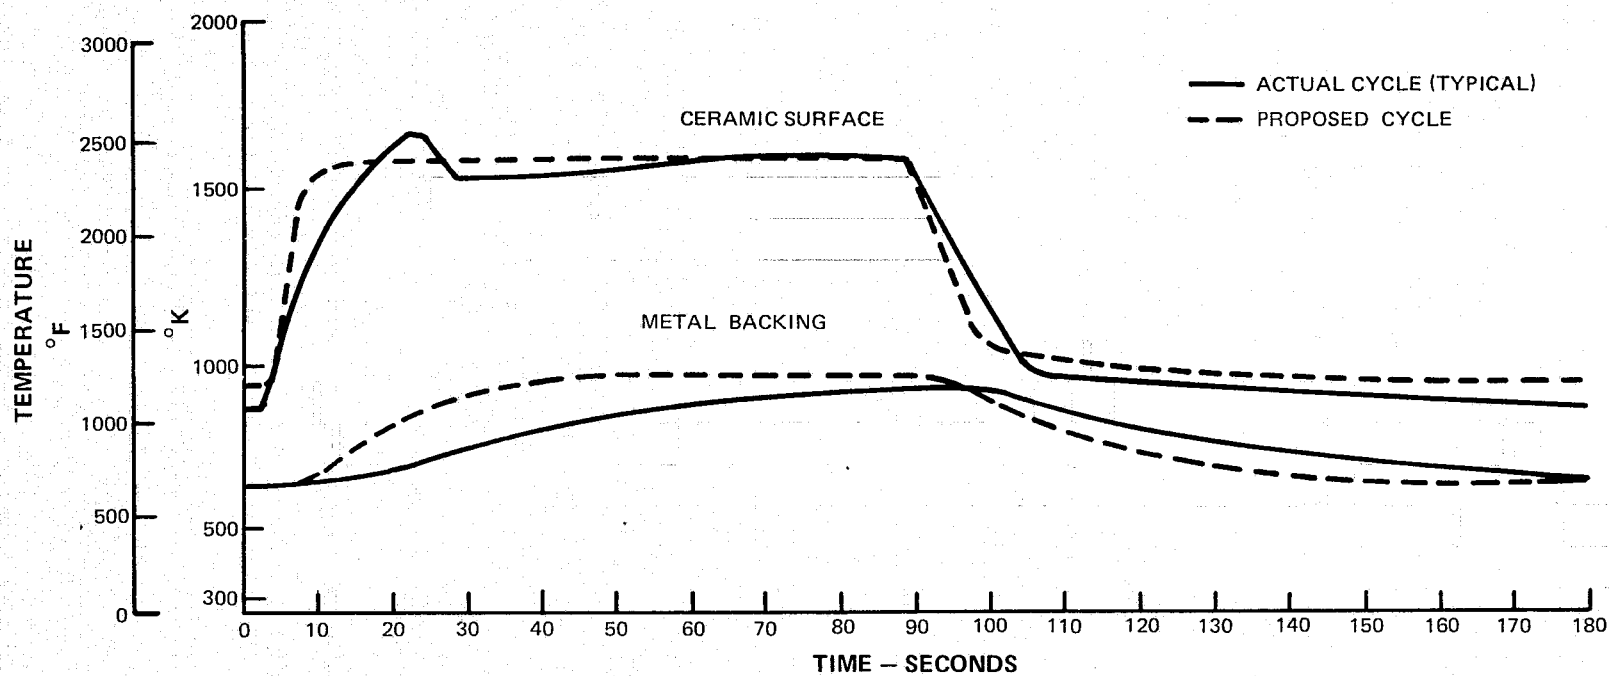
Figure 15 Thermal Fatigue Test Cycle, Abradability Specimen

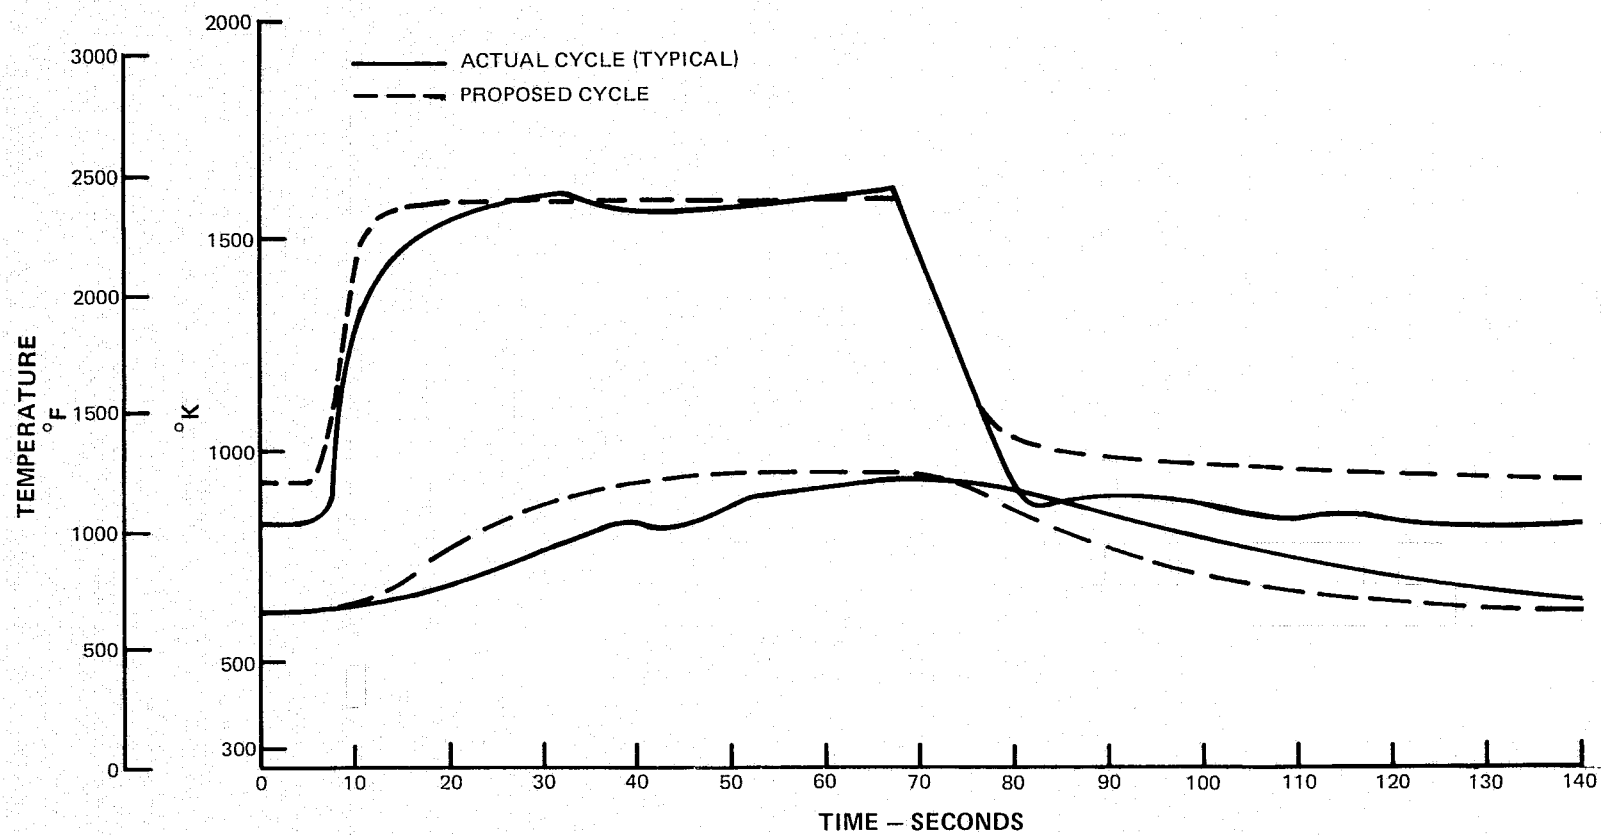
Figure 16 Thermal Fatigue Test Cycle, Erosion Specimen

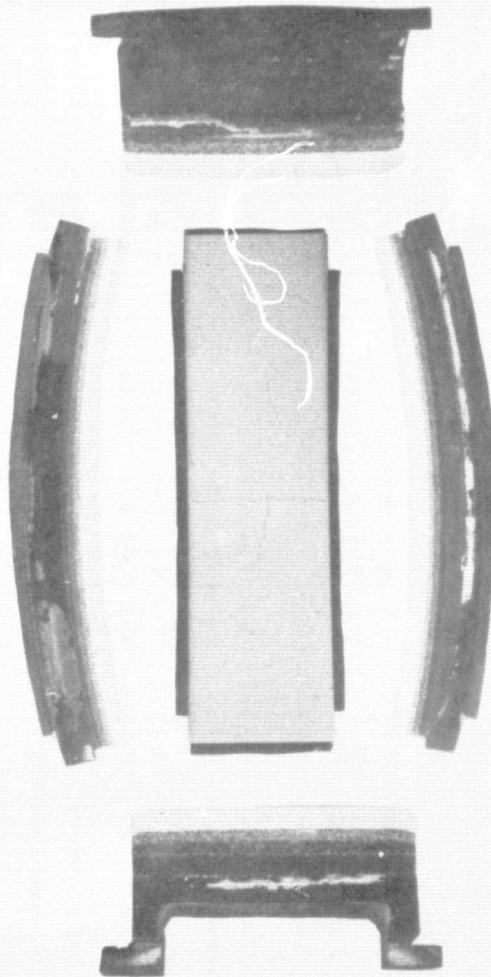
Figure 18 Thermal Fatigue Specimen (Test No. 1)

MAX. TEMP.: SURFACE - 1617°K (2450°F) BACK - 944°K (1240°F)
MIN. TEMP.: SURFACE - 839°K (1050°F) BACK - 600°K (620°F)
MAX. GRADIENT: 1142°K (1595°F) @ 24 SEC. INTO HEATUP
CYCLE DURATION: HEATING - 88 SEC. COOLING - 92 SEC.
NO. CYCLES: 100

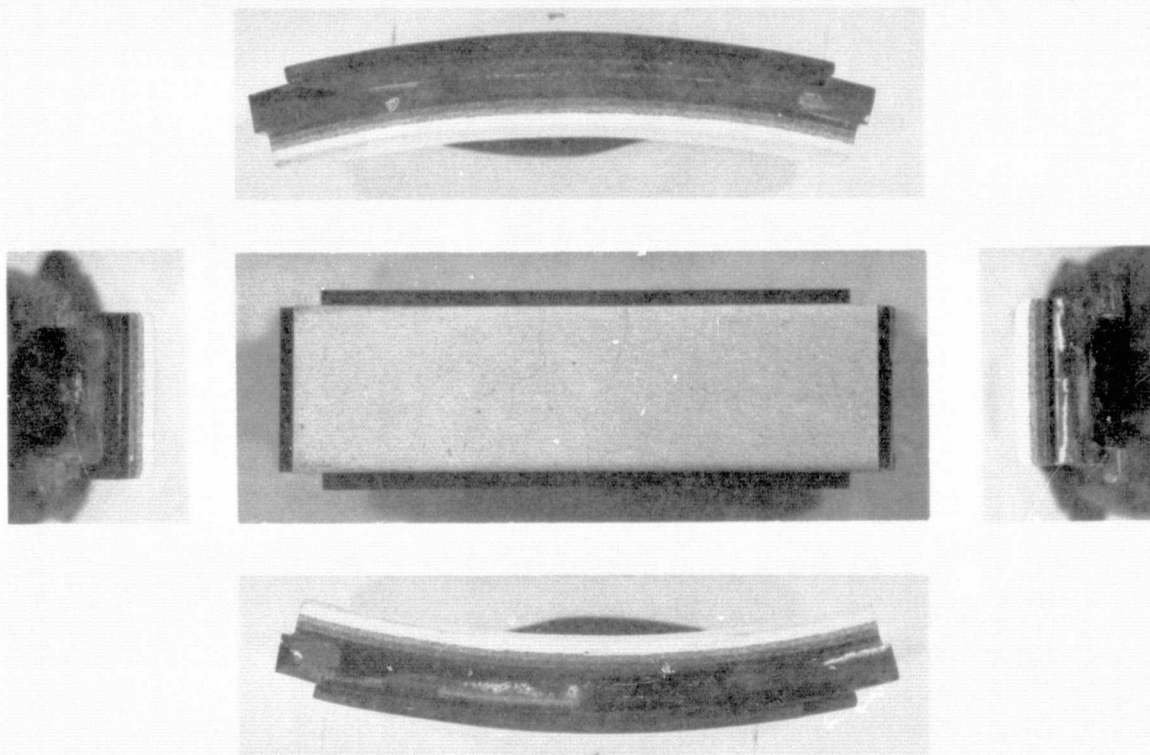
Figure 19 Thermal Fatigue Specimen (Test No. 2)

MAX. TEMP.: SURFACE — 1600°K (2420°F) BACK — 917°K (1190°F)
MIN. TEMP.: SURFACE — 855°K (1080°F) BACK — 630°K (675°F)
MAX. GRADIENT: 1236°K (1765°F) @ 20 SEC. INTO HEATUP
CYCLE DURATION: HEATING — 96 SEC. COOLING — 84 SEC.
NO. CYCLES: 100

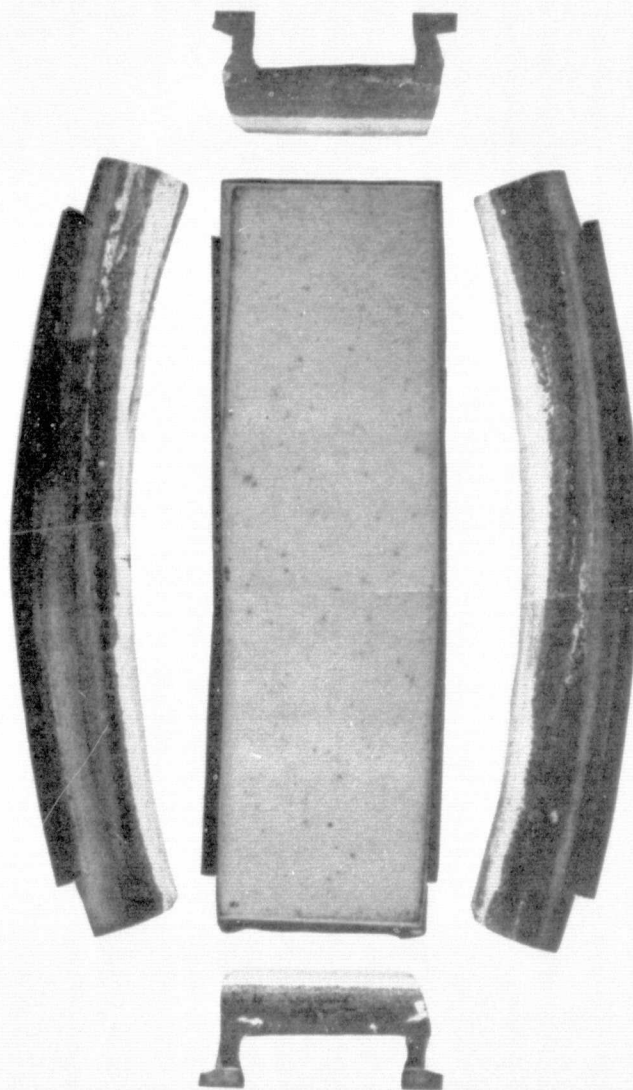
Figure 20 Thermal Fatigue Specimen (Test No. 3)

THERMAL CYCLE:
MAX. TEMP.: SURFACE — 1644° K (2500° F) BACK — 939° K (1230° F)
MIN. TEMP.: SURFACE — 867° K (1100° F) BACK — 644° K (700° F)
MAX. GRADIENT: 1136° K (1585° F) @ 20 SEC. INTO HEATUP
CYCLE DURATION: HEATING — 85 SEC. COOLING — 95 SEC.
NO. CYCLES: 100

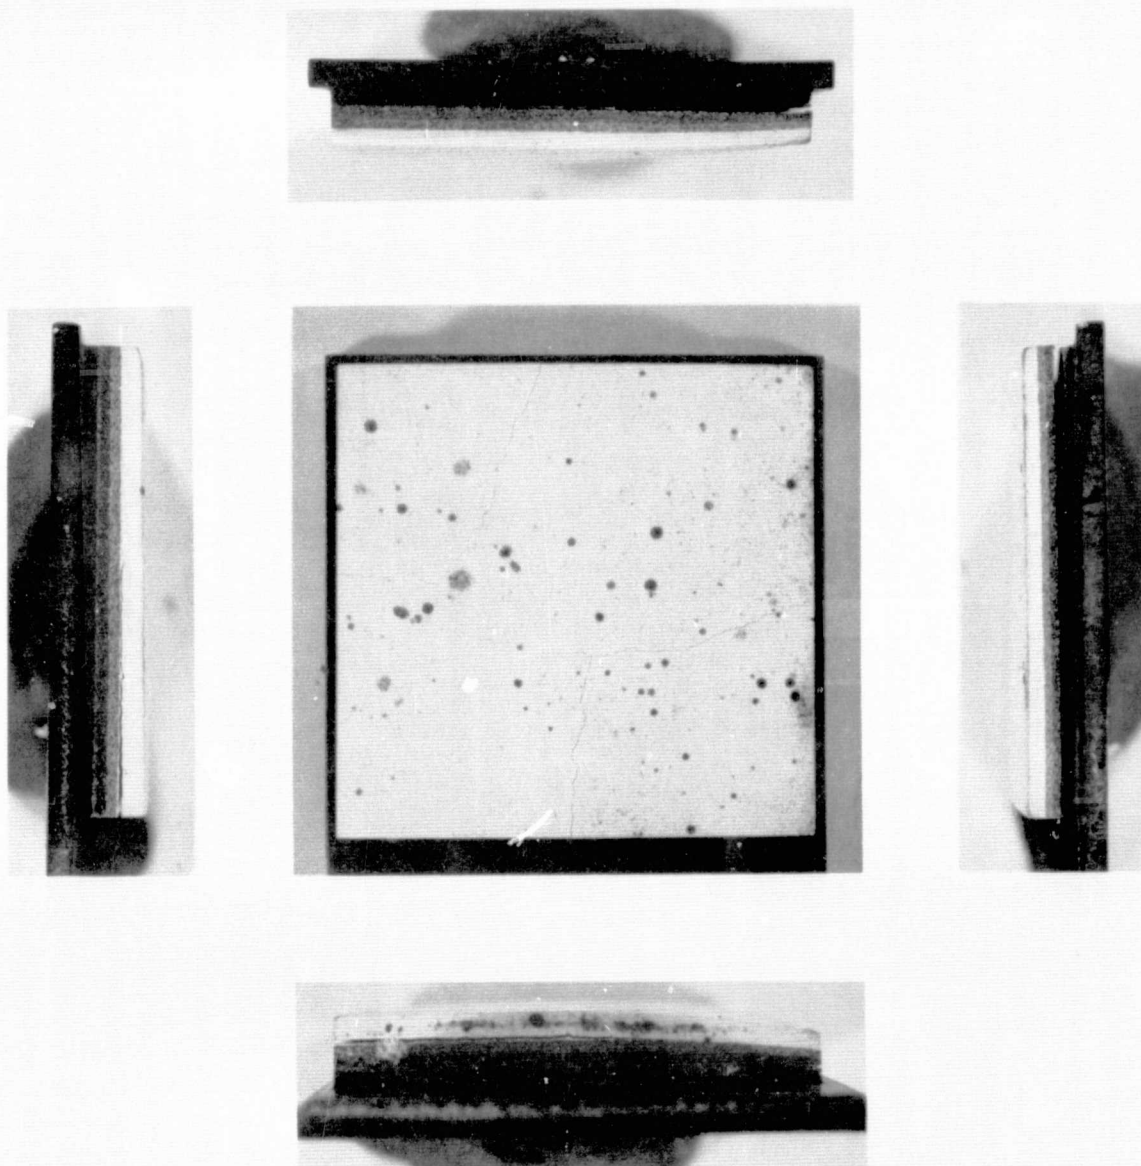
Figure 21 Thermal Fatigue Specimen (Test No. 4)

MAX. TEMP.: SURFACE - 1555°K (2340°F) BACK - 922°K (1200°F)
MIN. TEMP.: SURFACE - 811°K (1000°F) BACK - 644°K (700°F)
MAX. GRADIENT: 1030°K (1395°F) @ 22.5 SEC. INTO HEAT UP
CYCLE DURATION: HEATING - 75 SEC. COOLING - 68 SEC.
NO. CYCLES: 100

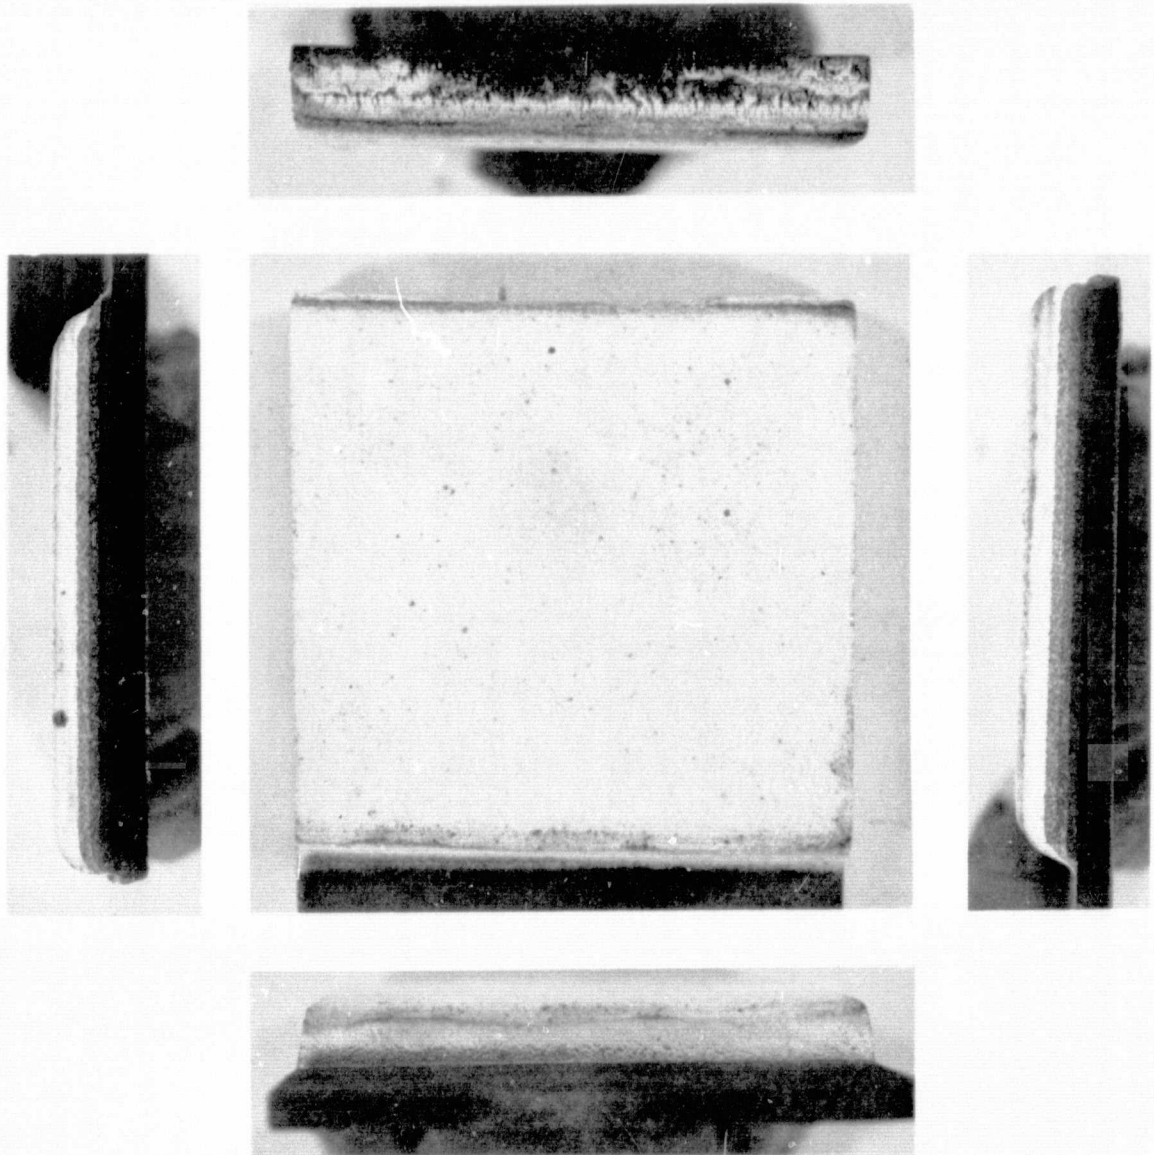
Figure 22 Thermal Fatigue Specimen (Test No. 5)

CYCLE DURATION: HEATING — 63 SEC. COOLING — 80 SEC.

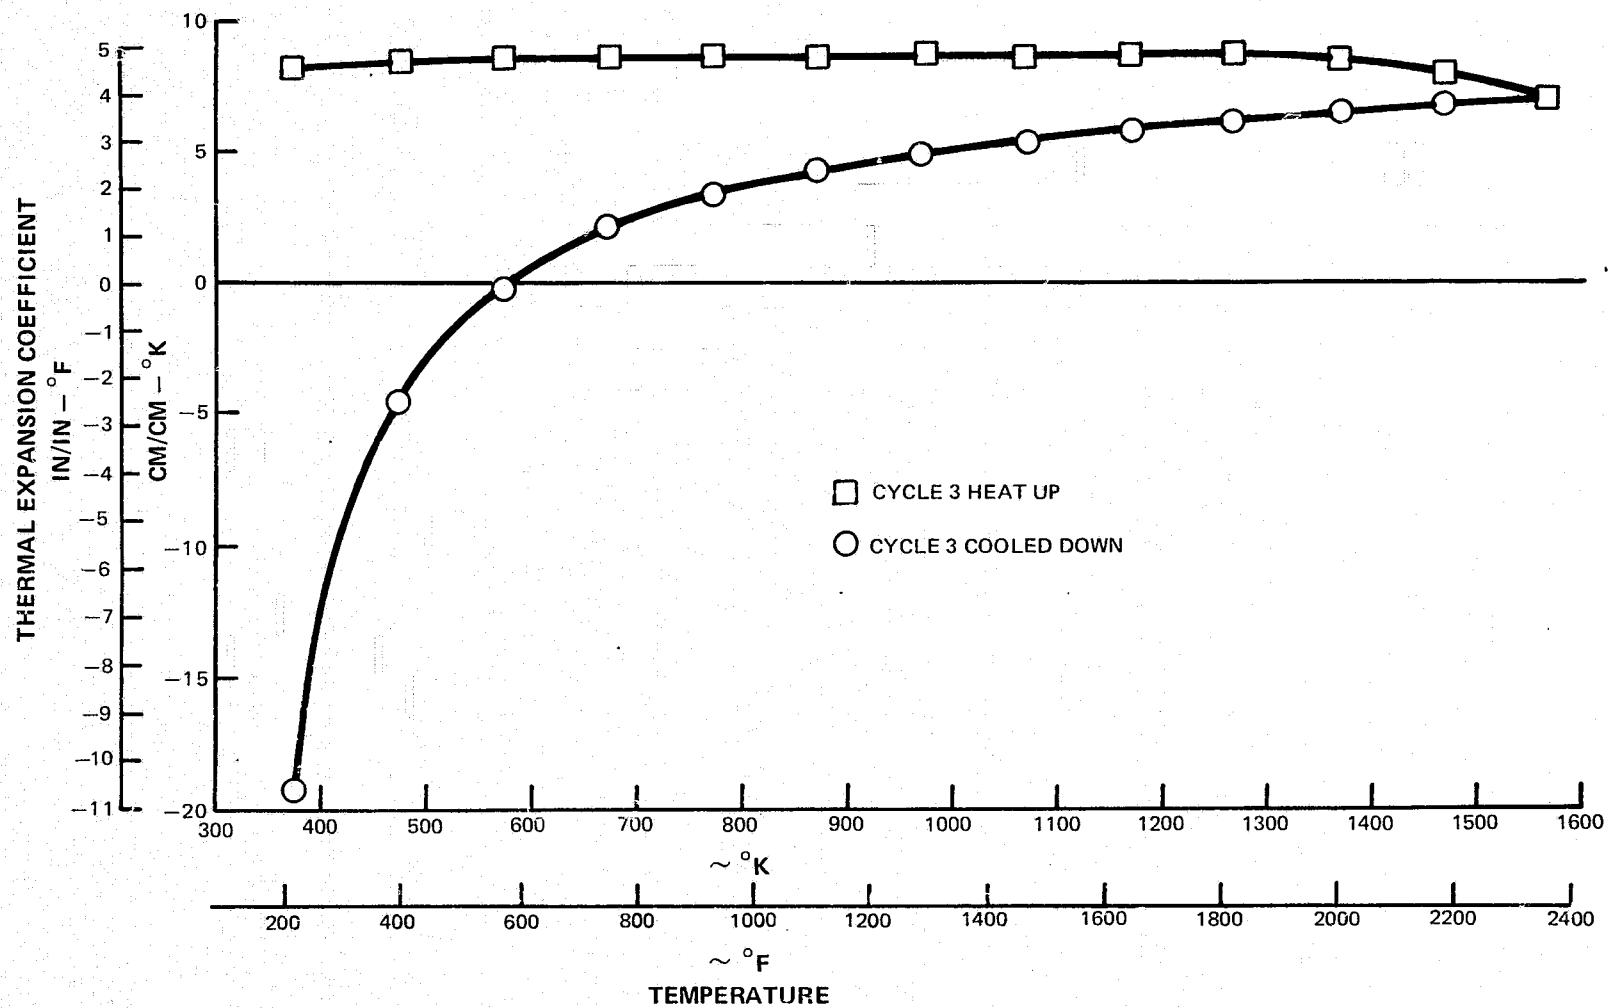
Figure 25 Sprayed ZrO_2 , Mean Coefficient of Thermal Expansion from $293^{\circ}K$ ($68^{\circ}F$)

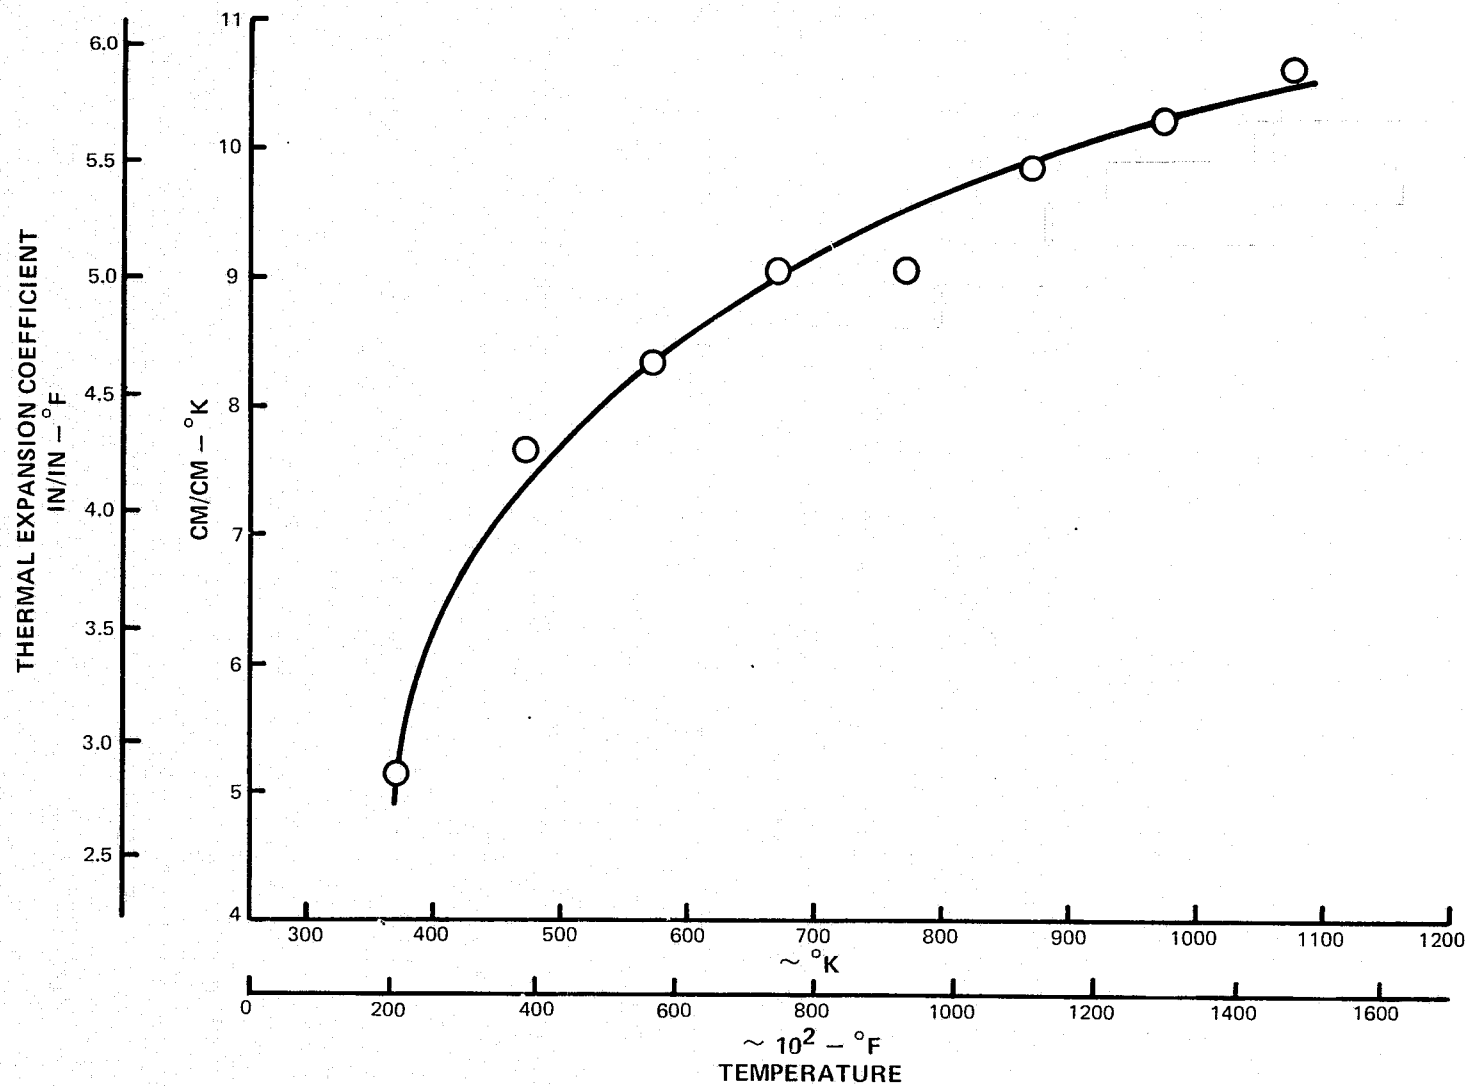
Figure 26 Sprayed 85/15 ZrO₂/CoCrAlY Mean Coefficient of Thermal Expansion from 293°K (68°F)

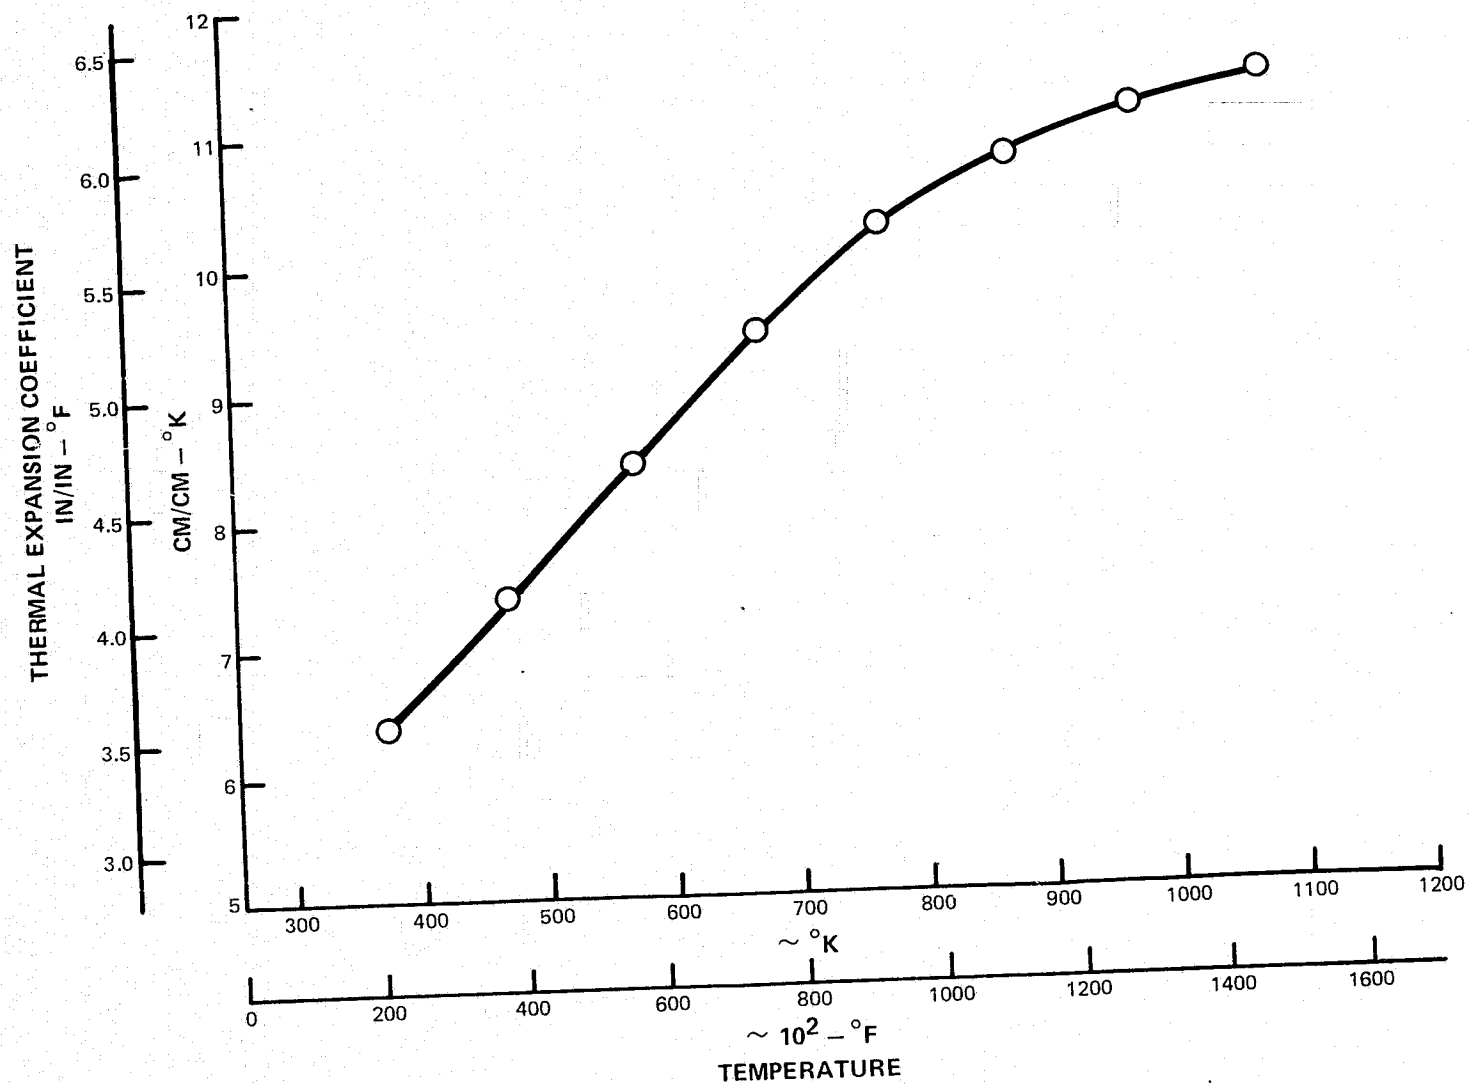
Figure 27 Sprayed 70/30 $ZrO_2/CoCrAlY$ Mean Coefficient of Thermal Expansion from 293°K (68° F)
