DEVELOPMENT OF A PLASMA SPRAYED CERAMIC GAS PATH
SEAL FOR HIGH PRESSURE TURBINE APPLICATIONS

FINAL REPORT

by
L. T. Shiembob

PRATT & WHITNEY AIRCRAFT GROUP
COMMERCIAL PRODUCTS DIVISION
UNITED TECHNOLOGIES CORPORATION

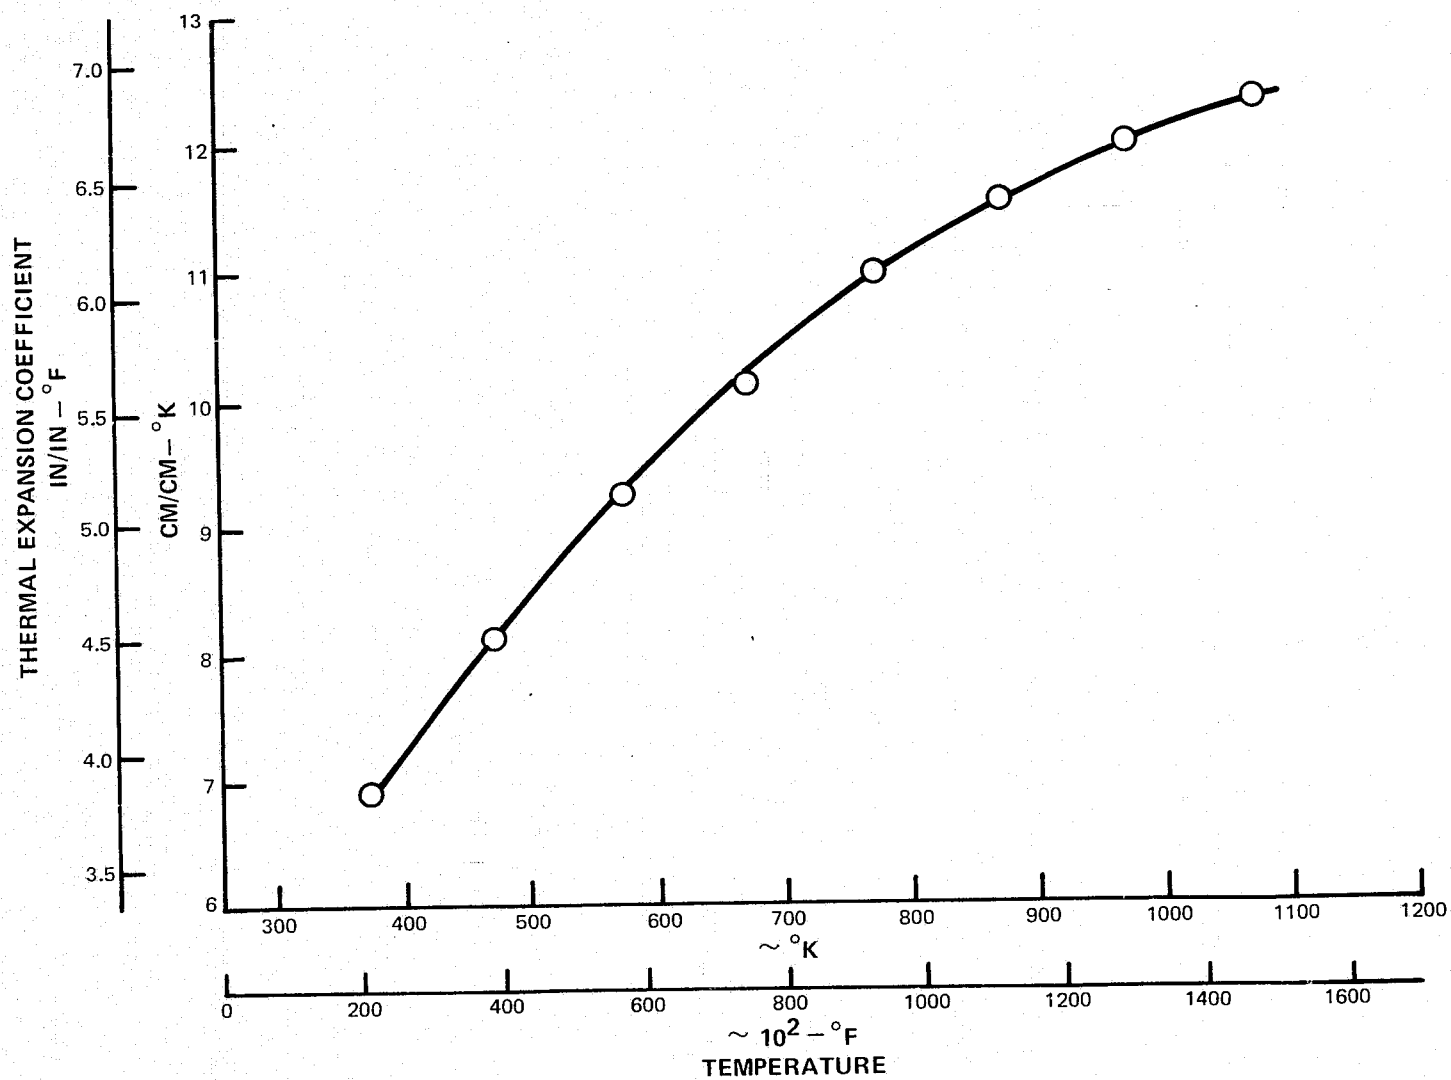
Figure 28 Sprayed 40/60 ZrO₂/CoCrAlY Mean Coefficient of Thermal Expansion from 293° K (68°F)

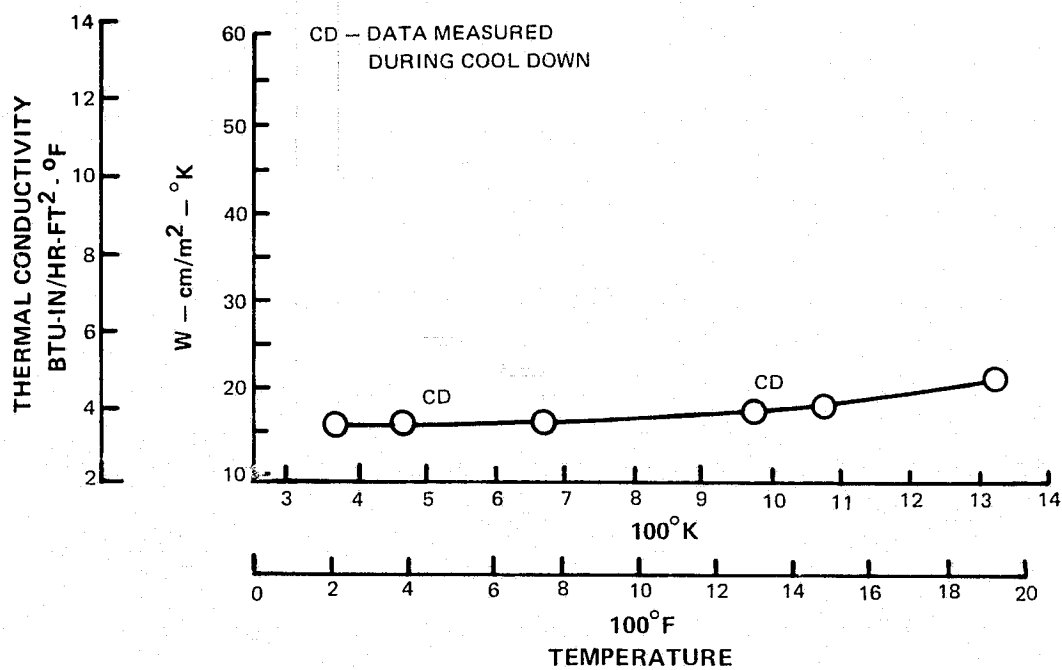
Figure 29 Thermal Conductivity of Sprayed ZrO_2 Layer

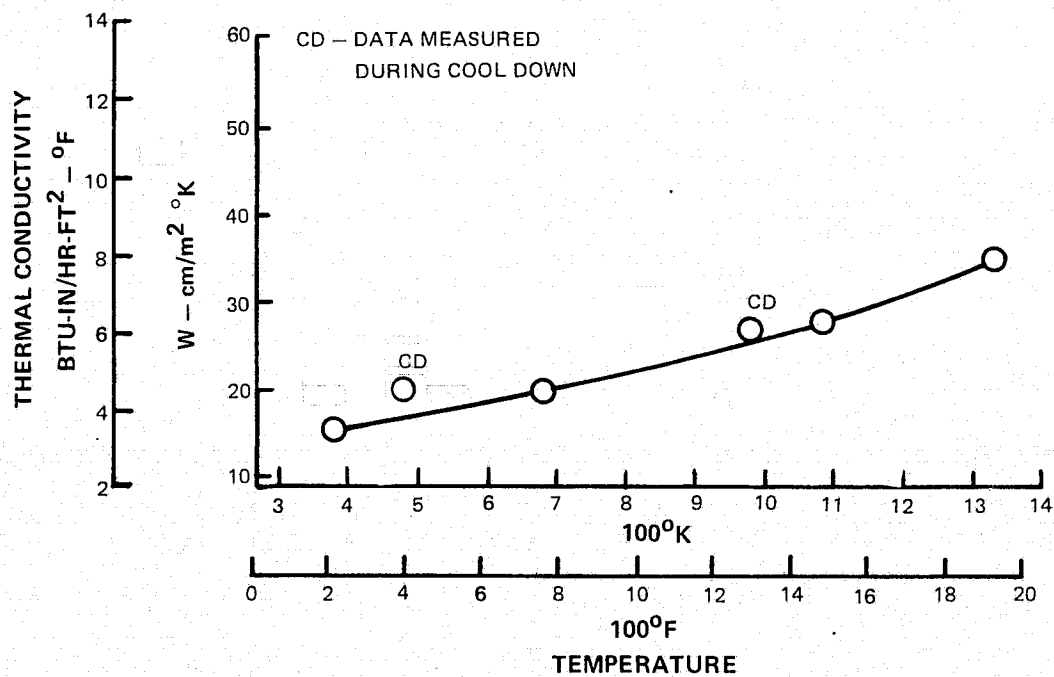
Figure 30 Thermal Conductivity of Composite Sprayed $ZrO_2/CoCrAlY$ Seal Coating

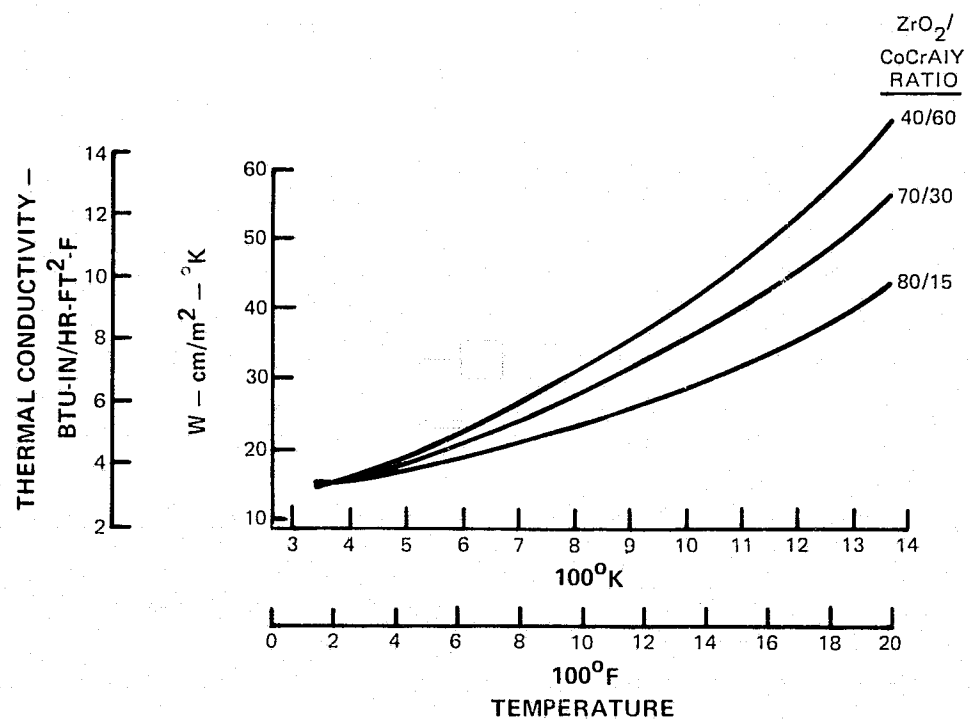
Figure 31 Estimated Thermal Conductivities for Mixed $ZrO_2/CoCrAlY$ Layers

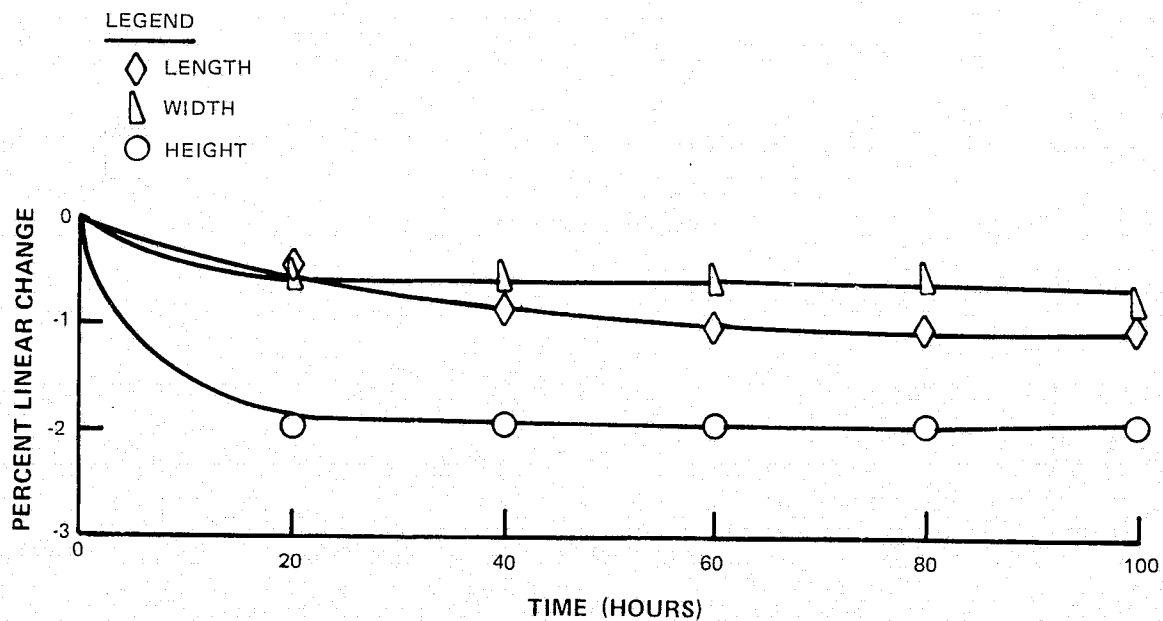
Figure 32 Linear Change Due to Thermal Exposure at $1589K$ ($2400F$), ZrO_2 Layer

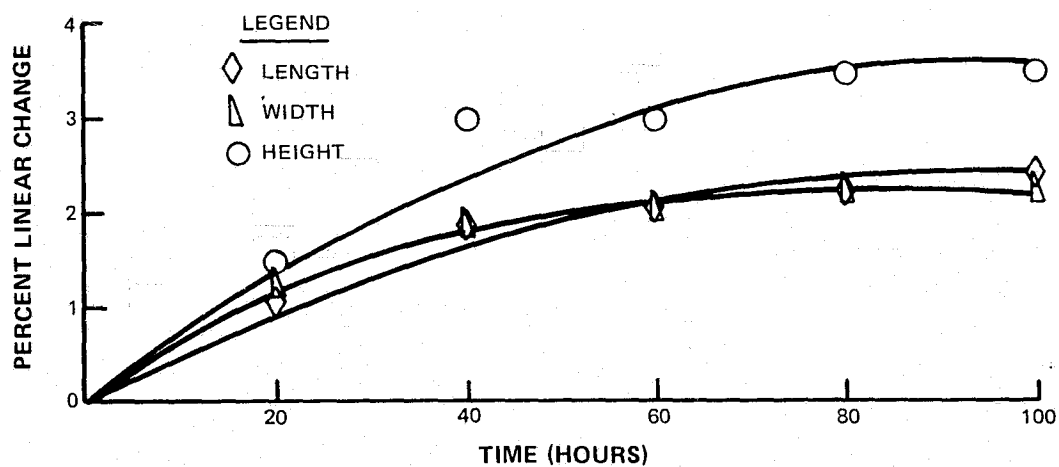
Figure 33 Linear Change Due to Thermal Exposure at 1144K (1600F), 85/15 ZrO₂/CoCrAlY Layer

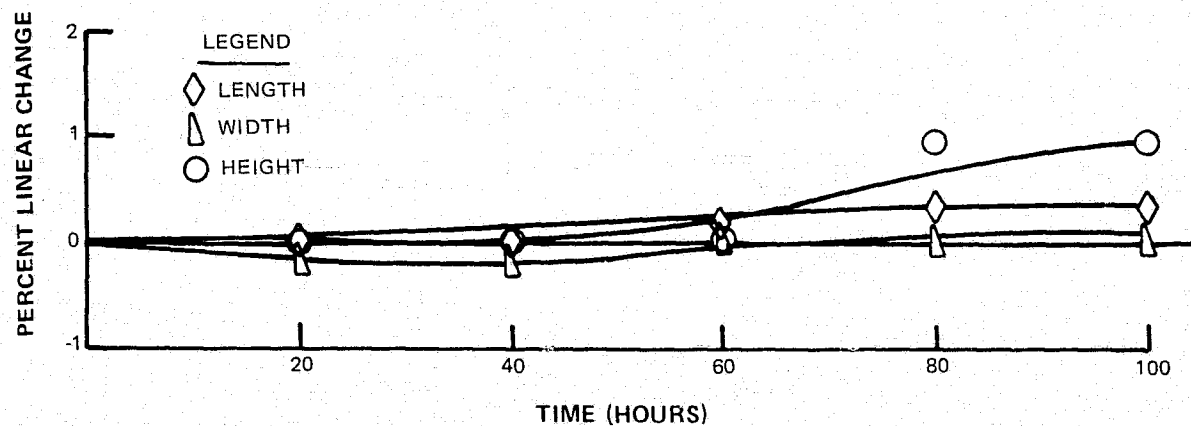
Figure 35 Linear Change Due to Thermal Exposure at 1005K (1350F), 40/60 ZrO₂/CoCrAlY Layer

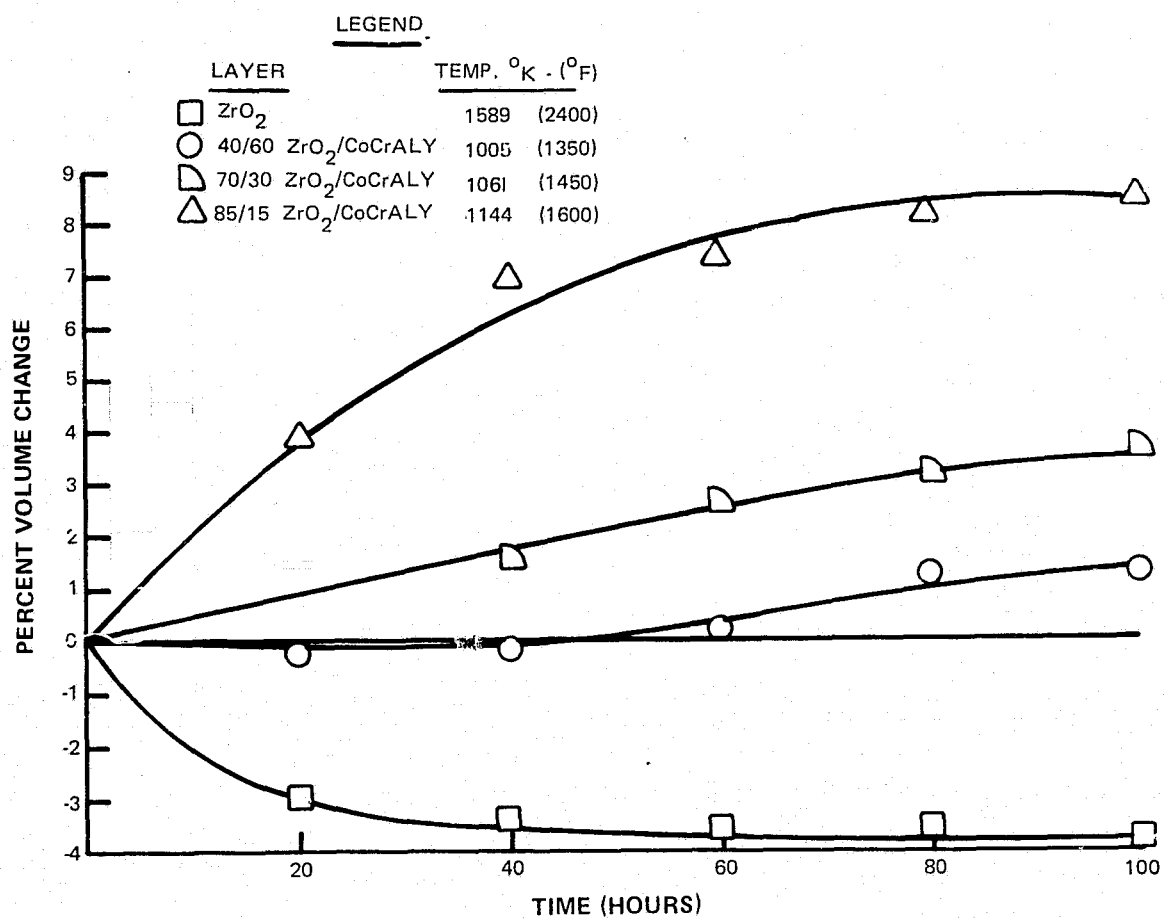
Figure 36 Volume Change Due to Thermal Exposure

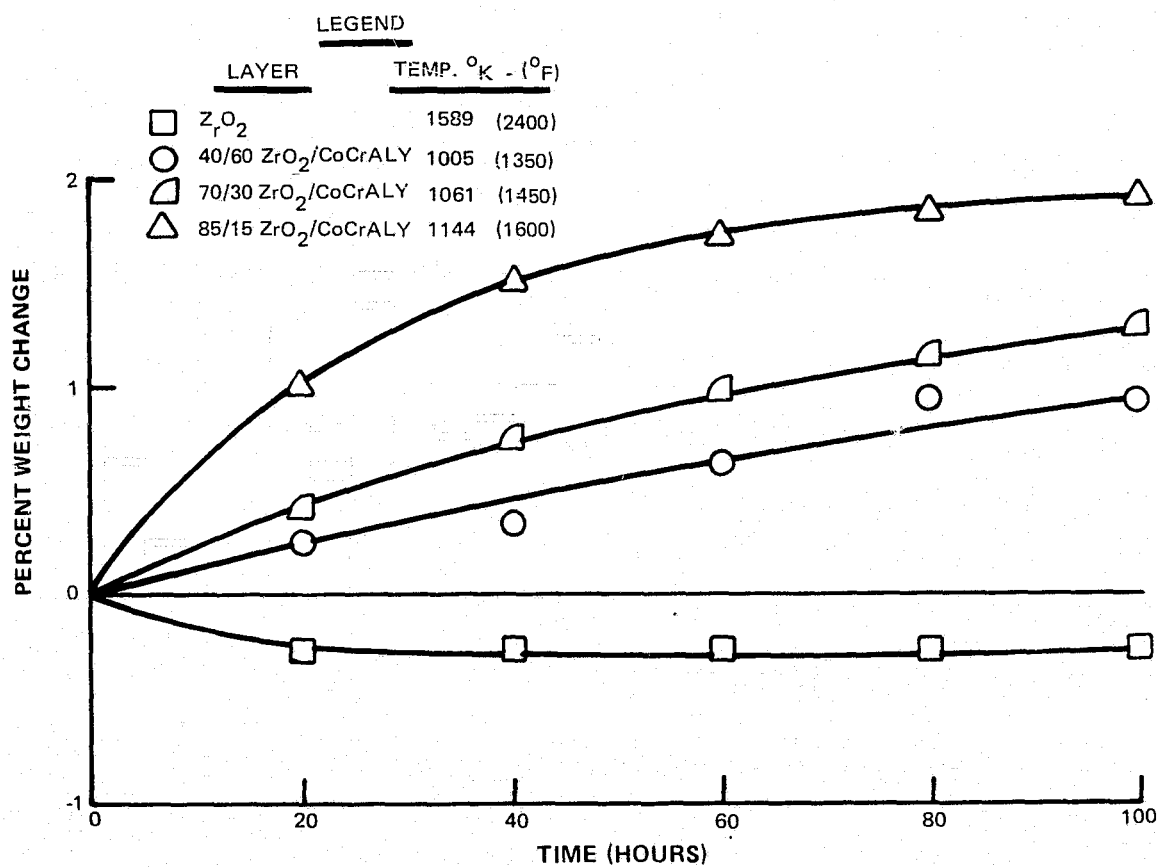
Figure 37 Weight Change Due to Thermal Exposure

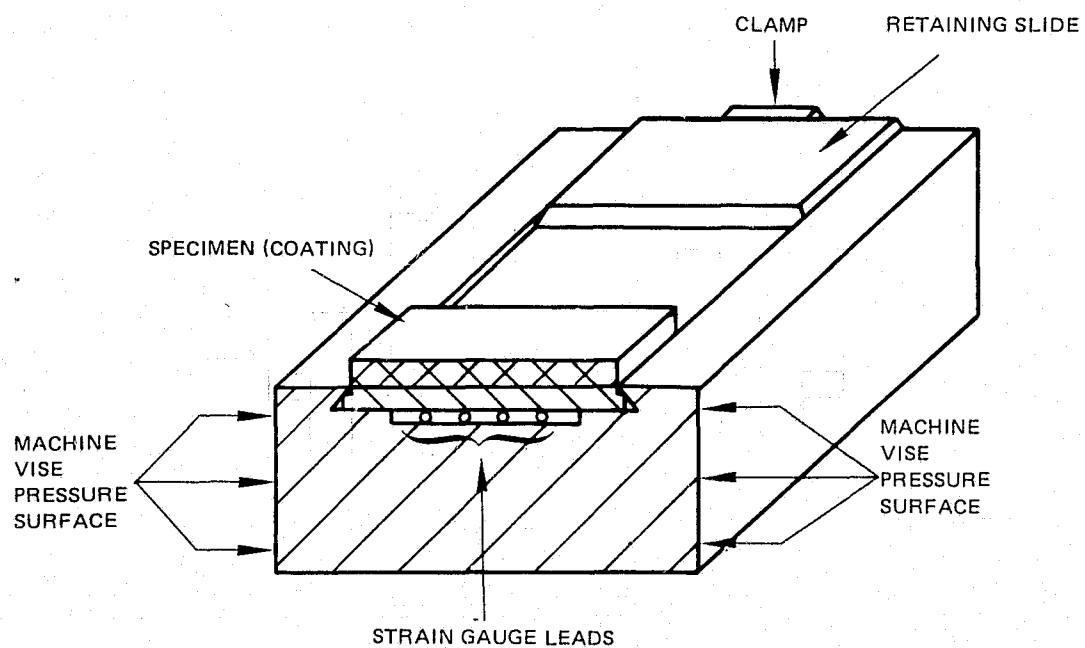
Figure 38 Residual Stress Machining Fixture

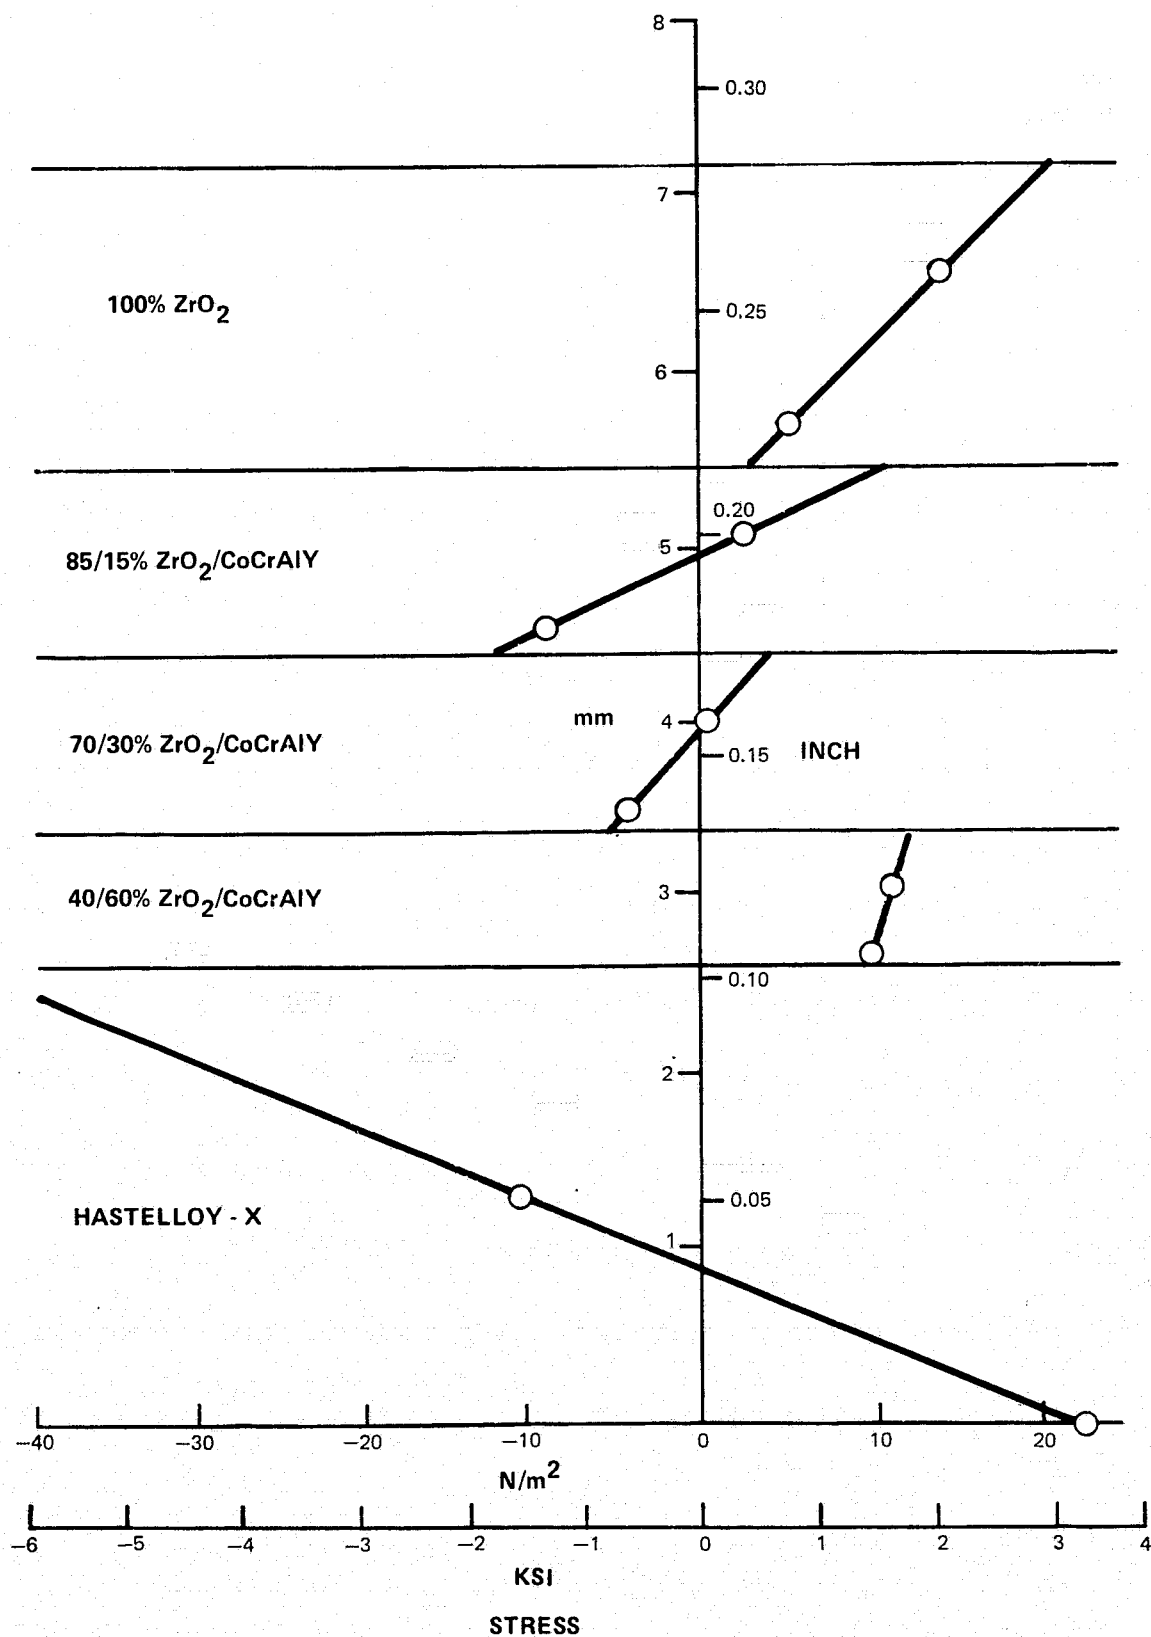
Figure 39 Residual Stress Distribution in Plasma Sprayed ZrO₂/CoCrAlY Erosion Specimen

Residual stresses in the sprayed materials are tensile and are believed to be contributing to the tensile stress cracking observed during thermal fatigue testing. Processing modifications to generate compressive residual stresses in the sprayed coating are considered feasible and would be expected to improve the thermal fatigue resistance of the seal system.

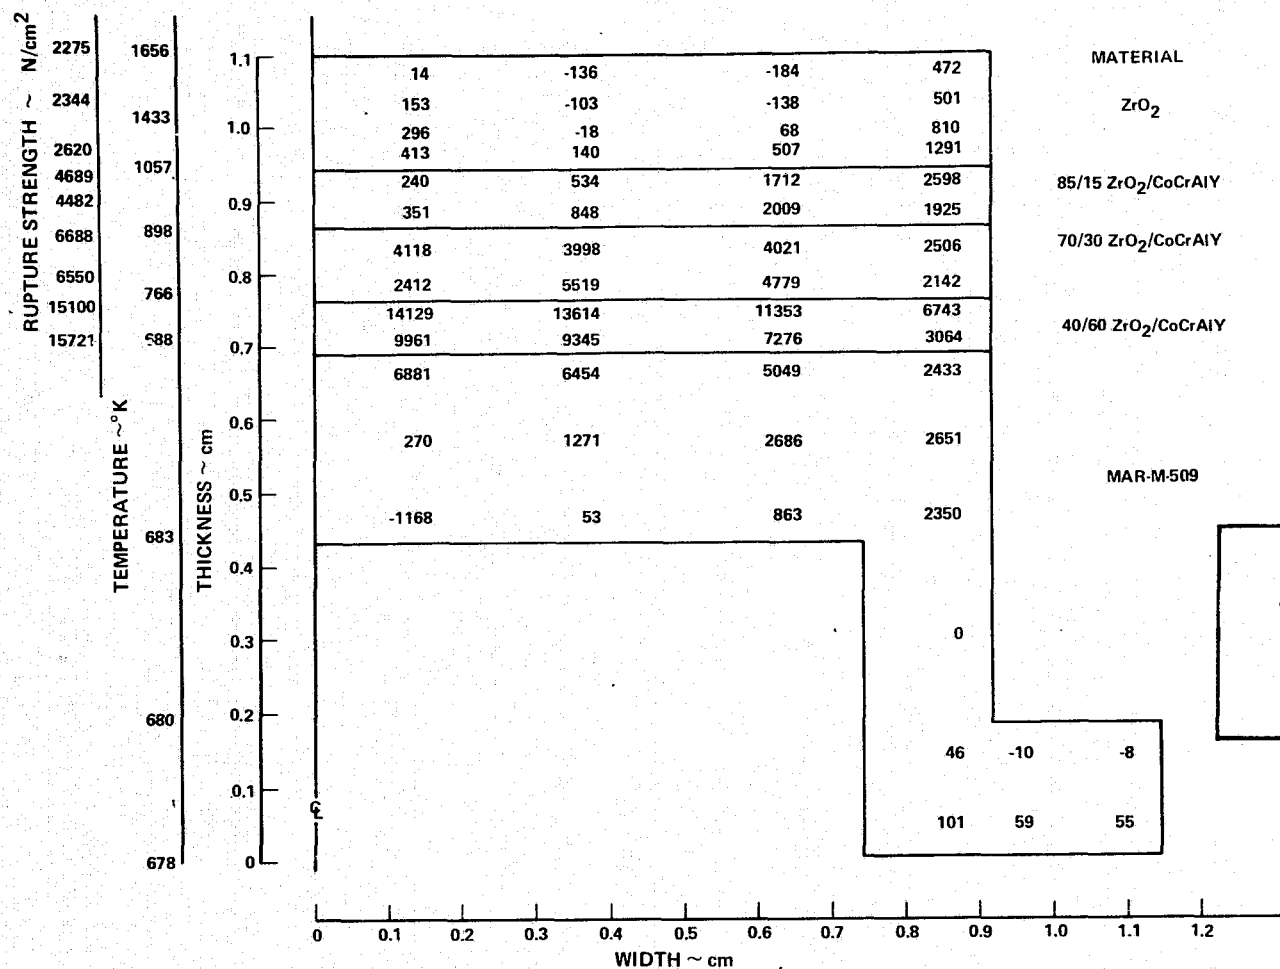
NOTE: 1. STRESSES ARE SYMMETRICAL ABOUT Q
 2. NEGATIVE VALUES INDICATE COMPRESSIVE STRESSES
 3. UNITS: N/CM²

Figure 44 Thermal Fatigue Test Specimen Maximum Principal Axial Stresses at 20.5 Sec. Accel.

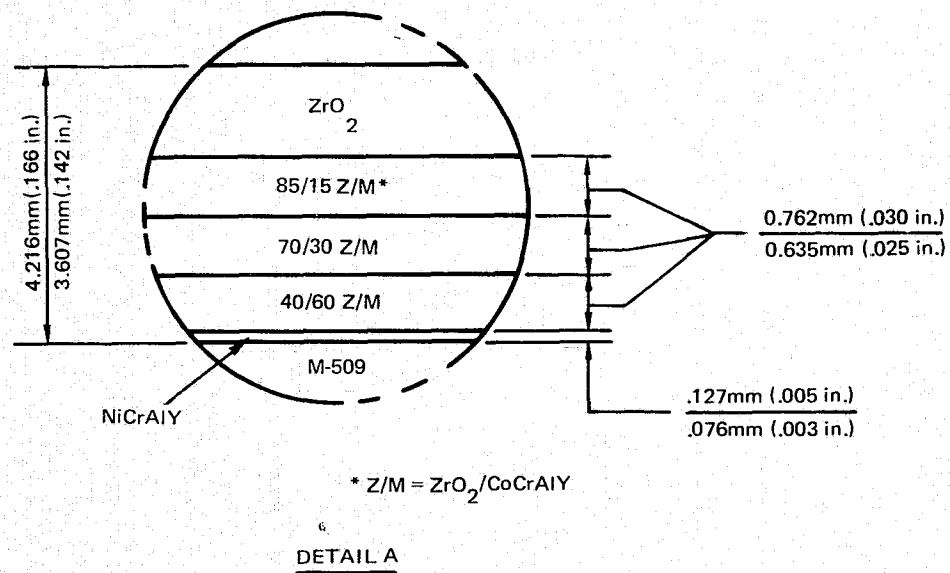
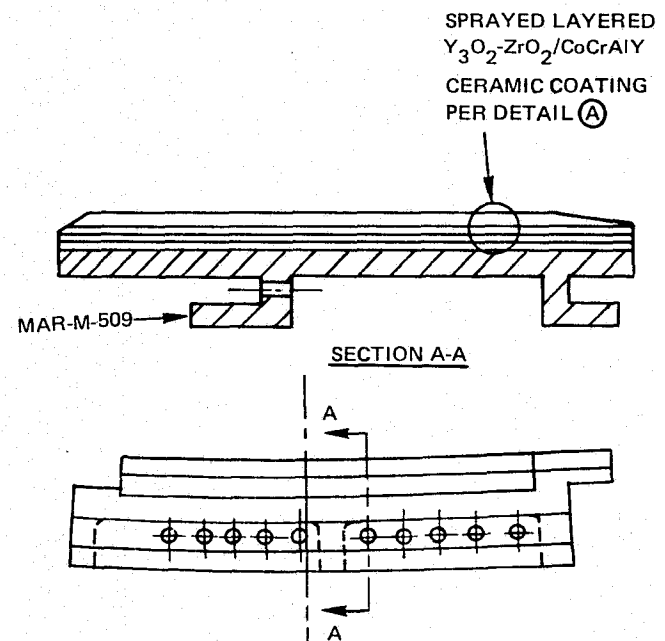
Figure 49 Typical Engine Seal Segment

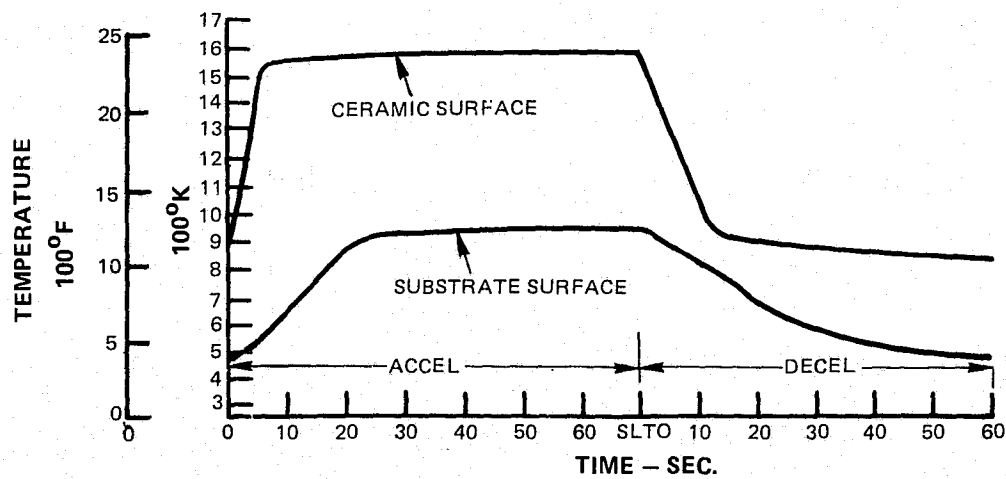
Figure 50 Engine Seal Segment Calculated Temperature Cycle at Hottest Location

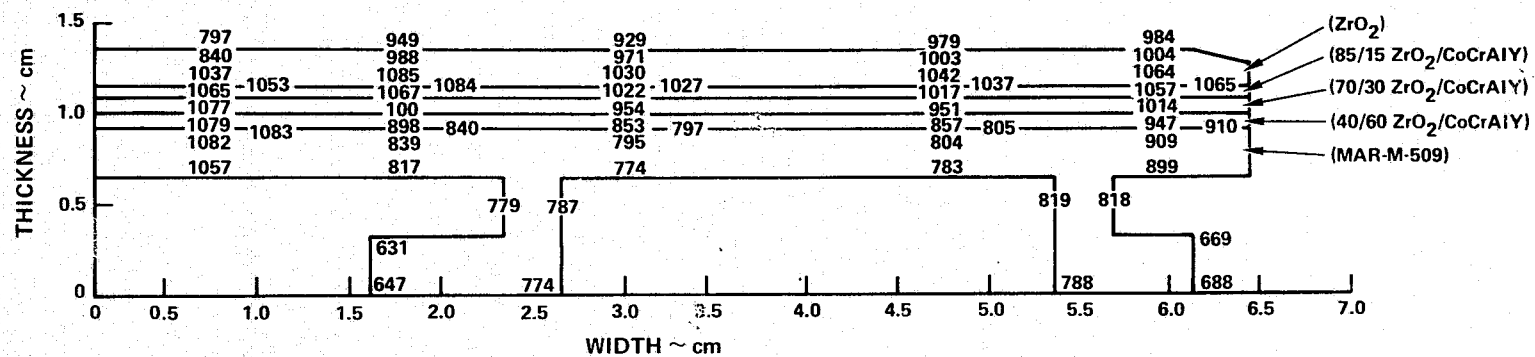
Figure 51 Engine Seal Segment Temperature Distribution at 12 Sec. Decel.

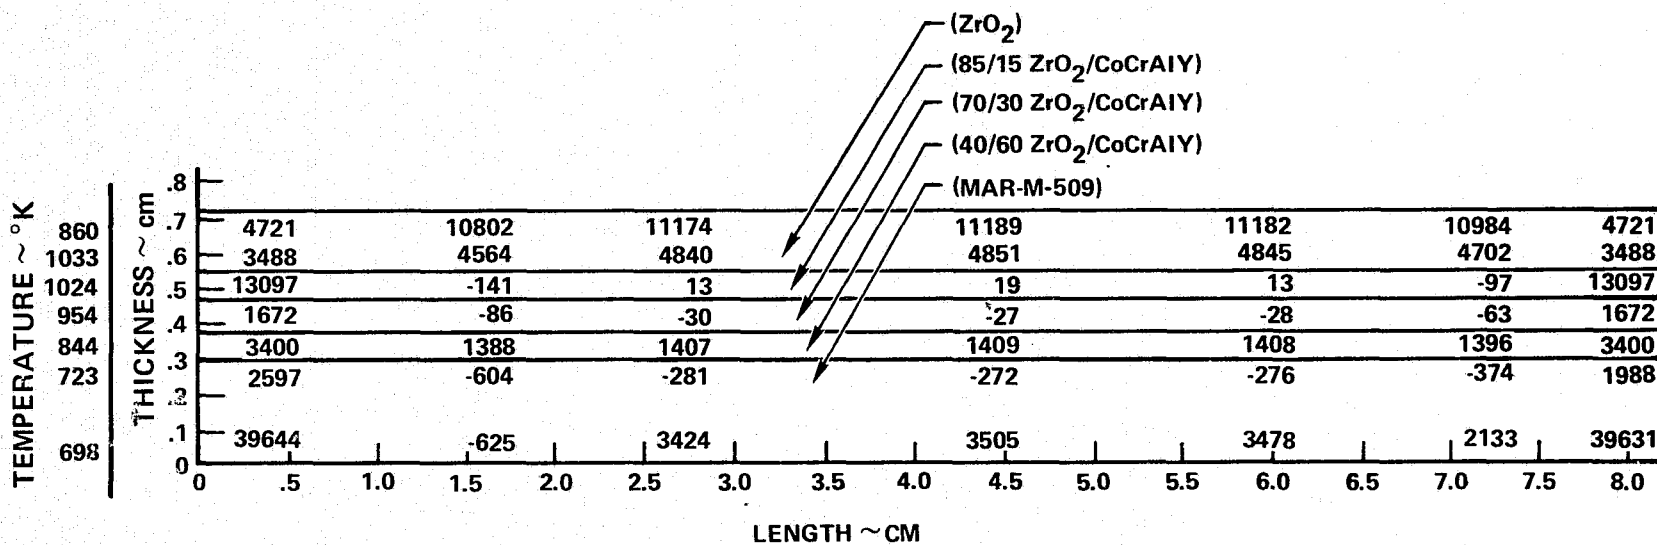
NOTE: 1. NEGATIVE NUMBERS INDICATE
COMPRESSIVE STRESSES
2. UNITS: N/CM²

Figure 53 Engine Seal Segment Maximum Principal Circumferential Stress
Distribution at 12 Sec. Decel.

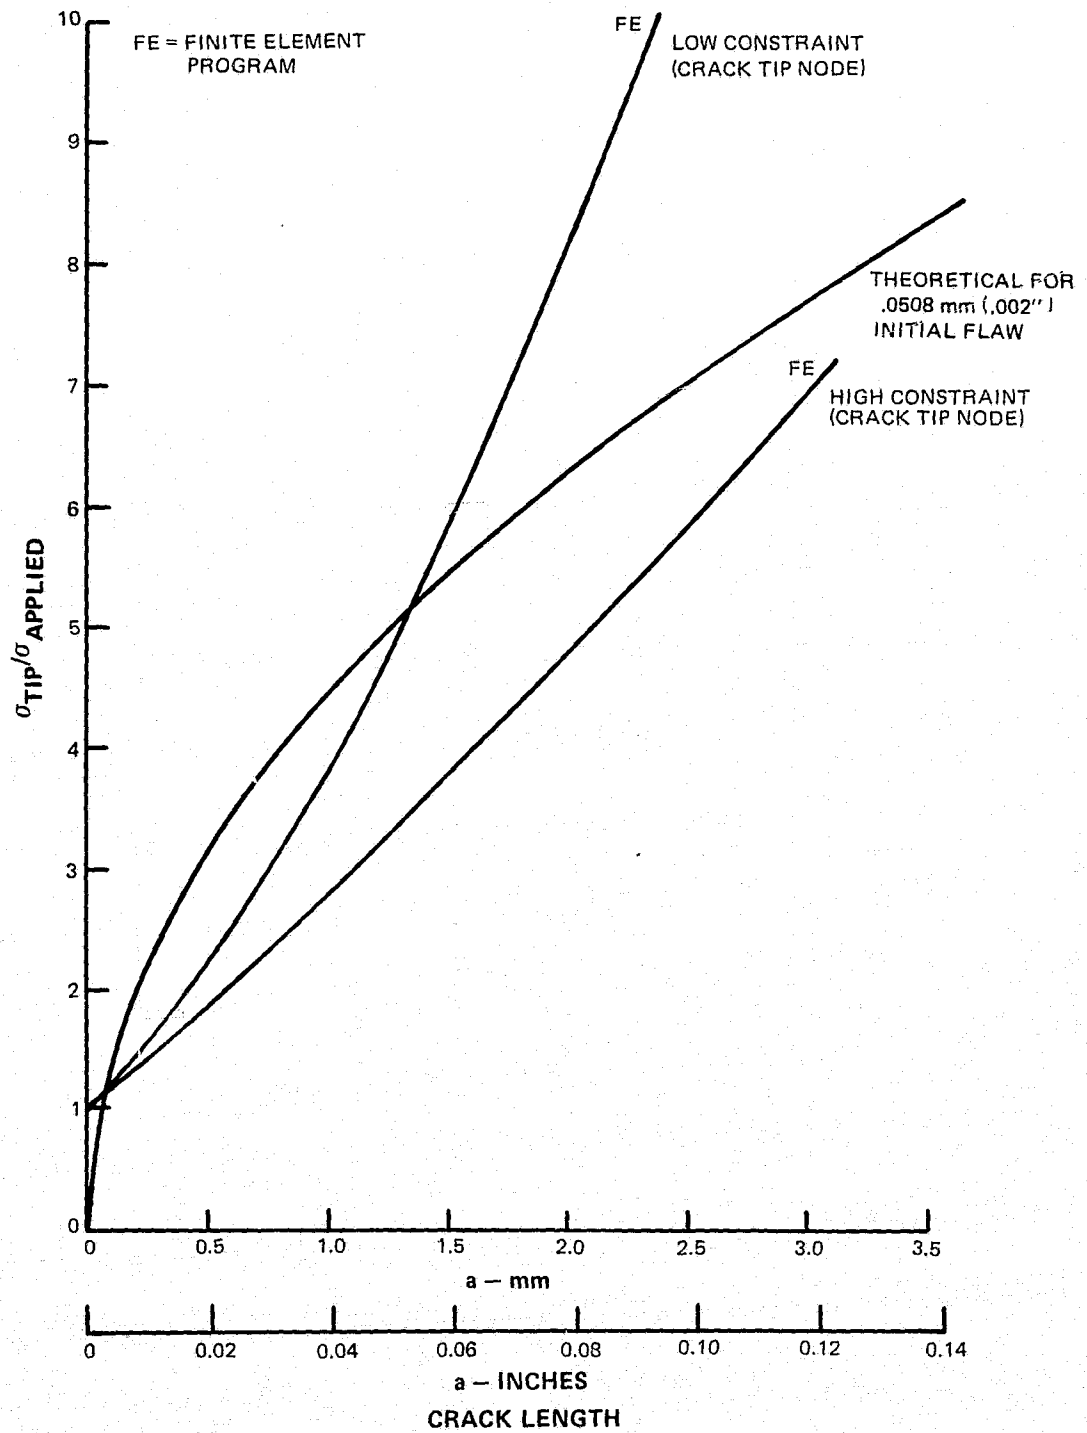
Figure 54 Crack Tip to Applied Stress Ratio vs. Crack Length

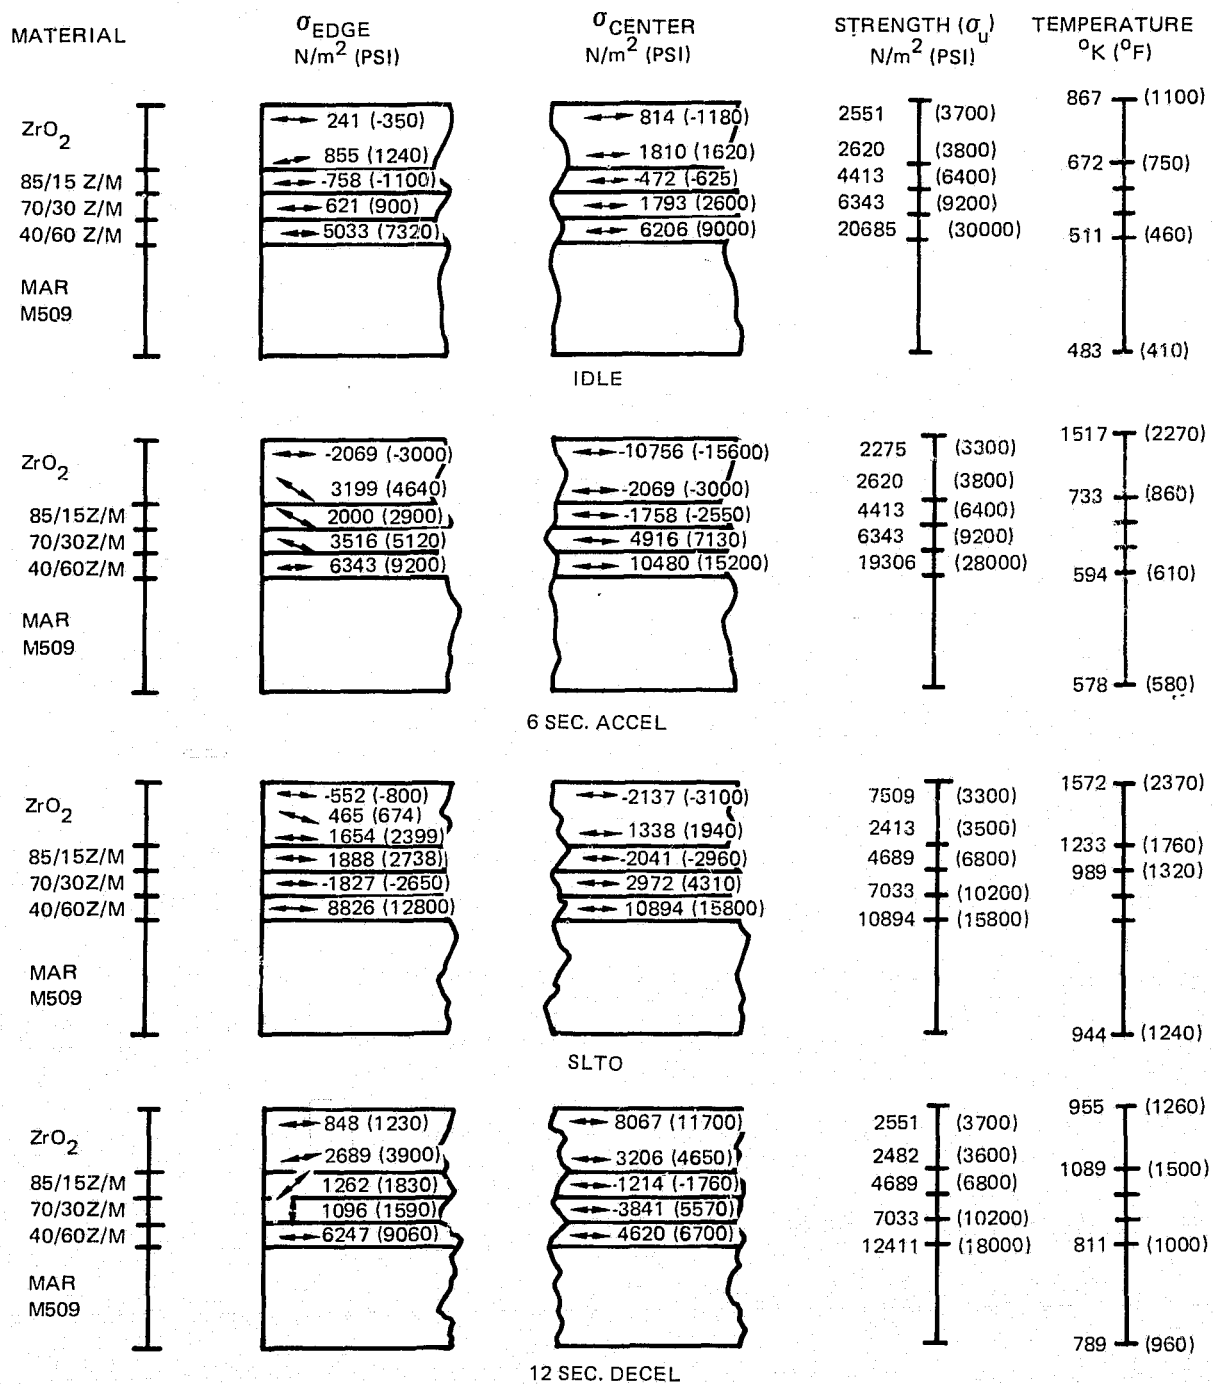
- NOTE: 1. AT SEVERAL LOCATIONS $\sigma > \sigma_u$, BUT ONLY THE 12 SEC. DECEL 8067 (11700) SURF. σ IS OVER STRAIN TO FAILURE LIMIT. DO NOT EXPECT EDGE CRACKS.
2. STRESSES ARE MAX. PRINCIPAL STRESS. ARROWS INDICATE DIRECTION.
3. Z/M = ZrO₂/CoCrAlY

Figure 55 Initial Stress Field

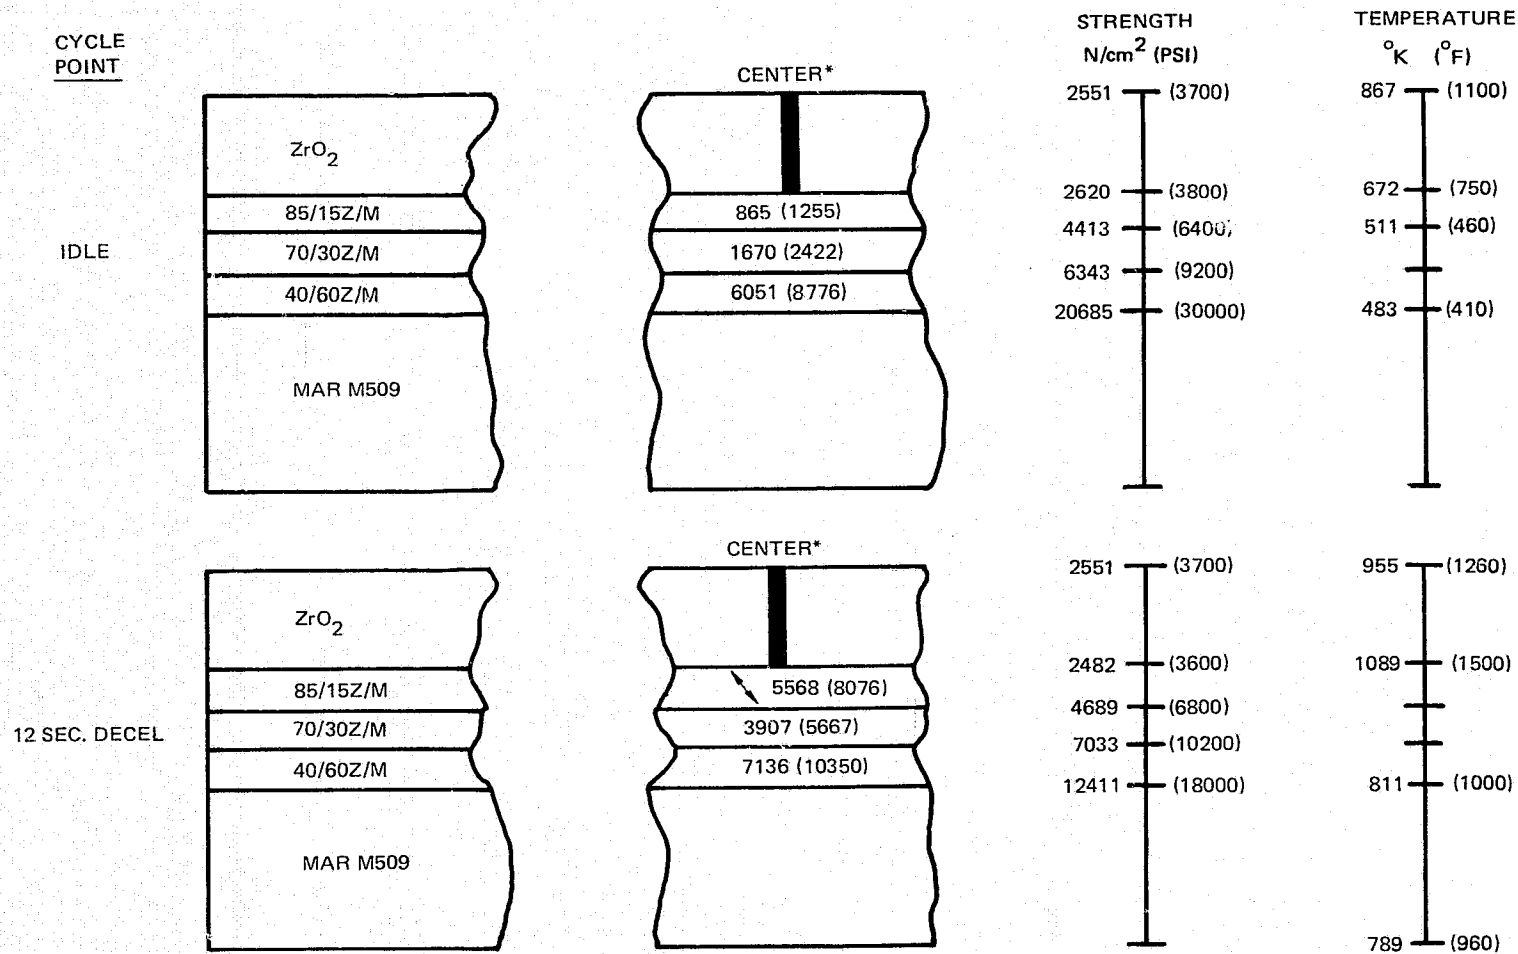
*ALL STRESS ARE PARALLEL TO THE INTERFACE EXCEPT THE STRESS AT THE CRACK TIP WHICH WAS AT APPROXIMATELY $\pi/4$ RADIAN (45 DEGREES).

Figure 56 Crack Entering 85/15ZrO₂/CoCrALY Layer

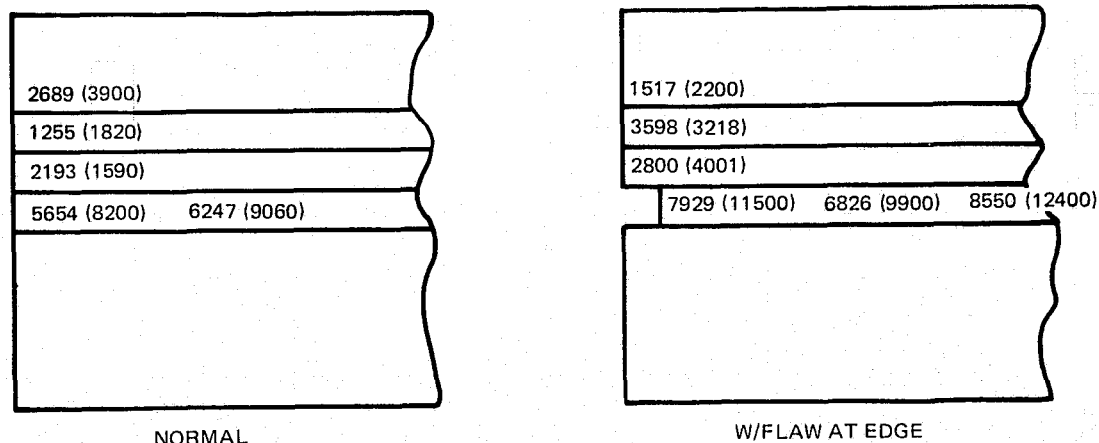
NOTE: UNITS = MAX. PRINCIPAL STRESS $\sim \text{N/CM}^2$ (PSI)

Figure 58 Stress at Irregular Edge

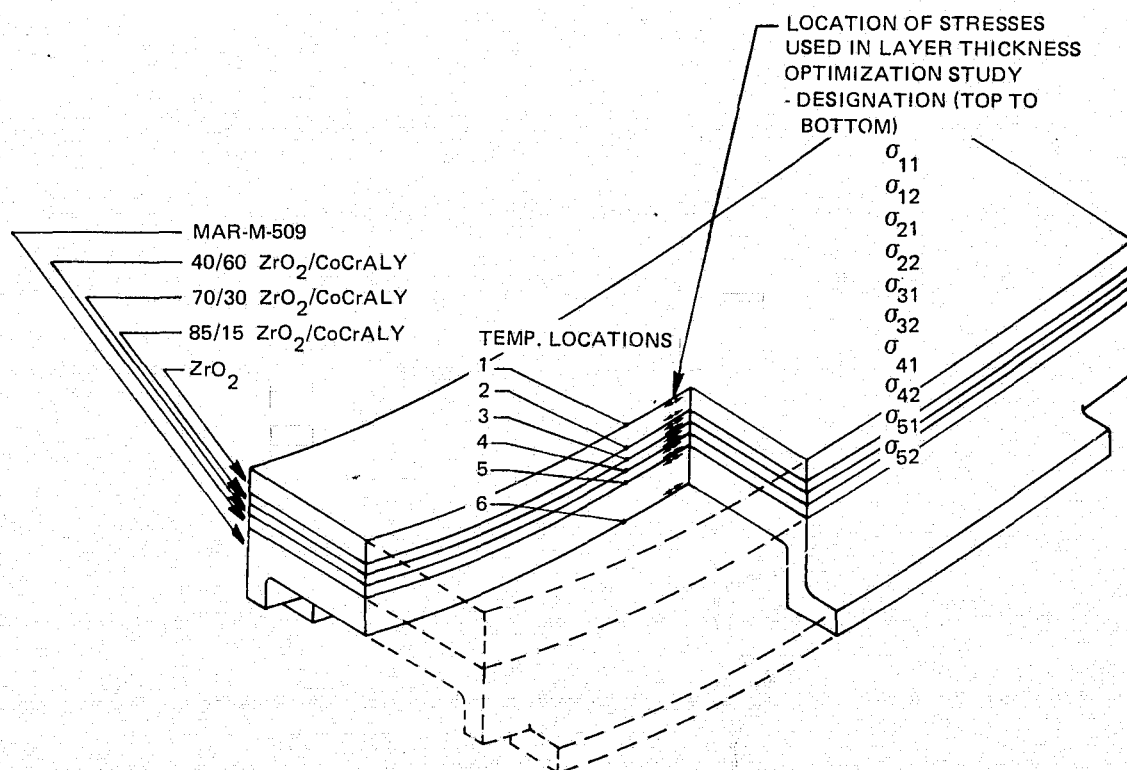
Figure 59 Location of Temperatures and Stresses Reported in Table XIII

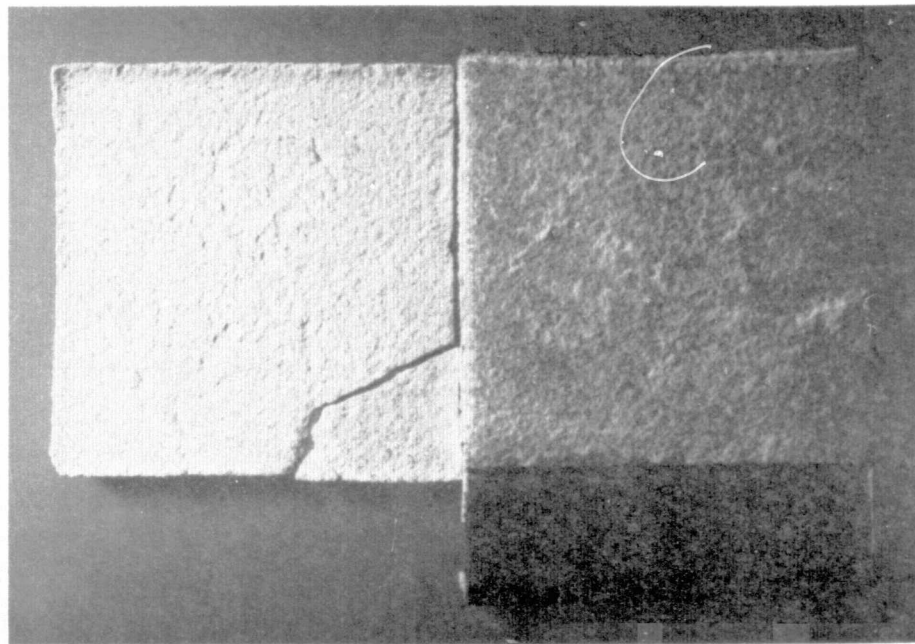
Figure 60 Erosion Specimen, Optimized Configuration

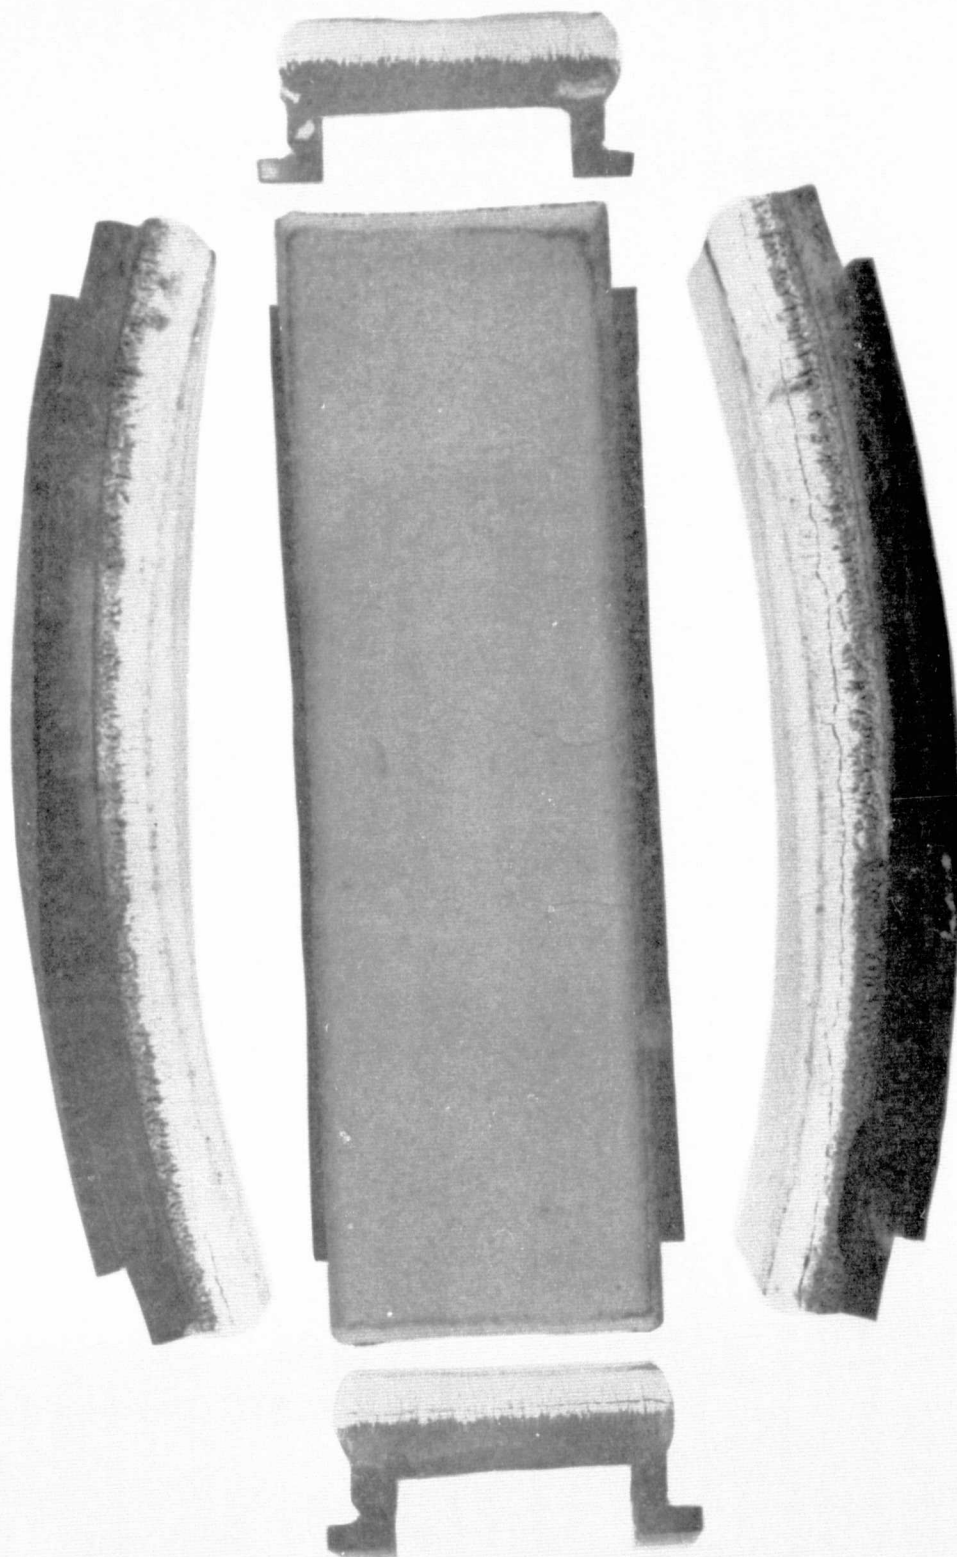
Figure 61 Optimized Configuration, Post Thermal Fatigue Test (Test No. 6)
