DEVELOPMENT OF A PLASMA SPRAYED CERAMIC GAS PATH
SEAL FOR HIGH PRESSURE TURBINE APPLICATIONS

FINAL REPORT

by
L. T. Shiembob

PRATT & WHITNEY AIRCRAFT GROUP
COMMERCIAL PRODUCTS DIVISION
UNITED TECHNOLOGIES CORPORATION

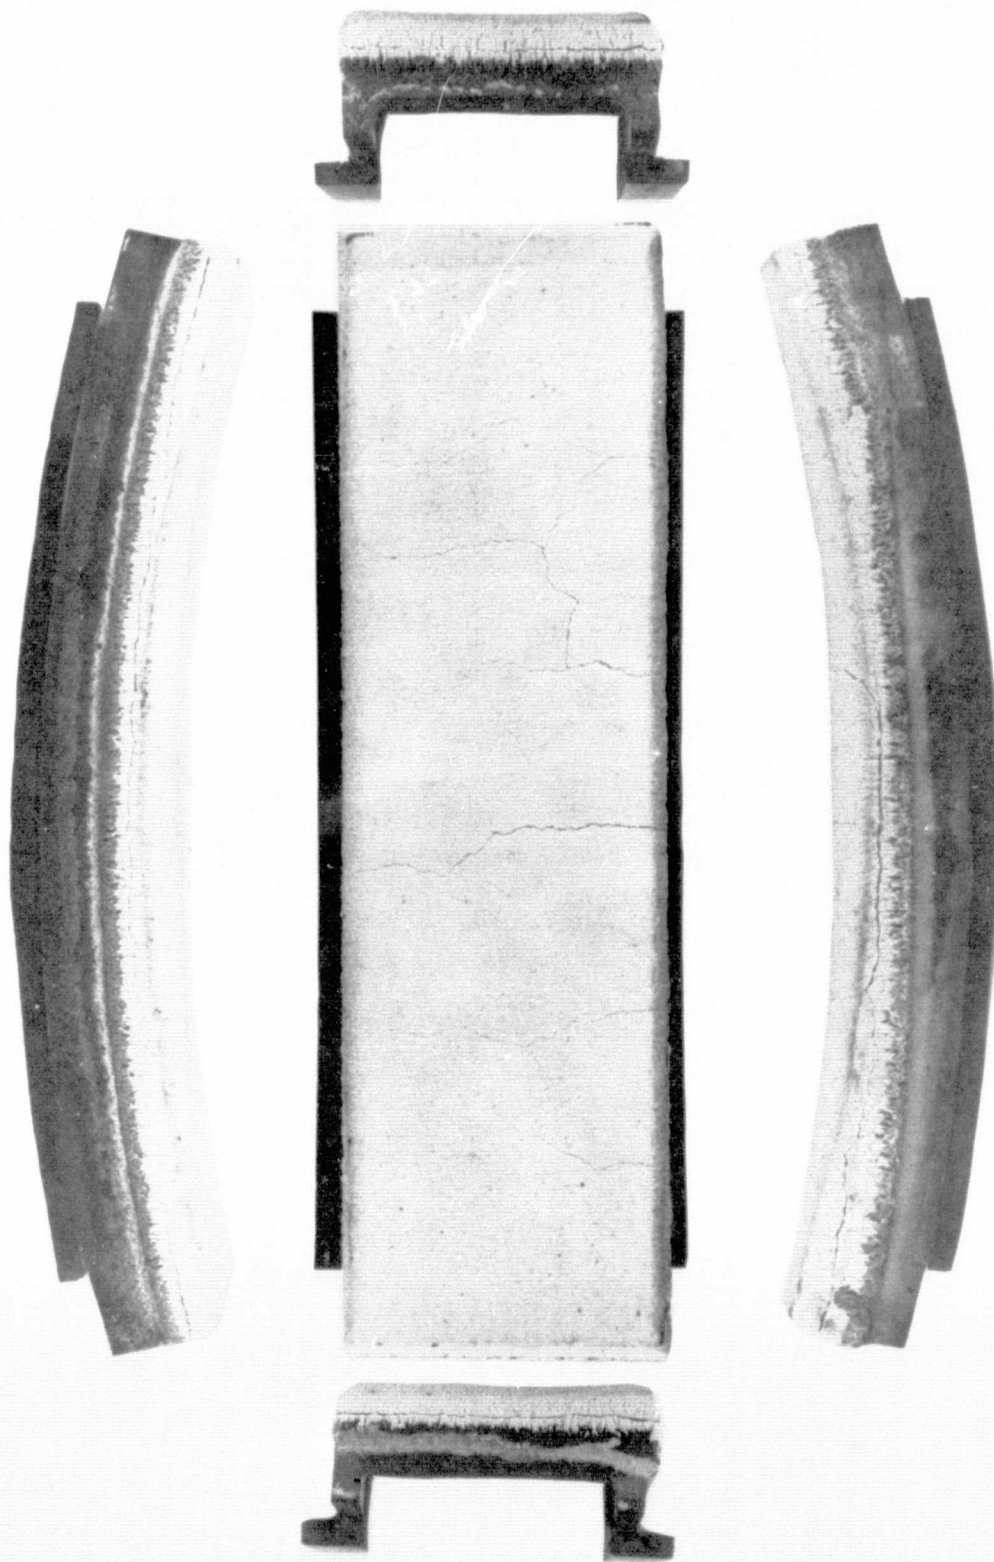
Figure 62 Optimized Configuration, Post Thermal Fatigue Test (Test No. 7)

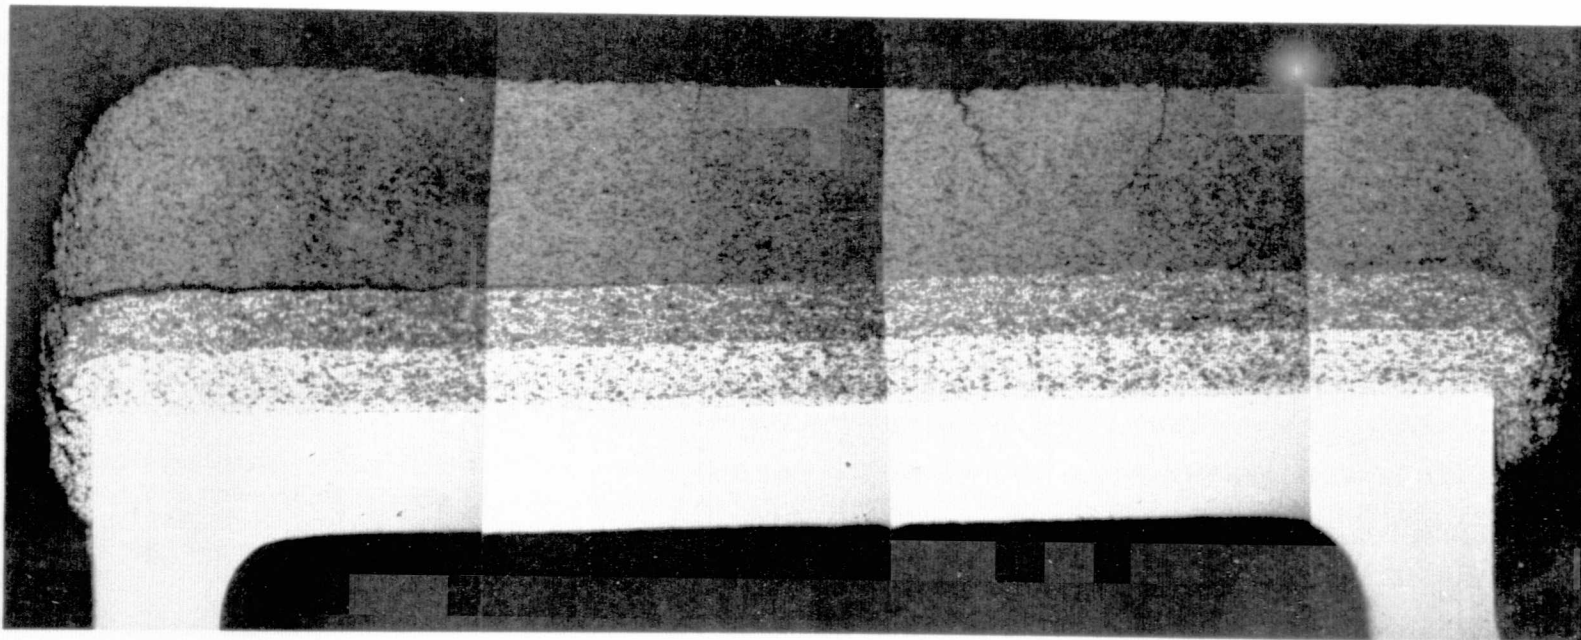
Figure 63 *Optimized Configuration, Thermal Fatigue Tested Specimen,
Axial Section (Test No. 6)*

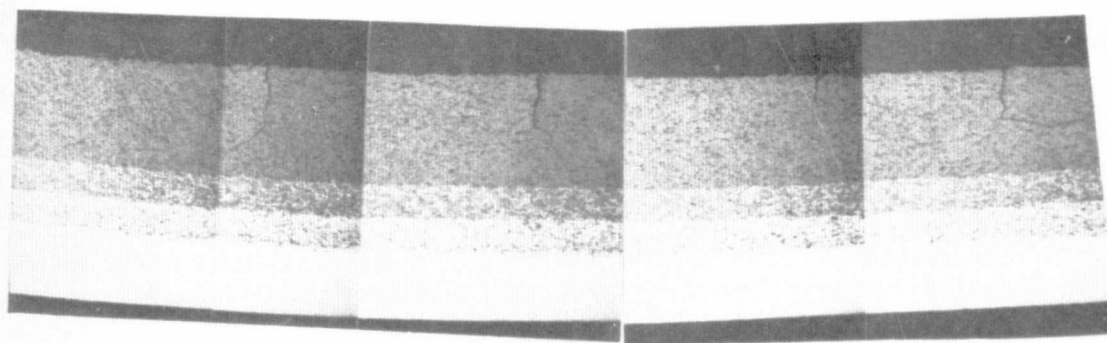
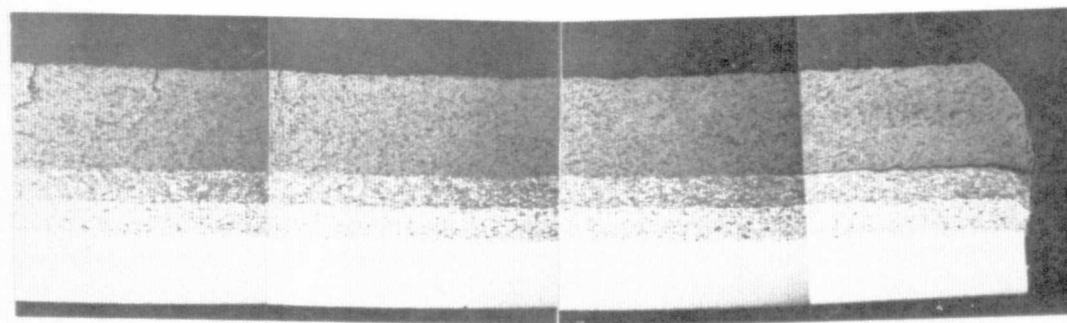
Figure 64 *Optimized Configuration, Post Thermal Fatigue Tested Specimen, Circumferential Section (Test No. 6)*

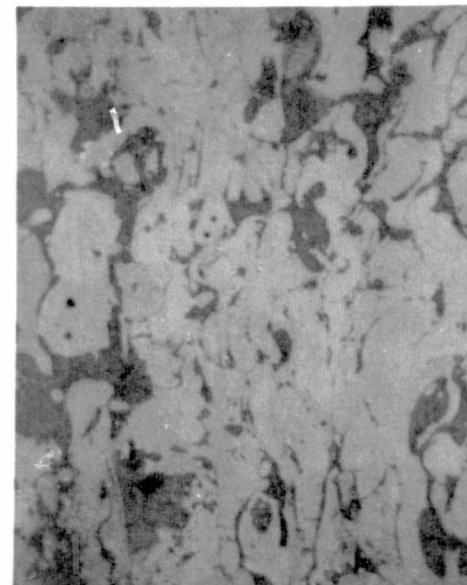
Figure 65 Optimized Configuration Microstructure
