NASA CR-135301  
9D4-NASIC-R1

CHARACTERIZATION, SHAPING, AND  
JOINING OF SiC/SUPERALLOY SHEET  
FOR EXHAUST SYSTEM COMPONENTS

WESTINGHOUSE RESEARCH AND DEVELOPMENT CENTER

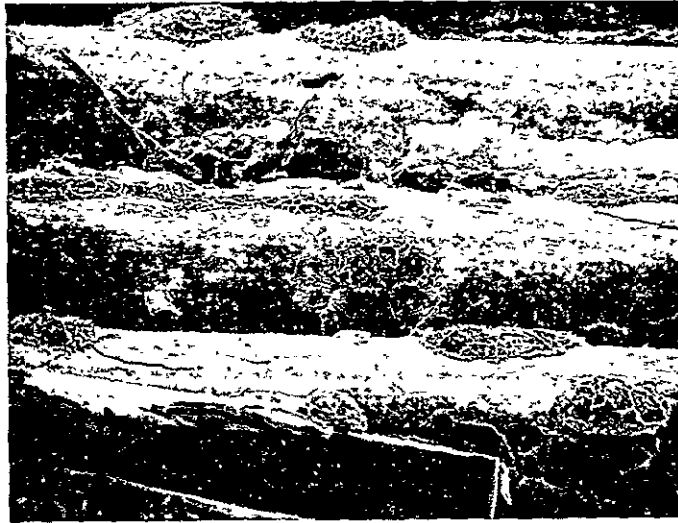
Fig. 31. SEM Photographs of "Blooms" on the Surface of Electrolytically Exposed HfC Coated SiC Filament From Composite Panel P-154.

The surface features and the X-ray analysis indicate that interaction occurred between the matrix and filament. The "blooms" are localized and only occur on certain filaments and not others. This leads us to conclude that coating imperfections allowed the interaction to occur. Further, we can see that the exposed filaments were not damaged by the fabrication process or HIP sequence as was originally feared.

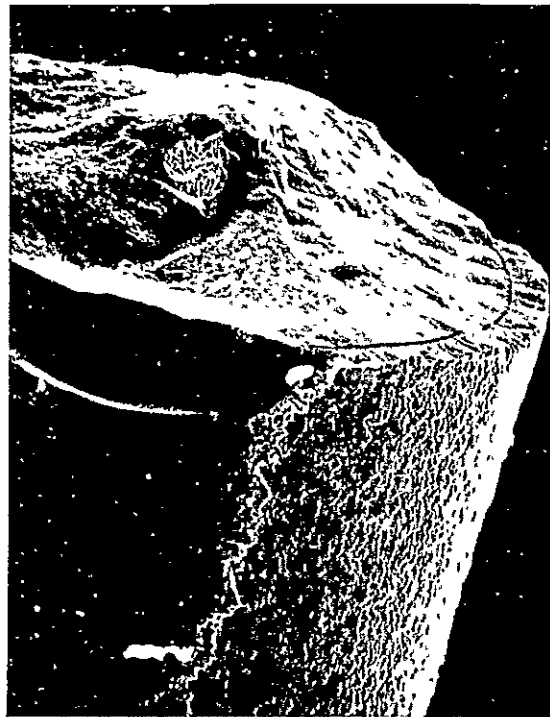
Fig. 37. SEM Photographs of CVD HfC Coated SiC Filament.  
Fiber Lot 85-125 - Run No. 31.

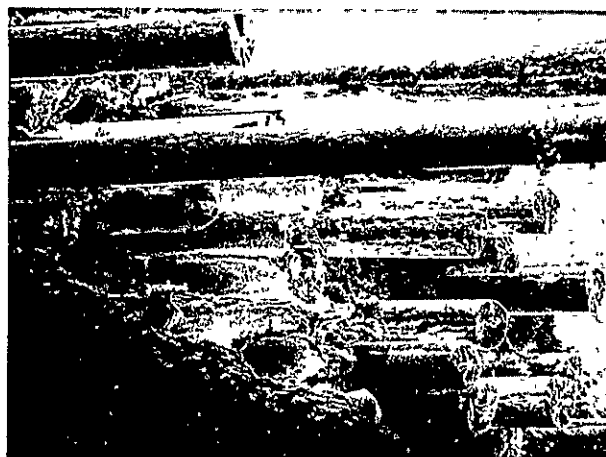
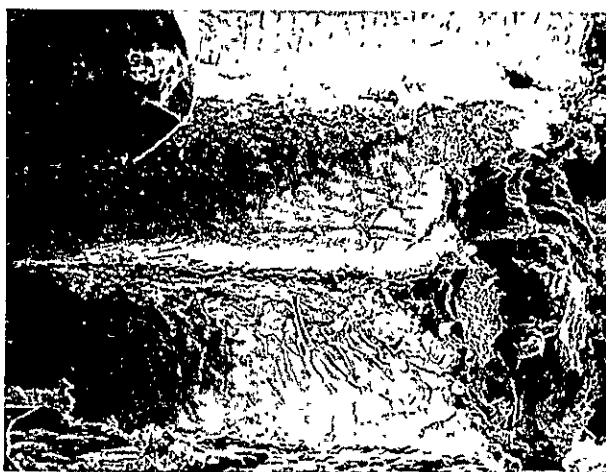
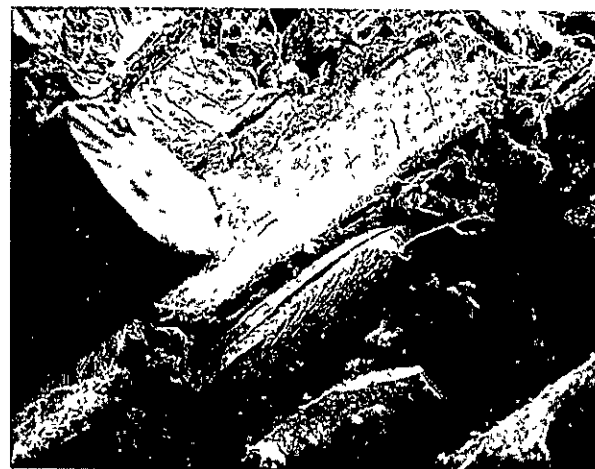
Fig. 41. Fracture Surfaces of HfC Coated SiC/Waspalloy Composite P-154 After Tensile Testing at Indicated Temperatures

Again the values were significantly lower than rule-of-mixture predictions. A SEM examination of the fracture surfaces in Fig. 41 shows the L/D ratio of pulled out filament to be approximately 12. The shearing took place at the interface between the coating and the filament, as shown in Fig. 41. This phenomenon occurred at both 982°C and 76°C.
