USE OF AERIAL THERMOGRAPHY
IN CANADIAN ENERGY CONSERVATION PROGRAMS

J. Cihlar, R. J. Brown
Canada Centre for Remote Sensing
Ottawa, Canada

ABSTRACT

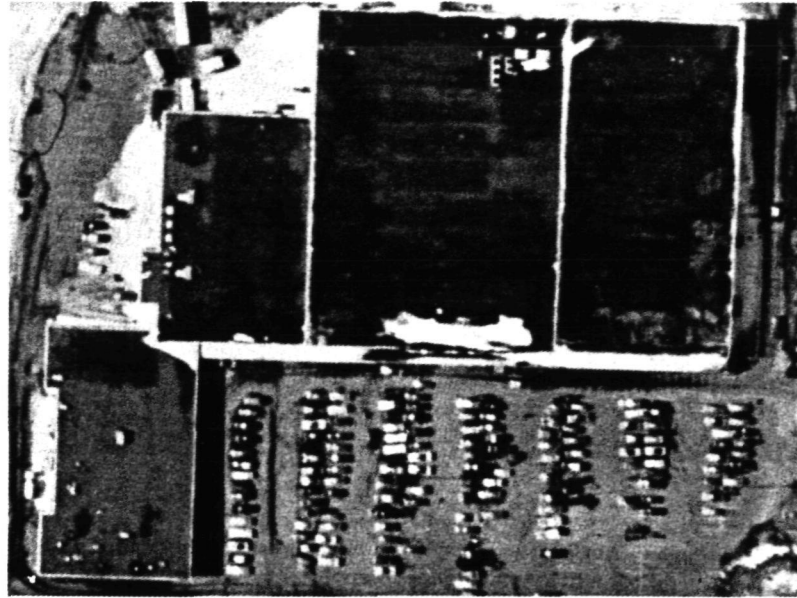
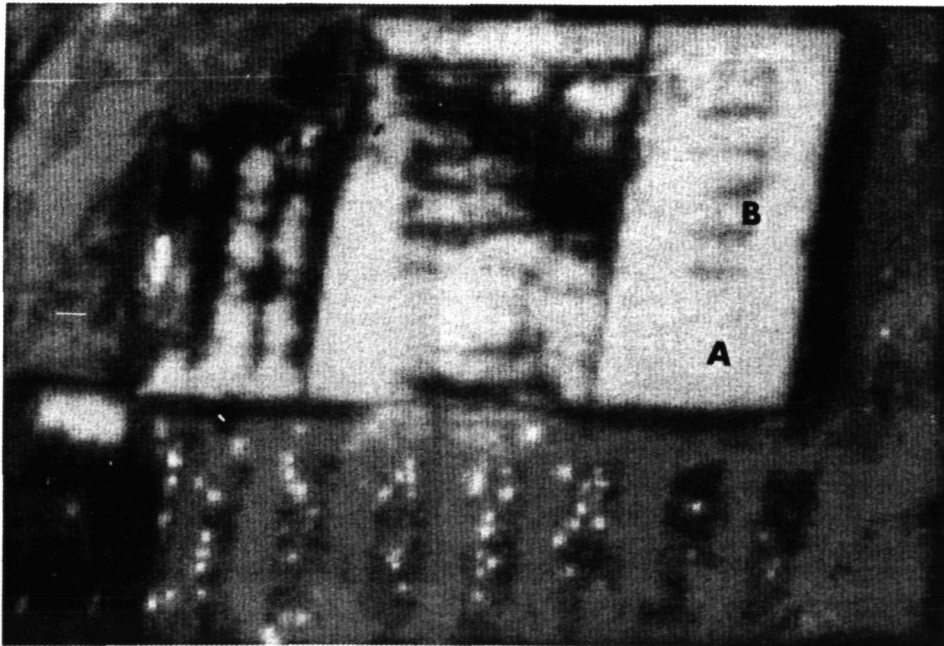
Figure 1 Aerial photograph (a) and nighttime thermogram (b) of a shopping mall. See text for explanation

Figure 1 shows a visual photograph and a nighttime thermogram of a shopping centre. In the thermogram light tones correspond to high radiation levels, and thus indicate "warm" sites. The shopping centre building was conspicuously light on the thermogram relative to other similar structures. Aerial photographs, daytime thermograms, and site inspection indicated that the roof was ice-covered to various degrees with (A, Figure 1b) or without (C) liquid water under the ice. In the high radiance areas the roof surface was soft, suggesting breakdown of the waterproof membrane. The "cold" areas (B, Figure 1b) were found during the inspection to be ice-free with a firm dry membrane. Thus the presence of ice appeared to correspond to areas of weak membrane and consequently of water-damaged insulation leading to a higher heat loss. Intermediate radiance levels on both daytime and nighttime thermograms exhibited at C (Figure 1b) could be explained by thinner ice cover and properly functioning thermal insulation (relative to A). The poor thermal performance of this roof was indicated during the discussion with building managers.

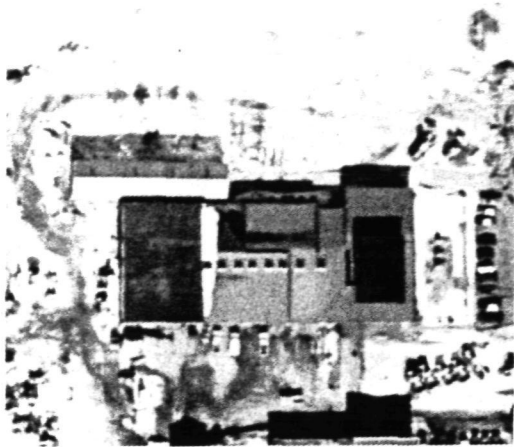
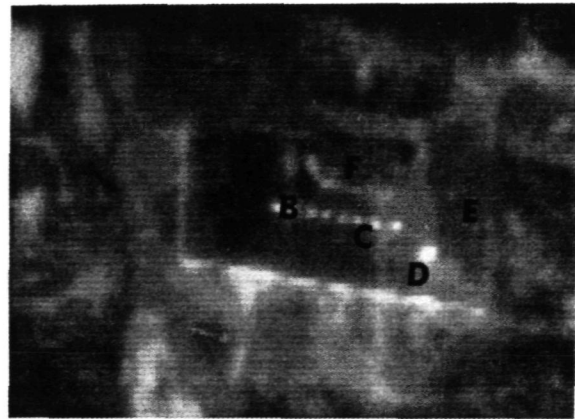
Figure 2 Aerial photograph (a) and nighttime thermogram (b) of a heavy machinery depot . See text for explanation

Thermal image of a building with different roofing materials is shown in Figure 2. Part A (Figure 2b) is covered with 1.8 cm thick rigid insulation under a tar/pitch membrane without gravel. The remainder of the building has 1.8 cm rigid insulation covered with tar and gravel. In general, the tar-only area appears "colder" than the tar and gravel section. This difference could be caused by different radiative physical properties (emissivity) of the surface materials. However, other explanations are possible. Part A is 3m higher than the remainder of the roof and could thus experience higher sensible heat loss. Furthermore, a small portion of the tar and gravel roof (B, Figure 2b) exhibited radiation levels similar to those of part A. The tar and gravel roof also contains eight skylights (C, Figure 2b), smokestacks (D) and a penthouse (E). These features and the surface discontinuities can be expected to affect the thermogram. The above examples show that a careful thermogram analysis is necessary to avoid interpreting emissivity and geometry effects as heat loss anomalies. The thermogram does, however, contain a significant thermal anomaly (F, Figure 2b). Aerial photography and on-site examination established this to be water collected at a low spot on the roof. Continued presence of water for extended periods of time is known to eventually cause roof deterioration.

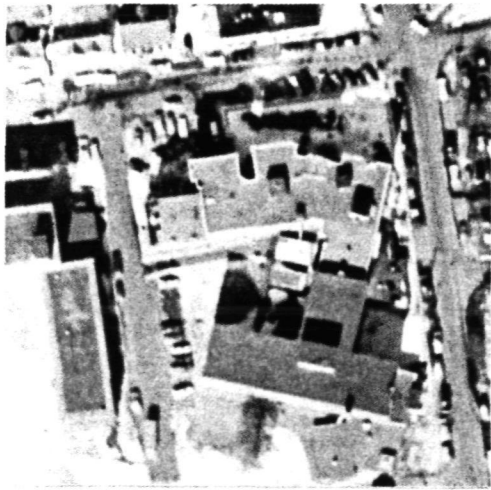
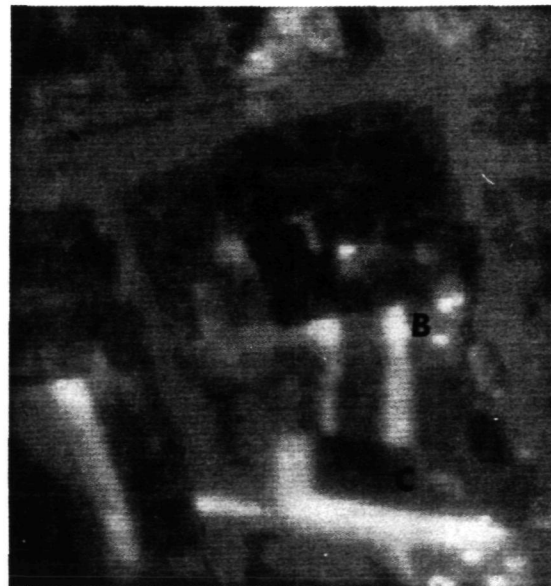
Figure 3 Aerial photograph (a) and nighttime thermogram (b) of a hospital. See text for explanation

Figure 3 is a thermogram of a hospital whose roof consists of three sections. In the upper section (A, Figure 3b), no heat anomalies unrelated to vents or similar structures could be identified. This roof is of the inverted type, i. e. a waterproof membrane is covered with slabs of waterproof insulation and these are in turn overlaid with 5 to 10 cm of crushed rock. This design presents problems in detecting a damaged membrane even when the roof is thermally sound. The central portion (B, Figure 3b) was uninsulated, and this is evident from a higher radiation level of this section. In the lower section (C), the roof was of conventional construction. The "warm" anomaly in this section was identified as a low spot near a drain located in the vicinity of a penthouse and interpreted as an incipient roof failure around the drain; otherwise, the roof had a uniform appearance on both air photographs and thermograms.
