APPLICATIONS OF THERMAL INFRARED IMAGERY FOR ENERGY CONSERVATION AND ENVIRONMENTAL SURVEYS

ABSTRACT

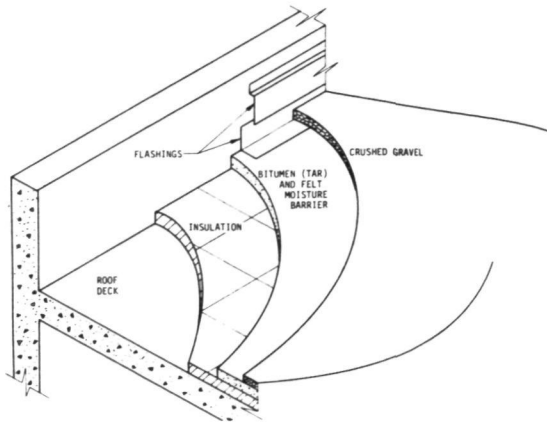
FIGURE 1.
CONSTRUCTION OF A BUILT-UP FLAT ROOF

ROOF SURVEY. The detection of moisture in flat built-up roofs with the use of handheld thermal infrared imaging instruments has proven to be one of the highest payoff applications of infrared technology. Previously, when a roof leaked and the leak could not be located easily, the entire roof was replaced. In most cases, repairing portions of a roof will correct the problem at a much lower cost than replacing the entire roof. To understand how infrared devices can be used to find wet areas in the roof, it is helpful to understand the construction of a built-up flat roof. Figure 1 is a cutaway drawing of a flat built-up roof showing the method of construction. A leak results when the moisture barrier develops a hole or tear, cracks occur due to age, or the flashings fail. When the moisture reaches the insulation through a failure of the moisture barrier or flashing, it can travel through the insulation with little interference. Interior leaks result when moisture passes through the insulation and the roof decking.

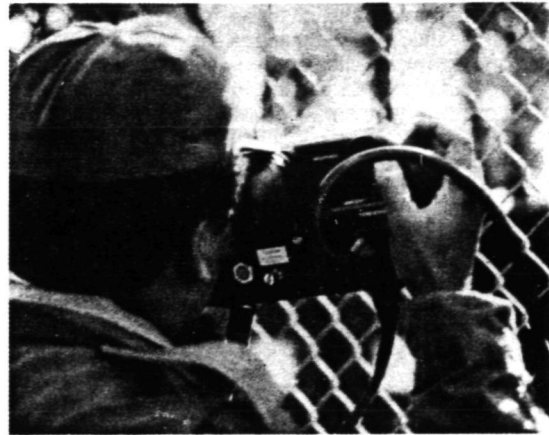
FIGURE 2.
PAS-10 THERMAL INFRARED DEVICE

The NVL equipment, designated PAS-10 (figure 10), is a thermal infrared device that operates in the 3- to 5-micron range of the electromagnetic spectrum. It weighs 9 pounds, is self-contained, and is battery operated. Although developed for tactical use, it has capabilities for the inspection of utility systems and roofs. This equipment has a real-time display, but photographs of the output can be obtained by mounting a camera against the single eyepiece and obtaining a time exposure. The cost of this equipment is approximately \$30,000.

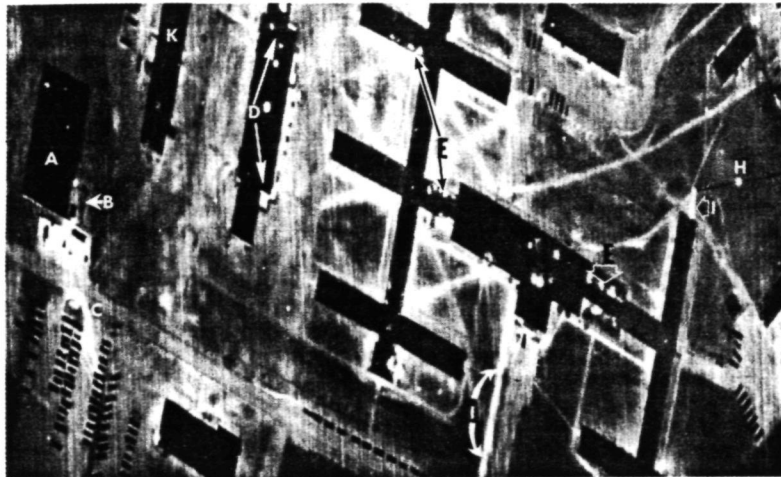
FIGURE 3.
AERIAL THERMAL INFRARED IMAGERY TAKEN AT 0420 HOURS ON 18 MARCH 1976

Figures 3 to 9. Figure 3 is a winter night infrared image of a portion of Vint Hill Farms Station showing Buildings 160 (E, figure 3); 162 (D, figure 3); 163 (K, figure 3); and 166 (A and B, figure 3). Figures 4 and 5, obtained during the summer phase, are day and predawn infrared images, respectively, and are essentially of the same area as figure 3. In general, the winter day thermal infrared imagery was of little value in this study. This was due primarily to excessive amounts of solar radiation existing during daylight hours but also to large amounts of standing water on the roofs during the time of image acquisition. Thus, the sensitivity range of the scanner was exceeded. Although figures 6, 7, and 8 are of the same area as figures 3 and 5, they are winter color** and color infrared photography and summer color infrared photography, respectively.

The roof of Building 166 (A, figure 3) and the connected utility room roof (B, figure 3), which contains a heating plant, are flat built-up roofs surfaced with similar roofing materials, tar and gravel. The utility building, however, is vented to ambient air. Ground measurements obtained at the time of image acquisition indicate that the external temperature of the utility room roof was -5.00C, while the roof of the main portion of Building 166 was -10.00C. This 5.00 variance in temperature between these two roofs can be seen in figure 3, A and B. The utility room roof (B, figure 3) is the warmer, indicated by its lighter tone. Ceiling temperature measurements obtained within Building 166 and the utility room were +10.00C and +14.00C, respectively. If the insulation value of these two roofs were the same, the utility room roof would appear as having a higher temperature, but not to the extent indicated on the imagery. Examination of the winter and color and color infrared photography did not reveal the existence of standing water on either of these roofs that would have contributed to this difference.

The large warm area (C, figure 3) is the discharge of a hot water hose that was employed to maintain three temperature reference basins. These basins, used to provide a known temperature reference, appear as three small white dots to the left of C in figure 3. It was anticipated that these basins could be used with optical microdensitometry techniques to obtain quantitative temperature data from the thermal imagery. Unfortunately, the image size of these basins was too small for practical use.

dropped to the same temperature as the roof by early morning (time of the winter night imagery), and only the deep pools of water provide a temperature contrast (figure 3). Two things become evident from a study of this image. First, to be most effective, the infrared flights should be scheduled earlier, approximately 1900 to 2200 hours. Second, roof surfaces should be free of standing water.

Steam line heat losses were also detected on the thermal imagery. An uninsulated expansion joint in an aboveground steam line can be seen as H in figures 3, 5, and 8. Underground steam line heat losses can be seen as I and Y in figures 3 and 5. The underground steam line leading from the heating plant (J, figure 5) to Building 160 (Z, figure 6) lies under the concrete sidewalk marked I in figure 5. The steam line marked Y in figure 5 is buried approximately 30 feet and then surfaces.

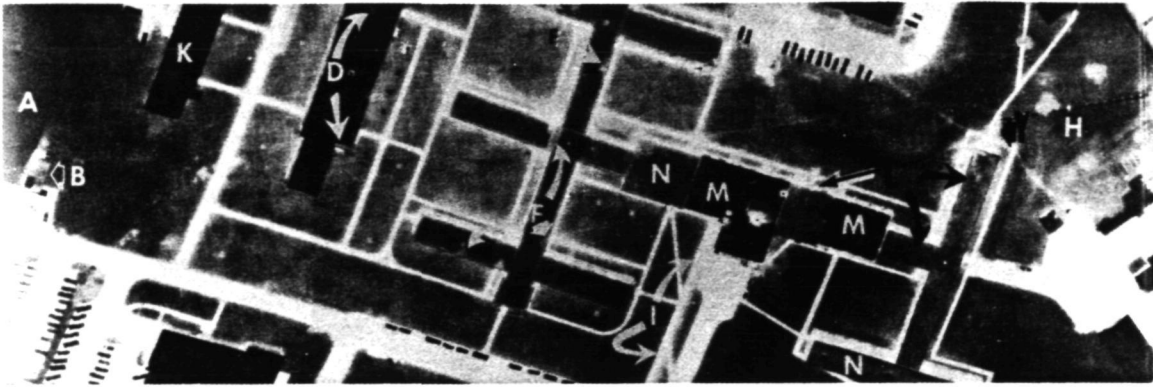
FIGURE 5.
AERIAL THERMAL INFRARED IMAGERY TAKEN AT 0450 HOURS ON 21 JULY 1976

The summer night thermal imagery also indicated the high thermal loss through the roof of the utility room (B, figure 5). The image, in this instance, correlated quite well with ground temperature measurements, which established the presence of a 3^oC difference in temperature between the roofs of the utility room and Building 166 (A and B, figure 5). The detection of this small temperature difference demonstrates the effectiveness of night versus day acquired infrared imagery. It also demonstrates that on a clear, cold, windless night the roofs of insulated buildings can be colder than both the internal building temperature and the external ambient air temperature (A, figure 5). The influence of air temperature, with little or no wind, is not considered as important as an unobstructed sky in the energy emission process of roofs. During the time of image acquisition, the temperatures of these two buildings were as follows:

The roof of Building A has a colder surface temperature than B because the heat flow from the building interior to the roof surface is retarded by insulation. In Building B, the internal to external heat flow to the roof is largely unrestricted; therefore, its temperature would be expected to be at or near that of the ambient air.

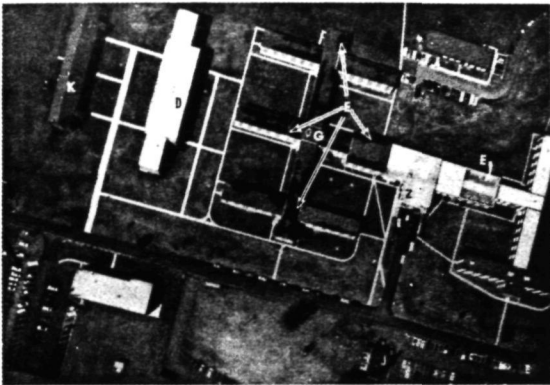
FIGURE 6. AERIAL COLOR PHOTOGRAPHY TAKEN
AT 1345 HOURS ON 18 MARCH 1976. SCALE -
1:2,000

During the predawn winter flight, ambient air and grass temperatures were measured at -10^oC and the asphalt roadway, -8^oC. These temperature variations correspond to the gray tone patterns on figure 4. The amount of grass cover and other features, such as pathways and sidewalks that produce different tones of gray on the thermal imagery, can be better visualized by viewing the color and color infrared photography obtained during the same day (figures 6 and 7).

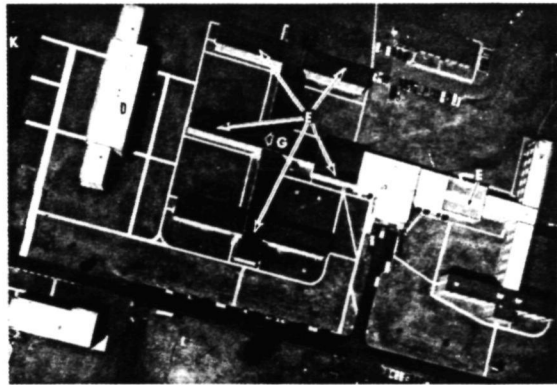
FIGURE 7. AERIAL COLOR INFRARED TAKEN AT
1345 HOURS ON 18 MARCH 1976. SCALE -
1:2,000

The relationship between the gray tones on the infrared imagery and the normal variables encountered on a roof surface such as light- and dark-colored roof materials, vents, surface water, and water within the insulation is evident on Building 160 (figures 6 and 7). Roof surface water is marked as E in figures 3, 6, and 7. On the top of roofs, water or moisture images as a dark color on the color photograph (figure 6) and as a black tone on the color infrared photograph (figure 7). The temperature of most of the roof surface water has

The roof surface of Building 163 (K, figure 7) is a peaked asphalt, shingle roof that is dark green in color. The tone of this roof surface and the roof of Building 162 (D, figures 4 and 5) exhibit the same thermal image tonal characteristics. Roof D is a built-up roof surfaced with gray gravel. Although there is a variance in both the reflectivity and emissivity between these two roofs, roof construction differences have caused the roof surfaces to have the same image tones.

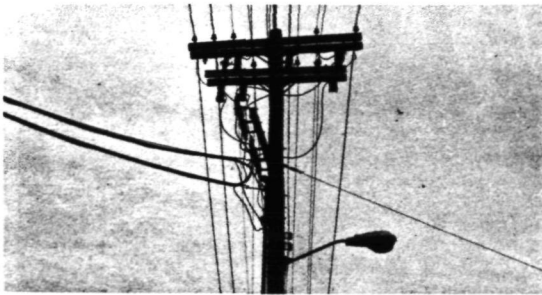
FIGURE 11. AN ELECTRICAL DISTRIBUTION POLE CONTAINING HIGH VOLTAGE CIRCUITS

ELECTRICAL SURVEY. The electrical distribution systems at Arlington Hall Station and Vint Hill Farms Station were inspected on 12 to 15 and 17 to 18 March 1976, respectively. Although Vint Hill Farms Station had no electrical problems, there were five faulty connections discovered at Arlington Hall Station that required maintenance. Also a number of connections at Arlington Hall were found that appeared to be faulty, but upon detailed inspection proved to be the result of circuit imbalance. Figures 10 and 11 are presented to illustrate the ability of the infrared equipment to locate maintenance areas in a highly effective and safe manner. Figure 10 shows an electrical distribution pole containing high-voltage circuits. Figure 11 is a reproduction of the infrared display that indicates a faulty connection either at the cable termination or at the lightning arrester on the same pole.

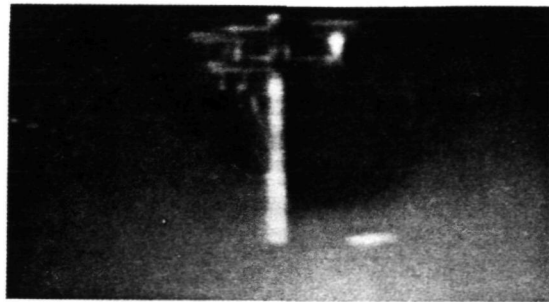
FIGURE 12. A REPRODUCTION OF THE INFRARED DISPLAY INDICATING A FAULTY CONNECTION

Loose or corroded connections, poor contacts, unbalanced loads, and loose bus joints introduce additional resistance into an electrical circuit causing these connections to have a temperature that is higher than normal. These "hot" connections are imaged on the thermal infrared equipment as white areas. The advantage of this survey method is that the electrical power is not interrupted during the survey.

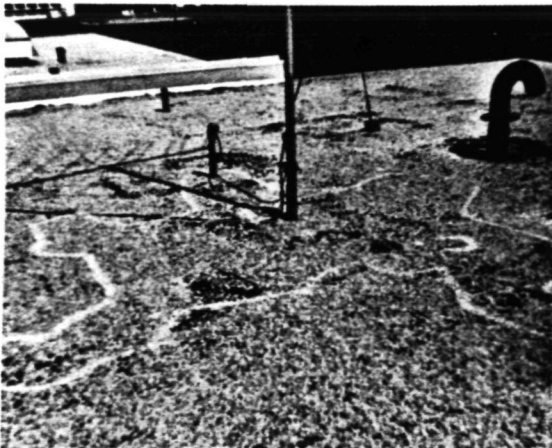
FIGURE 13. AN ANTENNA INSTALLATION OF BUILDING 162, VINT HILL FARMS STATION. AREA OUTLINED IS UNDERLAIN BY WET INSULATION.

The roof of Building 162, a barracks, had two areas that were indicated by the handheld infrared equipment to be underlain by wet insulations. The first area was associated with a guyed television antenna that was installed improperly, enabling precipitation to penetrate the moisture barrier (figures 12 and 13). The second area detected was near the roof parapet and was probably caused by an open joint in the flashing.
