**NASA TM-78877**

CYCLIC OXIDATION OF COATED OXIDE DISPERSION STRENGTHENED (ODS)  
ALLOYS IN HIGH VELOCITY GAS STREAMS AT 1100° C

by Michael A. Gedwill  
Lewis Research Center  
Cleveland, Ohio 44135  
May, 1978

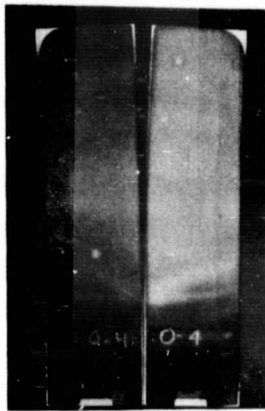
(a) PWA 267 COATED  
TD-NiCrAl AFTER 500 HRS.

Figure 4. - Photomicrographs showing surface appearance of coated TD-NiCrAl after cyclic oxidation at 1100°C in the Mach 1 burner rig. (One hour cycles).

The macroscopic appearance of several coated ODS NiCrAl specimens is shown in figures 4 and 5 after various Mach 1 test times at  $1100^{\circ}\text{C}$ . Figure 4 presents post-test photographs showing Mach 1 TD-NiCrAl specimens coated with three overlay coatings. Two of four specimens coated with PWA 267 experienced some flaking and blistering (fig. 4(a)) in 500-test hours or less probably because of poor coating adherence. (The PWA 267 was deposited as it was on conventional superalloys.) On

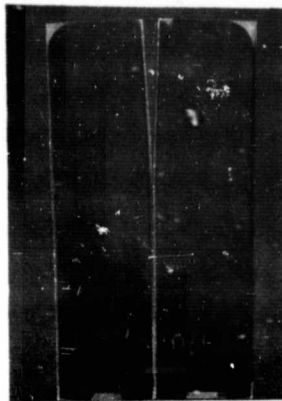
(b) PWA 267 COATED  
TD-NiCrAl AFTER 790 HRS.

the remaining two specimens, thermal fatigue cracks were first observed after about 600 hours of testing and oxidation attack of the substrate started after about 700 hours. After 790 test hours, however, serious leading edge (see fig. 1) attack and cracking was observed (fig. 4(b)). It was reported (refs. 13 and 14) that platinum additions to NiCrAl overlays have improved oxidation resistance. These platinum modified coatings on a nickel-base directionally solidified eutectic alloy ( $\gamma/\gamma' - \delta$ ) have shown no failures in excess of 1000 hours in 1100<sup>0</sup> C burner rig tests. Figure 4(c), however, shows that the PWA 267 + Pt coating experienced serious degradation at the leading and trailing edges in less than 600 hours. (Thermal fatigue cracking and leading edge coating failure were first observed after about 350 and 380 hours, respectively.) It is generally believed that life of overlay coatings increases with coating thickness. Thus, it is likely that premature failure of the PWA 267 + Pt coating on TD-NiCrAl can be partly due to its reduced thickness as compared to that of the unmodified overlay (0.069 mm compared to 0.097 mm). While the unmodified coating was the significantly better of the two PWA 267 coatings on TD-NiCrAl, it was not as good as Nascoat 70 which fully protected TD-NiCrAl from oxidation attack for more than 800 hours (fig. 4(d)). Only after about 850 hours at 1100<sup>0</sup> C did Nascoat 70 show failure at the trailing edge of the specimen. (The maximum temperature at the trailing edge has been reported (ref. 18) to be higher than that at the leading edge.) This failure was severe and extensive after 1000 hours (fig. 4(e)). Thermal fatigue cracking of Nascoat 70 specimens, however, was first observed at about the same time as that for the PWA 267 coated specimens, i. e., 600 hours. All the specimens tested in Mach 1 rig experienced bowing because of poor creep strength. The optimum texture for ODS alloys was not obtained during extrusion of the TD-NiCrAl alloy. However, the alloy was considered useful for evaluating coatings.
