**NASA TM-78949**

**ELASTOHYDRODYNAMIC FILM THICKNESS MEASUREMENTS  
OF ARTIFICIALLY PRODUCED SURFACE DENTS AND GROOVES**

**TECHNICAL PAPER to be presented at the  
Joint Lubrication Conference  
cosponsored by the American Society of Mechanical Engineers  
and the American Society of Lubrication Engineers  
Minneapolis, Minnesota, October 24-26, 1978**

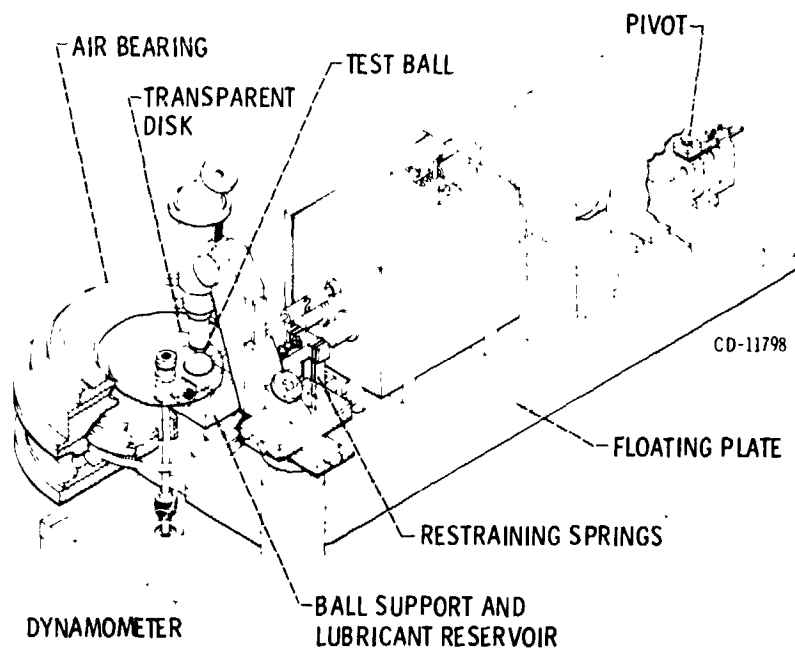
Figure 1. - Optical EHD rig.

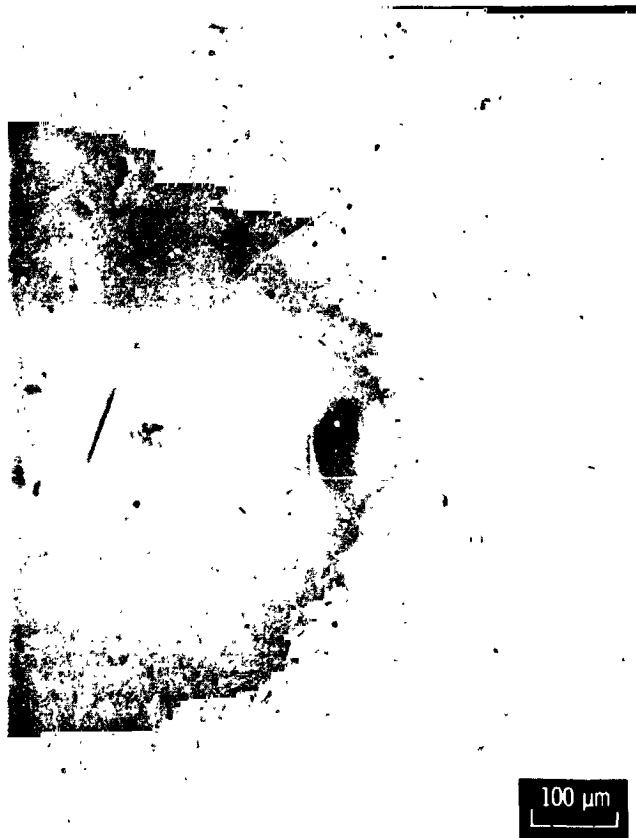
Figure 3. - Dent made with conical tool and 44.5 N load.

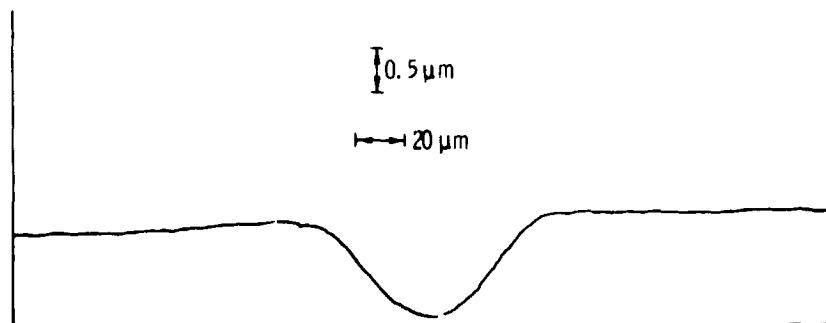
Figure 4. - Stylus trace of dent shown in figure 3.

The stylus trace provides a reference profile which gives the geometry of the dent in its undeformed condition. It can be thought of as representing the shape of the dent that would be expected if the influence of EHD has created a pressure environment around the dent which allows the dent to pass through the Hertzian region in an "undeformed" state; that is, the pressure around the dent is everywhere equal to the Hertzian pressure for smooth surfaces.

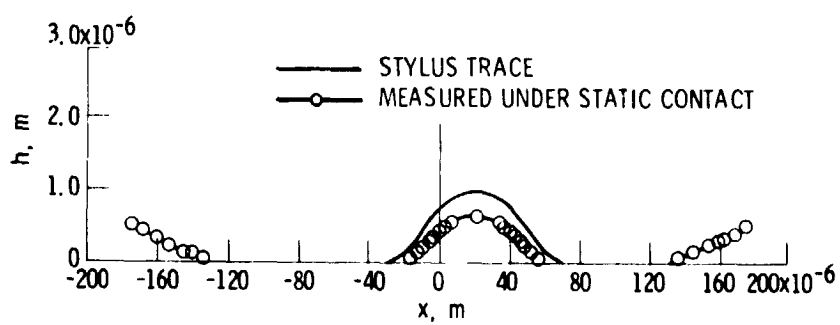
Figure 6. - Comparison of undeformed dent profile (stylus trace) with measured profile under static contact.

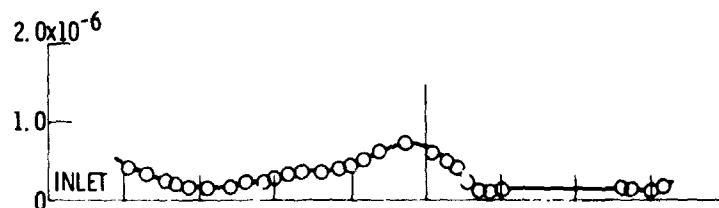
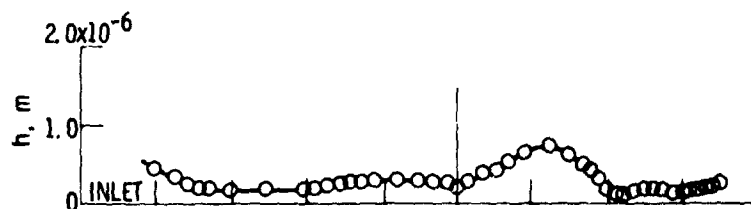
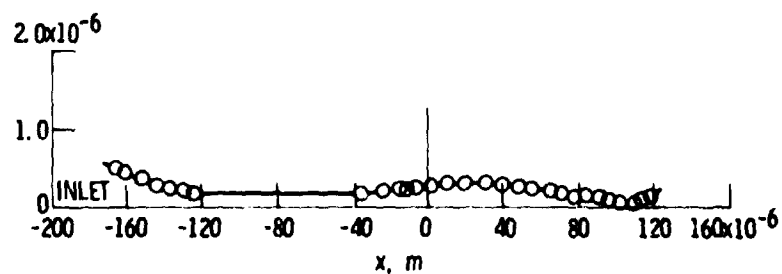
Figure 8.

(a) MEASURED PROFILE OF FIG. 7(a).

(b) MEASURED PROFILE OF FIG. 7(b).

(c) MEASURED PROFILE OF FIG. 7(c).

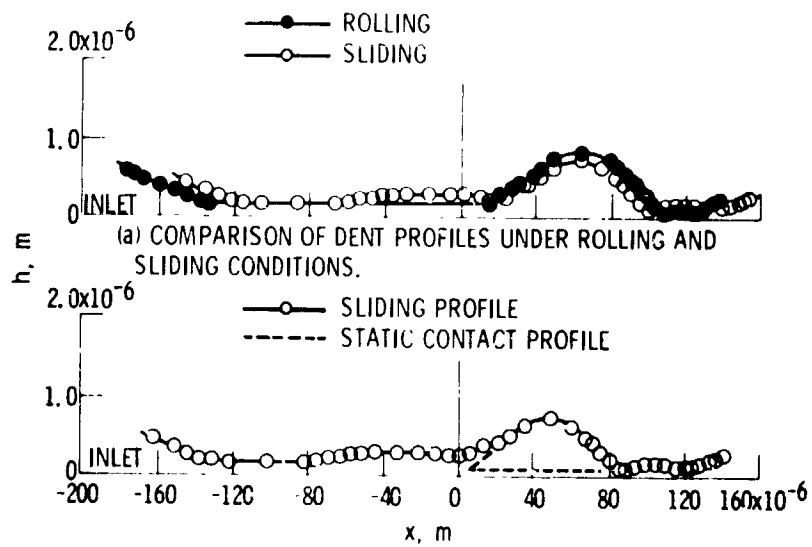
Figure 9.

(b) COMPARISON OF SLIDING PROFILE WITH STATIC CONTACT PROFILE.

Figure 9(a) compares the dent profiles for rolling and sliding conditions and figure 9(b) compares the sliding profile with the static profile. Substantial elastic deformation is seen at the trailing edge of the dent which implies high pressure and stress concentration in this region. This is in line with the very high pressures predicted by

An interesting feature concerning the leading edge of the dent is seen in figure 9(a). While the profile under rolling conditions shows the characteristic reduction in film thickness at the leading edge of the dent, the profile under sliding condition shows less local reduction at this location. The micro-EHD pressure generated by the sliding action associated with the built-up edge of the dent creates an increase in film thickness at this location.

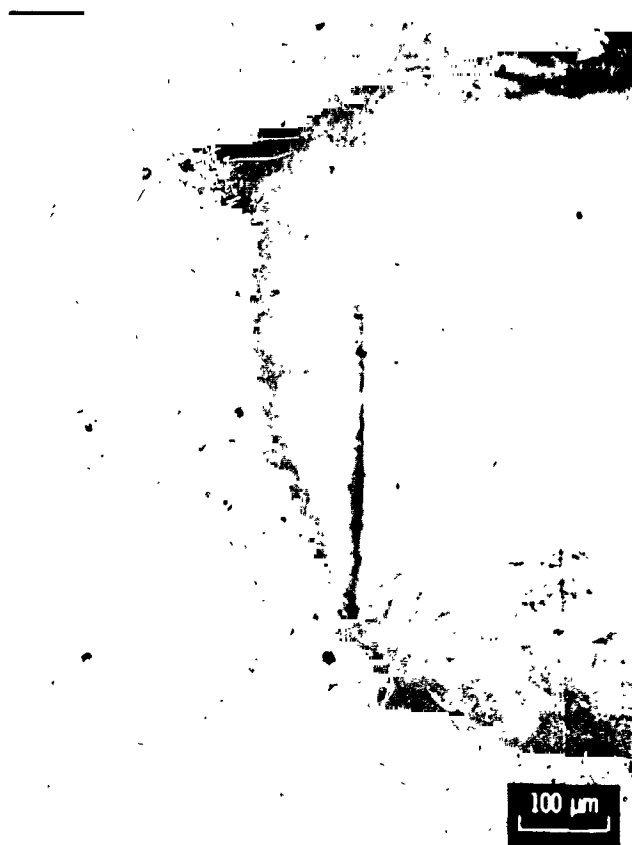
Figure 10. - Shallow groove made with wedge-shaped tool.

and the depth gradually decreases on both sides of the center along its length as shown in figure 10. However under static Hertzian contact conditions, figure 11 shows that the groove width and depth are essentially constant in the Hertzian region. The groove appears uniform because the elastic deformation gradually decreases from the center of the groove (center of Hertzian circle). The stylus trace of this groove is shown in figure 12 and a comparison between the stylus and static configurations is shown in figure 13. This groove is very shallow measuring only  $0.5\text{ }\mu\text{m}$  deep which is one-half the depth of the dent discussed above.

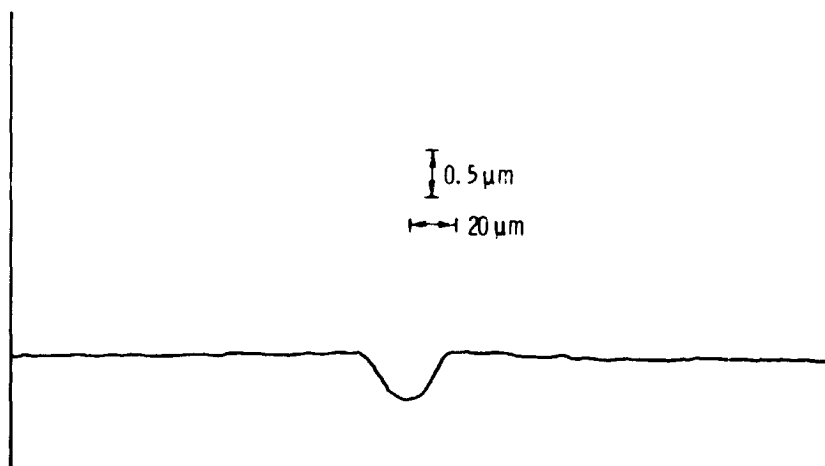
Figure 12. - Stylus trace of shallow groove in figure 10.

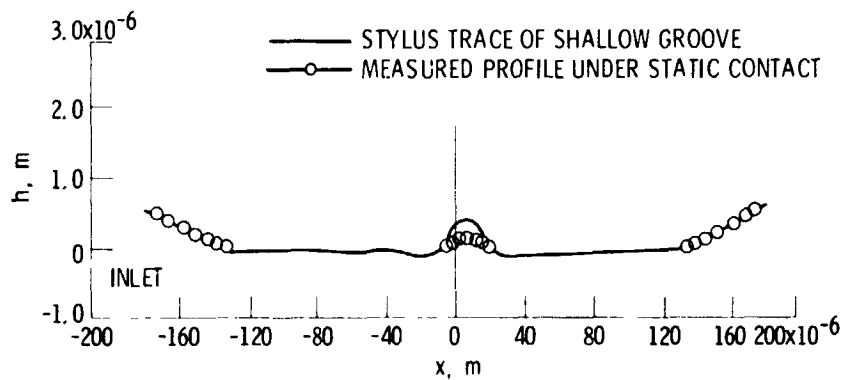
Figure 13. - Comparison of stylus trace of shallow groove with groove profile under static conditions.

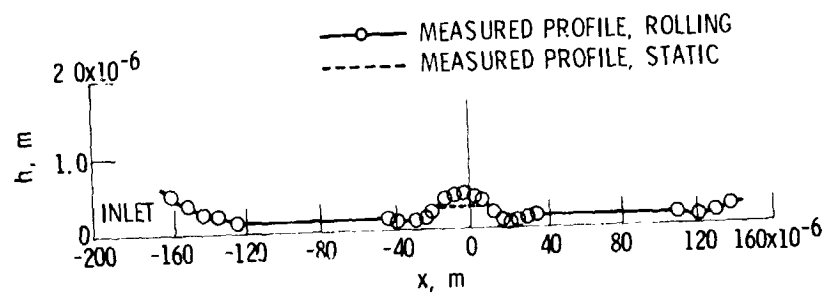
Figure 15. - Comparison of static profile with dynamic profile under rolling conditions.

A photomicrograph of this groove under rolling conditions is shown in figure 14. Its cross-sectional profile and static profile are given in figure 15. The general EHD features associated with the groove under rolling conditions are similar to those observed with a dent under rolling conditions. A reduction in film thickness is again observed at the leading edge of the defect.

If the static profile is compared with the dynamic profile, as shown in figure 15, it is seen that under the given dynamic conditions the elastic deformation has been substantially relieved from its static condition. This was not observed for the dent discussed above. The difference between the elastic deformations of the groove and dent under dynamic conditions is due to the relative size of these defects with respect to the film thickness; or more precisely, with respect to the size of the inlet region as discussed in reference 20. If the defect is small and does not significantly modify the shape of the inlet region the local hydrodynamic pressure generated in the vicinity of the defect will not be very different from that for smooth surfaces. The defect will then pass through the Hertzian region with less elastic deformation and its shape will approach its undeformed shape as represented by the stylus trace.

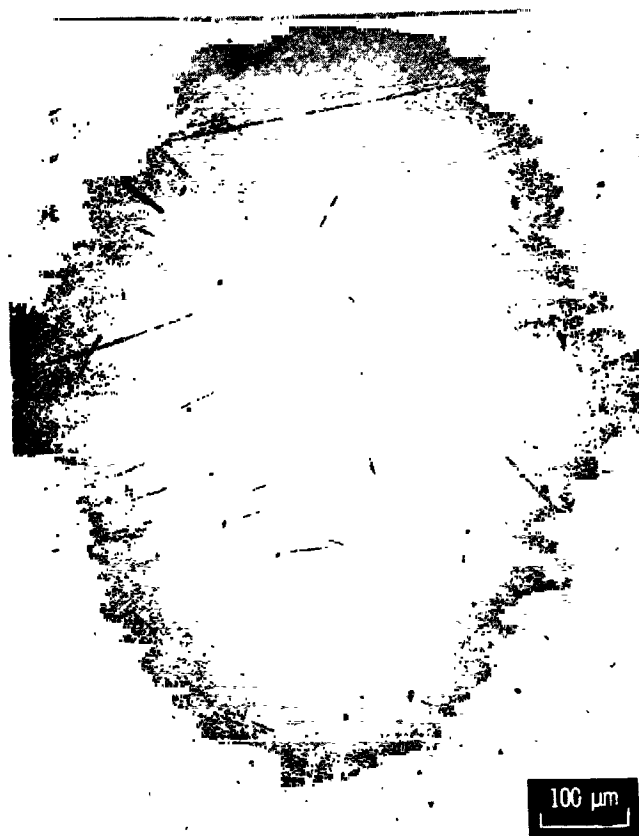
Figure 18. - Deep groove made with sharp wedge-shaped tool.

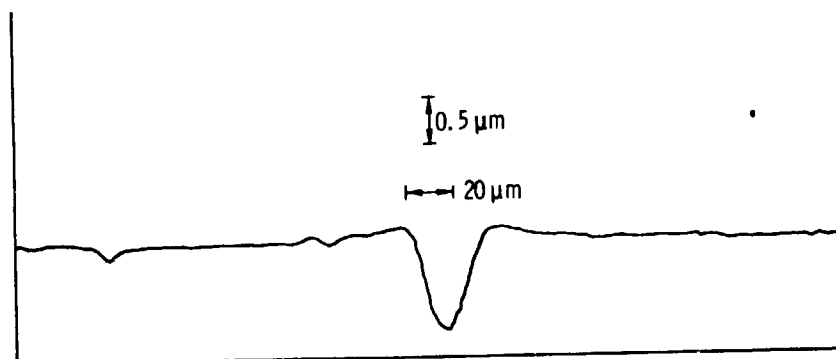
Figure 19. - Stylus trace of deep groove.

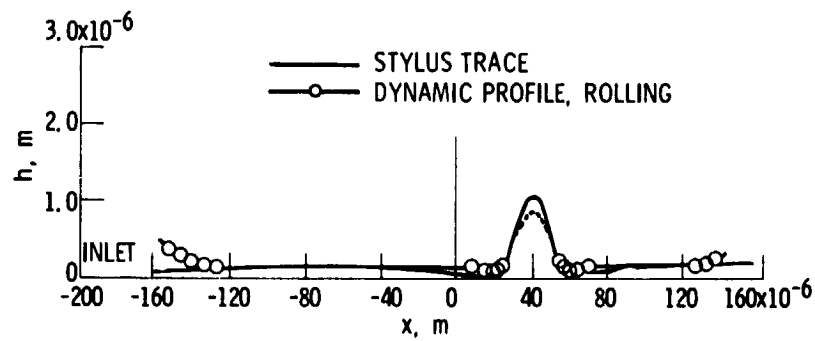
Figure 21. - Comparison of stylus trace of deep groove with dynamic profile under rolling conditions.

The deep groove under rolling conditions is shown in figure 20 and its cross-sectional profile is shown in figure 21 along with the stylus trace. The interference fringes along the steeply sloped sides of the groove are too close together to be adequately resolved for measurement purposes. Only measurements along the edges of the groove could be obtained.

Under rolling conditions an adequate film thickness is seen to occur at the edges of the groove even through the height of the built-up edge ( $0.15\text{ }\mu\text{m}$ ) is the same order of magnitude as the nominal film thickness ( $0.14\text{ }\mu\text{m}$ ). There is very little distinction between the leading edge of the groove and the trailing edge as seen previously for the shallow groove and the dent. Here a local reduction in film thickness occurs on both sides of the groove; but the reduction is only minor compared to the size of the built-up edge. It is evident that a substantial micro-EHD activity can be associated with the built-up edge along the groove. These results are in line with the asperity lubrication discussed by Chow and Cheng (16).

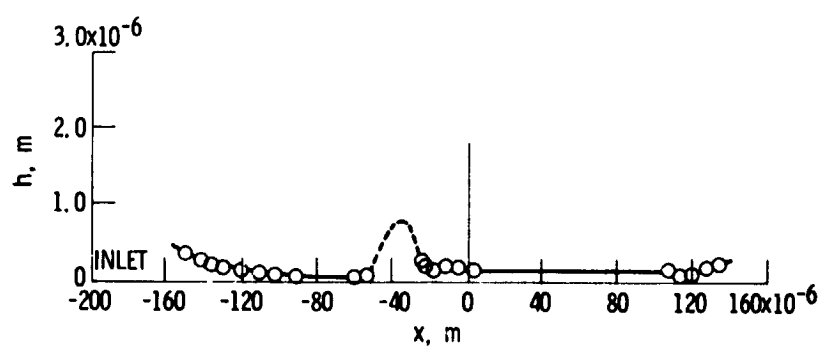
Figure 23. - Cross-sectional profile of deep groove in figure 22.

When this deep groove passes through the Hertzian region under sliding conditions additional micro-EHD activity can occur as shown in figure 22. The cross-sectional profile across the center of the groove is plotted in figure 23.

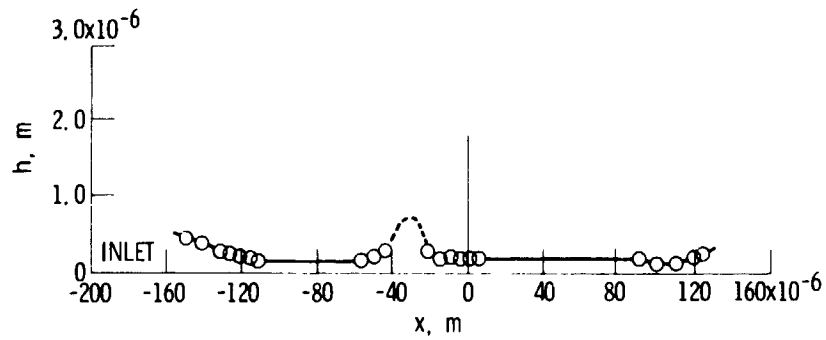
Figure 24. - Cross-sectional profile across portion of groove in figure 22 which does not show reduced film thickness at trailing edge.

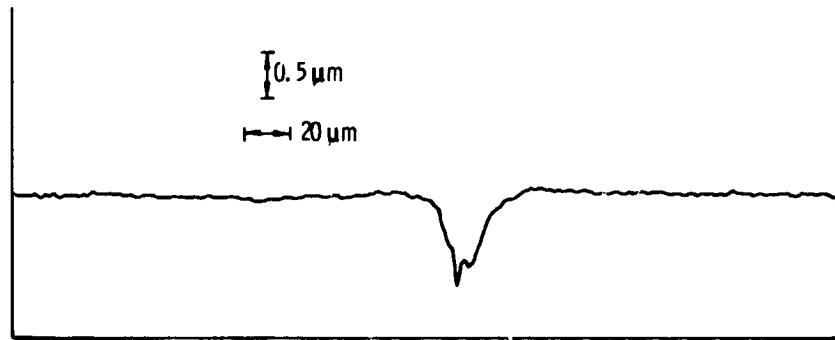
Figure 25. - Stylus trace across portion of groove showing rounded shoulders.

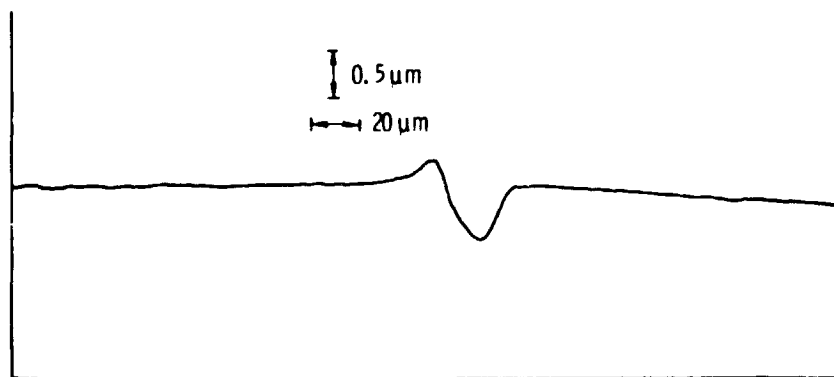
Figure 27. - Stylus trace of groove in figure 26. Trace taken perpendicular to flow direction.

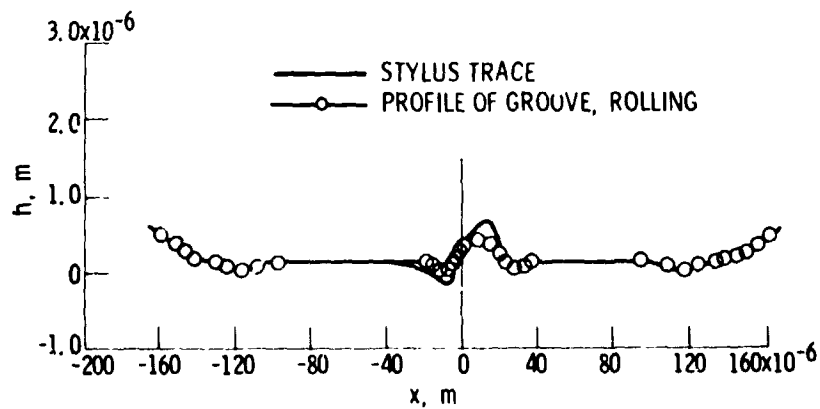
Figure 29. - Comparison of stylus trace of groove oriented parallel to the flow direction with dynamic profile under rolling conditions.

The parallel groove under rolling conditions is shown in figure 28, the cross-sectional profile along with the stylus trace are plotted in figure 29. The superposition of the stylus trace on the dynamic profile shows a reduction in film thickness on the side of the groove that does not have a built-up edge. This reduction in film thickness is similar to that found at the ends of rollers for line contact geometries (23, 32). The reduction in film thickness is very localized and is due to the side-leakage that occurs as the groove passes through the inlet region.

The groove under sliding conditions is shown in figure 30 and its cross-sectional profile is plotted in figure 31. The film thickness distribution for rolling (fig. 29) and sliding (fig. 31) are almost identical. This is contrary to what was observed when the groove was oriented perpendicular to the direction of flow where substantial differences were observed between rolling and sliding conditions. For the case when the groove is oriented in the direction of flow, there is comparatively little change in the geometry of the groove in this direction as it passes through the Hertzian region so that the presence of sliding will not significantly alter the micro-EHD activity. Thus, for topographical features oriented in the direction of flow the micro-EHD action is confined to the inlet region for sliding as well as for rolling conditions.

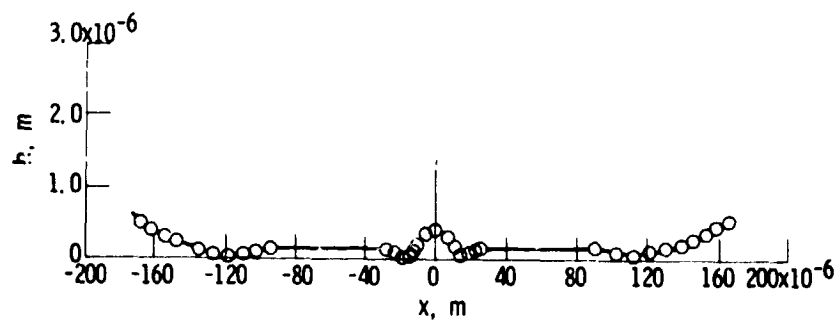
Figure 31. - Cross-sectional plot (perpendicular to flow direction) of groove in figure 30.
