NASA Technical Paper 1274

Erosion/Corrosion of Turbine Airfoil Materials in the High- Velocity Effluent of a Pressurized Fluidized Coal Combustor

Glenn R. Zellars, Anne P. Rowe,
and Carl E. Lowell

JULY 1978

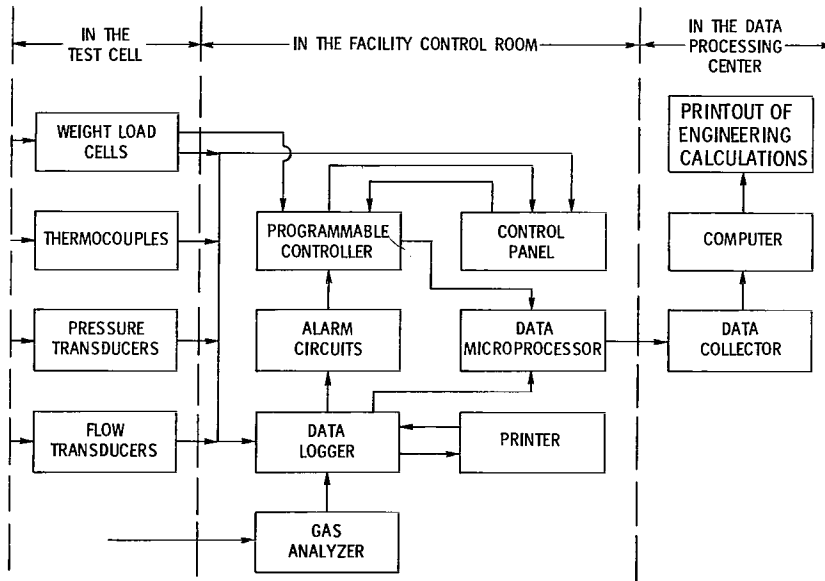
Figure 5. - Schematic of data acquisition system.

The Lewis PFB is extensively instrumented to record, monitor, and control operations. The facility was designed to operate with minimum manpower by using a programmable controller and an abort monitoring and annunciator system. Figure 5 is a schematic representation of the data acquisition, data recording, and data processing connections. The data logger receives nearly 200 responses from pressure transducers, thermocouples, and flowmeter readings located in the test cell. The data logger acquires this research data, digitizes and displays signals, logs data on printed paper tapes and a typewriter, and provides alarm set points for PFB process control. The remote collector terminal microcomputer accepts the string of characters from the data logger, puts them into an acceptable format for the central data collector, and transmits data in character synchronous mode to the data collector. The central data collector performs transmission error checking, creates a legal record of data on magnetic tape, and transmits data to the central computer in character format for research calculations.

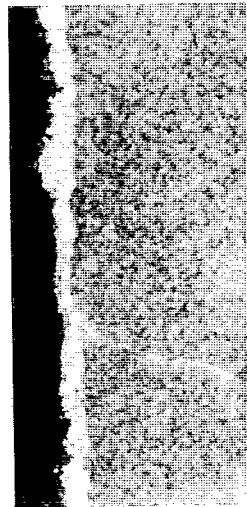
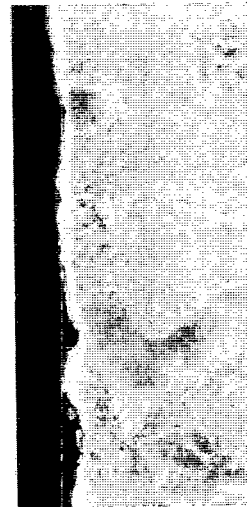
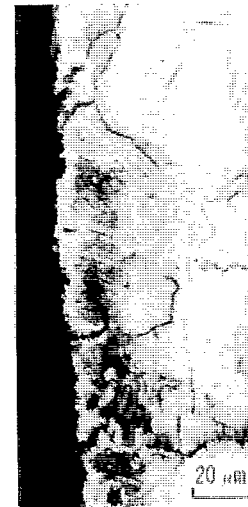
Figure 23. - Right faces near ends of alloys exposed at 270 meters per second and 790° C for 36 hours.

In the final test, at 270 meters per second and 790^o C for 36 hours, the same types of corrosion products were presumably formed as in the third test, but the reaction products were removed more rapidly at the higher velocity. Figure 21 shows one example of nickel-rich oxides underlaid by a chromium-rich region and then a depleted zone containing NiS particles. However, as seen in figure 22, most of the reaction products and depleted zones have been eroded away. Examination of cross sections near the free ends of the specimens instead of at the centers, where the temperature was perhaps lower than at the center but the erosive force was certainly less, revealed both reaction products and depleted zones as shown in figure 23.
