597  
NASA CR - 135319

## ADVANCED CERAMIC MATERIAL FOR HIGH TEMPERATURE TURBINE TIP SEALS

### INTERIM TECHNICAL PROGRESS REPORT NO. 1

Solar Division of International Harvester Company  
San Diego, California

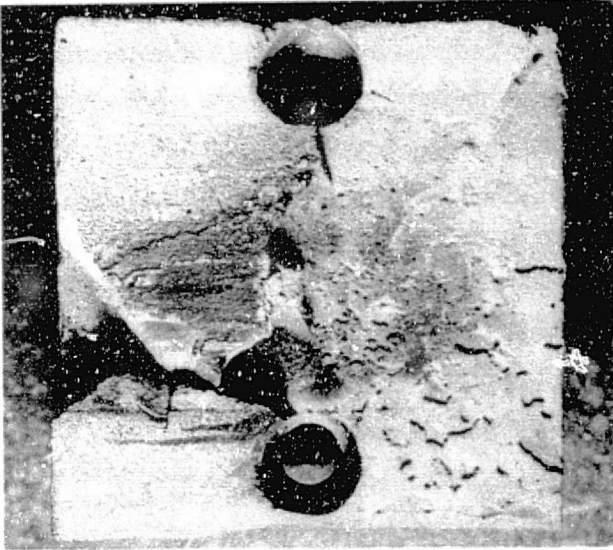
Reaction bonded 60 percent dense silicon nitride and sintered silicon nitride from two alternate vendors were also tested with similar results (Figs. 14 and 15). The reaction bonded structure shattered completely during test with no evidence of abrading prior to failure. Mechanical stresses and blade wear were low. High thermal stresses, due to frictional heating, were indicated by blade and sample appearance. The sintered structure also did not abrade. Cracking and chipping occurred in the rub area without total material loss. Transfer of the blade material to the ceramic surface was also evident. The sintered structure shows some improvement over reaction bonded structures, but cannot be described as a true abradable material.

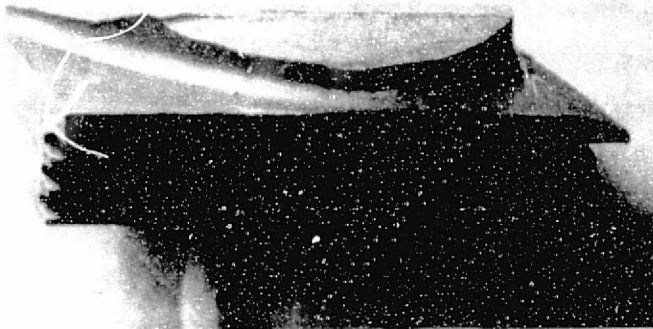
Figures 17 and 18 illustrate the appearance of a MAR-M421 turbine blade (reduced in the tip section to parallel the ceramic inserts) after rub. The tip is worn for approximately 64 percent of the total penetration. Wear is over twice that of the ceramic tips from similar tests. Views are presented in Figures 19 and 20 of silicon nitride tips subjected to this test. A single fracture has occurred. Although not readily visible, small

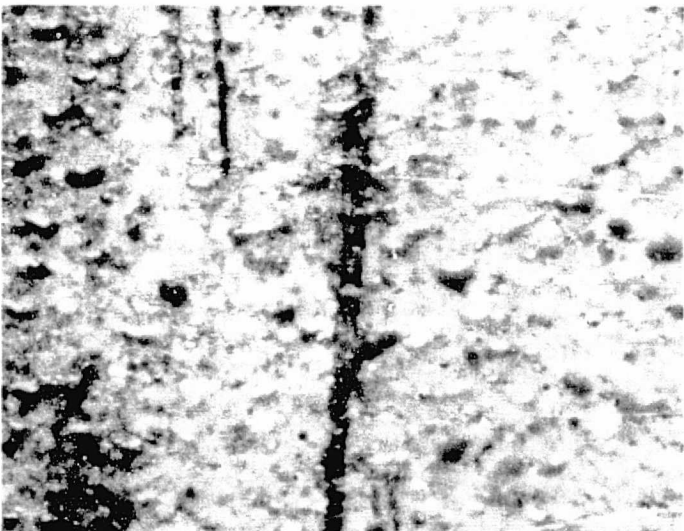
Figure 40.

Reaction Bonded Silicon  
Nitride After Hot Gas  
Erosion Test Showing  
Crack Propagation (A)  
From Impact Crater (B)

Magnification: 22X

| <u>Figure</u> | | <u>Page</u> |
|---|---|---|
| 40 | Reaction Bonded Silicon Nitride After Hot Gas Erosion Test Showing Crack Propagation From Impact Crater | 33 |
